**CONTRACT NO. 1/WSD/19 & 6/WSD/21**

IN-SITU REPROVISIONING OF SHA TIN WATER TREATMENT WORKS (SOUTH WORKS) – WATER TREATMENT WORKS AND **ANCILLARY FACILITIES Environmental Permit EP-494/2015**

In-Situ Reprovisioning of Sha Tin Water Treatment Works (South Works) – Water Treatment Works and Ancillary Facilities
Environmental Permit EP-494/2015
Submission of 95<sup>th</sup> monthly EM&A Report

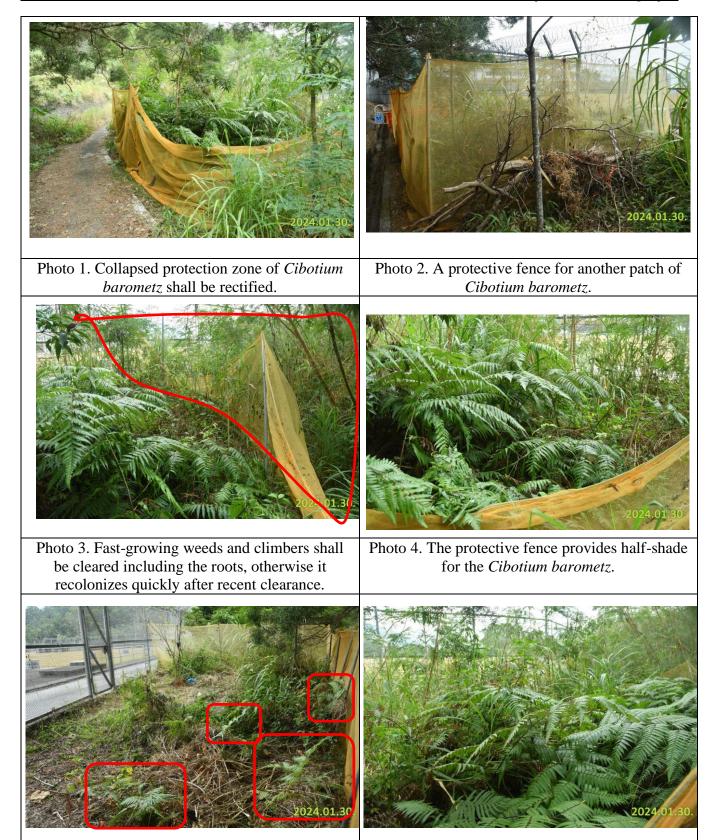
Photo 5 & 6. Despite the *Cibotium barometz* (red) are growing in satisfactory condition, it has already been hidden by weeds and climbers, which may deplete their health/ growth condition.

- 2.5.6 Weeding by hand held tools within protection zone of Cibotium barometz is urgently needed.
- 2.5.7 Root ball of TA572 and TA327 tree should be kept moisture especially during dry and non-raining day.

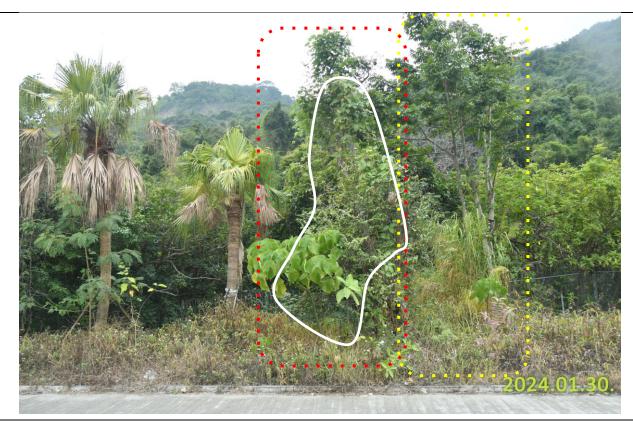
Photo 7. Transplanted Incense Tree (*Aquilaria sinensis*) – TA327 (red); and Ailanthus (*Ailanthus fordii*) – TA572 (yellow). Climber (white) should be removed, including the roots, to relieve the canopy

- 2.5.1 The condition of TA572 was observed in fair health despite in poor form. TA327 was in fair condition; while already dead TA326 collapsed under Signal No. 10 typhoon Mangkhut in September 2018. Tree guying cables have been installed to provide external support to the two remaining transplanted trees. Climbing vines on TA327 should be removed, including the roots, to reduce rapid colonization covering the canopy.

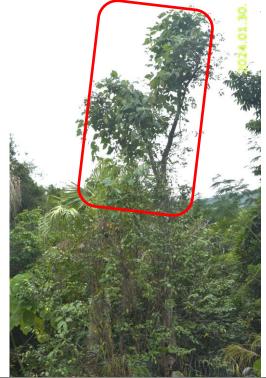
Photo 8. Sprouts at lower trunk of TA327 (*Aquilaria sinensis*). Climber (red) should be removed, including the roots, to relieve the canopy

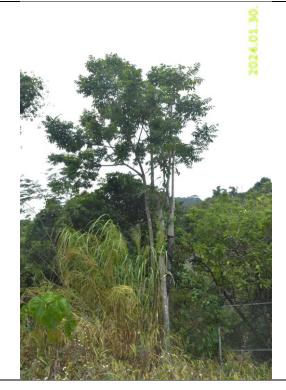
Photo 9. TA572 (*Ailanthus fordii*) was found vigorous and in generally good condition. Surrounding weeds/ grass should be removed

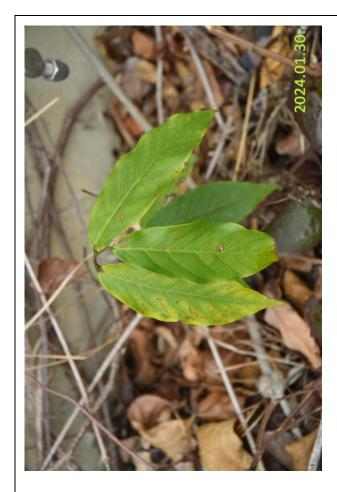
Photo 10. New sprouts of the *Desmos chinensis* that reported dead previously. Sign of dehydration detected.

- 2.5.4 New small sprouts keep emerging from the two *Desmos chinensis* that have been reported dead previously. Construction materials was also found too close to the planter. An eye-catching protective fence shall be set up as a protection zone. No construction materials shall be placed near/ within the protection zone.

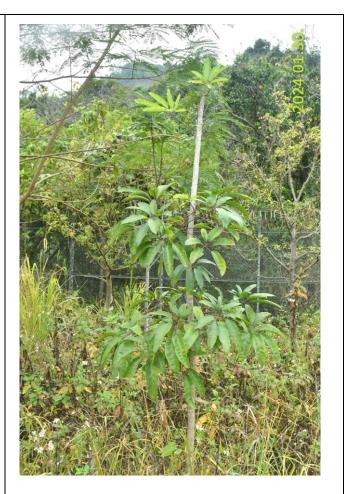
Photo 11. *Schefflera heptaphylla* as compensatory planting of TA326.

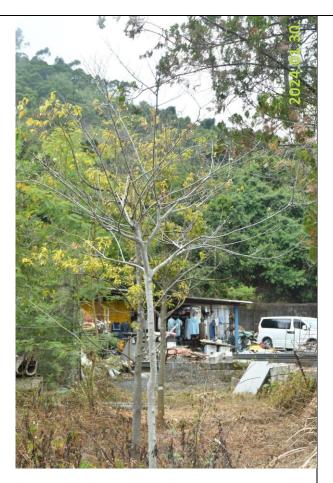
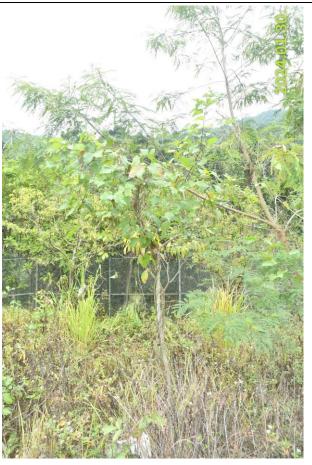
Photo 12 and 13. The two exotic *Syzygium jambos* (mis-treated as the native *Syzygium levinei*) are replaced by another native tree *Celtis sinensis* (due to market availability) as compensatory planting of TA326. Note: *Celtis sinensis* is a deciduous species.

- 2.5.2 Compensatory planting of TA326 has been completed on 25 March 2020 by planting two *Syzygium levinei* and one *Schefflera heptaphylla*. However, the two native *Syzygium levinei* were mis-planted by two exotic *Syzygium jambos*, which has been replaced by another native tree species *Celtis sinensis* on 31 May 2021. Climbing vines on one of the Celtis sinensis should be removed, including the roots, to reduce rapid colonization covering the canopy.
