Service Contract No. WD/02/2021

Environmental Team for Hung Shui Kiu/Ha Tsuen New Development Area Stage 1 -**Site Formation and Engineering Infrastructure**

Monthly EM&A Report (**January 2023**)

(Environmental Permit No. EP-528/2017)

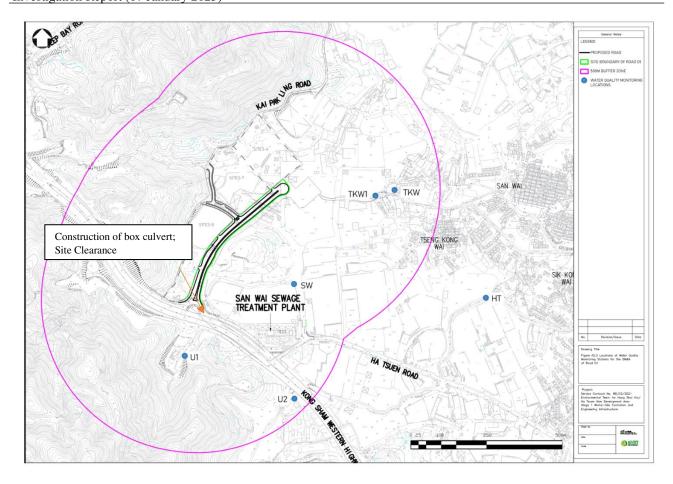
Figure 1 Location Plan of Impact Water Quality Monitoring Stations (Site activities held on 17 January 2023 were reported in text boxes)

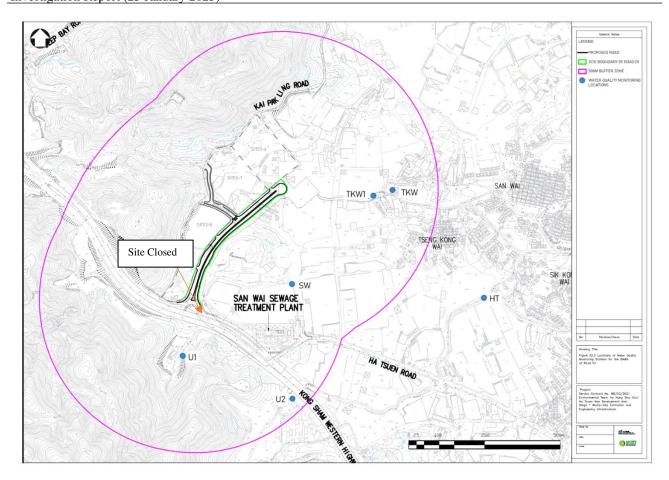
Figure 1 Location Plan of Impact Water Quality Monitoring Stations (Site activities held on 25 January 2023 were reported in text boxes)
