**Service Contract No. WD/02/2021**

**Environmental Team for Hung Shui Kiu/Ha Tsuen**  
**New Development Area Stage 1 –**  
**Site Formation and Engineering Infrastructure**

**Monthly EM&A Report**  
**(November 2023)**

**(Environmental Permit No. EP-528/2017)**

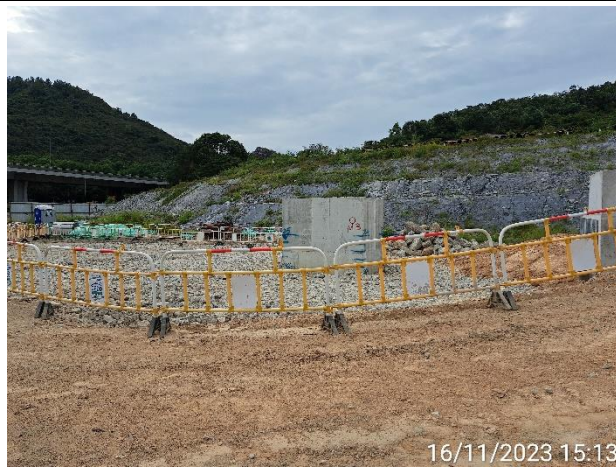
(P1)

Stockpile of dusty materials was covered properly to avoid generation of muddy runoff. No muddy surface runoff was observed during the site inspection.

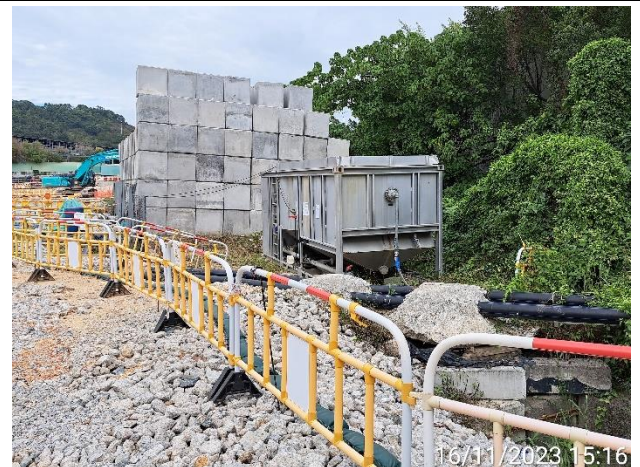
(P2)

Surface runoff and site effluent were collected and diverted to the WetSep for temporary storage and treatment before the water was used for fugitive dust suppression on site or discharged at designated location under the requirement of effluent discharge licence.

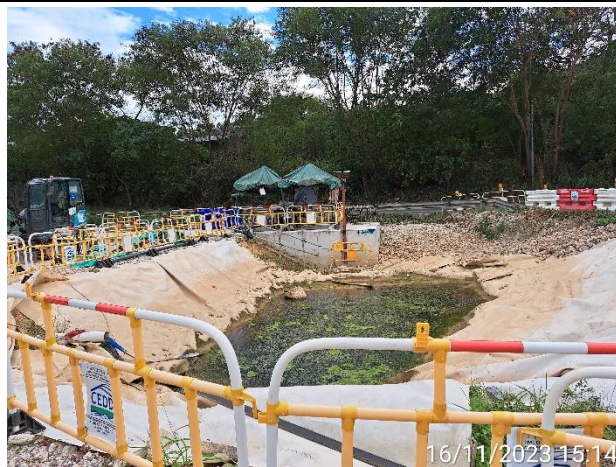
(P3)

Surface runoff was directed to the sump/ detention pond for temporary storage. No muddy surface runoff and no direct discharge of construction effluent was observed.

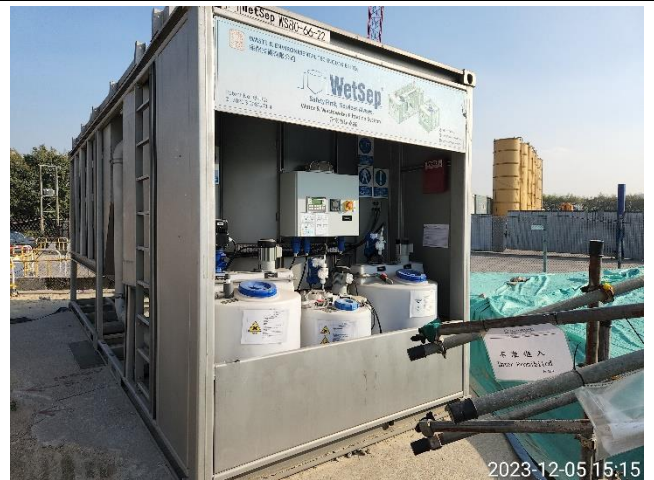
(P9)

A WetSep was provided on site to treat and store construction effluent from Site 3-6, Site 3-7 and Contaminated Soil Treatment Area. No off-site effluent discharge was recorded in November 2023.

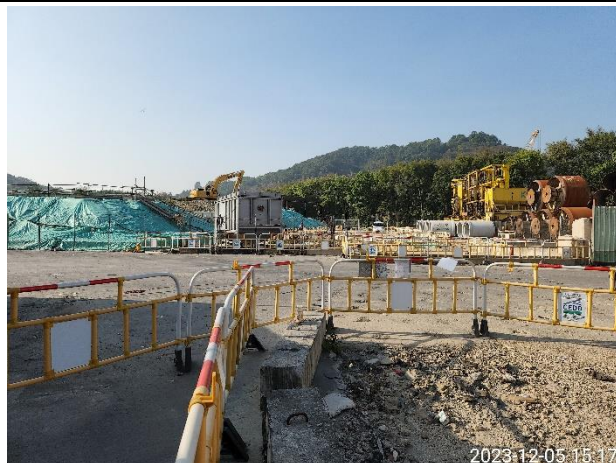
(P10)

An effluent discharge license for Site 3-6, Site 3-7 and Contaminated Soil Treatment Area has been acquired in November 2023. A channel constructed for off-site discharge of treated effluent was dry and no wastewater was observed.

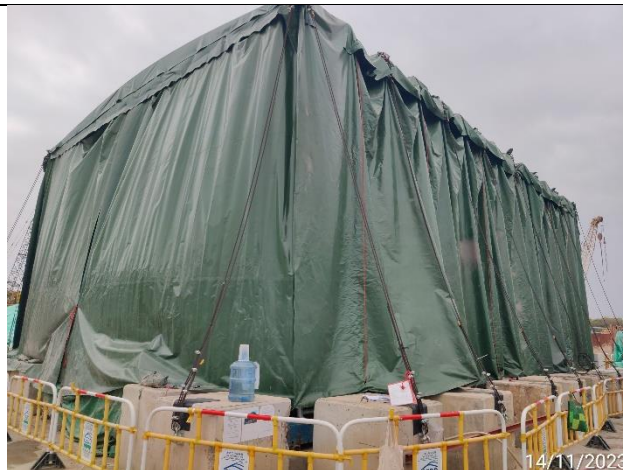
(R2)

The contaminated soil treatment area were covered by impervious canvas. No surface runoff or effluent was leaked from the contaminated soil treatment area during the site inspection.

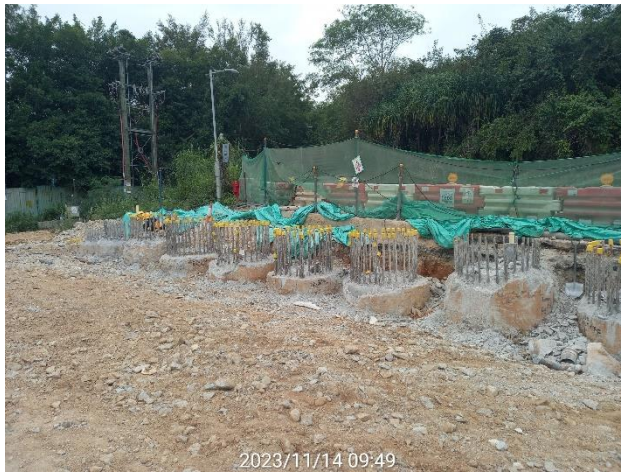
(R3)

No effluent discharge from the site was observed.

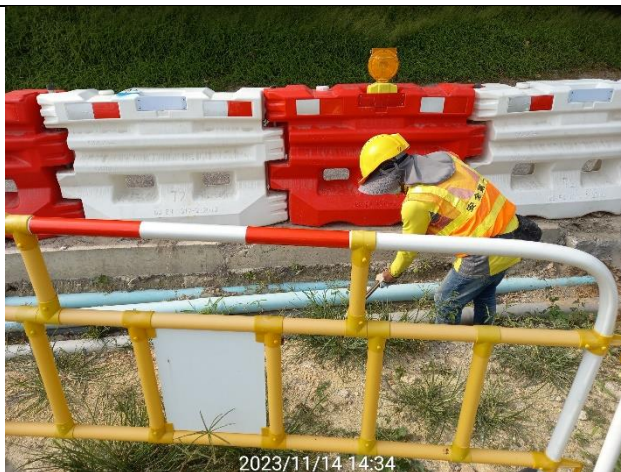
(R4)

No effluent discharge from the site was observed.

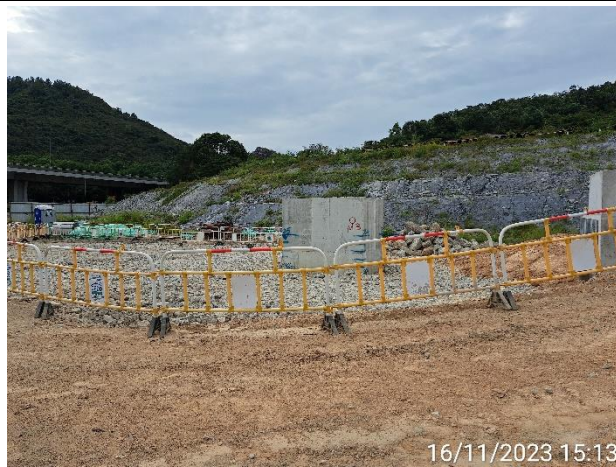
(P1)

Stockpile of dusty materials was covered properly to avoid generation of muddy runoff. No muddy surface runoff was observed during the site inspection.

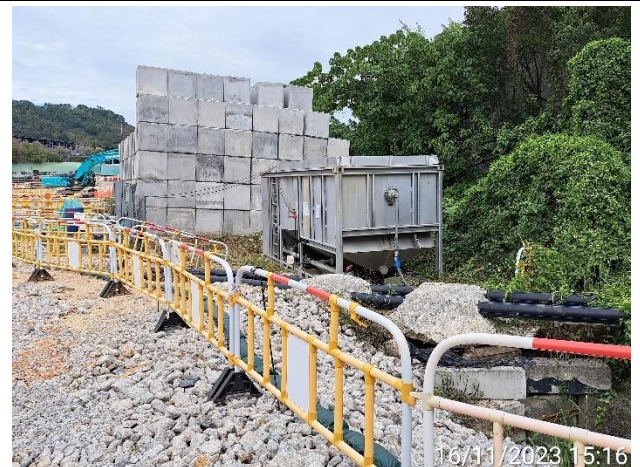
(P2)

Surface runoff and site effluent were collected and diverted to the WetSep for temporary storage and treatment before the water was used for fugitive dust suppression on site or discharged at designated location under the requirement of effluent discharge licence.

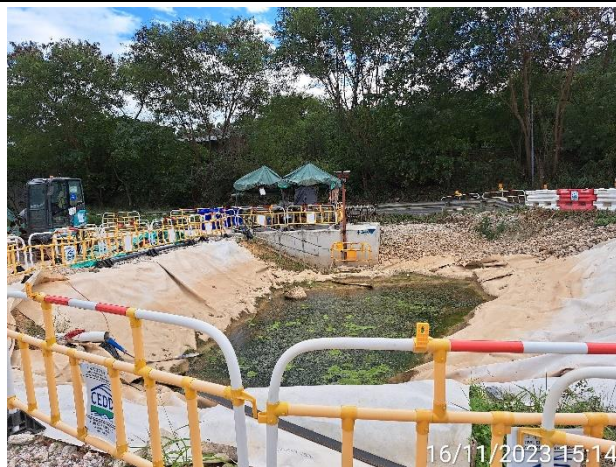
(P3)

Surface runoff was directed to the sump/ detention pond for temporary storage. No muddy surface runoff and no direct discharge of construction effluent was observed.

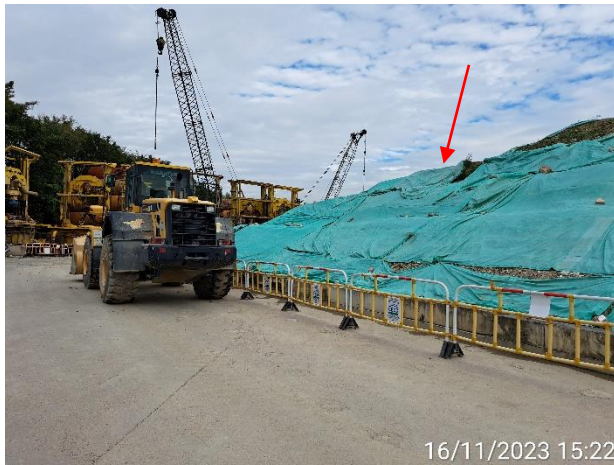
(P4)

Contaminated materials were stocked on site pending for decontamination.

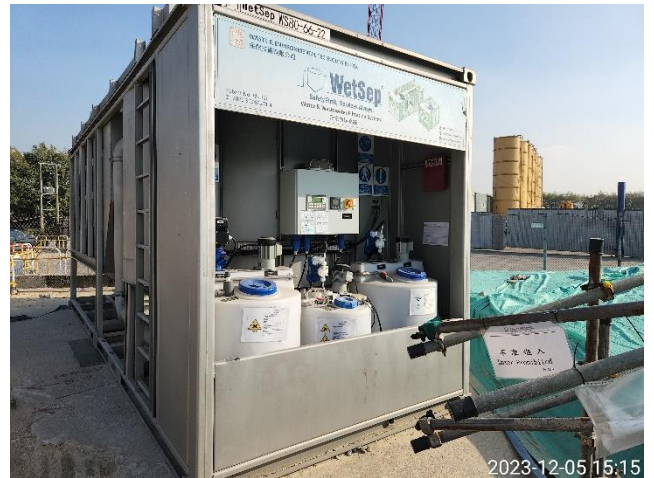
(P9)

A WetSep was provided on site to treat and store construction effluent from Site 3-6, Site 3-7 and Contaminated Soil Treatment Area. No off-site effluent discharge was recorded in November 2023.

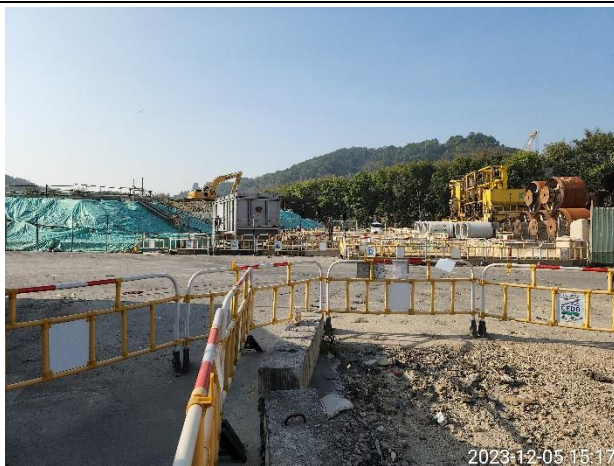
(P10)

An effluent discharge license for Site 3-6, Site 3-7 and Contaminated Soil Treatment Area has been acquired in November 2023. A channel constructed for off-site discharge of treated effluent was dry and no wastewater was observed.

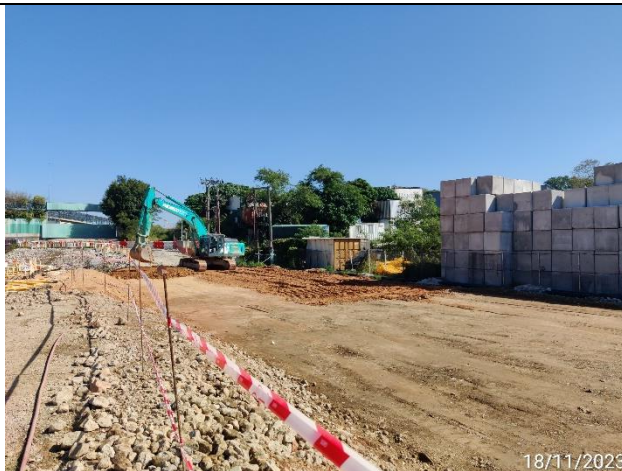
(R1)

No effluent discharge from the site was observed.

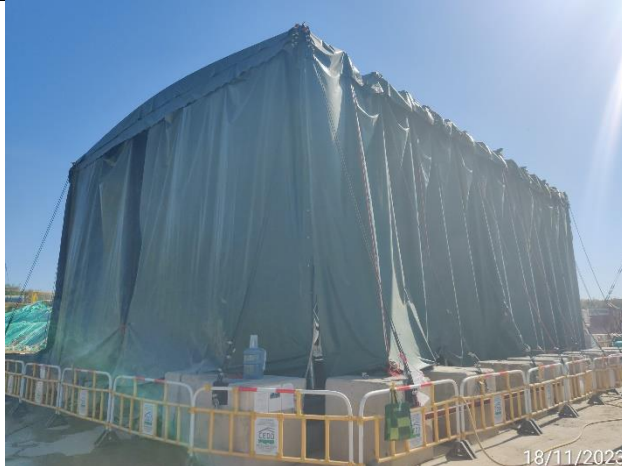
(R2)

The contaminated soil treatment area were covered by impervious canvas. No surface runoff or effluent was leaked from the contaminated soil treatment area during the site inspection.

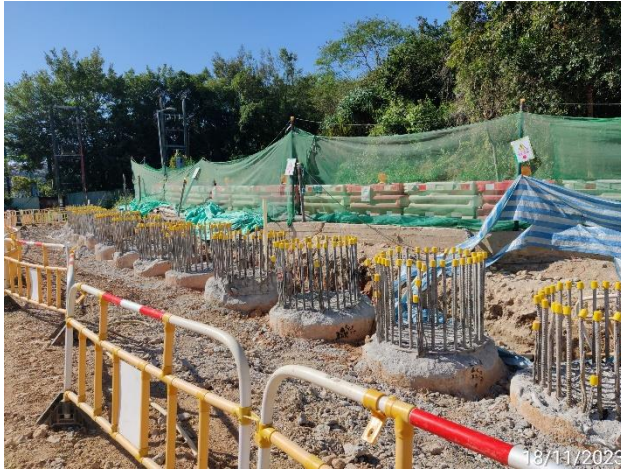
(R3)

No effluent discharge from the site was observed.

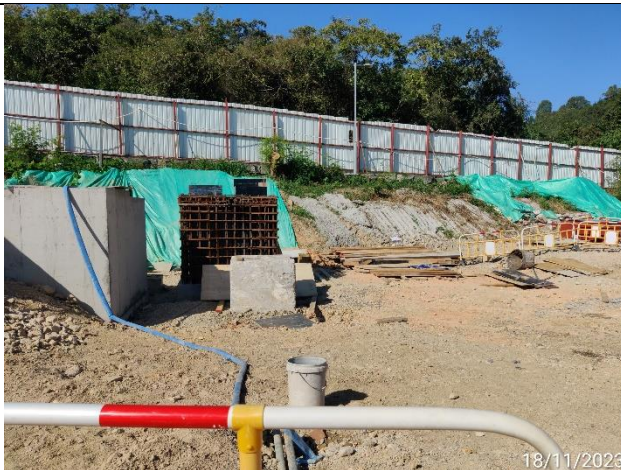
(R4)

No effluent discharge from the site was observed.
