Contract NO. DC/2007/12 - Design and Construction of Tsuen Wan Drainage Tunnel

Quarterly EM&A Report (April to June 2011)

Hyder Consulting Limited

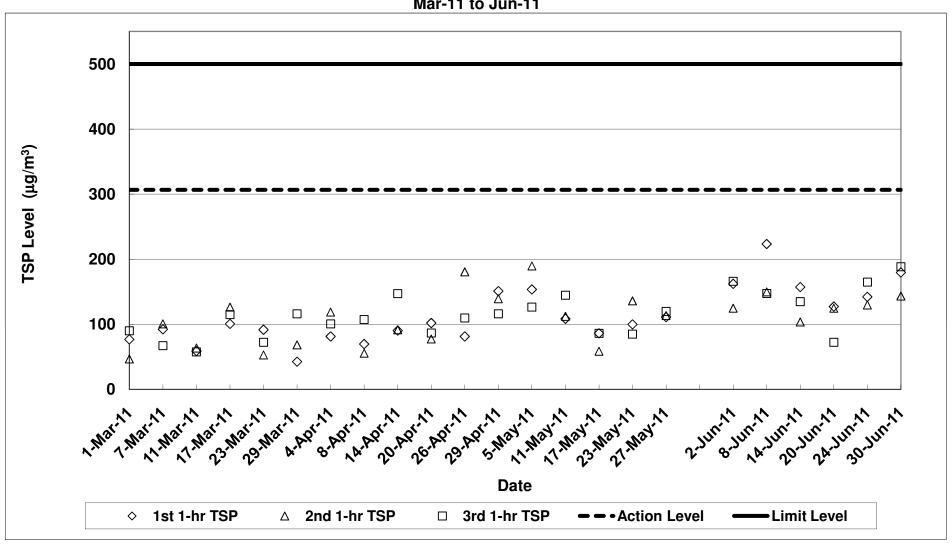
Contract No. DC/2007/12 - Design and Construction of Tsuen Wan Drainage Tunnel Air Quality Monitoring (1-hr TSP) Results at Sik Sik Yuen Ho Fung College - Intake (ASR1)

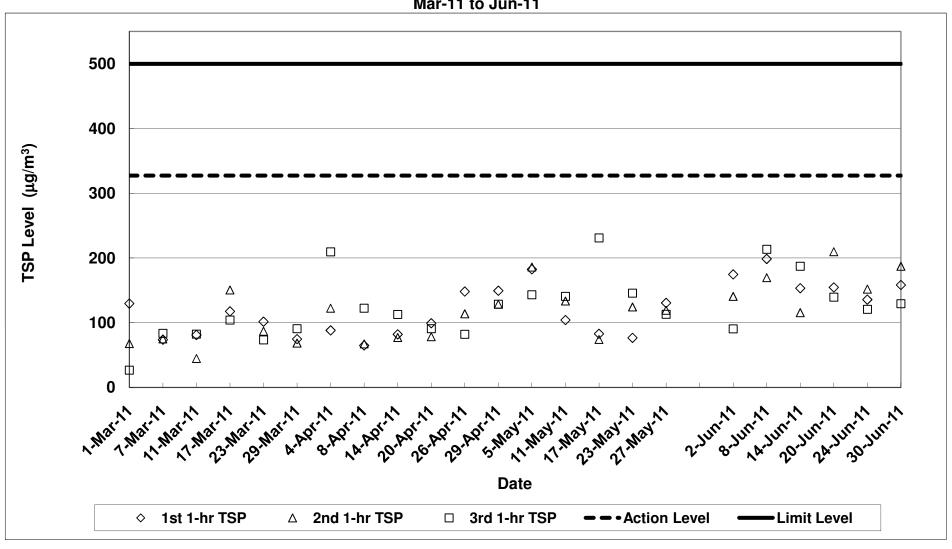
Contract No. DC/2007/12 - Design and Construction of Tsuen Wan Drainage Tunnel Air Quality Monitoring (1-hr TSP) Results at Hong Hoi Chee Hong Temple - Intake (ASR3)

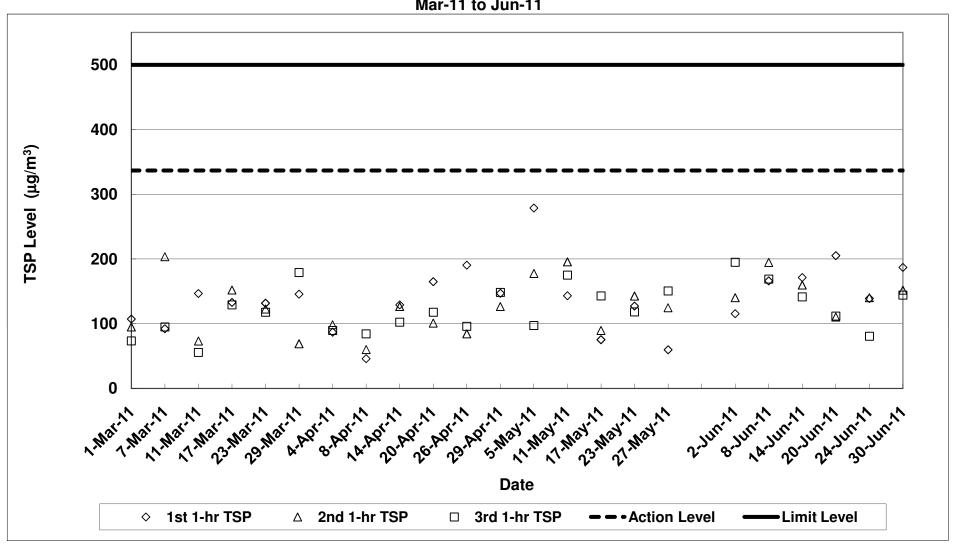
Contract No. DC/2007/12 - Design and Construction of Tsuen Wan Drainage Tunnel Air Quality Monitoring (1-hr TSP) Results at Long Beach Gardens - Outfall (ASR8)

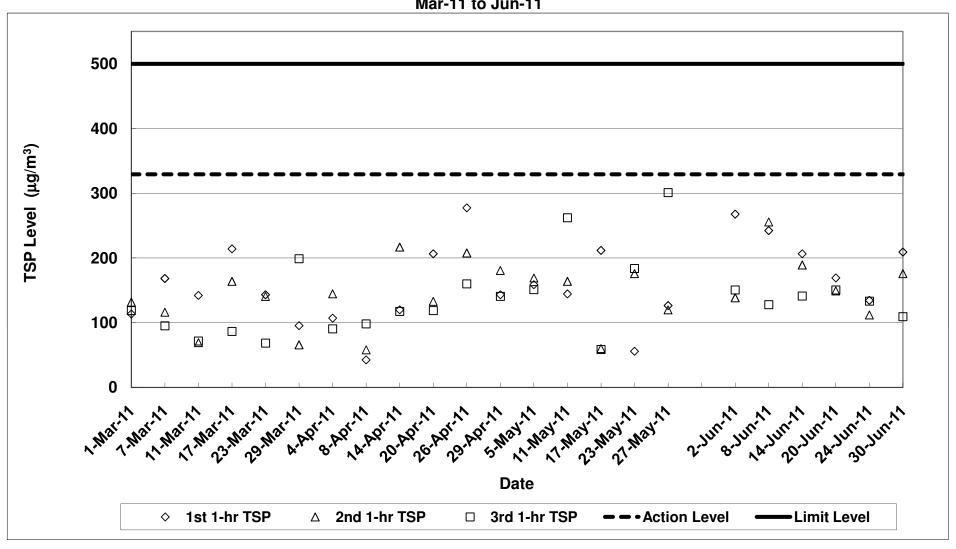
Contract No. DC/2007/12 - Design and Construction of Tsuen Wan Drainage Tunnel Air Quality Monitoring (1-hr TSP) Results at Greenview Terrace - Outfall (ASR9)

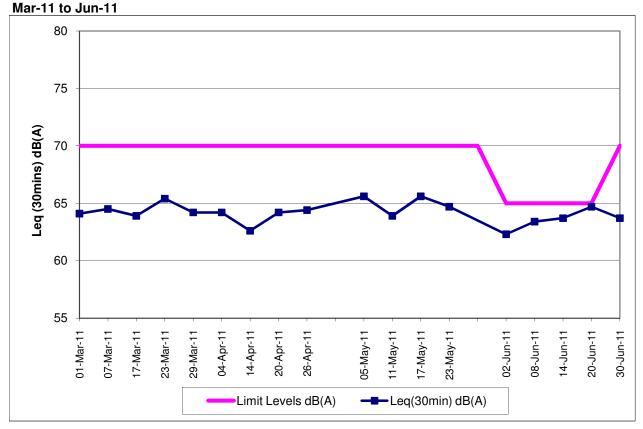
Contract No. DC/2007/12 - Design and Construction of Tsuen Wan Drainage Tunnel Noise Monitoring Results at Sik Sik Yuen Ho Fung College (NSR 1)

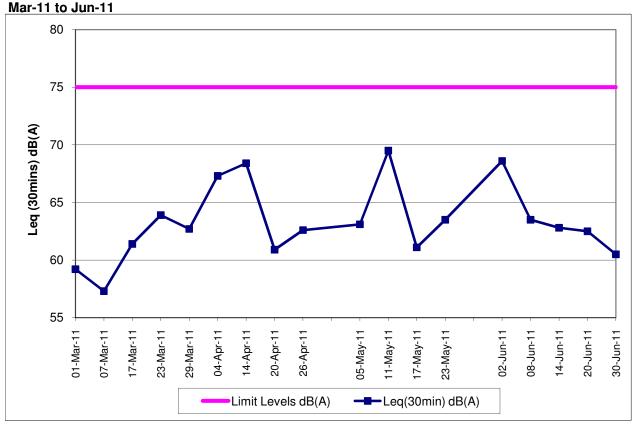
Contract No. DC/2007/12 - Design and Construction of Tsuen Wan Drainage Tunnel Noise Monitoring Results at Hong Hoi Chee Hong Temple (NSR 3)

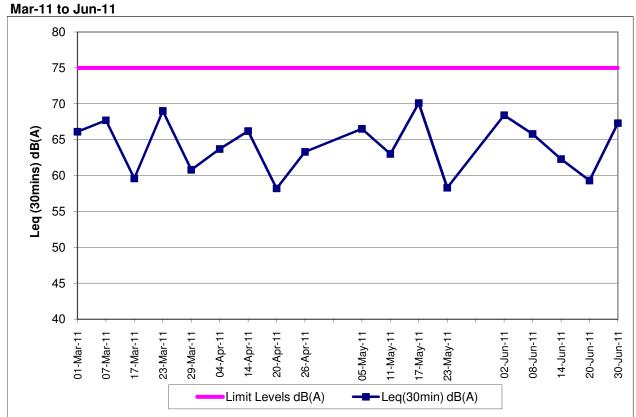
Contract No. DC/2007/12 - Design and Construction of Tsuen Wan Drainage Tunnel Noise Monitoring Results at Squatters (NSR 6)

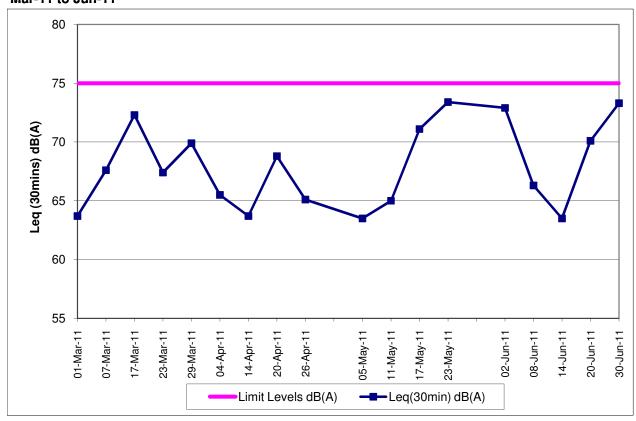
Contract No. DC/2007/12 - Design and Construction of Tsuen Wan Drainage Tunnel Noise Monitoring Results at Long Beach Gardens (NSR 8)

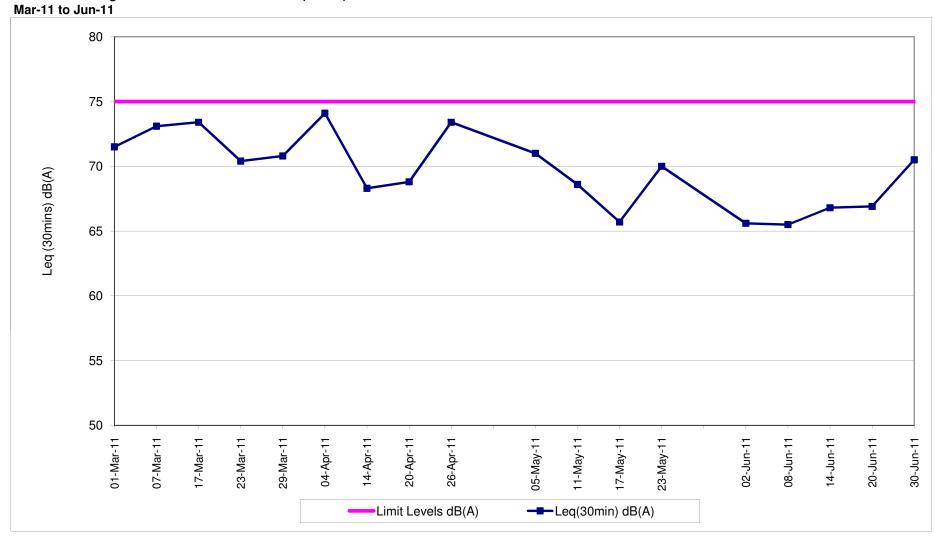
Contract No. DC/2007/12 - Design and Construction of Tsuen Wan Drainage Tunnel Noise Monitoring Results at Greenview Terrace (NSR 9)

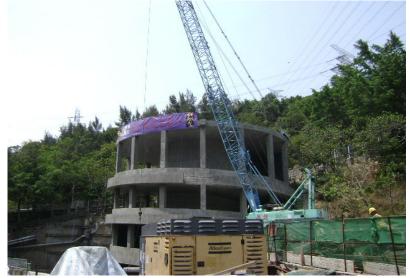
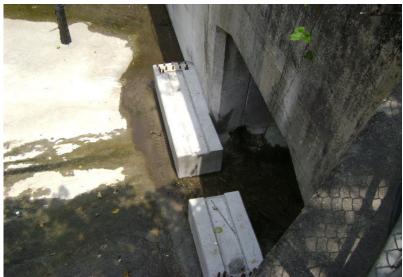
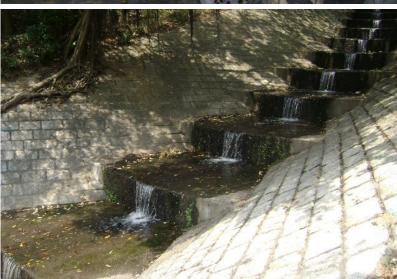
Photographic record for exceedance of Suspended Solids recorded at Sik Sik Yuen Ho Fung College (I-1) on 06-Apr-11

Site photo

Photo taken at I-1

Photo taken at I-1-C

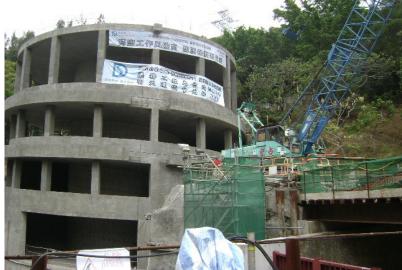
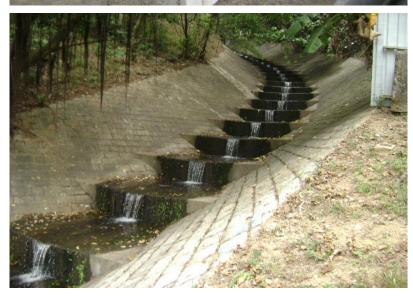
Photographic record for exceedance of Suspended Solids recorded at Sik Sik Yuen Ho Fung College (I-1) on 08-Apr-11

Site photo

Photo taken at I-1-C

Actions taken / to be taken	(1) Silt curtain had been provided along the Portion E boundary line and extended from seawater level to the bottom of seabed; (2) Floating type silt curtain had been employed at the inner side; (3) Sufficient slack of silt curtain was allowed to cope with the wave and tidal action to ensure the curtains (outer and inner) were rested on seabed; (4) condition of silt curtain was checked by the supervisor daily; (5) and seawall blocks installation was undertaken within the inner silt curtain area only.
Remarks	None

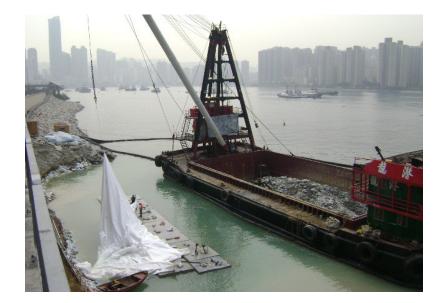
Photographic record for exceedance of Suspended Solids (SS) recorded at O-1(FT) on 08-Apr-11

Site photo

Actions taken / to be taken	(1) Silt curtain had been provided along the Portion E boundary line and extended from seawater level to the bottom of seabed; (2) Floating type silt curtain had been employed at the inner side; (3) Sufficient slack of silt curtain was allowed to cope with the wave and tidal action to ensure the curtains (outer and inner) were rested on seabed; (4) condition of silt curtain was checked by the supervisor daily; (5) and seawall blocks installation was undertaken within the inner silt curtain area only.
Remarks	None

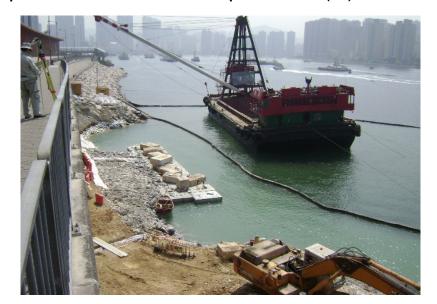
Photographic record for exceedance of Suspended Solids (SS) recorded at O-1(FT) on 11-Apr-11

Site photo

Actions taken / to be taken	(1) Silt curtain had been provided along the Portion E boundary line and extended from seawater level to the bottom of seabed; (2) floating type silt curtain had been employed at the inner side; (3) sufficient slack of silt curtain was allowed to cope with the wave and tidal action to ensure the curtains (outer and inner) were rested on seabed; (4) condition of silt curtain was checked by the supervisor daily; (5) and seawall blocks installation was undertaken within the inner silt curtain area only.
Remarks	None

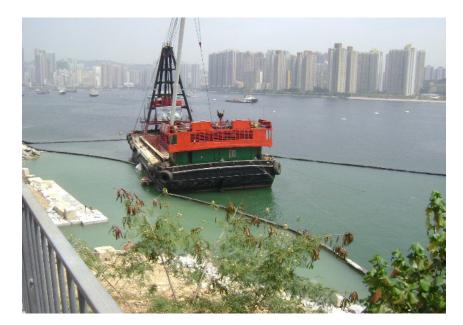
Photographic record for exceedance of Suspended Solids (SS) recorded at O-1(FT) on 13-Apr-11

Site photo

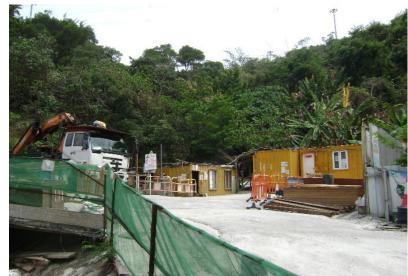
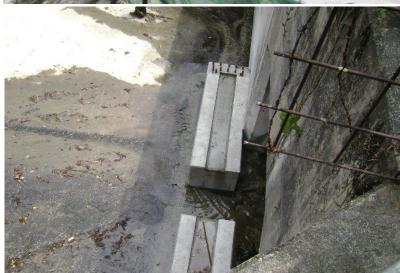
Photographic record for exceedance of Suspended Solids recorded at Sik Sik Yuen Ho Fung College (I-1) on 18-Apr-11

Site photo

Photo taken at I-1

Actions taken / to be taken	(1) Silt curtain was provided along the Portion E boundary line and extended from seawater level to the bottom of seabed; (2) floating type silt curtain was employed at the inner side; (3) sufficient slack of silt curtain was allowed to cope with the wave and tidal action to ensure the curtains (outer and inner) were rested on seabed; (4) condition of silt curtains was checked by the supervisor daily; and (5) seawall blocks installation was undertaken within the inner silt curtain area only.
Remarks	None

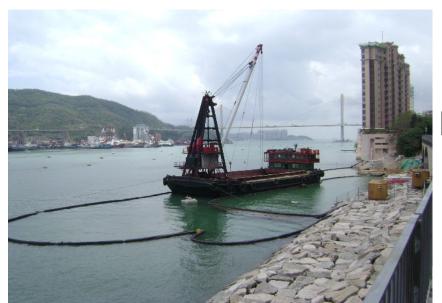
Photographic record for exceedance of Dissolved Oxygen (marine surface) recorded at O-1(FT) on 07-May-11

Site photo

Actions taken / to be taken	(1) Silt curtain was provided along the Portion E boundary line and extended from seawater level to the bottom of seabed; (2) floating type silt curtain was employed at the inner side; (3) sufficient slack of silt curtain was allowed to cope with the wave and tidal action to ensure the curtains (outer and inner) were rested on seabed; (4) condition of silt curtains was checked by the supervisor daily; and (5) seawall blocks installation was undertaken within the inner silt curtain area only.
Remarks	None

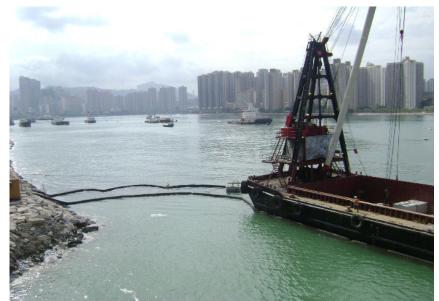
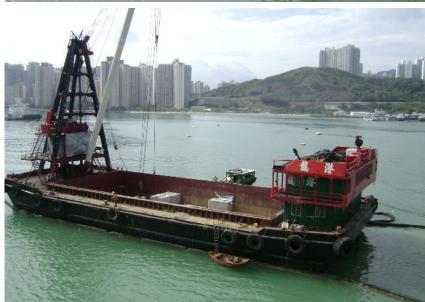
Photographic record for exceedance of Dissolved Oxygen (marine surface) recorded at O-1(ET) on 07-May-11

Project	Tsuen Wan Drainage Tunnel
Date	07-May-11
Time	12:28 PM
Monitoring Location	O-1(ET)
Parameter	Dissolved Oxygen (marine surface)
Action & Limit Levels (mg/L)	7.02 / 6.94
Measured Level (mg/L)	6.90
Control Station	O-1-C(ET)
Measured Level at the Control Station (mg/L)	6.88
Possible reason for Action or Limit Level Non-compliance	The measured DO level (marine surface) was below the baseline limit level but was within the ranges of 3-year (2007 - 2009) marine surface DO records between 4.3 and 9.4 mg/L at EPD WM4 marine water quality monitoring station near Ma Wan and between 4.2 and 8.6 mg/L at EPD VM14 marine water quality monitoring station towards the north of Rambler Channel. Adjusting level of installed seawall blocks and survey check on installed seawall blocks were conducted at the Outfall basin (Portion E) during monitoring. Since there was no other marine works conducted during the monitoring, the exceedance was considered to be contributed by natural variation and no further action was required.

Site photo

Actions taken / to be taken	(1) Silt curtain was provided along the Portion E boundary line and extended from seawater level to the bottom of seabed; (2) floating type silt curtain was employed at the inner side; (3) sufficient slack of silt curtain was allowed to cope with the wave and tidal action to ensure the curtains (outer and inner) were rested on seabed; (4) condition of silt curtains was checked by the supervisor daily; and (5) seawall blocks installation was undertaken within the inner silt curtain area only.
Remarks	None

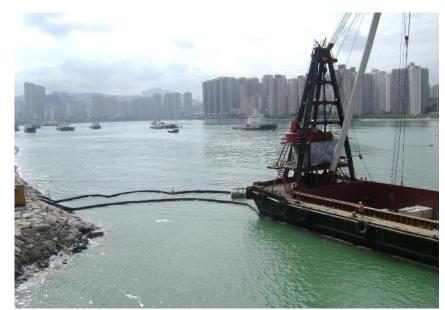
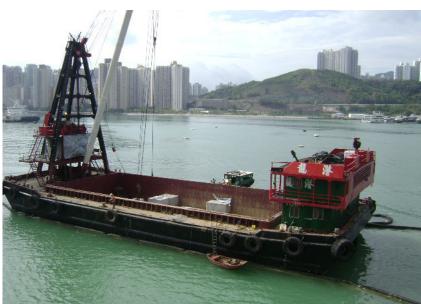
Photographic record for exceedance of Dissolved Oxygen (marine mid-depth) recorded at O-1(ET) on 07-May-11

Project	Tsuen Wan Drainage Tunnel
Date	07-May-11
Time	12:28 PM
Monitoring Location	O-1(ET)
Parameter	Dissolved Oxygen (marine mid-depth)
Action & Limit Levels (mg/L)	7.02 / 6.94
Measured Level (mg/L)	6.84
Control Station	O-1-C(ET)
Measured Level at the Control Station (mg/L)	6.76
Possible reason for Action or Limit Level Non-compliance	The measured DO level (marine mid-depth) was below the baseline limit level but was within the ranges of 3-year (2007 - 2009) marine mid-depth DO records between 2.6 and 9.1 mg/L at EPD WM4 marine water quality monitoring station near Ma Wan and between 3.9 and 8.5 mg/L at EPD VM14 marine water quality monitoring station towards the north of Rambler Channel. Adjusting level of installed seawall blocks and survey check on installed seawall blocks were conducted at the Outfall basin (Portion E) during monitoring. Since there was no other marine works conducted during the monitoring, the exceedance was considered to be contributed by natural variation and no further action was required.

Site photo

Actions taken / to be taken	(1) Silt curtain was provided along the Portion E boundary line and extended from seawater level to the bottom of seabed; (2) floating type silt curtain was employed at the inner side; (3) sufficient slack of silt curtain was allowed to cope with the wave and tidal action to ensure the curtains (outer and inner) were rested on seabed; (4) condition of silt curtains was checked by the supervisor daily; and (5) seawall blocks installation was undertaken within the inner silt curtain area only.
Remarks	None

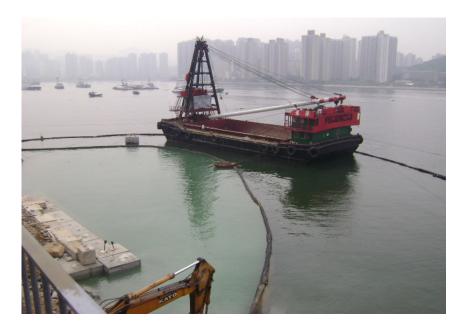
Photographic record for exceedance of Suspended Solids (SS) recorded at O-1(FT) on 03-May-11

Project	Tsuen Wan Drainage Tunnel
Date	03-May-11
Time	5:35 PM
Monitoring Location	O-1(FT)
Parameter	Suspended Solids (SS)
Action & Limit Levels (mg/L)	14.10 / 18.08 (derived from the baseline monitoring data)
Measured Level (depth- averaged) at Monitoring Location	8.45
Control Station	O-1-C(FT)
Measured Level (depth averaged) at Control Station (mg/L)	6.97
Possible reason for Action or Limit Level Non-compliance	The measured SS level (depth-averaged) at O-1(FT) was below the baseline action/limit level but was higher than 120% of the control station's SS level (O-1-C(FT)) at the same tide of the same day. Only placing seawall blocks was undertaken and there was no other marine works conducted during the monitoring. Silt curtain was deployed along the Portion E boundary line and extended from seawater level to seabed. Floating type silt curtain was also employed at the inner side. As such, the exceedance was considered to be contributed by natural variation and no further action was required.

Actions taken / to be taken	(1) Silt curtain was provided along the Portion E boundary line and extended from seawater level to the bottom of seabed; (2) floating type silt curtain was employed at the inner side; (3) sufficient slack of silt curtain was allowed to cope with the wave and tidal action to ensure the curtains (outer and inner) were rested on seabed; (4) condition of silt curtains was checked by the supervisor daily; and (5) seawall blocks installation was undertaken within the inner silt curtain area only.
Remarks	None

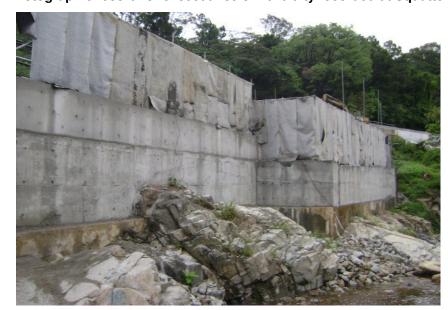
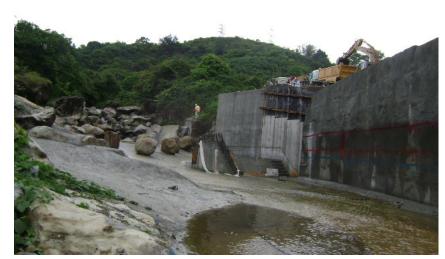
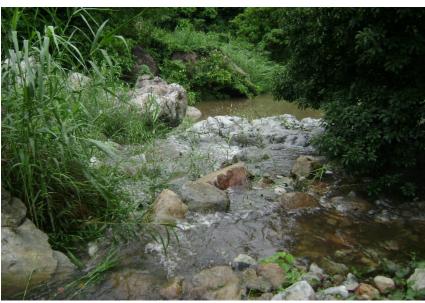
Photographic record for exceedance of Turbidity recorded at Squatters (I-3) on 13-May-11

Project	Tsuen Wan Drainage Tunnel
Date	13-May-11
Time	10:20 AM
Monitoring Location	Squatters (I-3)
Parameter	Turbidity
Action & Limit Levels (NTU)	3.99 / 4.18
Measured Level (NTU)	19.08
Control Station	I-3-C
Measured Level at the Control Station (NTU)	19.19
Possible reason for Action or Limit Level Non-compliance	The measured turbidity level was higher than baseline limit level, but lower than the turbuidity level of the control station (I-3-C). General site cleaning and housekeeping, monitoring of deformation monitoring point (DMP), drilling and rock breaking in shaft, installation of concrete blocks in shaft, digging trail pit and breaking of blinding layer at PB wall were undertaken during measurement. No direct disturbance was observed from the site and 33.5 mm rainfall was recorded on the same day. The exceedance was considered to be contributed by high turbidity level at upsteam location and rainfall. Since the exceedance was non-projected related, no further action was required.

Site photo

Photo taken at I-3

Photo taken at I-3-C

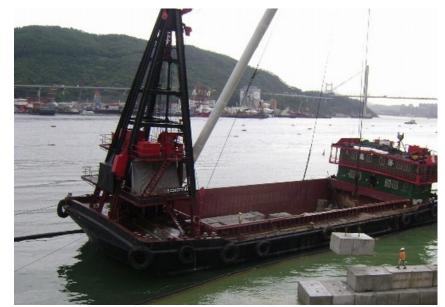
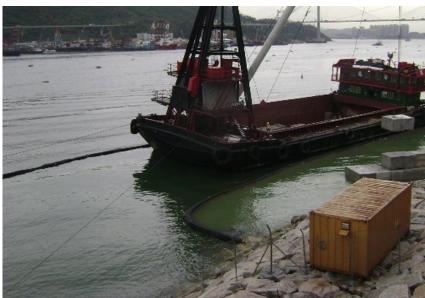
Photographic record for exceedance of Dissolved Oxygen (marine surface) recorded at O-1(ET) on 13-May-11

Project	Tsuen Wan Drainage Tunnel
Date	13-May-11
Time	9:40 AM
Monitoring Location	O-1(ET)
Parameter	Dissolved Oxygen (marine surface)
Action & Limit Levels (mg/L)	7.02 / 6.94
Measured Level (mg/L)	6.90
Control Station	O-1-C(ET)
Measured Level at the Control Station (mg/L)	7.08
Possible reason for Action or Limit Level Non-compliance	The measured DO level (marine surface) was below the baseline limit level but was within the ranges of 3-year (2007 - 2009) marine surface DO records between 4.3 and 9.4 mg/L at EPD WM4 marine water quality monitoring station near Ma Wan and between 4.2 and 8.6 mg/L at EPD VM14 marine water quality monitoring station towards the north of Rambler Channel. Loading seawall blocks onto installed seawall blocks and preparation work for geotextile were conducted at the Outfall basin (Portion E) during monitoring. Since there was no other marine works conducted during the monitoring, the exceedance was considered to be contributed by natural variation and no further action was required.

Site photo

Actions taken / to be taken	(1) Silt curtain was provided along the Portion E boundary line and extended from seawater level to the bottom of seabed; (2) floating type silt curtain was employed at the inner side; (3) sufficient slack of silt curtain was allowed to cope with the wave and tidal action to ensure the curtains (outer and inner) were rested on seabed; (4) condition of silt curtains was checked by the supervisor daily; and (5) seawall blocks installation was undertaken within the inner silt curtain area only.
Remarks	None

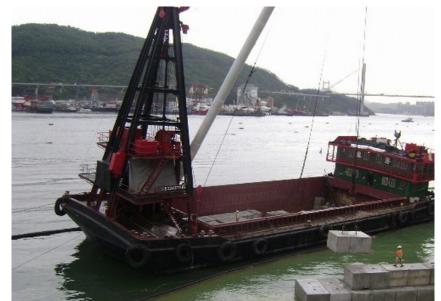
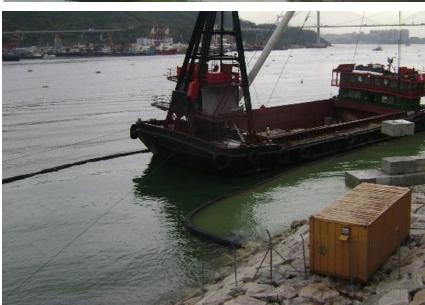
Photographic record for exceedance of Dissolved Oxygen (marine mid-depth) recorded at O-1(ET) on 13-May-11

Project	Tsuen Wan Drainage Tunnel
Date	13-May-11
Time	9:40 AM
Monitoring Location	O-1(ET)
Parameter	Dissolved Oxygen (marine mid-depth)
Action & Limit Levels (mg/L)	7.02 / 6.94
Measured Level (mg/L)	6.85
Control Station	O-1-C(ET)
Measured Level at the Control Station (mg/L)	7.01
Possible reason for Action or Limit Level Non-compliance	The measured DO level (marine mid-depth) was below the baseline limit level but was within the ranges of 3-year (2007 - 2009) marine mid-depth DO records between 2.6 and 9.1 mg/L at EPD WM4 marine water quality monitoring station near Ma Wan and between 3.9 and 8.5 mg/L at EPD VM14 marine water quality monitoring station towards the north of Rambler Channel. Loading seawall blocks onto installed seawall blocks and preparation work for geotextile were conducted at the Outfall basin (Portion E) during monitoring. Since there was no other marine works conducted during the monitoring, the exceedance was considered to be contributed by natural variation and no further action was required.

Site photo

Actions taken / to be taken	(1) Silt curtain was provided along the Portion E boundary line and extended from seawater level to the bottom of seabed; (2) floating type silt curtain was employed at the inner side; (3) sufficient slack of silt curtain was allowed to cope with the wave and tidal action to ensure the curtains (outer and inner) were rested on seabed; (4) condition of silt curtains was checked by the supervisor daily; and (5) seawall blocks installation was undertaken within the inner silt curtain area only.
Remarks	None

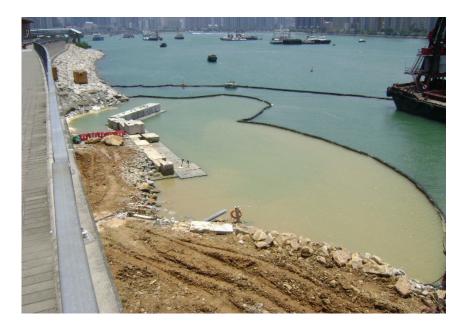
Photographic record for exceedance of Dissolved Oxygen (marine surface) recorded at O-1(FT) on 18-May-11

Project	Tsuen Wan Drainage Tunnel
Date	18-May-11
Time	5:30 PM
Monitoring Location	O-1(FT)
Parameter	Dissolved Oxygen (marine surface)
Action & Limit Levels (mg/L)	6.84 / 6.81
Measured Level (mg/L)	6.81
Control Station	O-1-C(FT)
Measured Level at the Control Station (mg/L)	6.90
Possible reason for Action or Limit Level Non-compliance	The measured DO level (marine surface) was below the baseline action level but was within the ranges of 3-year (2007 - 2009) marine surface DO records between 4.3 and 9.4 mg/L at EPD WM4 marine water quality monitoring station near Ma Wan and between 4.2 and 8.6 mg/L at EPD VM14 marine water quality monitoring station towards the north of Rambler Channel. Adjusting level of installed seawall blocks was conducted at the Outfall basin (Portion E) during monitoring and there was no other marine works conducted. Since the difference bewteen DO level at impact and control station was around 1.3% and the DO level at impact station was only 0.03 mg/L lower than the baseline action level, the exceedance was considered to be contributed by natural variation and no further action was required.

Actions taken / to be taken	(1) Silt curtain was provided along the Portion E boundary line and extended from seawater level to the bottom of seabed; (2) floating type silt curtain was employed at the inner side; (3) sufficient slack of silt curtain was allowed to cope with the wave and tidal action to ensure the curtains (outer and inner) were rested on seabed; (4) condition of silt curtains was checked by the supervisor daily; and (5) seawall blocks installation was undertaken within the inner silt curtain area only.
Remarks	None

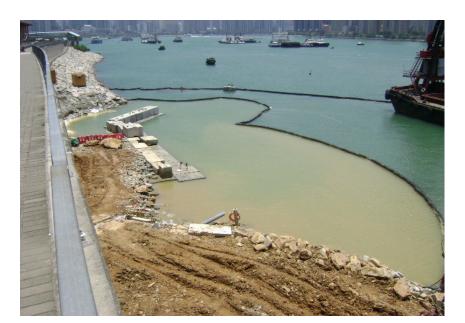
Photographic record for exceedance of Dissolved Oxygen (marine mid-depth) recorded at O-1(FT) on 18-May-11

Project	Tsuen Wan Drainage Tunnel
Date	18-May-11
Time	5:30 PM
Monitoring Location	O-1(FT)
Parameter	Dissolved Oxygen (marine mid-depth)
Action & Limit Levels (mg/L)	6.84 / 6.81
Measured Level (mg/L)	6.78
Control Station	O-1-C(FT)
Measured Level at the Control Station (mg/L)	6.79
Possible reason for Action or Limit Level Non-compliance	The measured DO level (marine mid-depth) was below the baseline limit level but was within the ranges of 3-year (2007 - 2009) marine mid-depth DO records between 2.6 and 9.1 mg/L at EPD WM4 marine water quality monitoring station near Ma Wan and between 3.9 and 8.5 mg/L at EPD VM14 marine water quality monitoring station towards the north of Rambler Channel. Adjusting level of installed seawall blocks was conducted at the Outfall basin (Portion E) during monitoring and there was no other marine works conducted. Since both DO levels at impact station and control station were just below the baseline limit level and the difference bewteen them was only 0.01 mg/L, the exceedance was considered to be contributed by natural variation and no further action was required.

Actions taken / to be taken	(1) Silt curtain was provided along the Portion E boundary line and extended from seawater level to the bottom of seabed; (2) floating type silt curtain was employed at the inner side; (3) sufficient slack of silt curtain was allowed to cope with the wave and tidal action to ensure the curtains (outer and inner) were rested on seabed; (4) condition of silt curtains was checked by the supervisor daily; and (5) seawall blocks installation was undertaken within the inner silt curtain area only.
Remarks	None

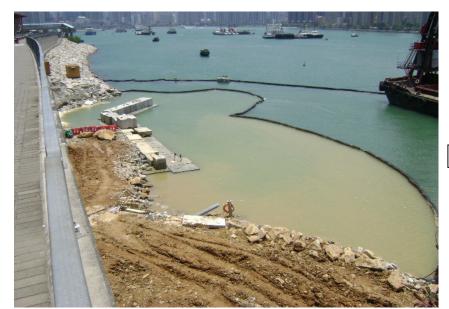
Photographic record for exceedance of Dissolved Oxygen (marine bottom) recorded at O-1(FT) on 18-May-11

Project	Tsuen Wan Drainage Tunnel
Date	18-May-11
Time	5:30 PM
Monitoring Location	O-1(FT)
Parameter	Dissolved Oxygen (marine bottom)
Action & Limit Levels (mg/L)	6.99 / 6.96
Measured Level (mg/L)	6.98
Control Station	O-1-C(FT)
Measured Level at the Control Station (mg/L)	6.74
Possible reason for Action or Limit Level Non-compliance	The measured DO level (marine bottom) was below the baseline action level but was within the ranges of 3-year (2007 - 2009) marine bottom DO records between 2.2 and 8.8 mg/L at EPD WM4 marine water quality monitoring station near Ma Wan and between 3.4 and 8.6 mg/L at EPD VM14 marine water quality monitoring station towards the north of Rambler Channel. Adjusting level of installed seawall blocks was conducted at the Outfall basin (Portion E) during monitoring and there was no other marine works conducted. Since the DO level at impact station was just below the baseline action level and the DO level at impact station was higher than that at control station, the exceedance was considered to be contributed by natural variation and no further action was required.

Actions taken / to be taken	(1) Silt curtain was provided along the Portion E boundary line and extended from seawater level to the bottom of seabed; (2) floating type silt curtain was employed at the inner side; (3) sufficient slack of silt curtain was allowed to cope with the wave and tidal action to ensure the curtains (outer and inner) were rested on seabed; (4) condition of silt curtains was checked by the supervisor daily; and (5) seawall blocks installation was undertaken within the inner silt curtain area only.
Remarks	None

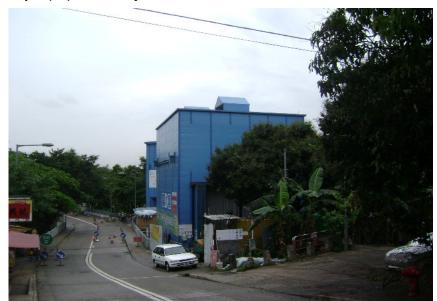
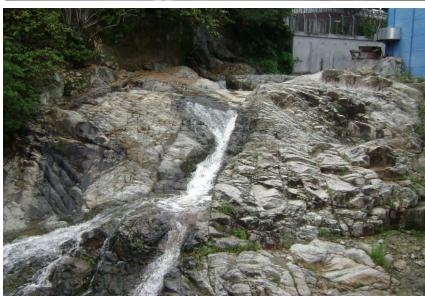
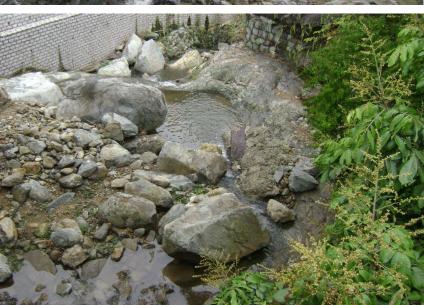
Photographic record for exceedance of Suspended Solid recorded at Hong Hoi Chee Hong Temple (I-2) on 13-May-11

Project	Tsuen Wan Drainage Tunnel
Date	13-May-11
Time	10:55 AM
Monitoring Location	Hong Hoi Chee Hong Temple (I-2)
Parameter	Suspended Solid
Action & Limit Levels (mg/L)	7.68 / 8.34
Measured Level (mg/L)	6.30
Control Station	I-2-C
Measured Level at the Control Station (mg/L)	4.10
Possible reason for Action or Limit Level Non-compliance	The measured SS level was below than baseline action level, but higher than 130% of the SS level of the control station (I-2-C). General site cleaning, housekeeping and temporary traffic arrangement, rock splitting and mucking at vortex drop shaft, drilling holes for rock splitting, construction of H-pile and excavation for pipe jacking at Portion G were undertaken during measurement. No direct disturbance was observed from the site and about 33.5 mm rainfall was recorded on the same day. The exceedance was considered to be contributed by natural variation and high rainfall. Since the exceedance was non-projected related, no further action was required.

Site photo

Photo taken at I-2

Photo taken at I-2-C

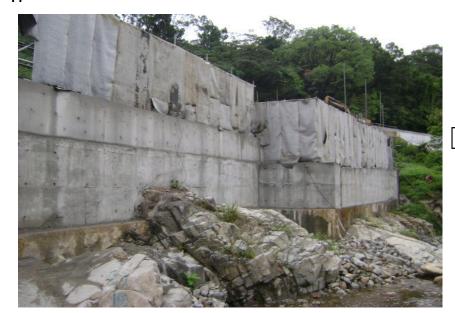
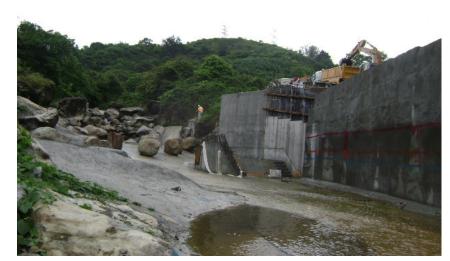
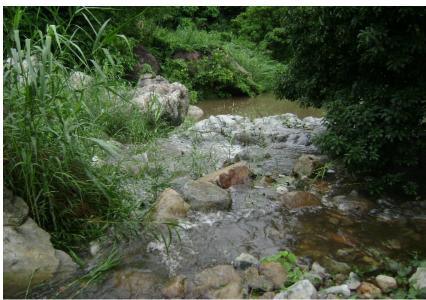
Photographic record for exceedance of Suspended Solid recorded at Squatters (I-3) on 13-May-

Site photo

Photo taken at I-3

Photo taken at I-3-C

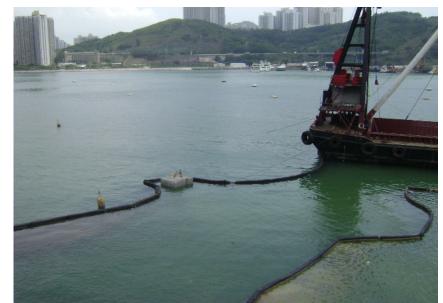
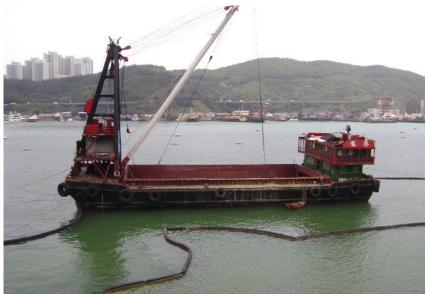
Photographic record for exceedance of Dissolved Oxygen (marine surface) recorded at O-1(ET) on 20-May-11

Site photo

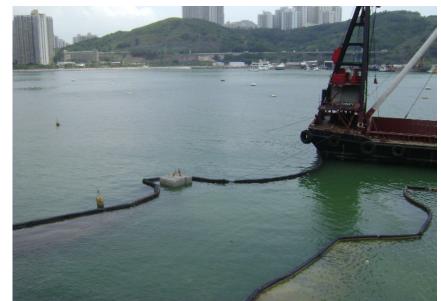
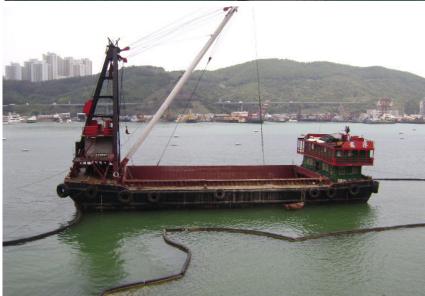
Photographic record for exceedance of Dissolved Oxygen (mid-depth) recorded at O-1(ET) on 20-May-11

Site photo

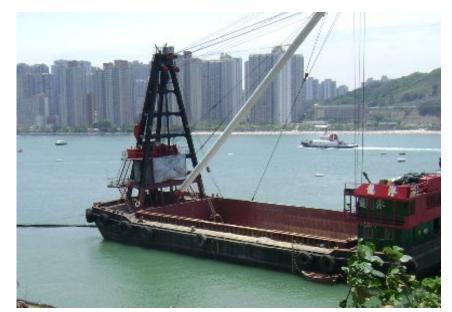
Photographic record for exceedance of Suspended Solids recorded at O-1(ET) on 18-May-11

Site photo

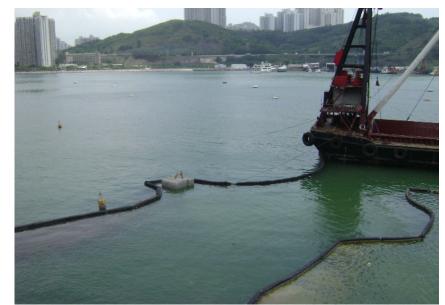
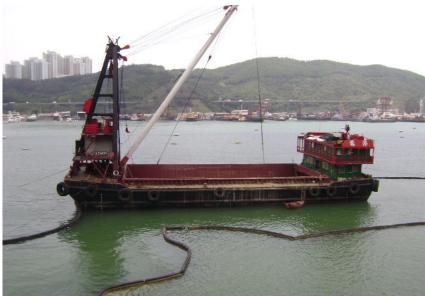
Photographic record for exceedance of Suspended Solids recorded at O-1(ET) on 20-May-11

Site photo

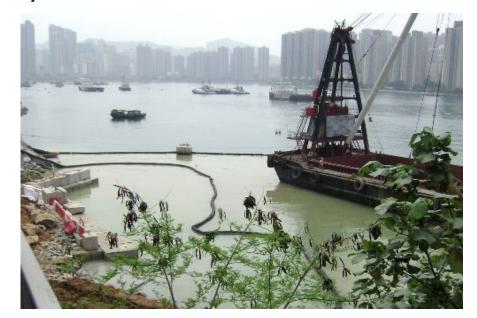
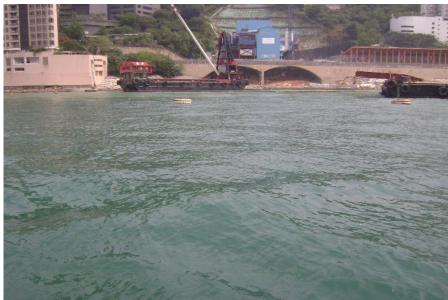
Photographic record for exceedance of Dissolved Oxygen (mid-depth) recorded at O-1(ET) on 27-May-11

Site photo

Photo taken at O-1(ET)

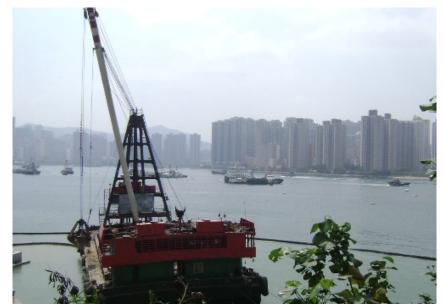
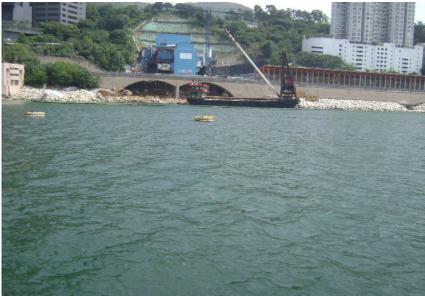
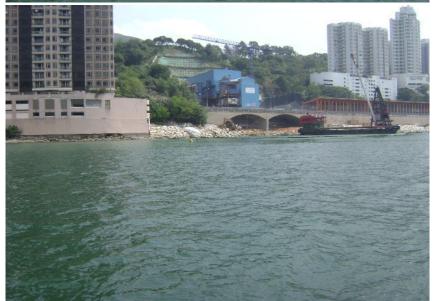
Photographic record for exceedance of Dissolved Oxygen (Surface) recorded at O-1(ET) on 30-May-11

Site photo

Photo taken at O-1(ET)

Photo taken at O-1-C(ET)

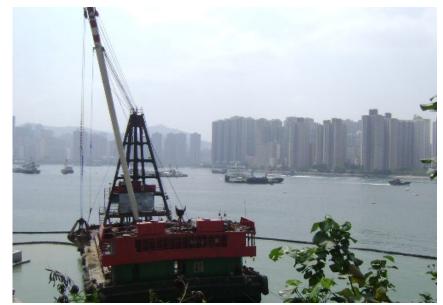
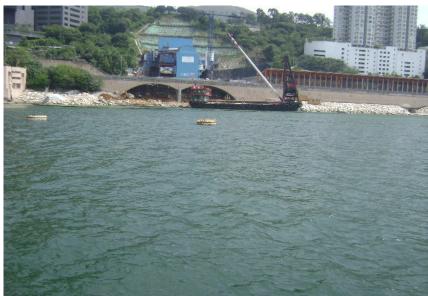
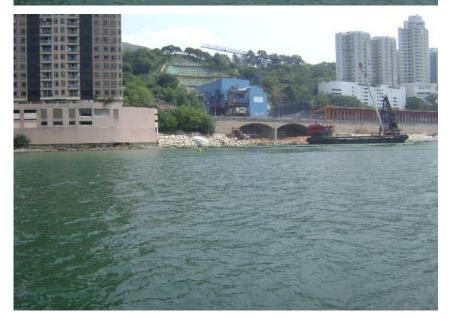
Photographic record for exceedance of Dissolved Oxygen (Mid-depth) recorded at O-1(ET) on 30-May-11

Site photo

Photo taken at O-1(ET)

Photo taken at O-1-C(ET)

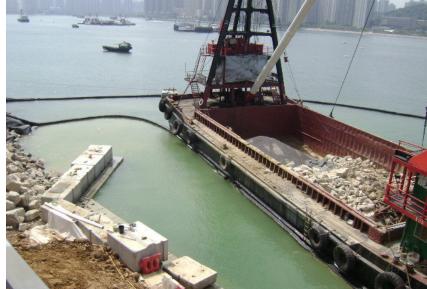
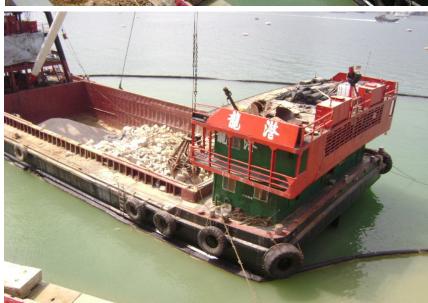
Photographic record for exceedance of Dissolved Oxygen (marine bottom) recorded at O-1(FT) on 30-May-11

Site photo

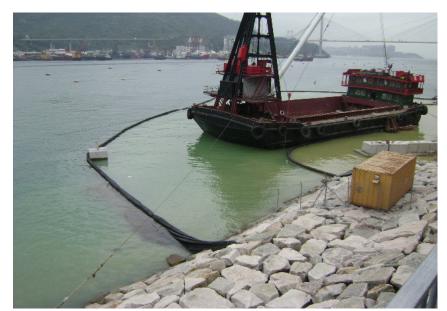
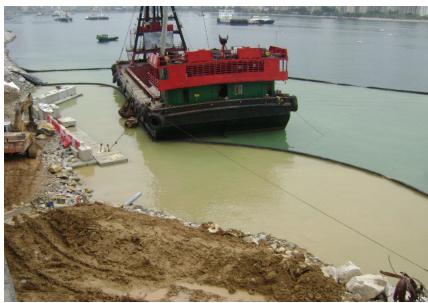
Photographic record for exceedance of Suspended Solids recorded at O-1(FT) on 27-May-11

Site photo

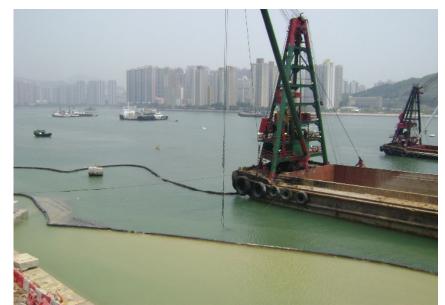
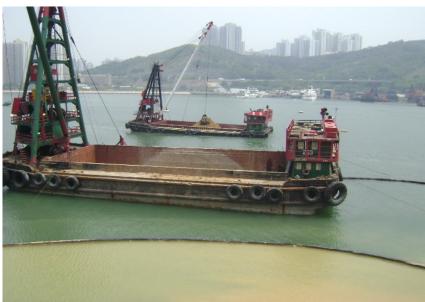
Photographic record for exceedance of Dissolved Oxygen (marine mid-depth) recorded at O-1(ET) on 01-Jun-11

Site photo

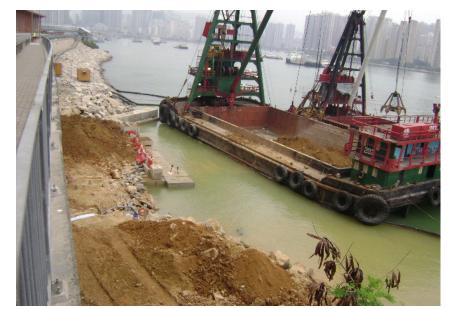
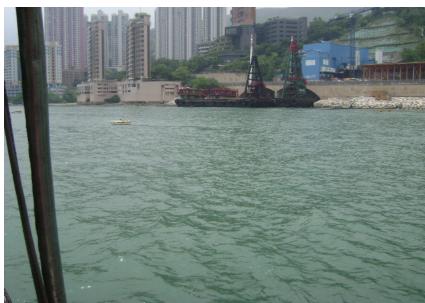
Photographic record for exceedance of Dissolved Oxygen (marine surface) recorded at O-1(ET) on 03-Jun-11

Site photo

Site photo (Photo taken at location near the site)

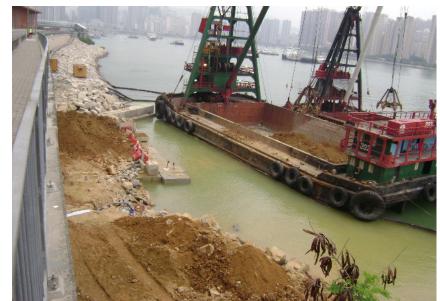
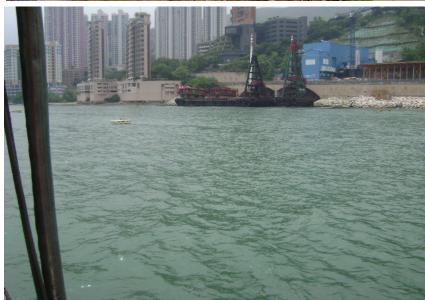
Photographic record for exceedance of Dissolved Oxygen (marine mid-depth) recorded at O-1(ET) on 03-Jun-11

Site photo

Site photo (Photo taken at location near the site)

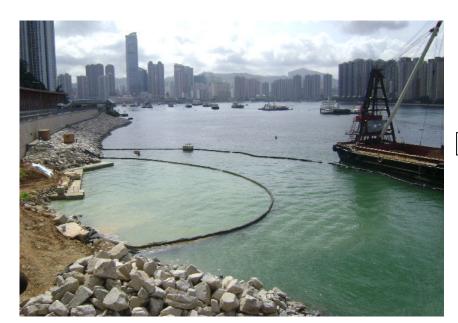
Photographic record for exceedance of Dissolved Oxygen (marine bottom) recorded at O-1(FT) on 07-Jun-11

Site photo

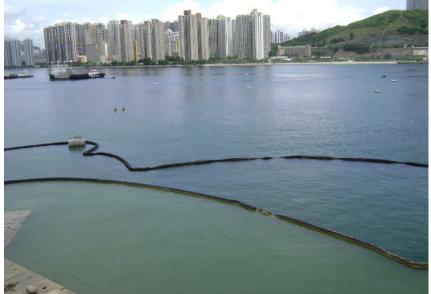
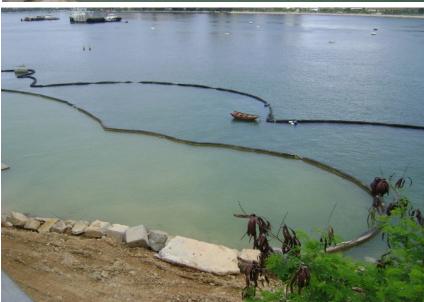
Photographic record for exceedance of Dissolved Oxygen (marine surface) recorded at O-1(ET) on 07-Jun-11

Site photo

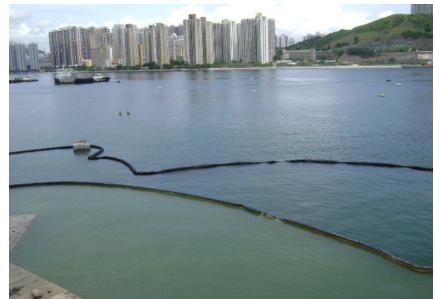
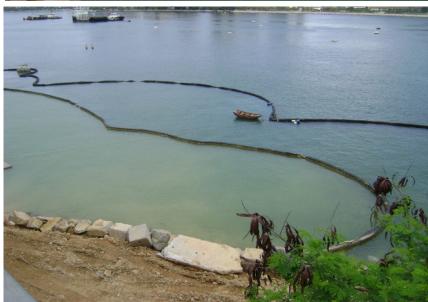
Photographic record for exceedance of Dissolved Oxygen (marine mid-depth) recorded at O-1(ET) on 07-Jun-11

Site photo

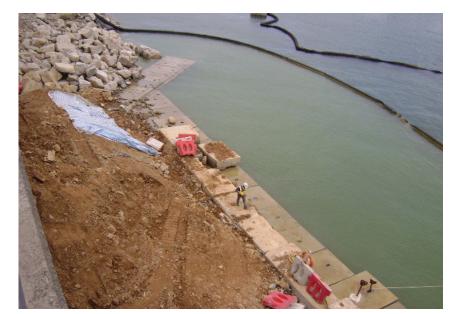
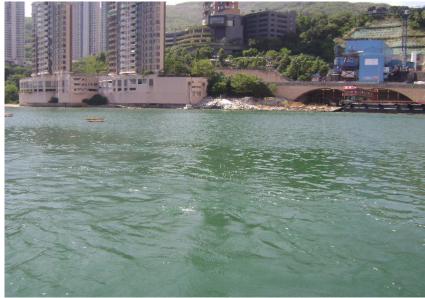
Photographic record for exceedance of Dissolved Oxygen (marine surface) recorded at O-1(ET) on 09-Jun-11

Site photo

Site photo (Photo taken at location near the site)

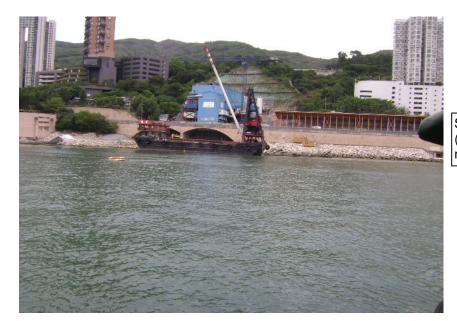
Photographic record for exceedance of Dissolved Oxygen (marine bottom) recorded at O-1(FT) on 11-Jun-11

Site photo (Photo taken at location near the site)

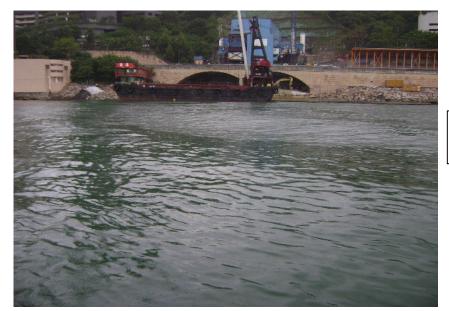
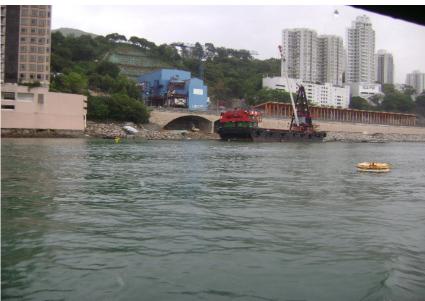
Photographic record for exceedance of Dissolved Oxygen (marine surface) recorded at O-1(ET) on 11-Jun-11

Site photo (Photo taken at location near O-1(ET)

Site photo (Photo taken at location near O-1-C(ET)

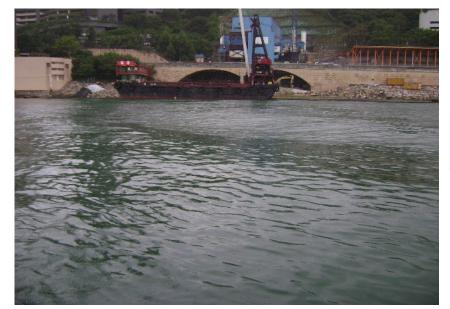
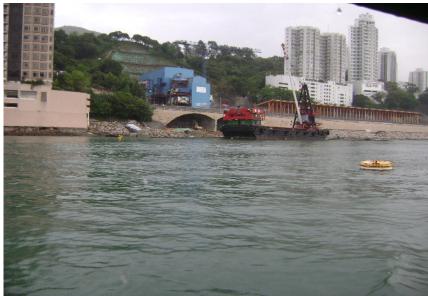
Photographic record for exceedance of Dissolved Oxygen (marine mid-depth) recorded at O-1(ET) on 11-Jun-11

Site photo (Photo taken at location near O-1(ET)

Site photo (Photo taken at location near O-1-C(ET)

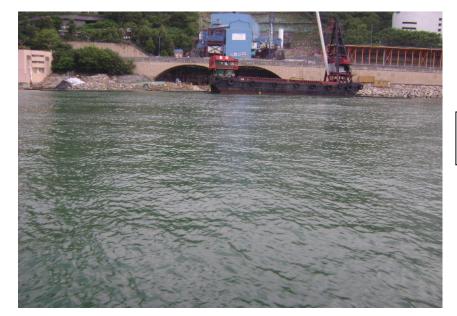
Photographic record for exceedance of Dissolved Oxygen (marine bottom) recorded at O-1(FT) on 13-Jun-11

Site photo (Photo taken at location near the site)

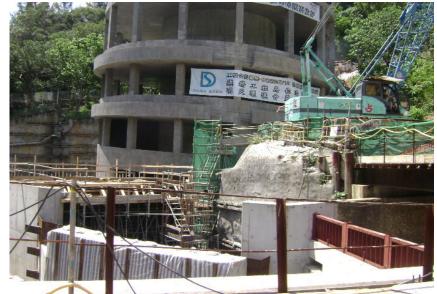
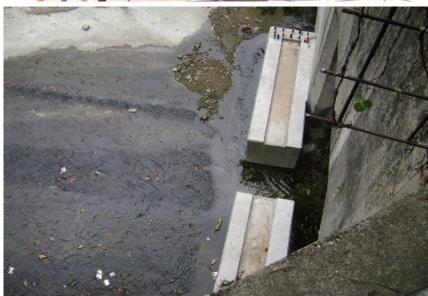
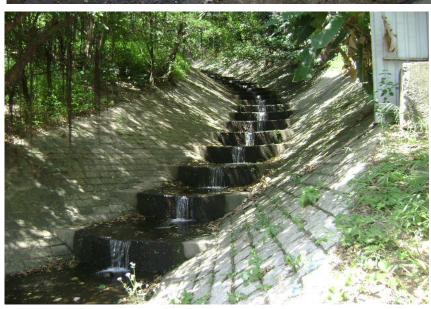
Photographic record for exceedance of Suspended Solid recorded at Sik Sik Yuen Ho Fung College (I-1) on 09-Jun-11

Site photo

Photo taken at I-1

Photo taken at I-1-C

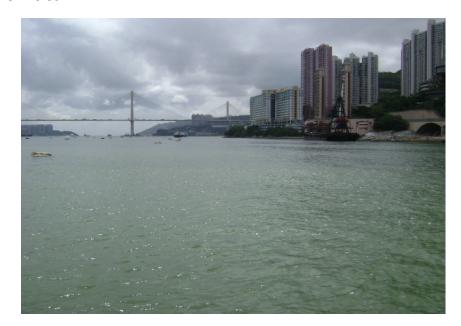
Photographic record for exceedance of Dissolved Oxygen (marine surface) recorded at O-1(FT) on 15-Jun-11

Site photo (Photo taken at location near O-1-C(FT)

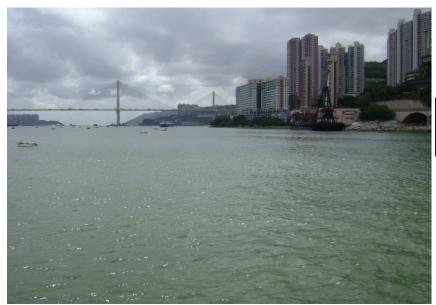
Photographic record for exceedance of Dissolved Oxygen (marine bottom) recorded at O-1(FT) on 15-Jun-11

Site photo (Photo taken at location near O-1-C(FT)

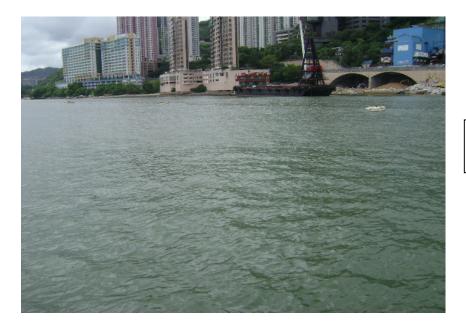
Photographic record for exceedance of Dissolved Oxygen (marine surface) recorded at O-1(ET) on 15-Jun-11

Site photo (Photo taken at location near the site)

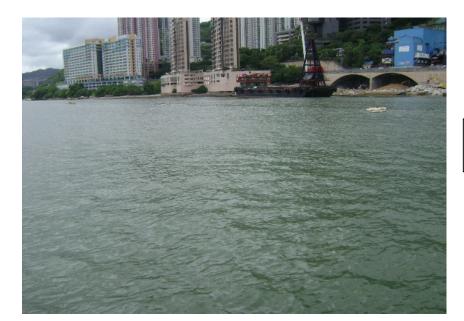
Photographic record for exceedance of Dissolved Oxygen (marine mid-depth) recorded at O-1(ET) on 15-Jun-11

Site photo (Photo taken at location near the site)

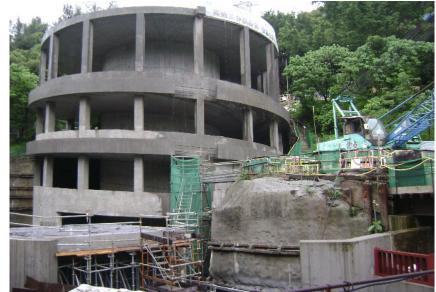
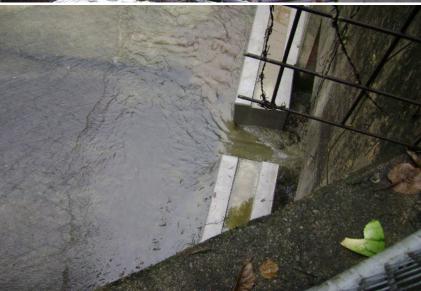
Photographic record for exceedance of Turbidity recorded at Sik Sik Yuen Ho Fung College (I-1) on 17-Jun-11

Site photo

Photo taken at I-1

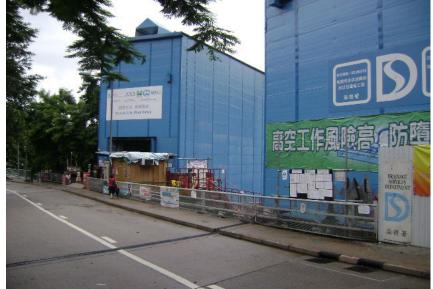
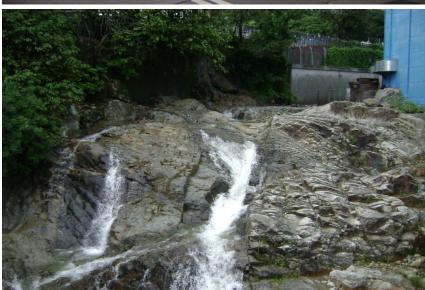
Photographic record for exceedance of Turbidity recorded at Hong Hoi Chee Hong Temple (I-2) on 17-Jun-11

Site photo

Photo taken at I-2

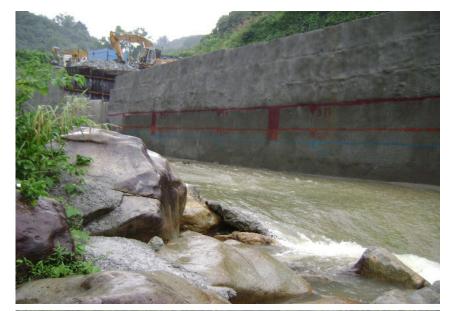
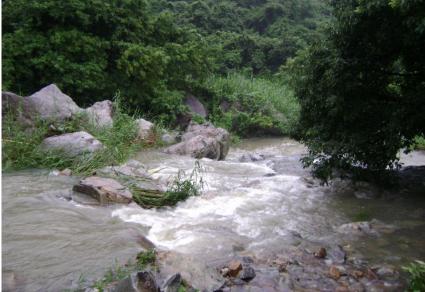
Photographic record for exceedance of Turbidity recorded at Squatters (I-3) on 17-Jun-11

Photo taken at I-3

Photo taken at I-3-C

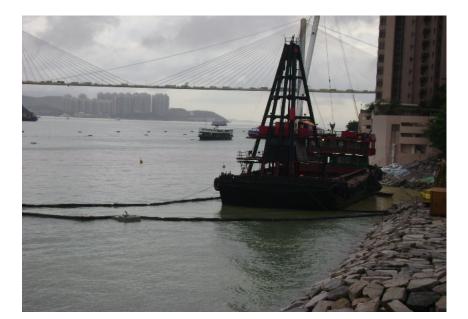
Photographic record for exceedance of Dissolved Oxygen (marine mid-depth) recorded at O-1(FT) on 17-Jun-11

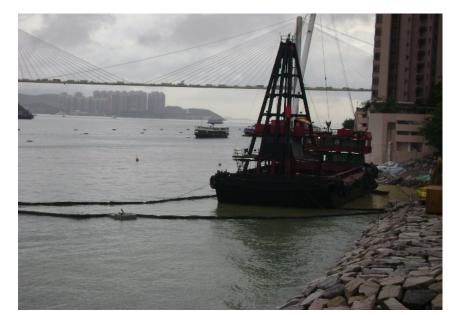
Photographic record for exceedance of Dissolved Oxygen (marine bottom) recorded at O-1(FT) on 17-Jun-11

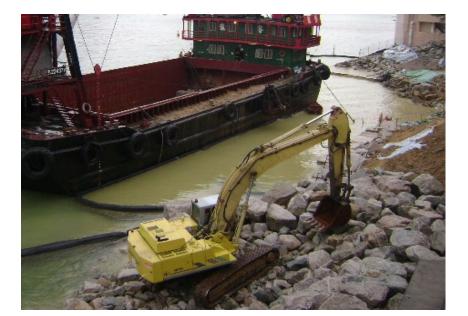
Photographic record for exceedance of Dissolved Oxygen (marine surface) recorded at O-1(ET) on 17-Jun-11

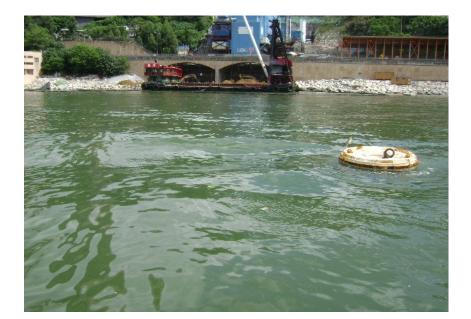
Photographic record for exceedance of Dissolved Oxygen (marine surface) recorded at O-1(FT) on 20-Jun-11

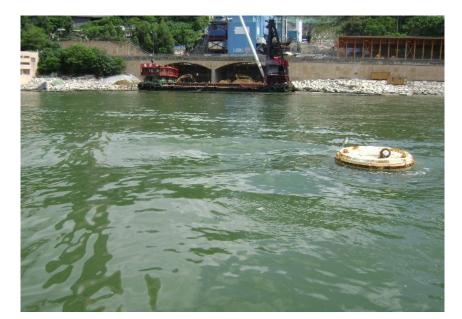
Photographic record for exceedance of Dissolved Oxygen (marine mid-depth) recorded at O-1(FT) on 20-Jun-11
