Contract NO. DC/2007/12 - Design and Construction of Tsuen Wan Drainage Tunnel

Quarterly EM&A Report (April to June 2011)

Hyder Consulting Limited

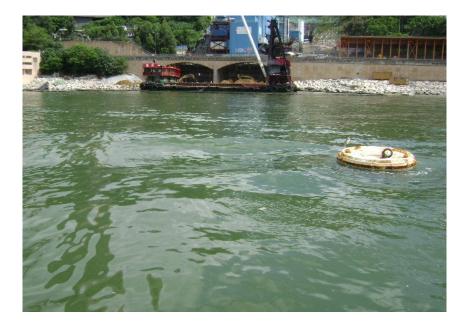
Photographic record for exceedance of Dissolved Oxygen (marine bottom) recorded at O-1(FT) on 20-Jun-11

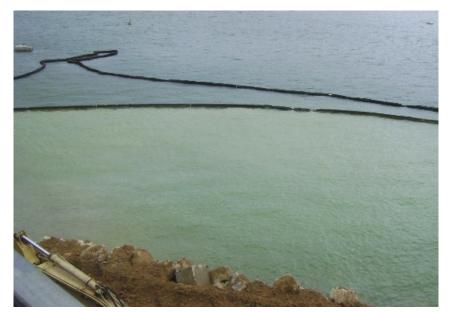
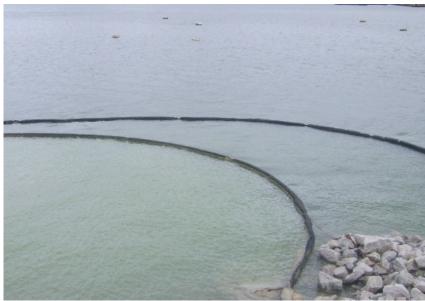
Photographic record for exceedance of Dissolved Oxygen (marine surface) recorded at O-1(ET) on 20-Jun-11

Site photo

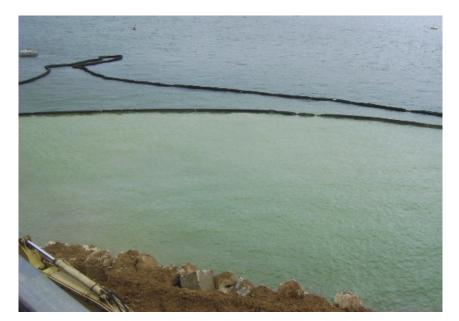
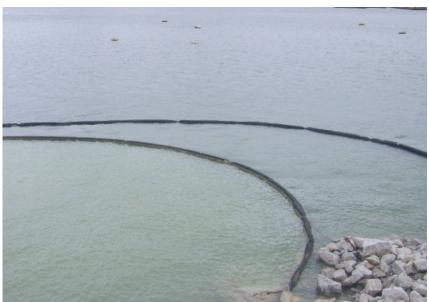
Photographic record for exceedance of Dissolved Oxygen (marine mid-depth) recorded at O-1(ET) on 20-Jun-11

Site photo

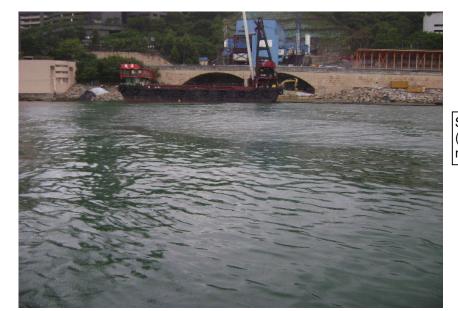
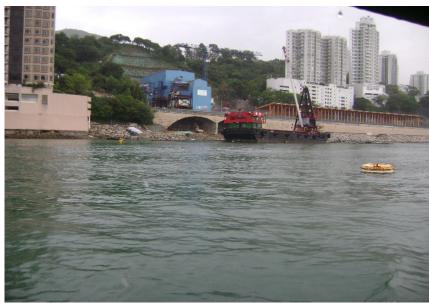
Photographic record for exceedance of Suspended Solids recorded at O-1(ET) on 11-Jun-11

Site photo (Photo taken at location near O-1(ET)

Site photo (Photo taken at location near O-1-C(ET)

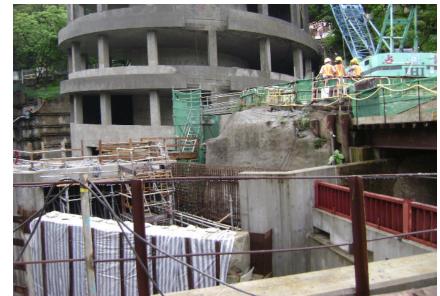
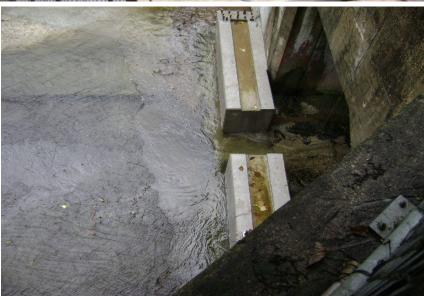
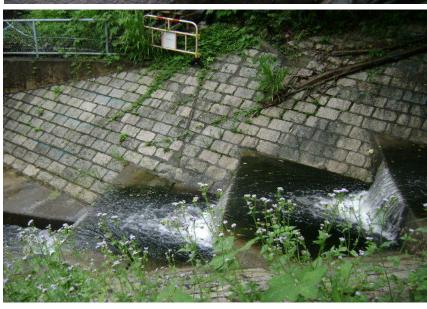
Photographic record for exceedance of Turbidity recorded at Sik Sik Yuen Ho Fung College (I-1) on 22-Jun-11

Site photo

Photo taken at I-1

Photo taken at I-1-C

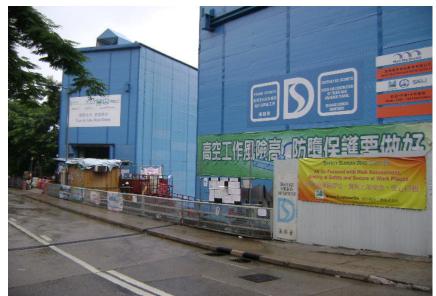
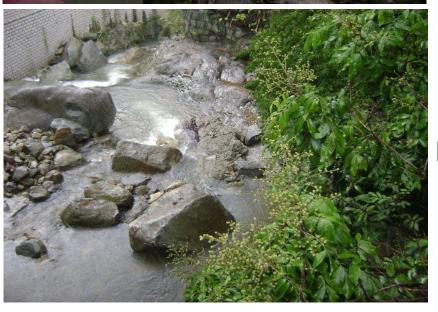
Photographic record for exceedance of Turbidity recorded at Hong Hoi Chee Hong Temple (I-2) on 22-Jun-11

Site photo

Photo taken at I-2-C

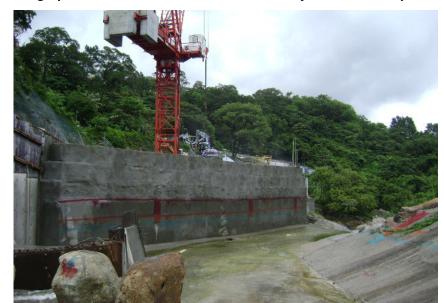
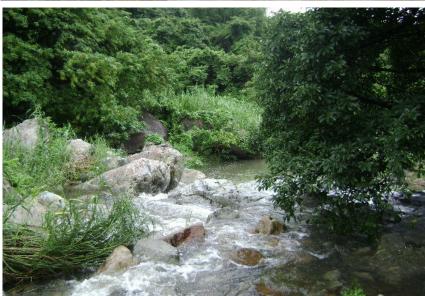
Photographic record for exceedance of Turbidity recorded at Squatters (I-3) on 22-Jun-11

Photo taken at I-3

Photo taken at I-3-C

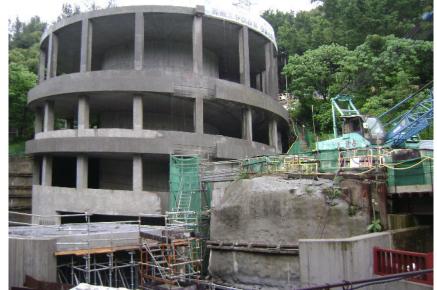
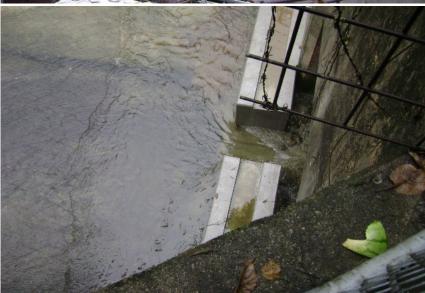
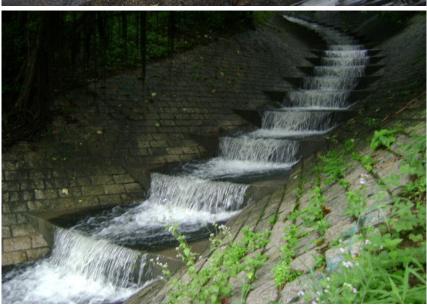
Photographic record for exceedance of Suspended Solids (SS) recorded at Sik Sik Yuen Ho Fung College (I-1) on 17-Jun-11

Site photo

Photo taken at I-1

Photo taken at I-1-C

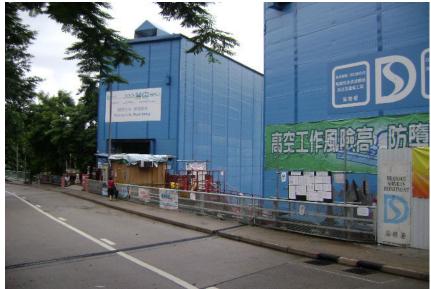
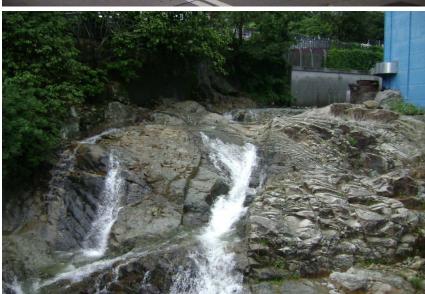
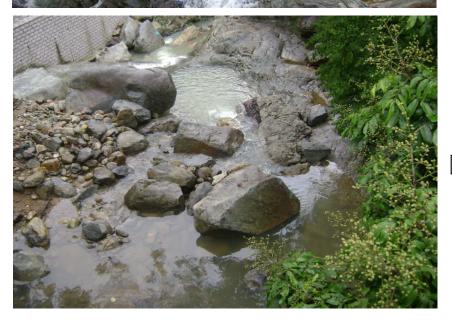
Photographic record for exceedance of Suspended Solids (SS) recorded at Hong Hoi Chee Hong Temple (I-2) on 17-Jun-11

Site photo

Photo taken at I-2

Photo taken at I-2-C

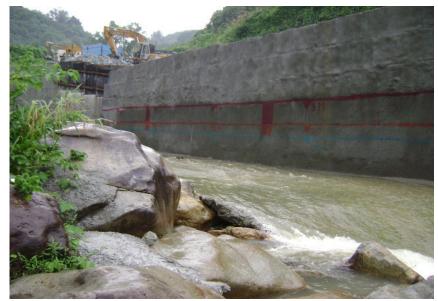
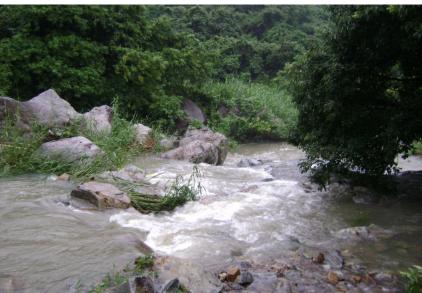
Photographic record for exceedance of Suspended Solids (SS) recorded at Squatters (I-3) on 17-Jun-11

Photo taken at I-3

Photo taken at I-3-C

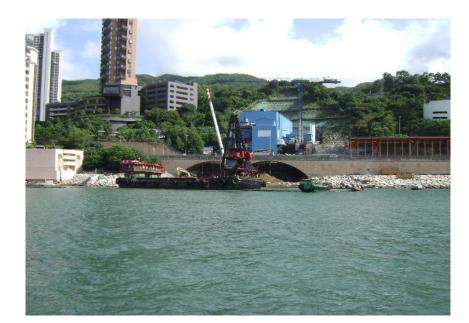
Photographic record for exceedance of Dissolved Oxygen (marine surface) recorded at O-1(ET) on 24-Jun-11

Site photo (Photo taken at location near O-1(ET))

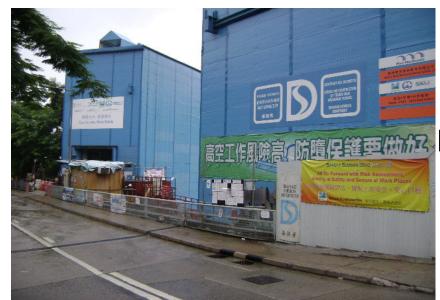
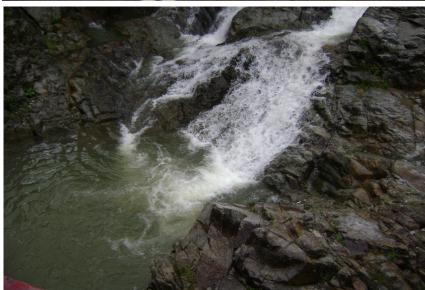
Photographic record for exceedance of Suspended Solids recorded at Hong Hoi Chee Hong Temple (I-2) on 22-Jun-11

Site photo

Photo taken at I-2

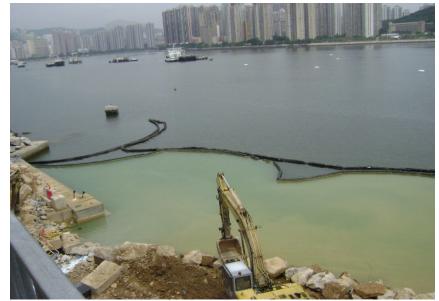
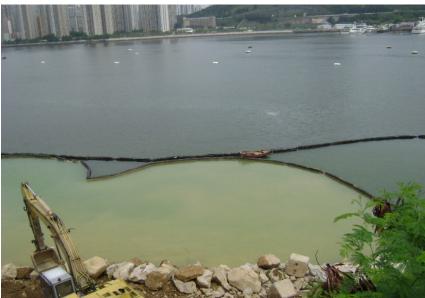
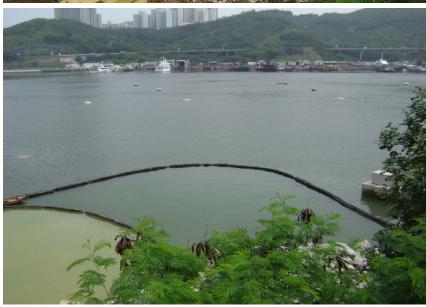
Photographic record for exceedance of Dissolved Oxygen (marine surface) recorded at O-1(FT) on 27-Jun-11

Site photo

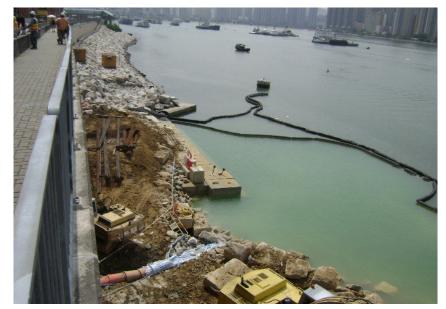
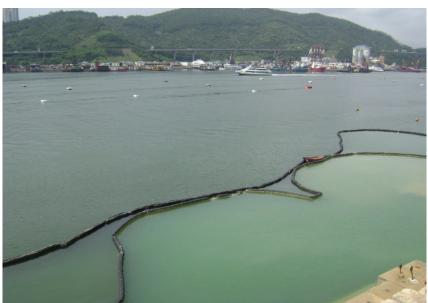
Photographic record for exceedance of Dissolved Oxygen (marine surface) recorded at O-1(ET) on 27-Jun-11

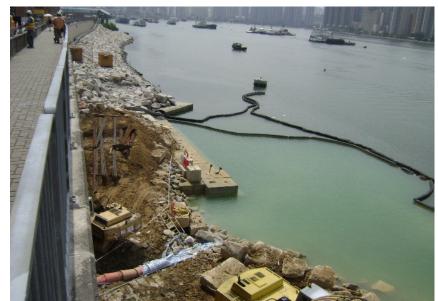
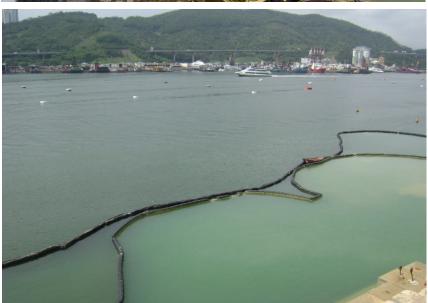
Photographic record for exceedance of Dissolved Oxygen (marine mid-depth) recorded at O-1(ET) on 27-Jun-11

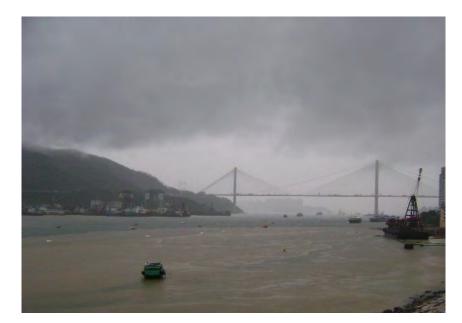
Photographic record for exceedance of Dissolved Oxygen (marine mid-depth) recorded at O-1(FT) on 29-Jun-11

Site photo (Photo taken at location near Greenview Terrace)

On 29 June 2011, 76.5 mm heavy rainfall was recorded. Huge amount of muddy water discharged from streams and drainage outfalls among the coast into marine water body was observed during afternoon on the monitoring day and caused turbid sea surface.

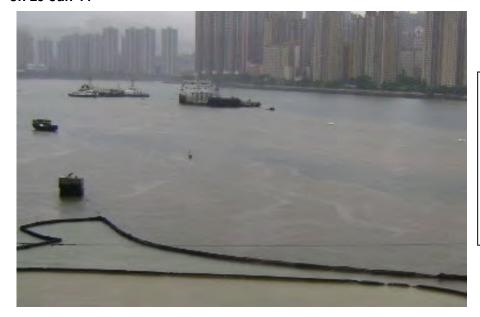
Photographic record for exceedance of Dissolved Oxygen (marine surface) recorded at O-1(ET) on 29-Jun-11

Site photo (The marine water between the inner and outer silt curtain was clearer than the marine water outside the construction site. No leakage of silt curtain was observed.)

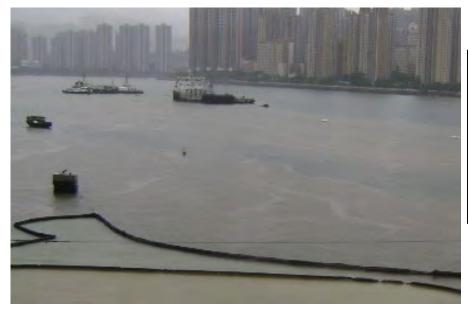
Photographic record for exceedance of Dissolved Oxygen (marine mid-depth) recorded at O-1(ET) on 29-Jun-11

Site photo (The marine water between the inner and outer silt curtain was clearer than the marine water outside the construction site. No leakage of silt curtain was observed.)

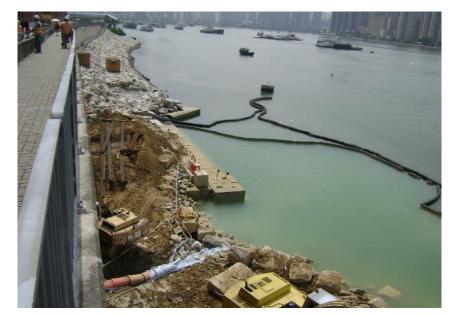
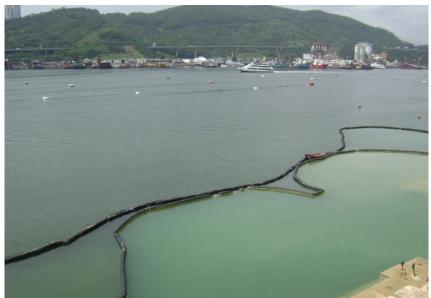
Photographic record for exceedance of Suspended Solids (SS) recorded at O-1(ET) on 27-Jun-11
