Maeda - CREC - SELI Joint Venture

Contract No. DC/2007/12 - Design and  
Construction of Tsuen Wan Drainage Tunnel

Monthly EM&A Report (June 2011)

Report No EB000364R0642

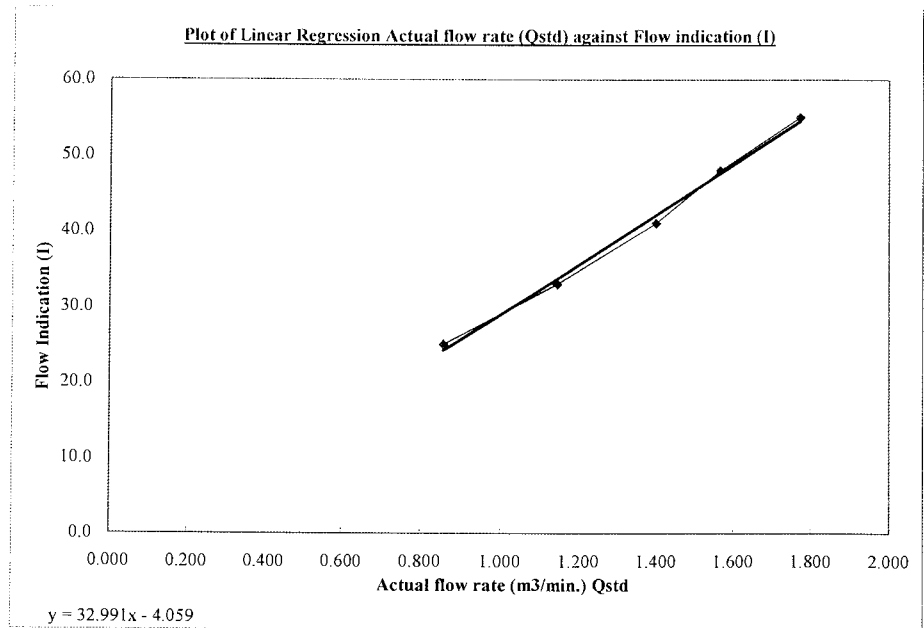
Sample no.	Pressure Drop (H), inch	Flow (corrected), m <sup>3</sup> /min	Actual flow rate (Qstd), m <sup>3</sup> /min	Flow indication (I), arbitrary
1	12.6	3.537	1.774	55.0
2	9.8	3.119	1.566	48.0
3	7.8	2.783	1.398	41.0
4	5.2	2.272	1.143	33.0
5	2.9	1.697	0.857	25.0

Correlation Coefficient : 0.9976

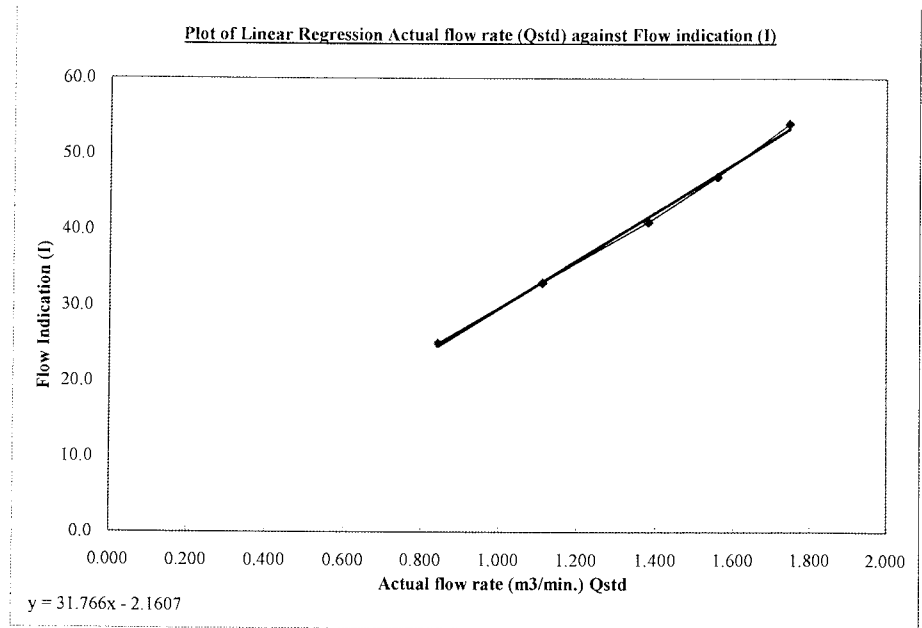
Sample no.	Pressure Drop (H), inch	Flow (corrected), m <sup>3</sup> /min	Actual flow rate (Qstd), m <sup>3</sup> /min	Flow indication (I), arbitrary
1	12.2	3.480	1.746	54.0
2	9.7	3.103	1.558	47.0
3	7.6	2.747	1.380	41.0
4	4.9	2.206	1.110	33.0
5	2.8	1.667	0.842	25.0

Correlation Coefficient : 0.9988

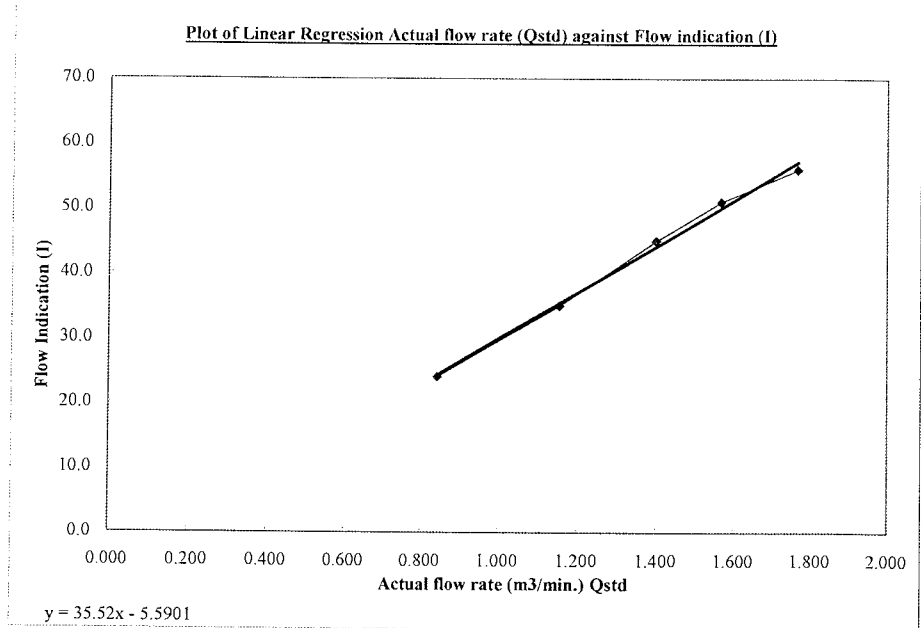
Sample no.	Pressure Drop (H), inch	Flow (corrected), m <sup>3</sup> /min	Actual flow rate (Qstd), m <sup>3</sup> /min	Flow indication (I), arbitrary
1	12.5	3.523	1.767	56.0
2	9.8	3.119	1.566	51.0
3	7.8	2.783	1.398	45.0
4	5.3	2.294	1.154	35.0
5	2.8	1.667	0.842	24.0

Correlation Coefficient : 0.9974

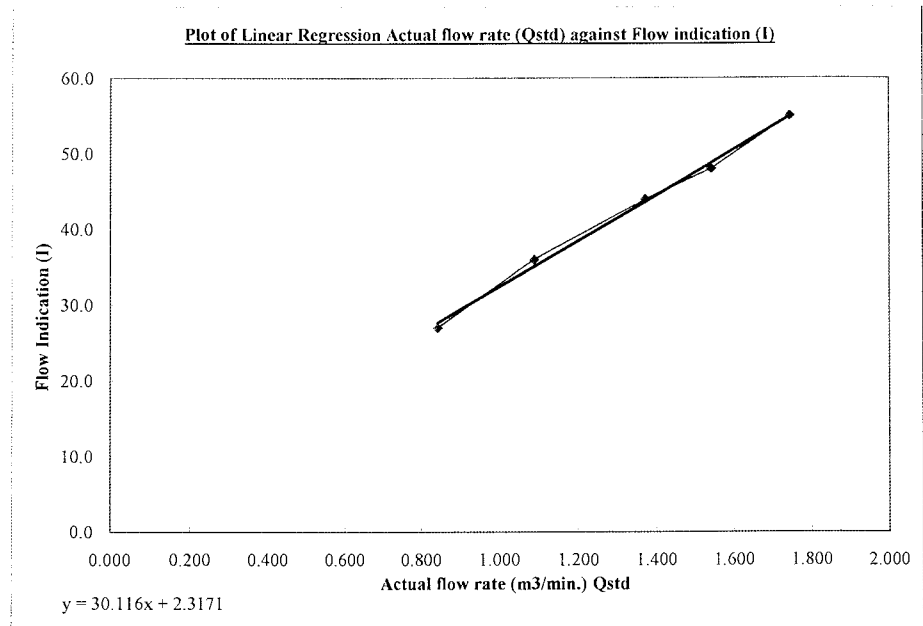
Sample no.	Pressure Drop (H), inch	Flow (corrected), m <sup>3</sup> /min	Actual flow rate (Qstd), m <sup>3</sup> /min	Flow indication (I), arbitrary
1	12.2	3.480	1.746	55.0
2	9.5	3.071	1.542	48.0
3	7.5	2.729	1.371	44.0
4	4.7	2.160	1.088	36.0
5	2.8	1.667	0.842	27.0

Correlation Coefficient : 0.9978

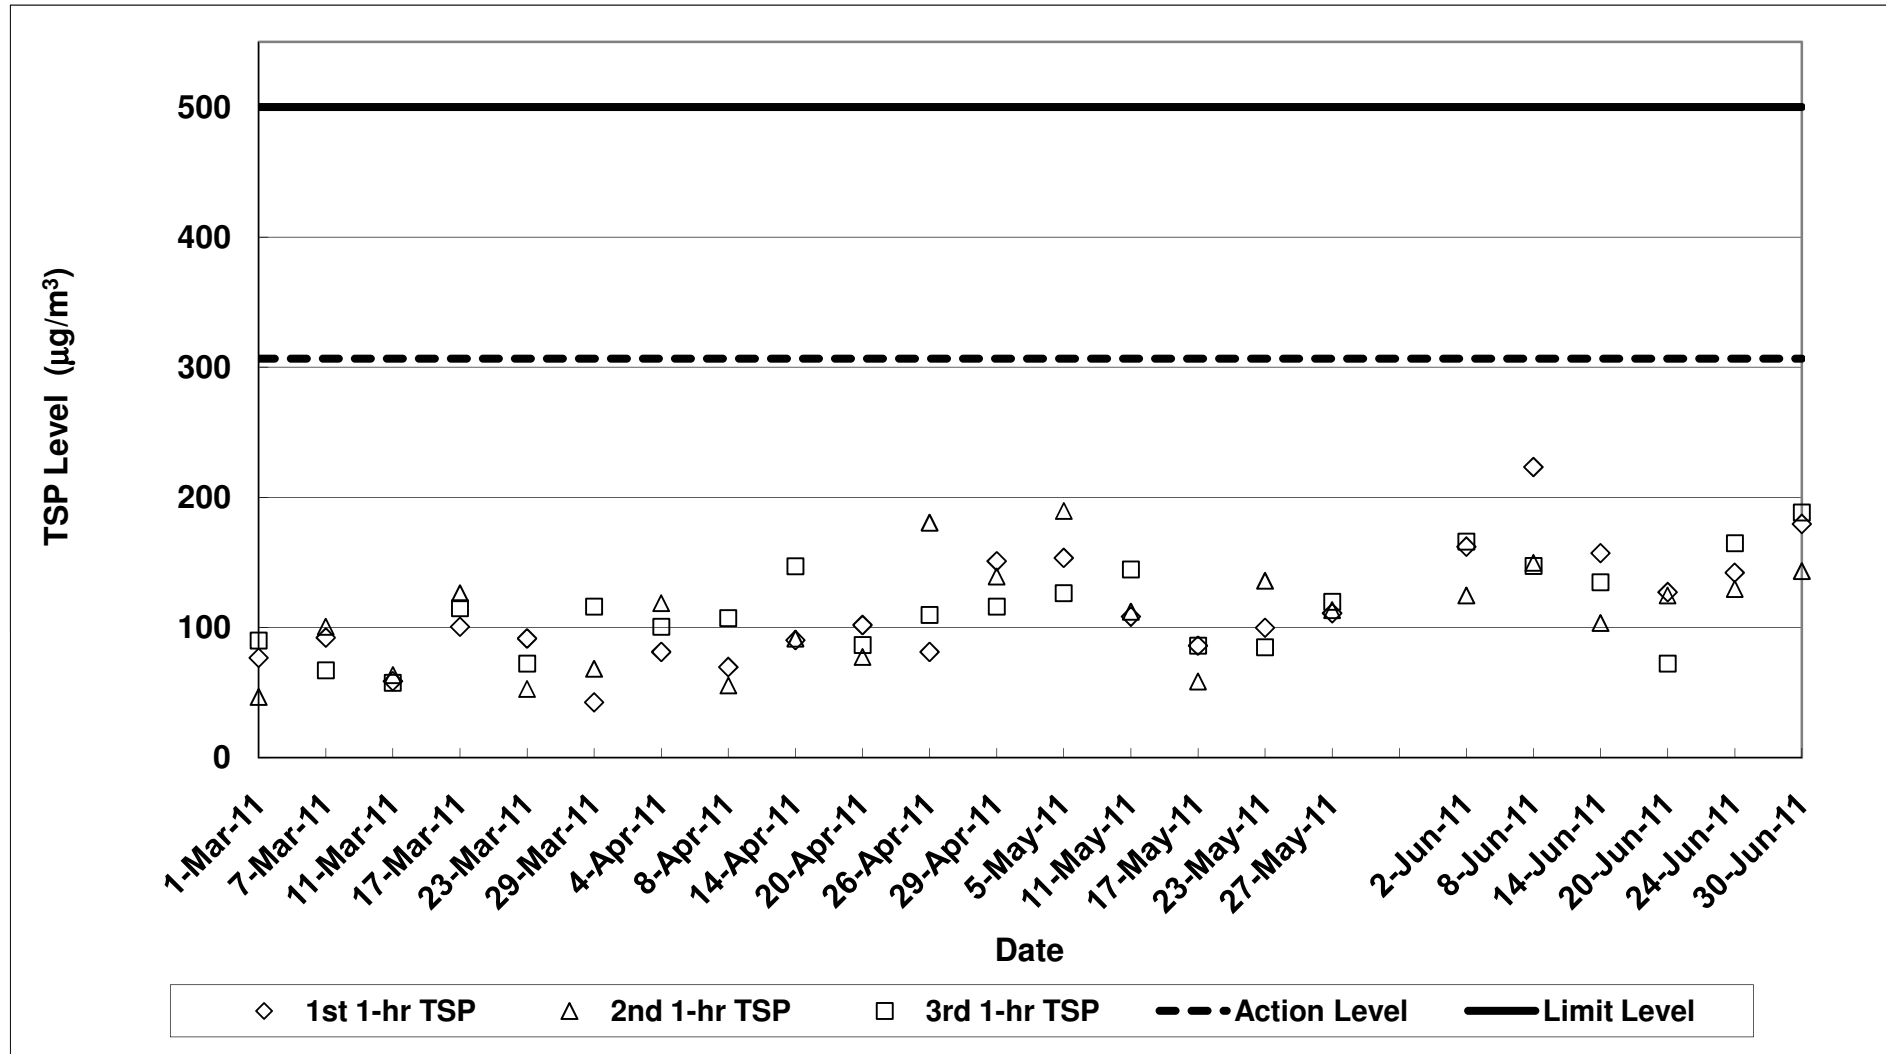
**Contract No. DC/2007/12 - Design and Construction of Tsuen Wan Drainage Tunnel  
 Air Quality Monitoring (1-hr TSP) Results at Sik Sik Yuen Ho Fung College - Intake (ASR1)  
 Mar-11 to Jun-11**

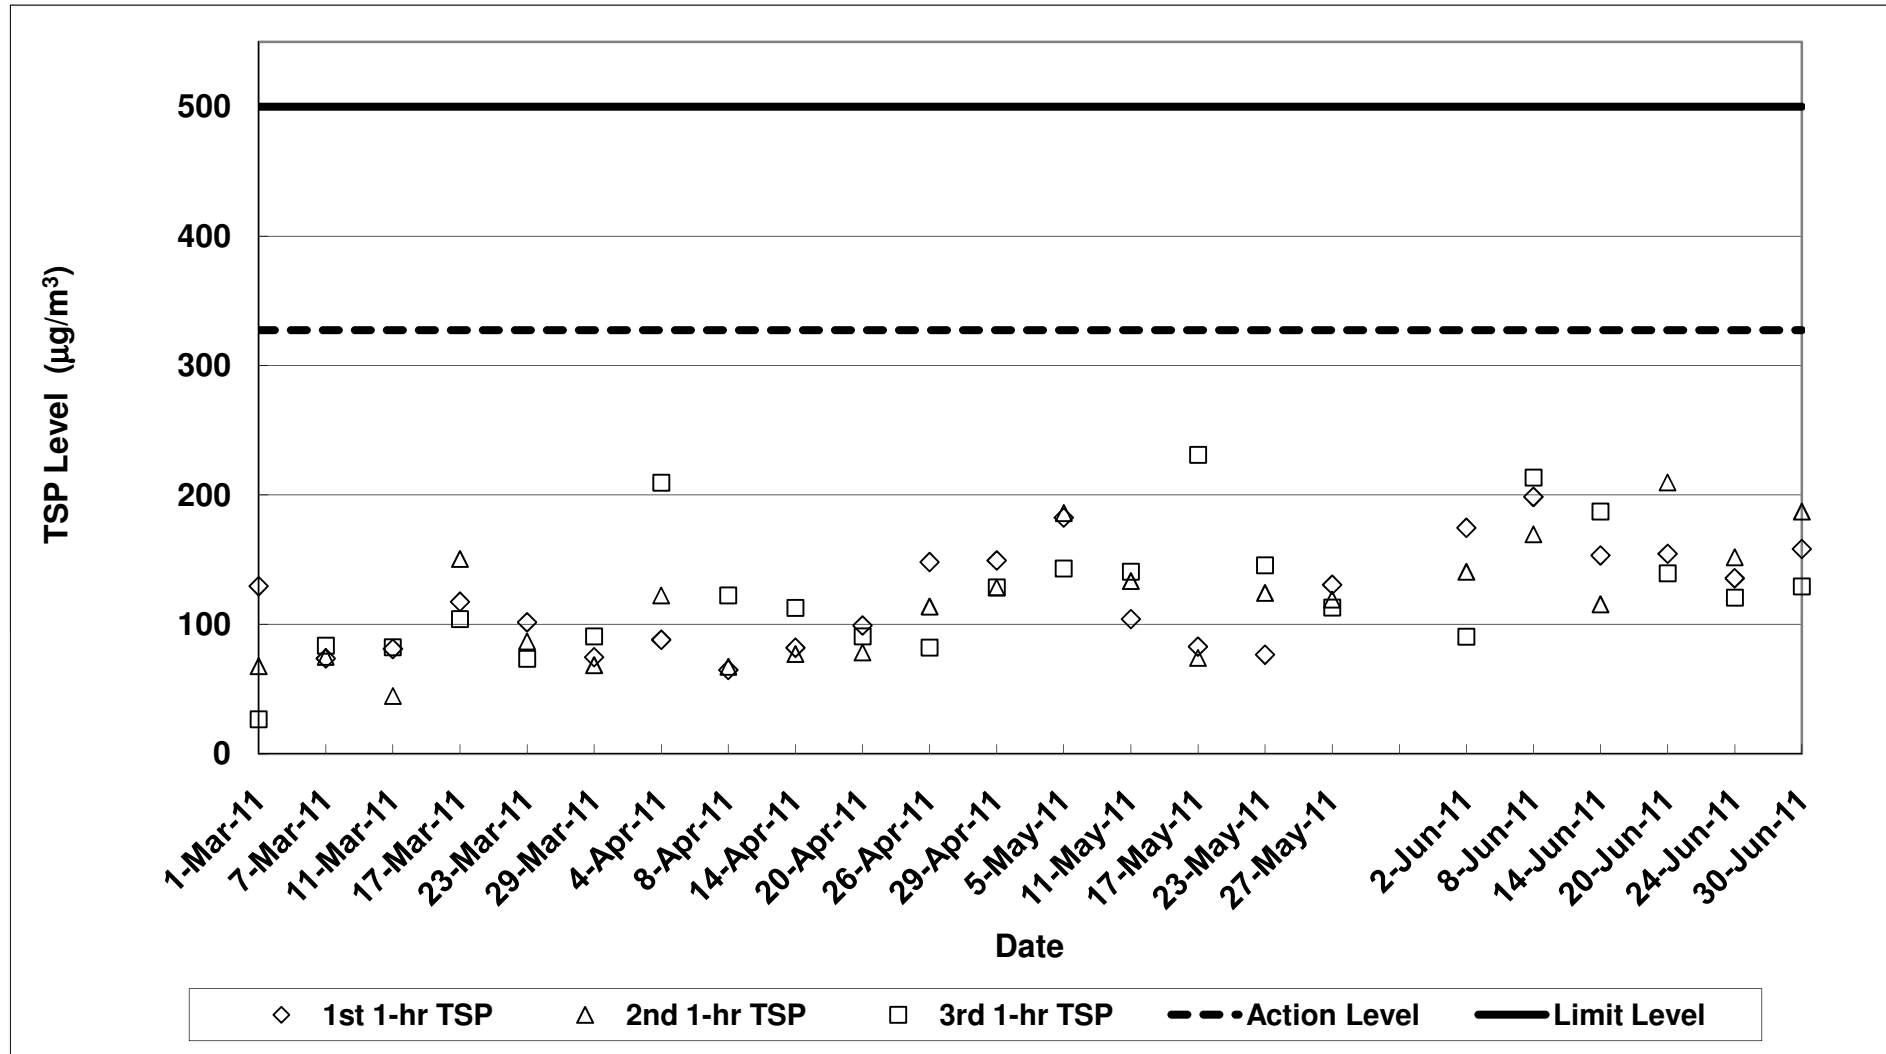
**Contract No. DC/2007/12 - Design and Construction of Tsuen Wan Drainage Tunnel  
 Air Quality Monitoring (1-hr TSP) Results at Hong Hoi Chee Hong Temple - Intake (ASR3)  
 Mar-11 to Jun-11**

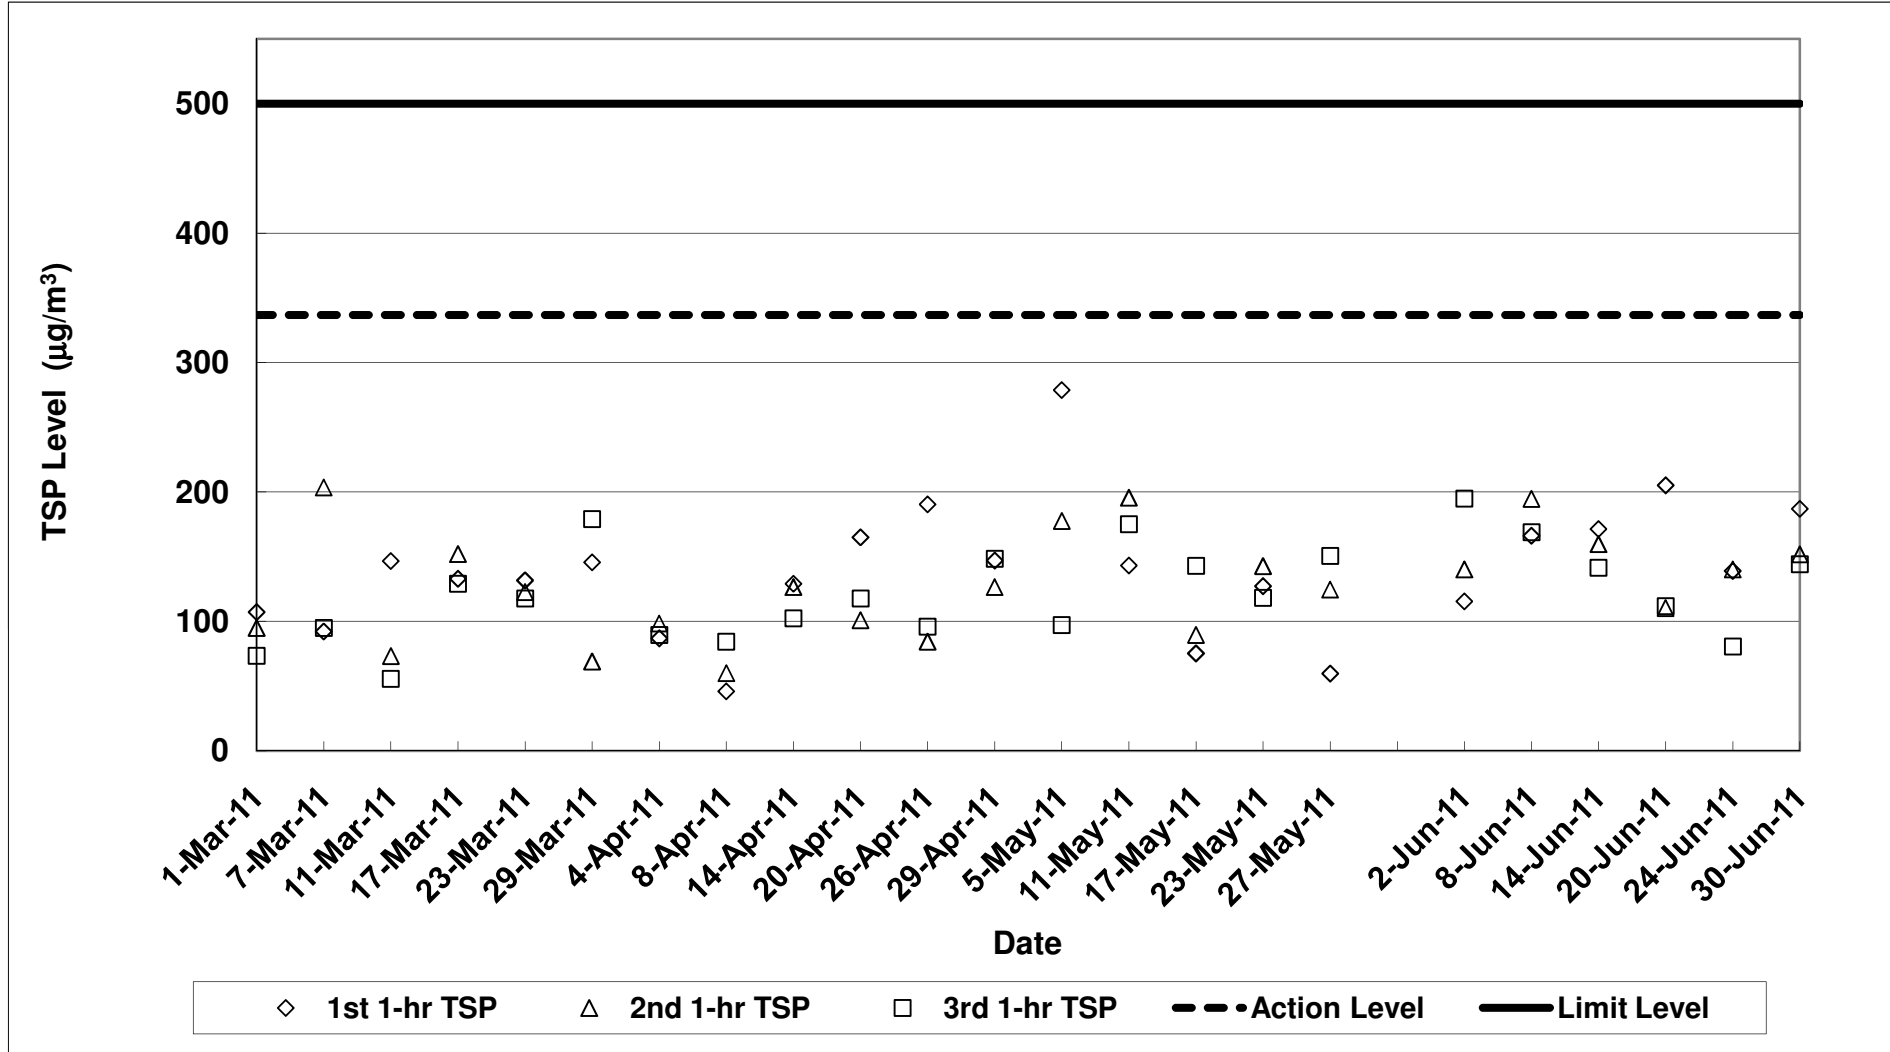
**Contract No. DC/2007/12 - Design and Construction of Tsuen Wan Drainage Tunnel  
 Air Quality Monitoring (1-hr TSP) Results at Long Beach Gardens - Outfall (ASR8)  
 Mar-11 to Jun-11**

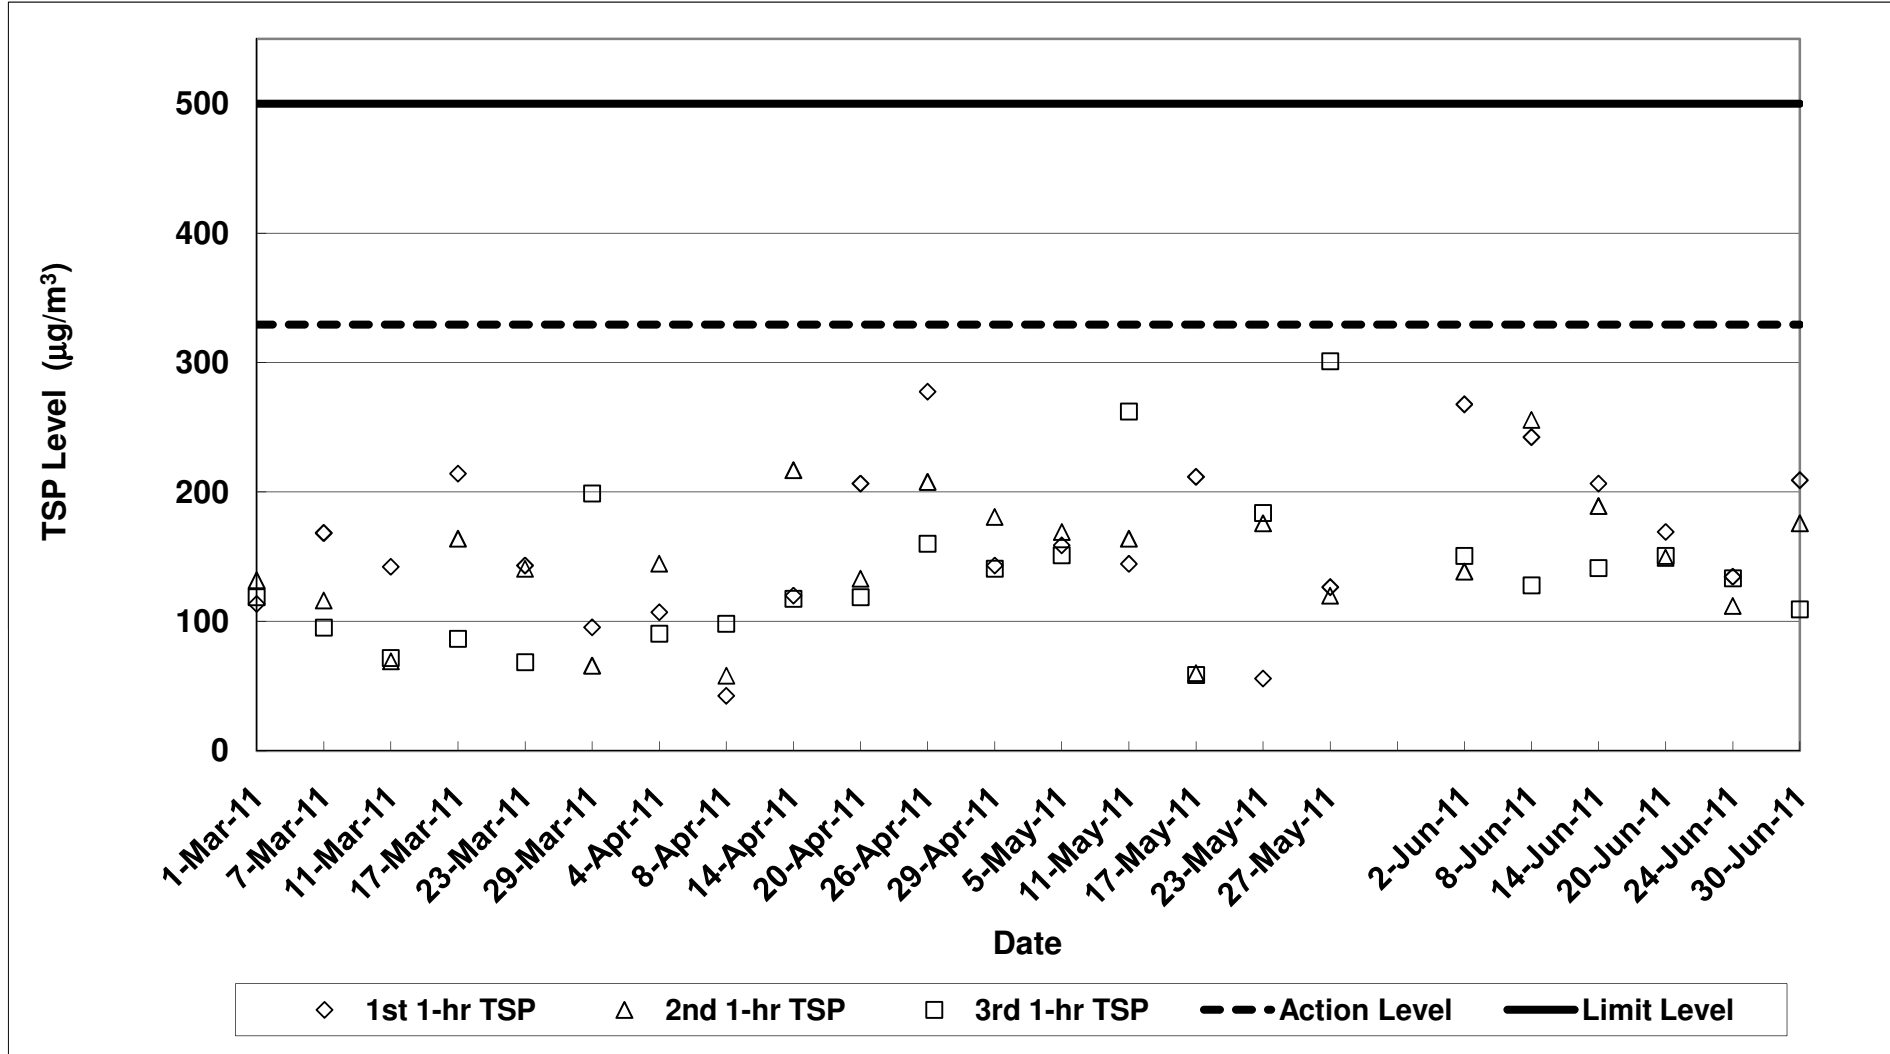
**Contract No. DC/2007/12 - Design and Construction of Tsuen Wan Drainage Tunnel  
 Air Quality Monitoring (1-hr TSP) Results at Greenview Terrace - Outfall (ASR9)  
 Mar-11 to Jun-11**

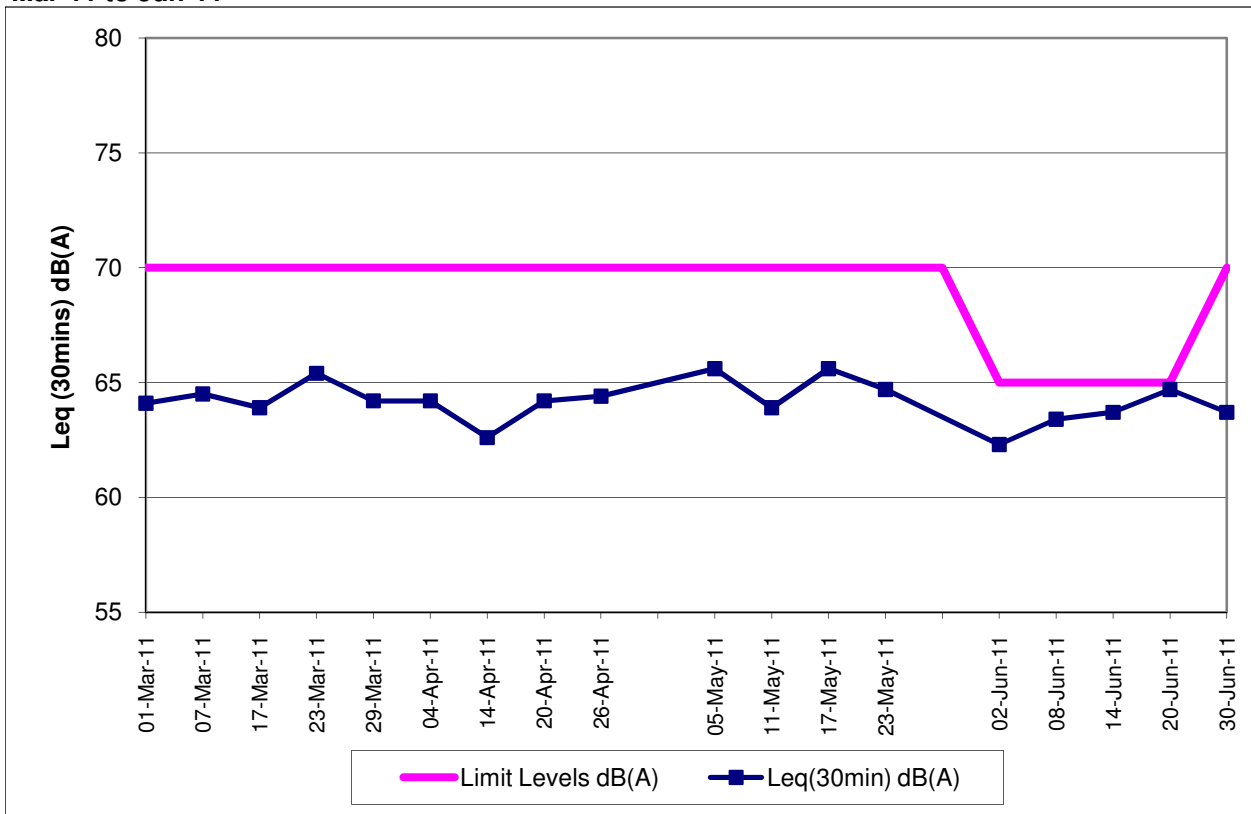
**Contract No. DC/2007/12 - Design and Construction of Tsuen Wan Drainage Tunnel  
Noise Monitoring Results at Sik Sik Yuen Ho Fung College (NSR 1)  
Mar-11 to Jun-11**

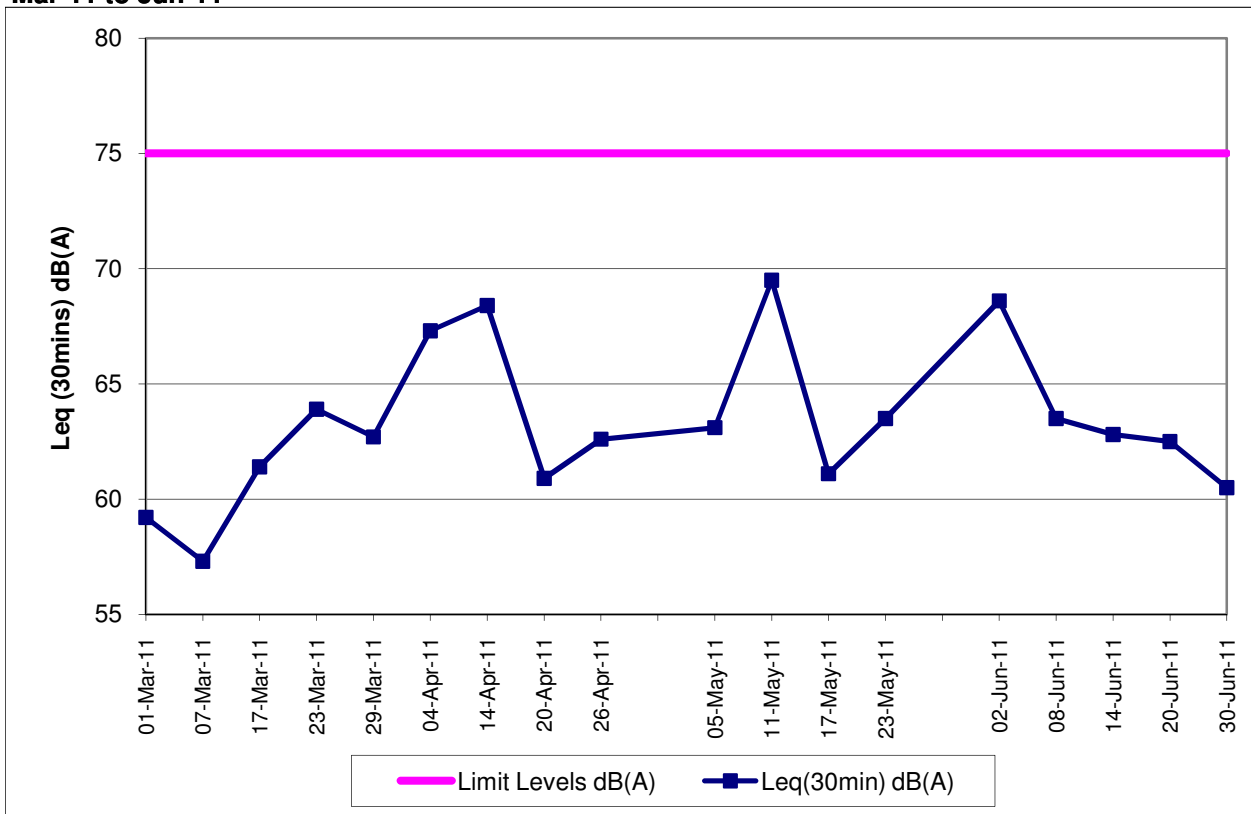
**Contract No. DC/2007/12 - Design and Construction of Tsuen Wan Drainage Tunnel  
Noise Monitoring Results at Hong Hoi Chee Hong Temple (NSR 3)  
Mar-11 to Jun-11**

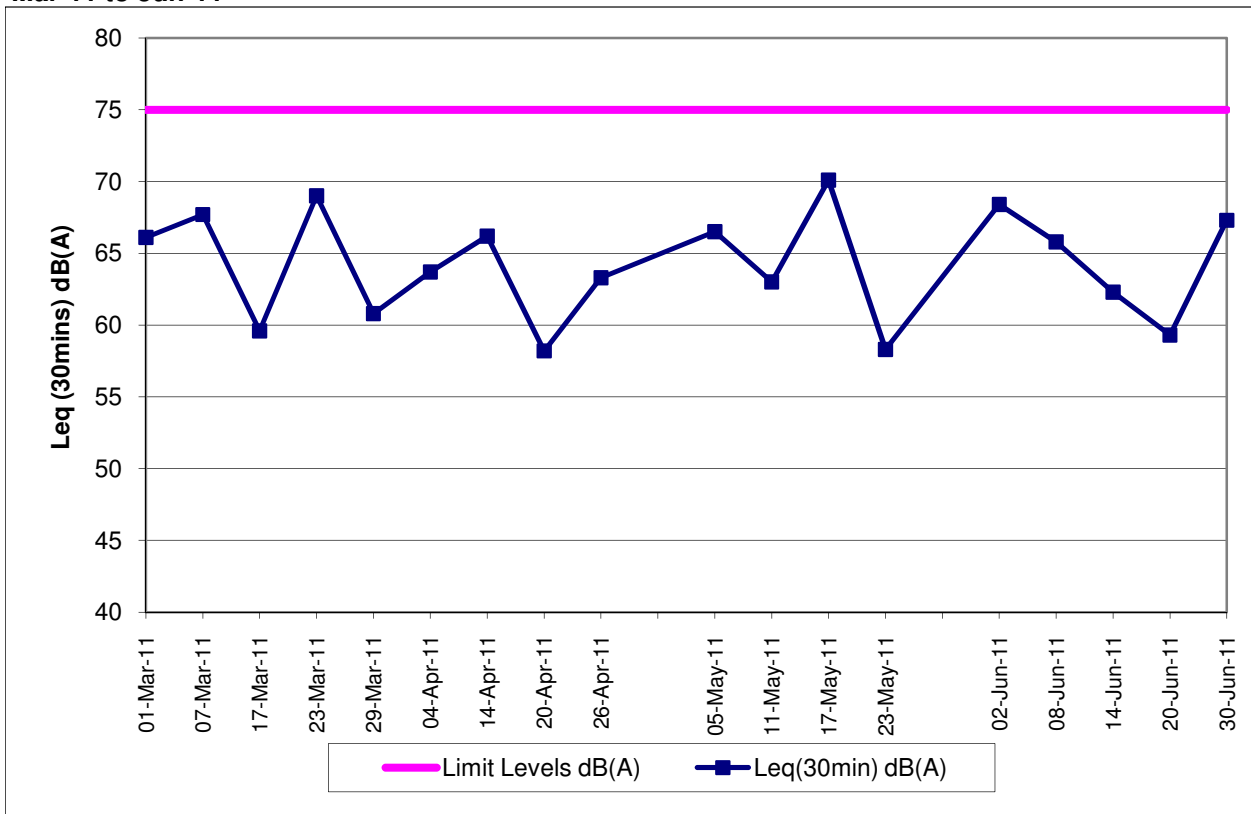
**Contract No. DC/2007/12 - Design and Construction of Tsuen Wan Drainage Tunnel  
 Noise Monitoring Results at Squatters (NSR 6)  
 Mar-11 to Jun-11**

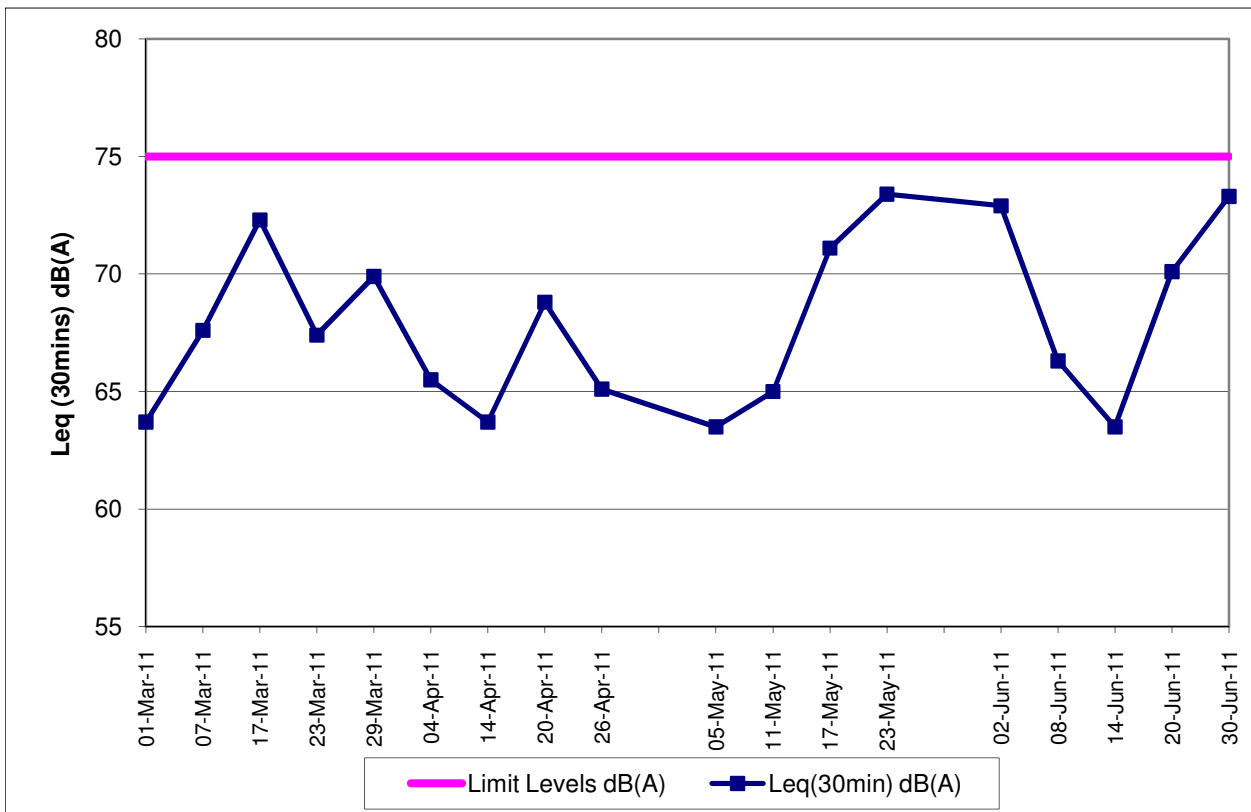
**Contract No. DC/2007/12 - Design and Construction of Tsuen Wan Drainage Tunnel  
 Noise Monitoring Results at Long Beach Gardens (NSR 8)  
 Mar-11 to Jun-11**

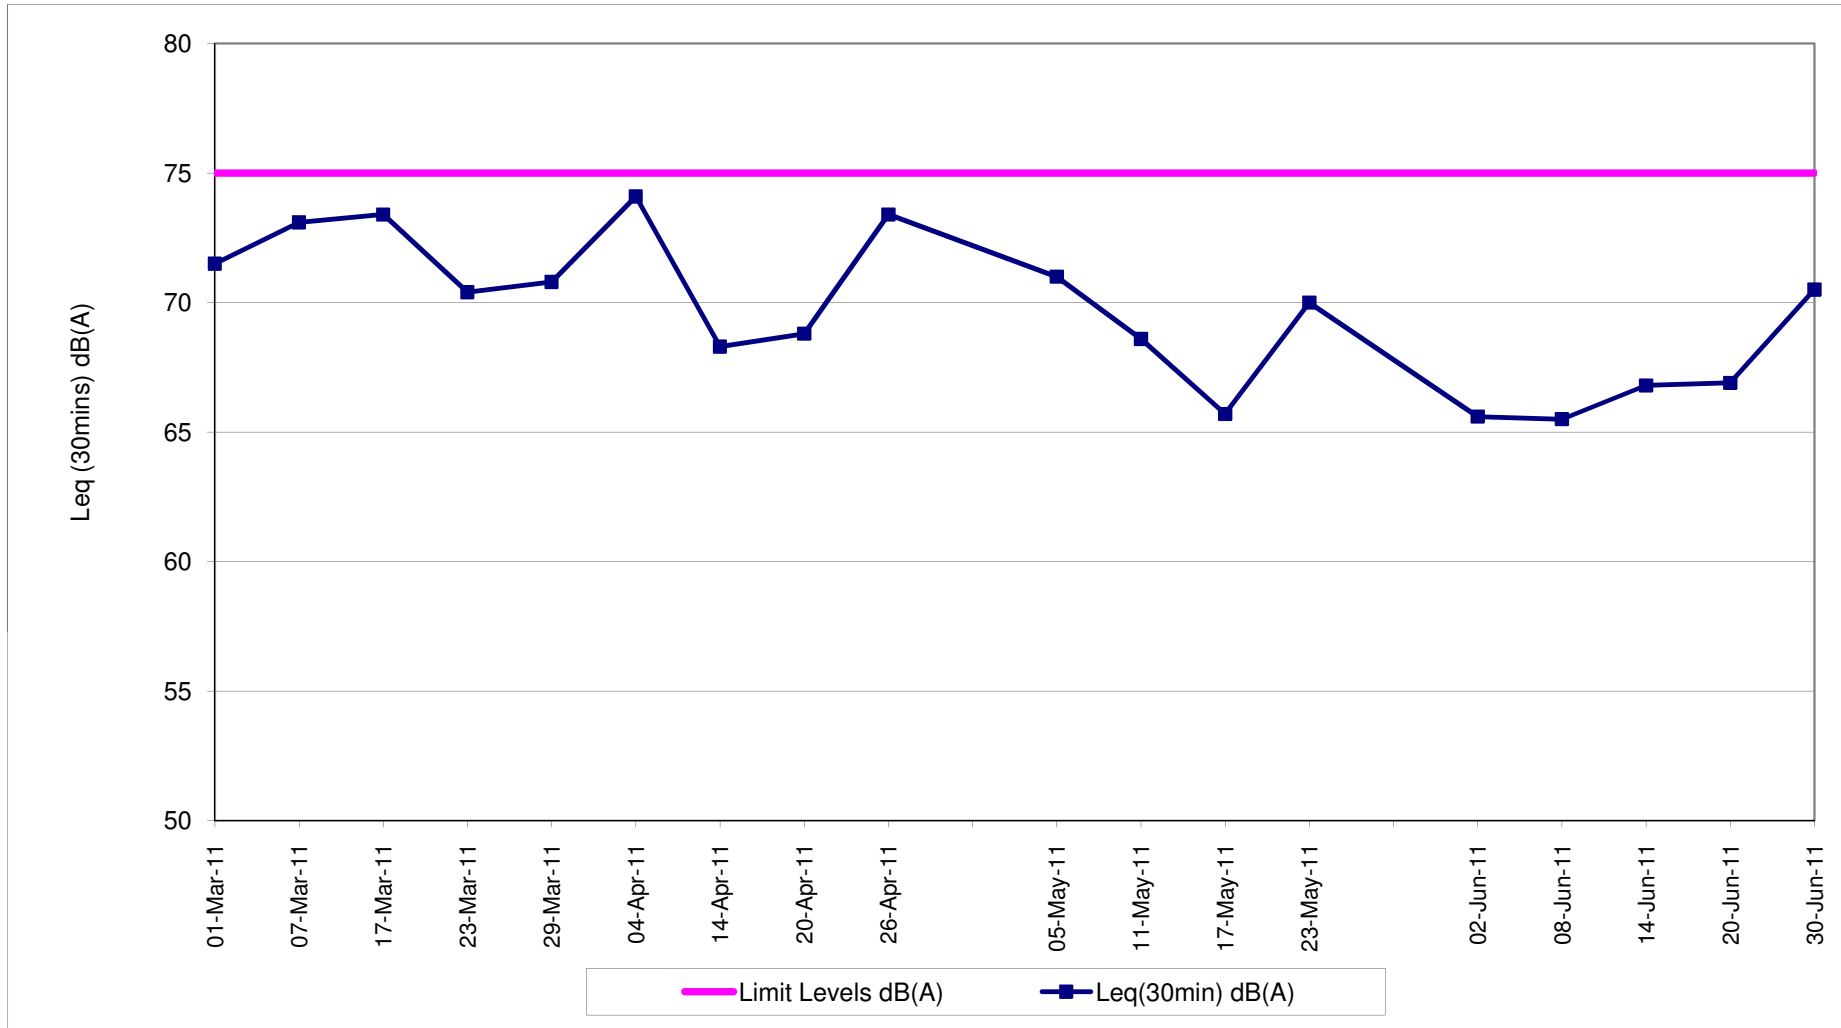
**Contract No. DC/2007/12 - Design and Construction of Tsuen Wan Drainage Tunnel  
Noise Monitoring Results at Greenview Terrace (NSR 9)  
Mar-11 to Jun-11**

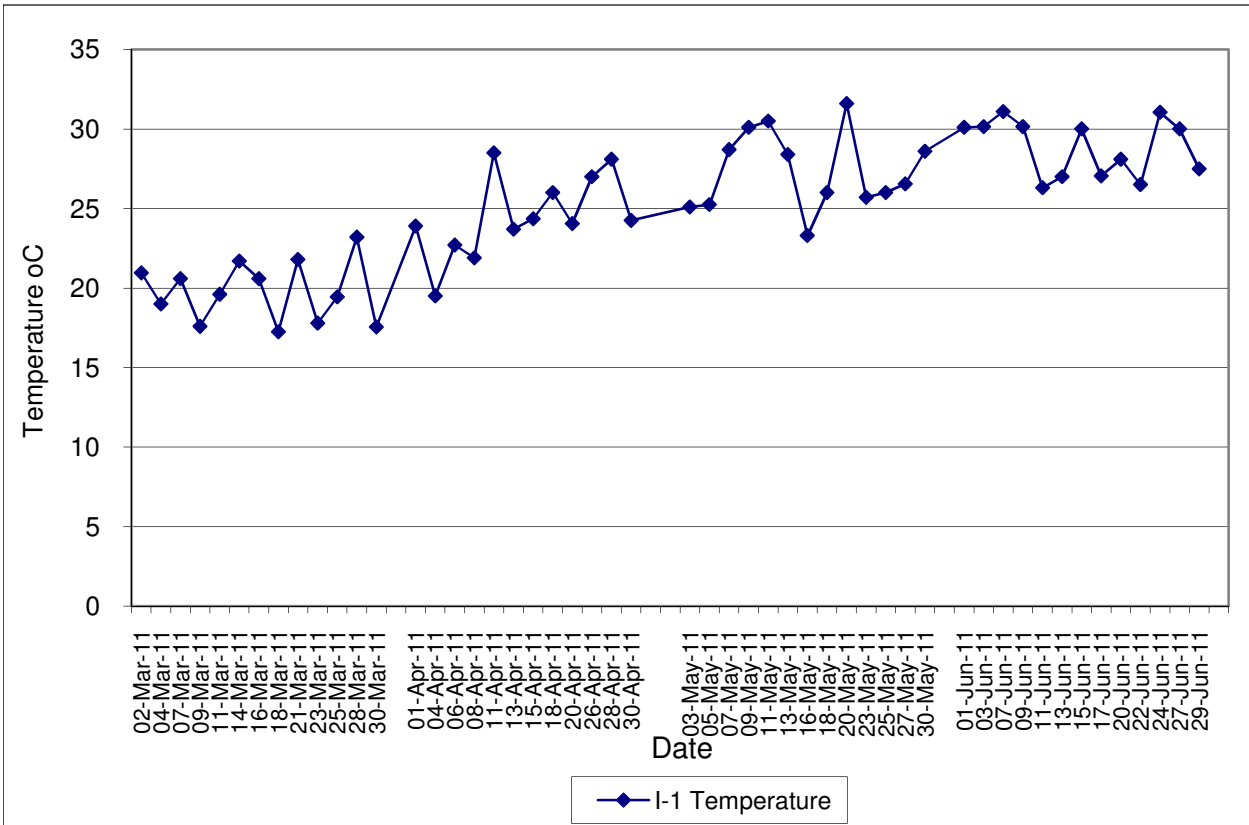
**Contract No. DC/2007/12 - Design and Construction of Tsuen Wan Drainage Tunnel  
 Water Quality Results at Sik Sik Yuen Ho Fung College (I-1)  
 Mar-11 to Jun-11**

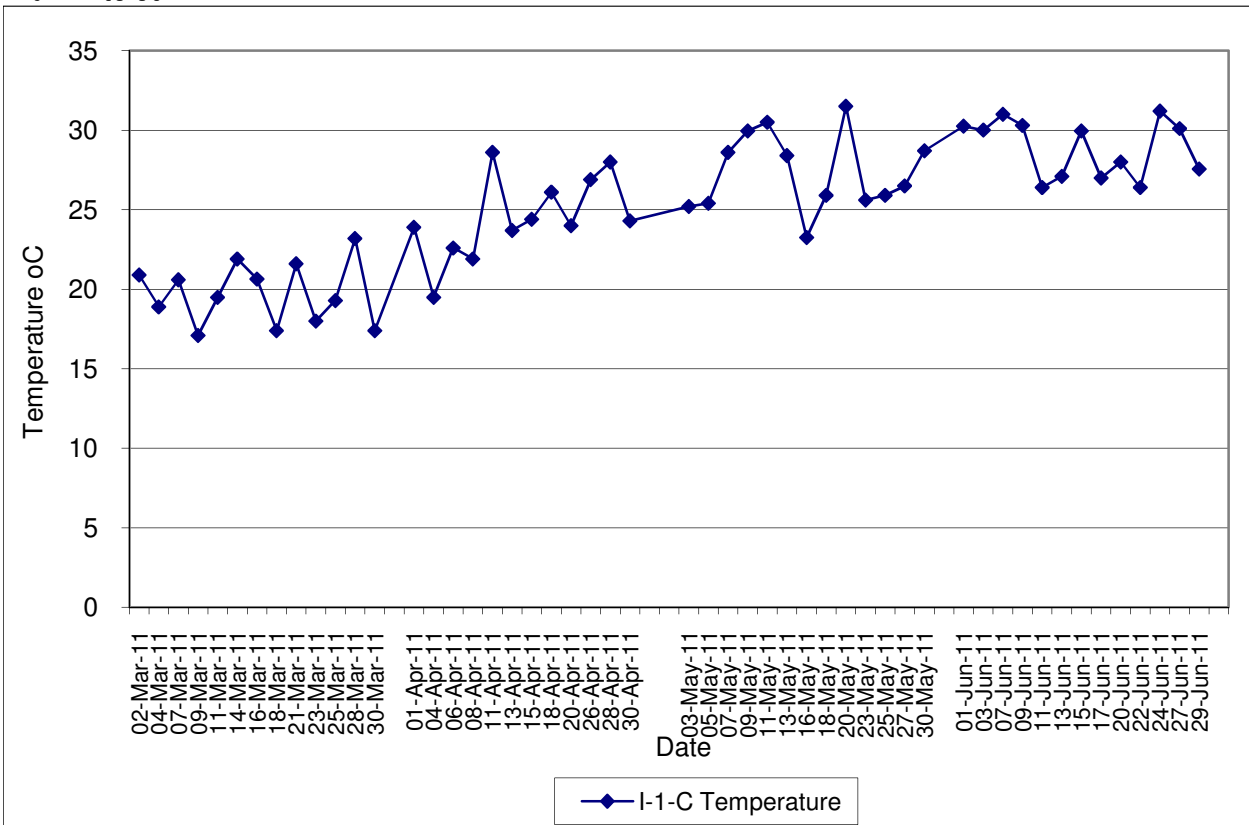
**Contract No. DC/2007/12 - Design and Construction of Tsuen Wan Drainage Tunnel  
 Water Quality Results at Sik Sik Yuen Ho Fung College (I-1-C)  
 Mar-11 to Jun-11**

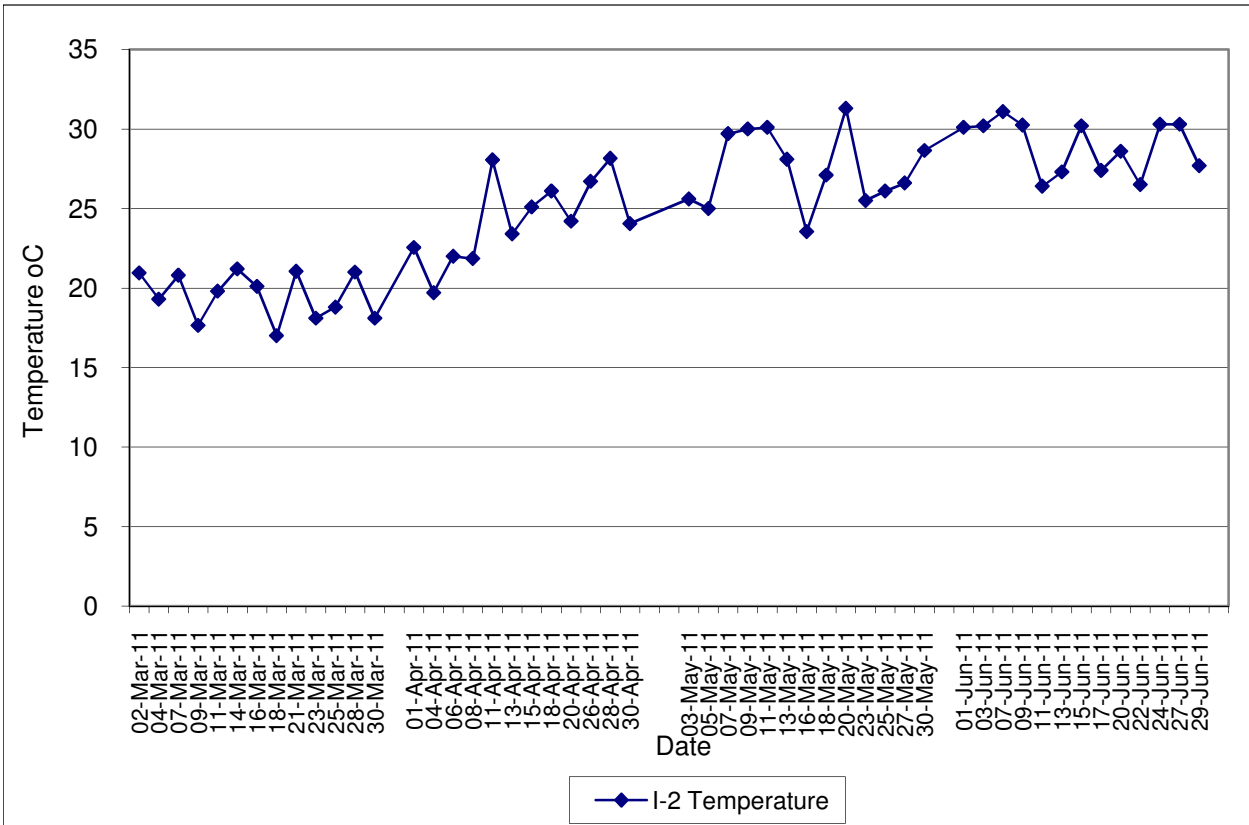
**Contract No. DC/2007/12 - Design and Construction of Tsuen Wan Drainage Tunnel**  
**Water Quality Results at Hong Hoi Chee Hong Temple (I-2)**  
**Mar-11 to Jun-11**

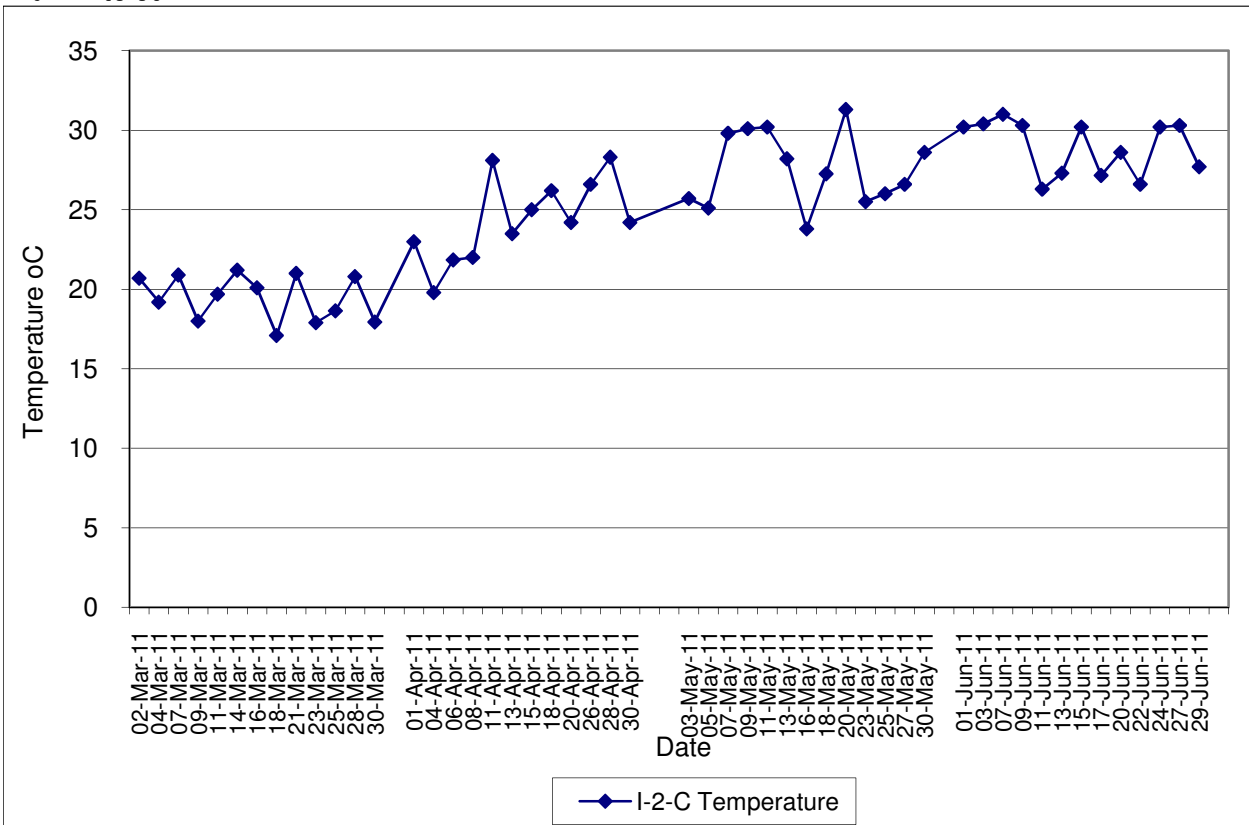
**Contract No. DC/2007/12 - Design and Construction of Tsuen Wan Drainage Tunnel**  
**Water Quality Results at Hong Hoi Chee Hong Temple (I-2-C)**  
**Mar-11 to Jun-11**

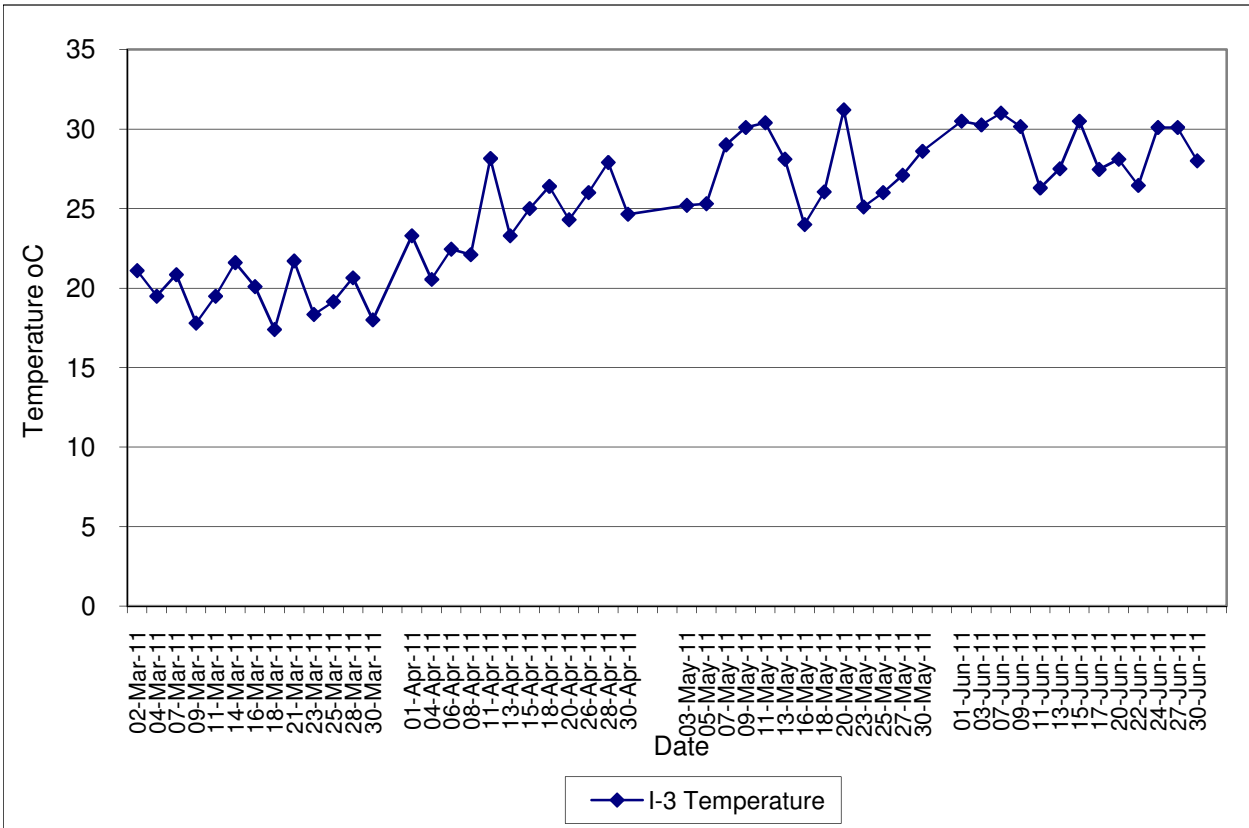
**Contract No. DC/2007/12 - Design and Construction of Tsuen Wan Drainage Tunnel**  
**Water Quality Results at Squatters (I-3)**  
**Mar-11 to Jun-11**
