Maeda - CREC - SELI Joint Venture

Contract No. DC/2007/12 - Design and  
Construction of Tsuen Wan Drainage Tunnel

Monthly EM&A Report (June 2011)

Report No EB000364R0642

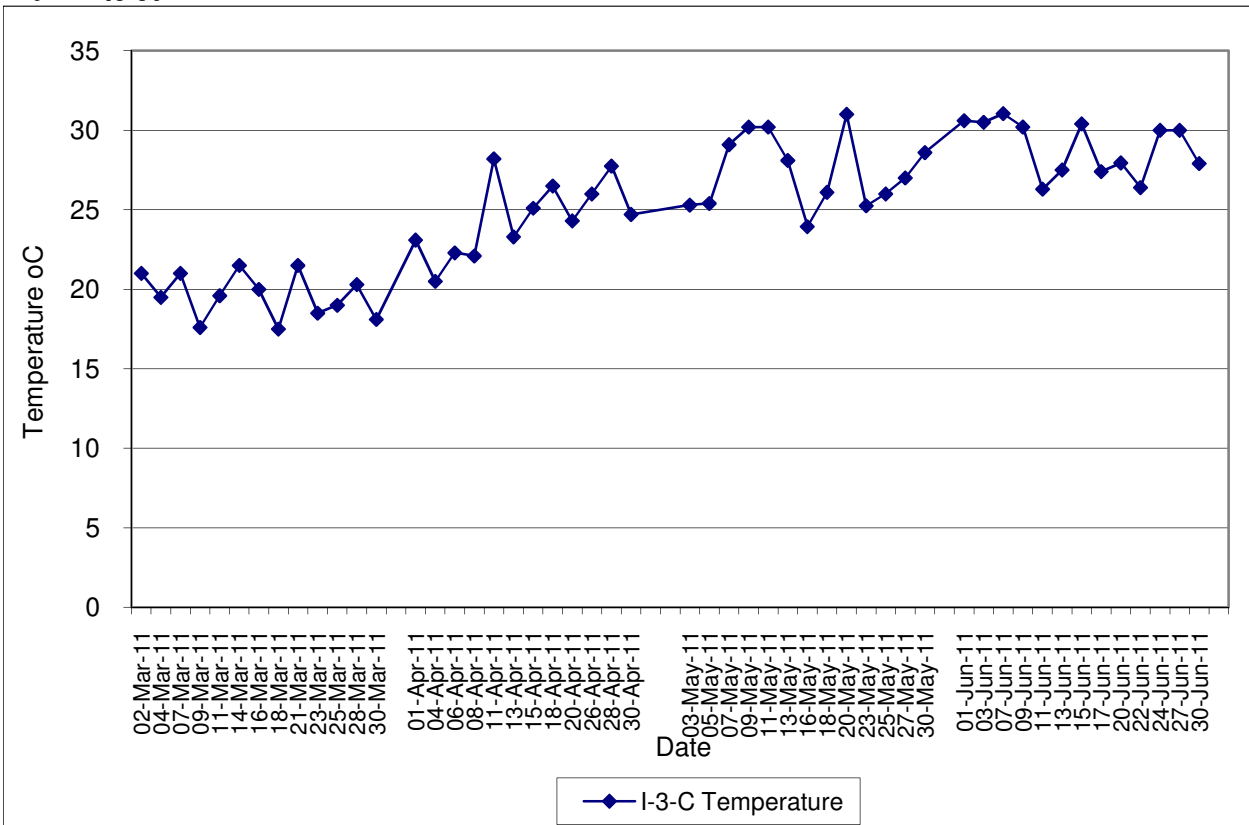
**Contract No. DC/2007/12 - Design and Construction of Tsuen Wan Drainage Tunnel**  
**Water Quality Results at Squatters (I-3-C)**  
**Mar-11 to Jun-11**

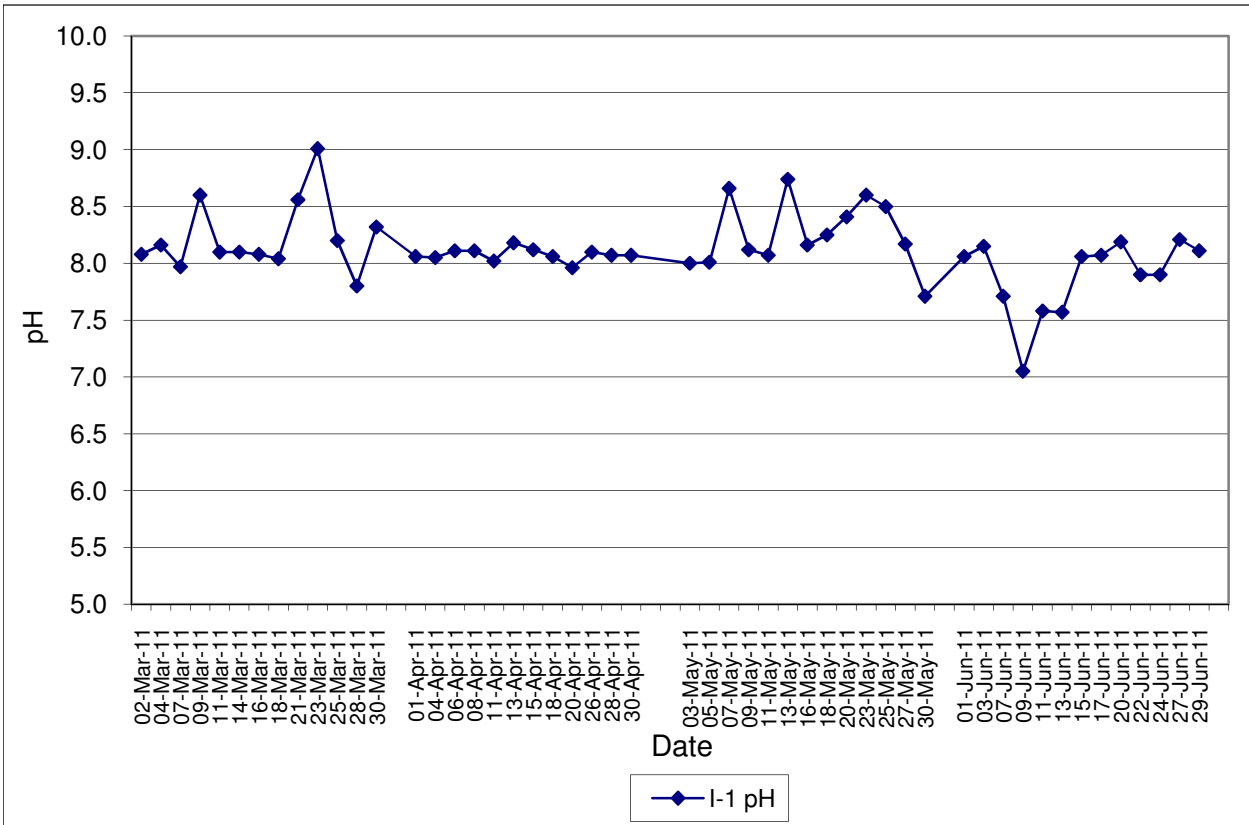
**Contract No. DC/2007/12 - Design and Construction of Tsuen Wan Drainage Tunnel**  
**Water Quality Results at Sik Sik Yuen Ho Fung College (I-1)**  
**Mar-11 to Jun-11**

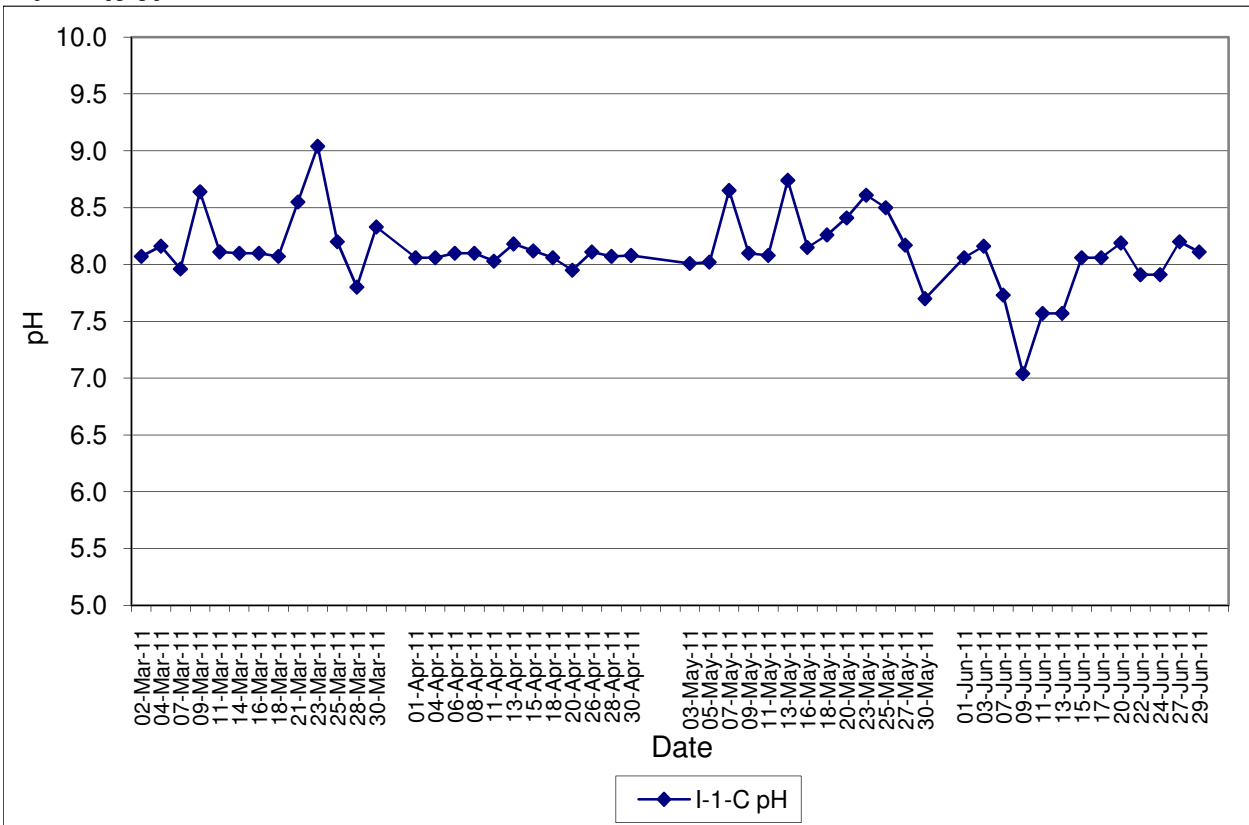
**Contract No. DC/2007/12 - Design and Construction of Tsuen Wan Drainage Tunnel**  
**Water Quality Results at Sik Sik Yuen Ho Fung College (I-1-C)**  
**Mar-11 to Jun-11**

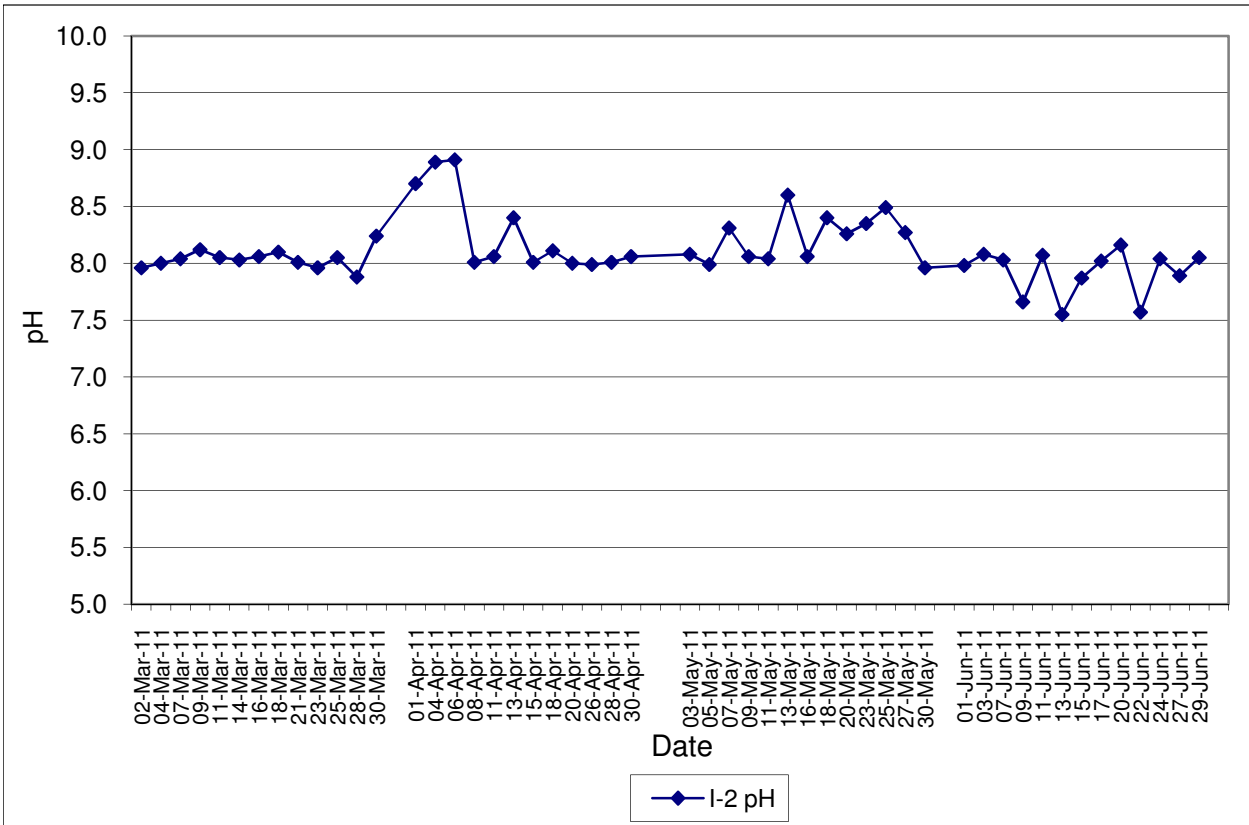
**Contract No. DC/2007/12 - Design and Construction of Tsuen Wan Drainage Tunnel**  
**Water Quality Results at Hong Hoi Chee Hong Temple (I-2)**  
**Mar-11 to Jun-11**

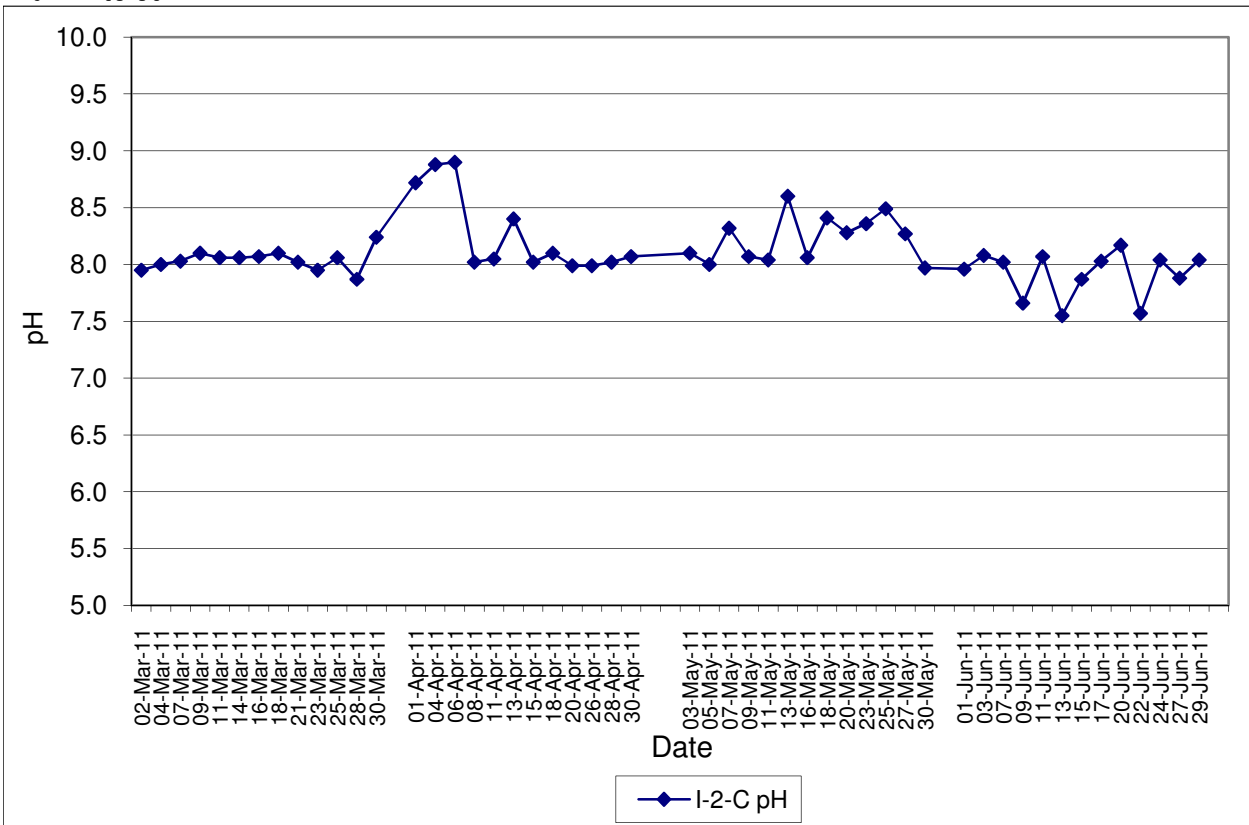
**Contract No. DC/2007/12 - Design and Construction of Tsuen Wan Drainage Tunnel**  
**Water Quality Results at Hong Hoi Chee Hong Temple (I-2-C)**  
**Mar-11 to Jun-11**

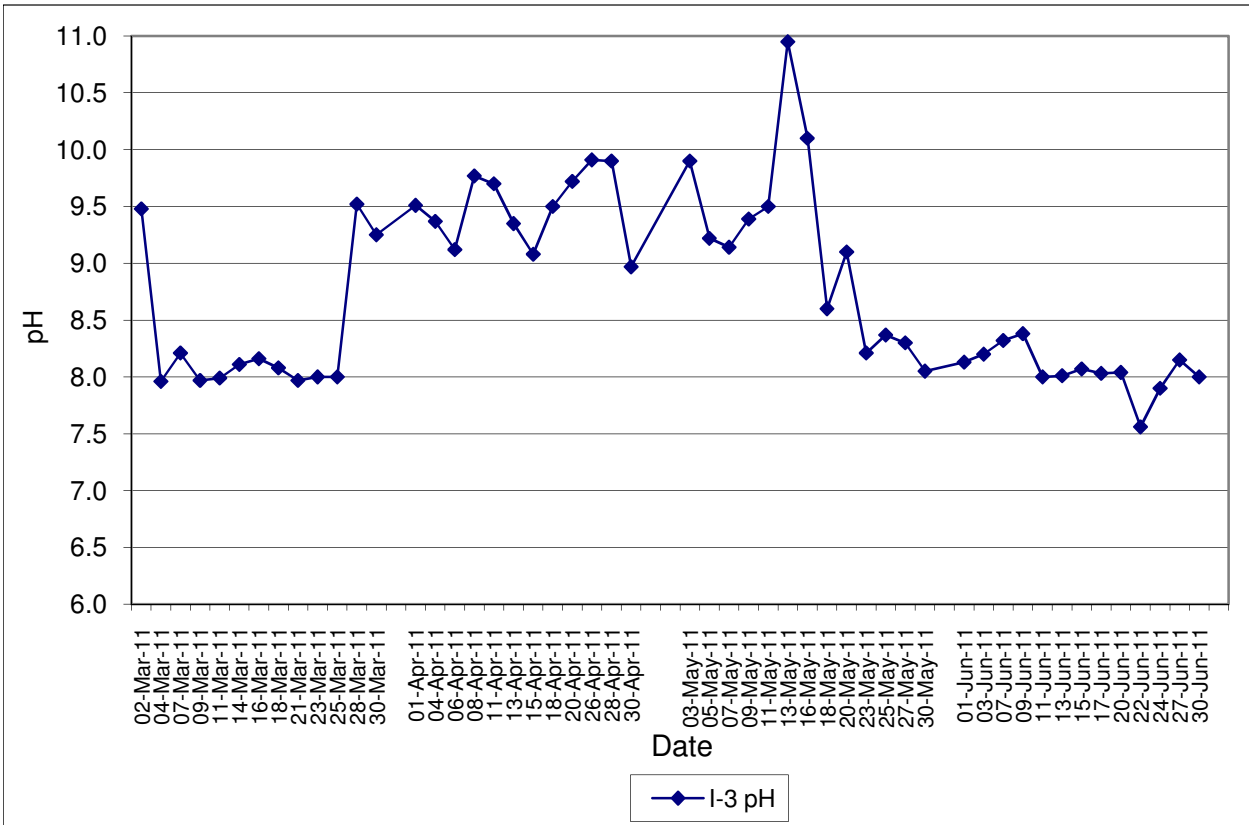
**Contract No. DC/2007/12 - Design and Construction of Tsuen Wan Drainage Tunnel**  
**Water Quality Results at Squatters (I-3)**  
**Mar-11 to Jun-11**

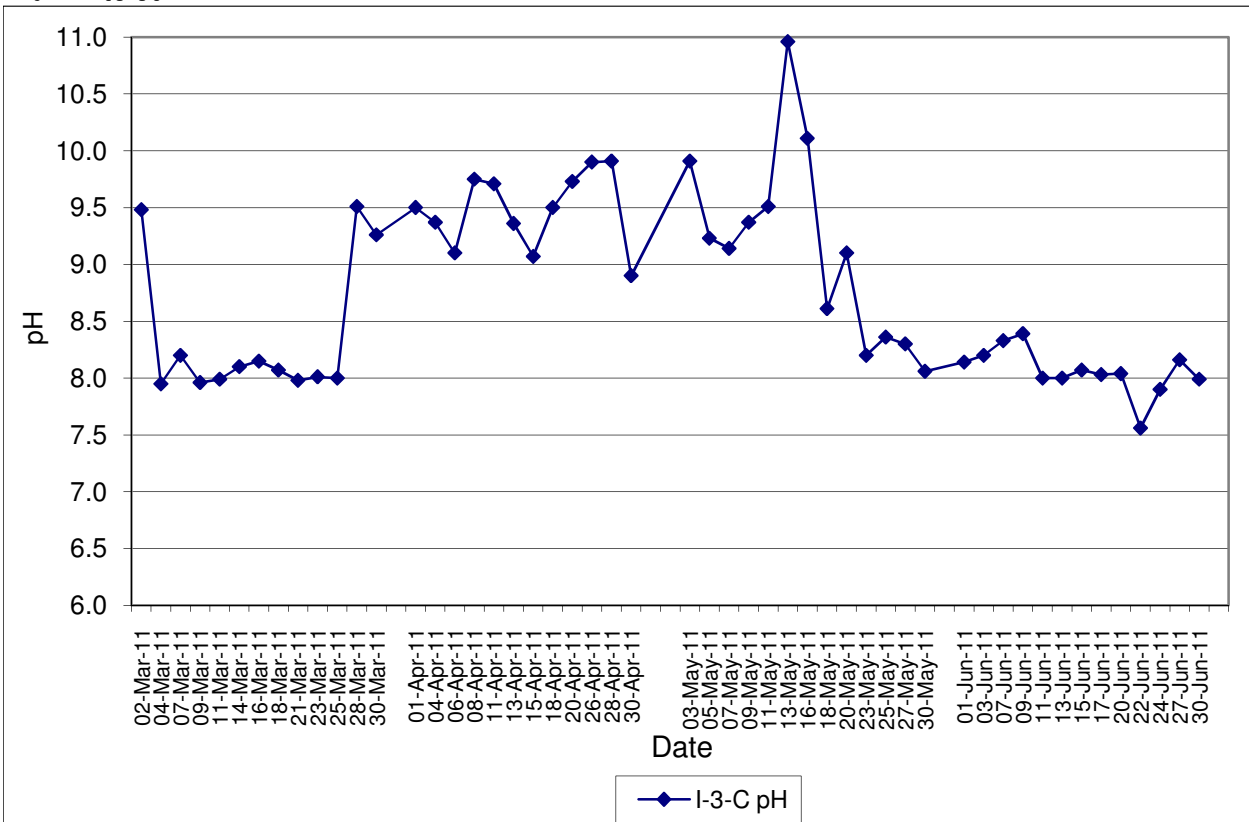
**Contract No. DC/2007/12 - Design and Construction of Tsuen Wan Drainage Tunnel**  
**Water Quality Results at Squatters (I-3-C)**  
**Mar-11 to Jun-11**

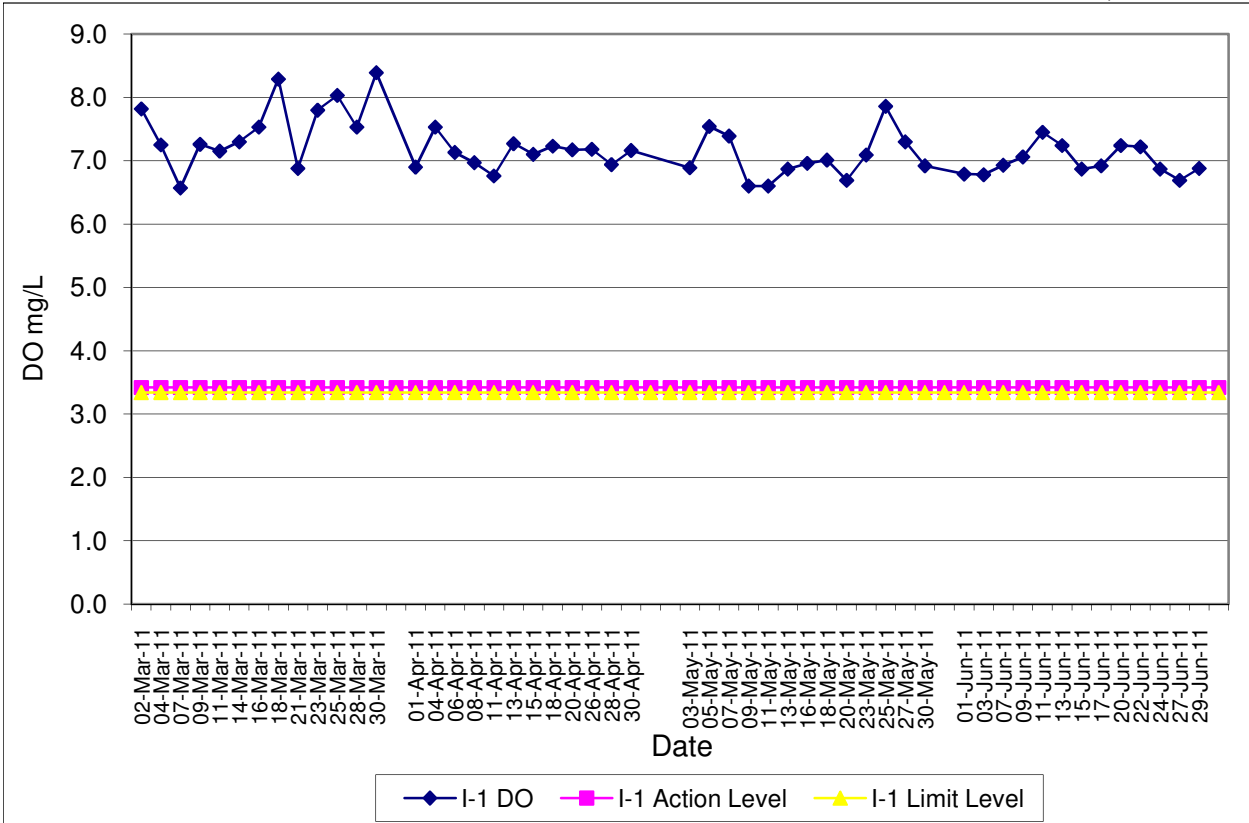
**Contract No. DC/2007/12 - Design and Construction of Tsuen Wan Drainage Tunnel  
Water Quality Results at Sik Sik Yuen Ho Fung College (I-1)**

Note: Exceedances of Action / Limit Levels occur when the levels of DO are below the respective limit levels.

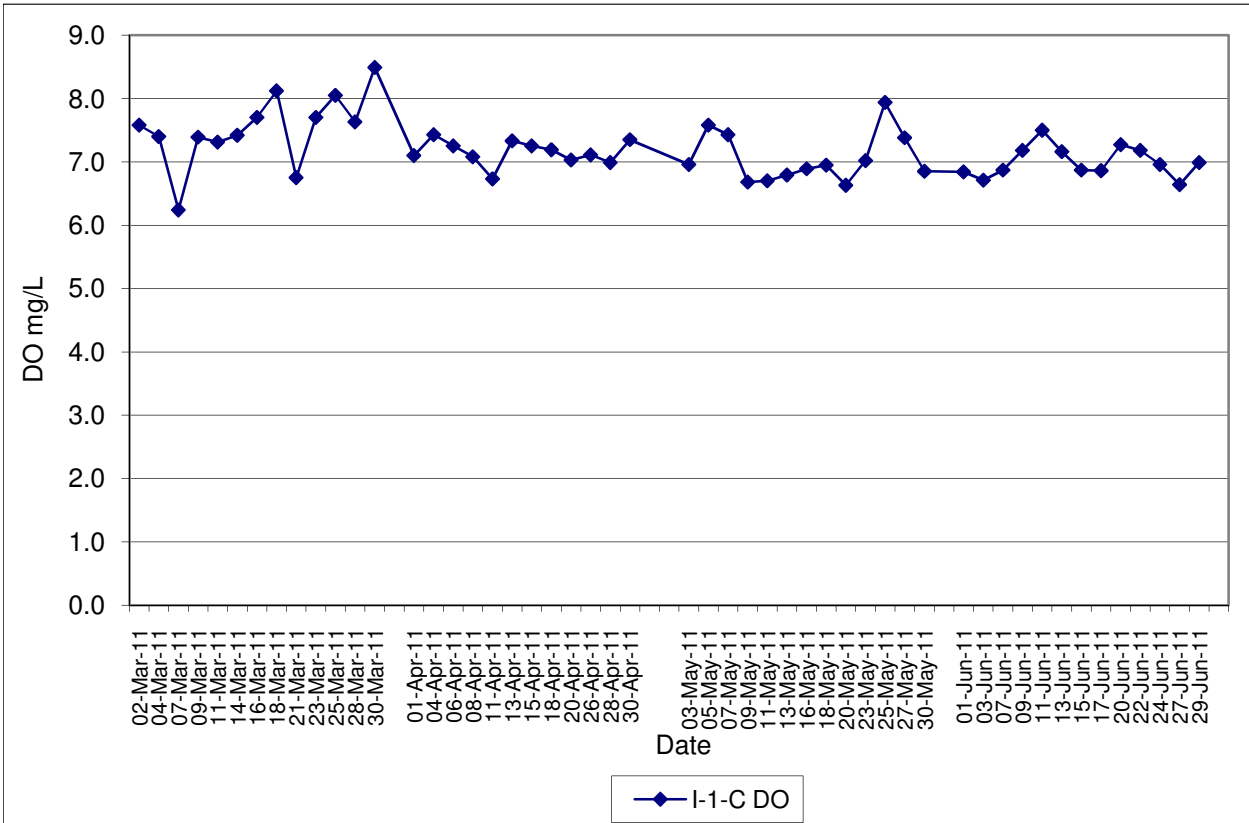
**Contract No. DC/2007/12 - Design and Construction of Tsuen Wan Drainage Tunnel  
Water Quality Results at Sik Sik Yuen Ho Fung College (I-1-C)**

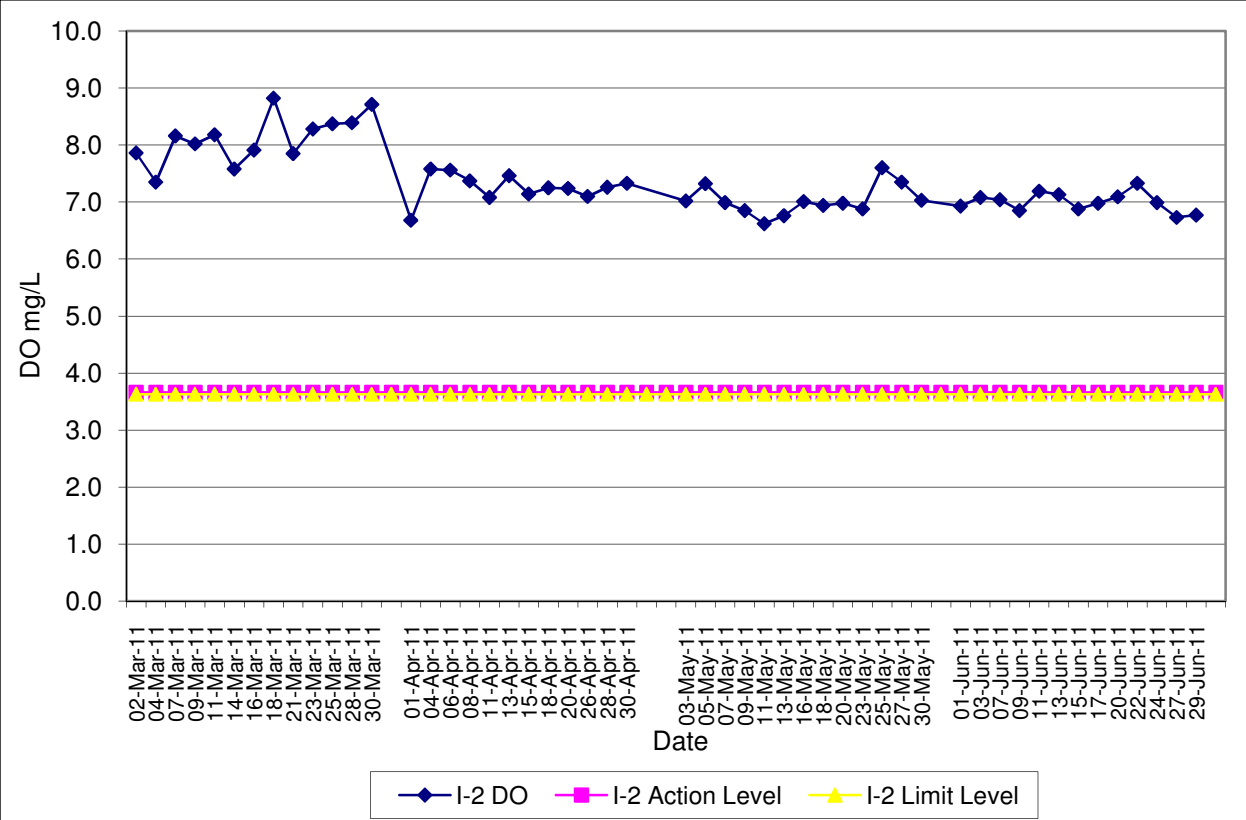
**Contract No. DC/2007/12 - Design and Construction of Tsuen Wan Drainage Tunnel**  
**Water Quality Results at Hong Hoi Chee Hong Temple (I-2)**  
**Mar-11 to Jun-11**

Note: Exceedances of Action / Limit Levels occur when the levels of DO are below the respective limit levels.

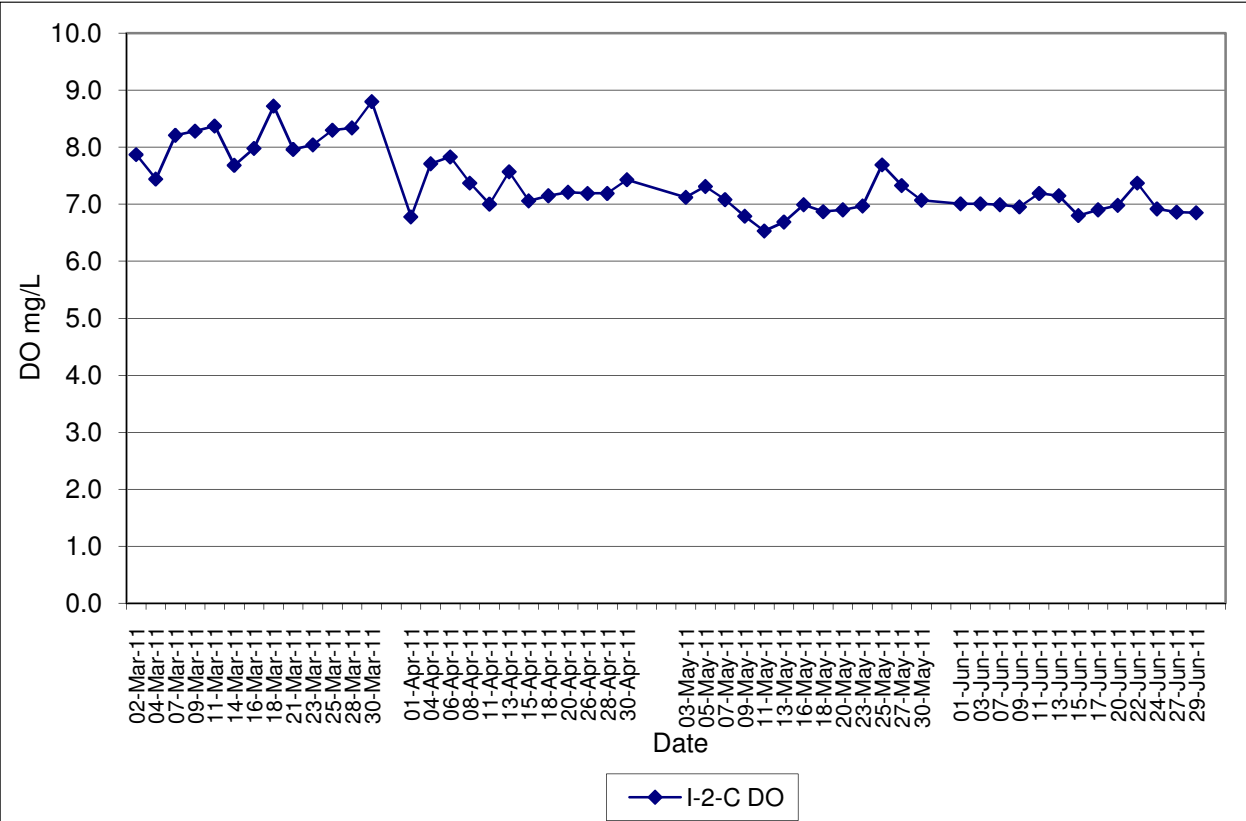
**Contract No. DC/2007/12 - Design and Construction of Tsuen Wan Drainage Tunnel**  
**Water Quality Results at Hong Hoi Chee Hong Temple (I-2-C)**  
**Mar-11 to Jun-11**

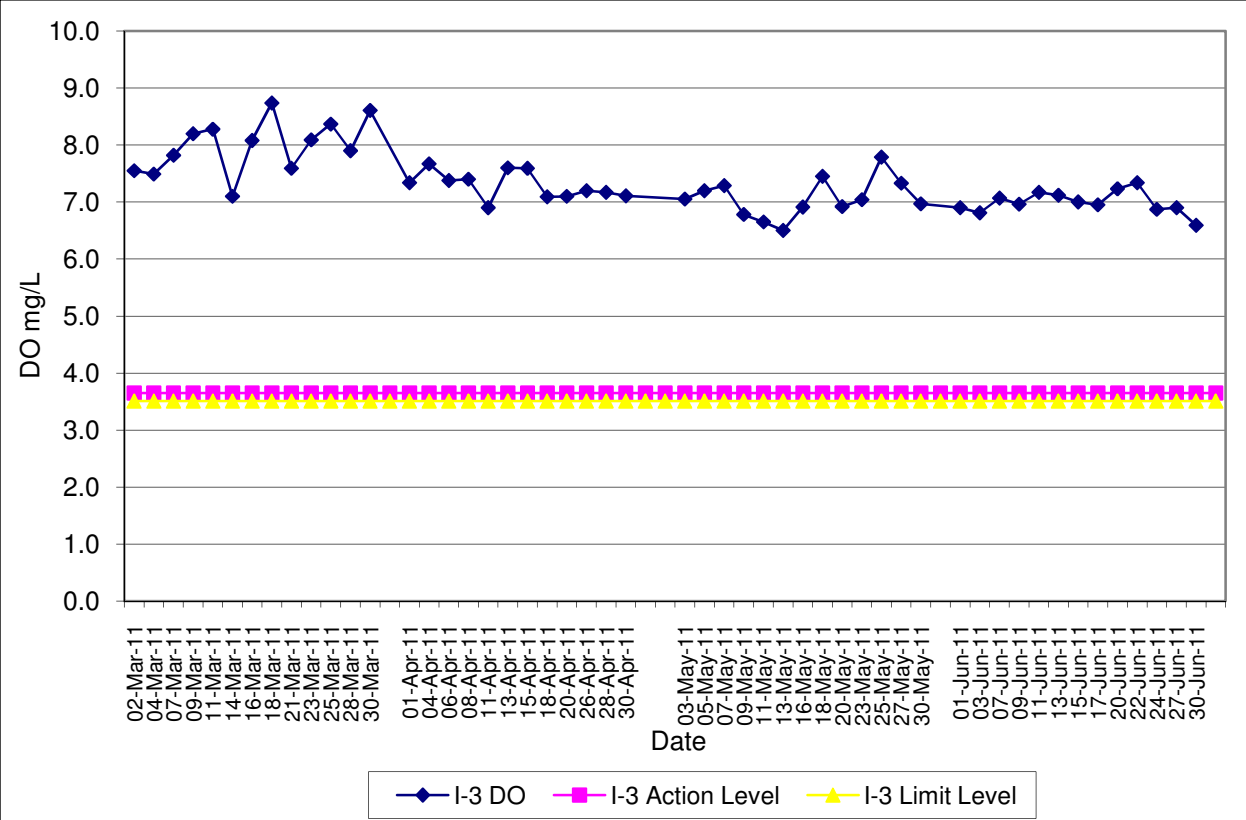
**Contract No. DC/2007/12 - Design and Construction of Tsuen Wan Drainage Tunnel  
Water Quality Results at Squatters (I-3)**

Note: Exceedances of Action / Limit Levels occur when the levels of DO are below the respective limit levels.

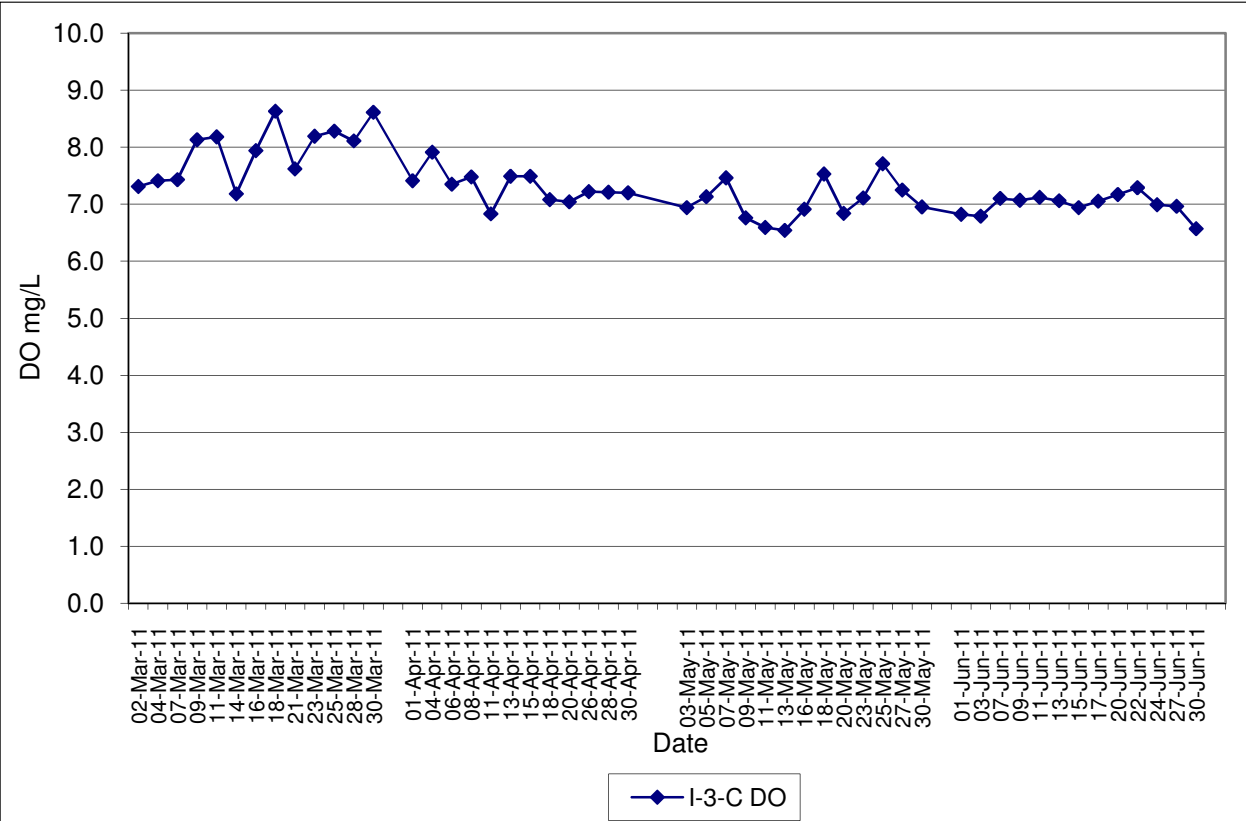
**Contract No. DC/2007/12 - Design and Construction of Tsuen Wan Drainage Tunnel  
Water Quality Results at Squatters (I-3-C)**

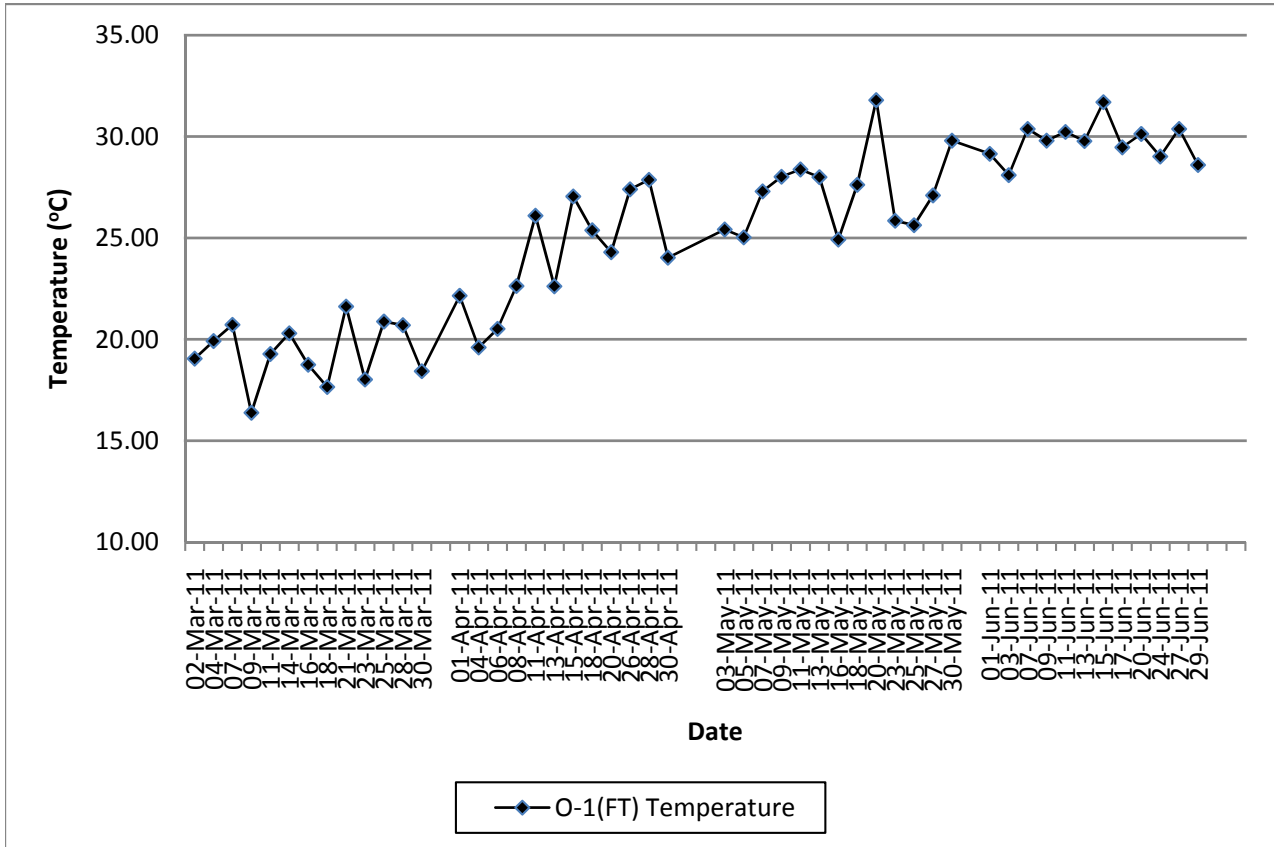
**Contract No. DC/2007/12 - Design and Construction of Tsuen Wan Drainage Tunnel  
Water Quality Results at Outfall 1 During Flood Tide (O-1(FT))  
Mar-11 to Jun-11**

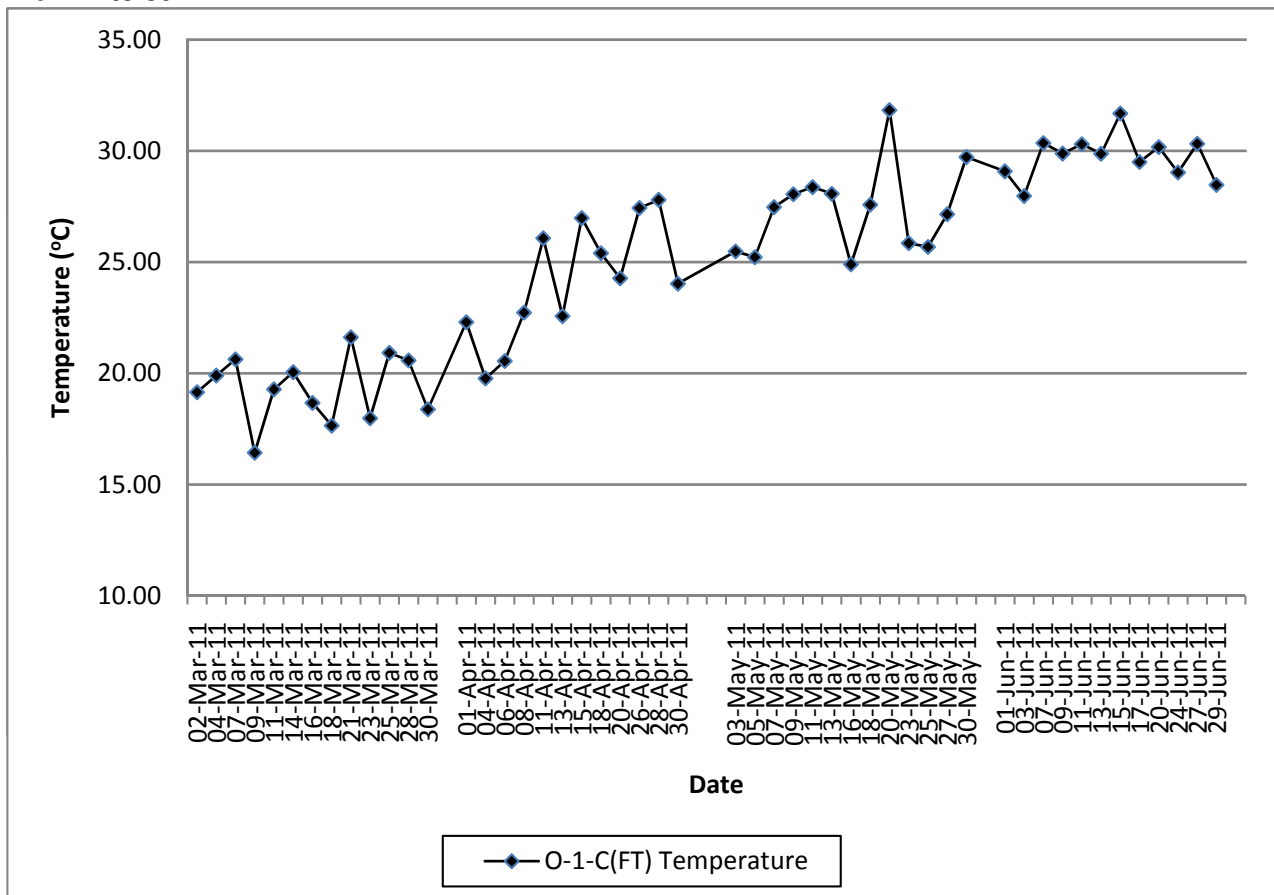
**Contract No. DC/2007/12 - Design and Construction of Tsuen Wan Drainage Tunnel  
Water Quality Results at Control of Outfall 1 During Flood Tide (O-1-C(FT))  
Mar-11 to Jun-11**

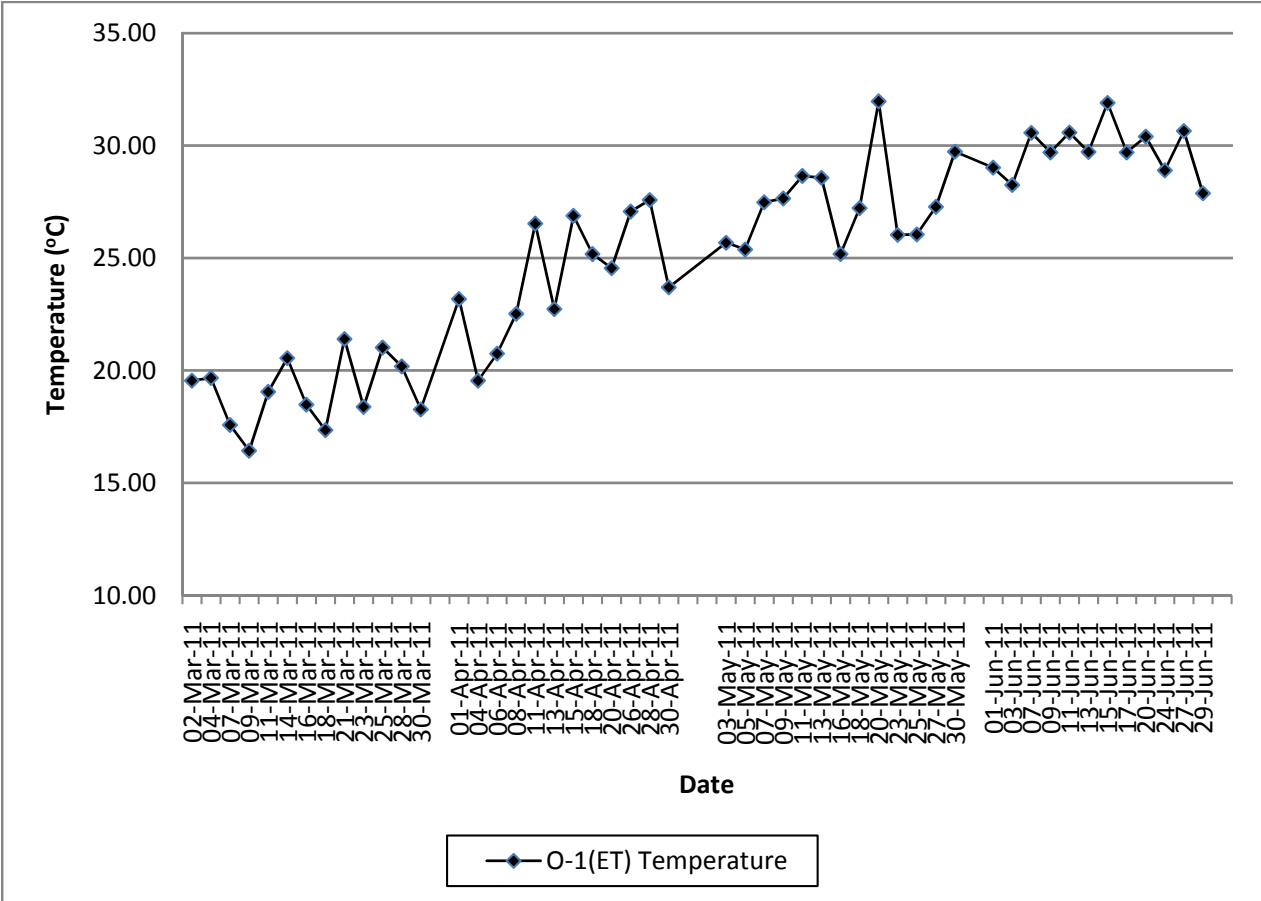
**Contract No. DC/2007/12 - Design and Construction of Tsuen Wan Drainage Tunnel  
 Water Quality Results at Outfall 1 During Ebb Tide (O-1(ET))  
 Mar-11 to Jun-11**

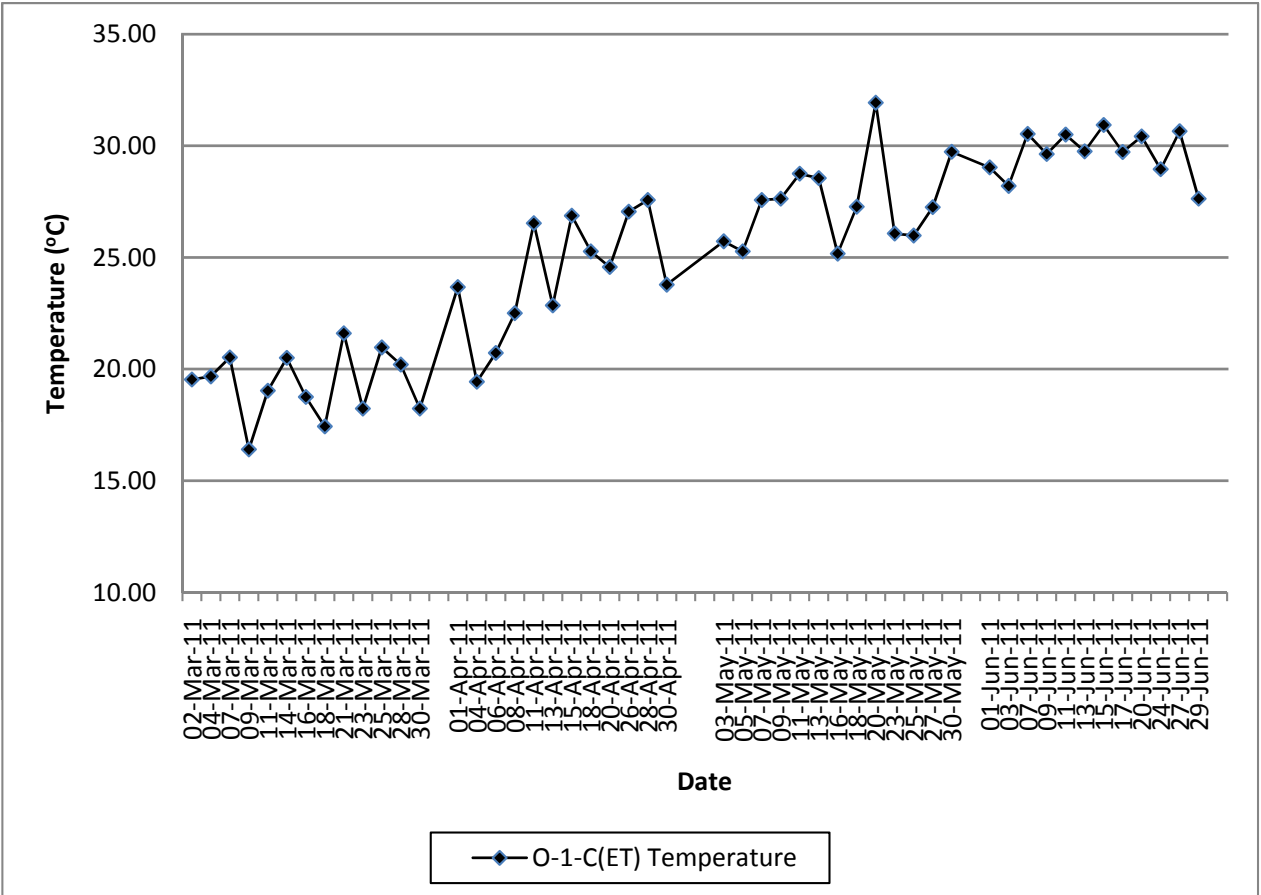
**Contract No. DC/2007/12 - Design and Construction of Tsuen Wan Drainage Tunnel  
 Water Quality Results at Control of Outfall 1 During Ebb Tide (O-1-C(ET))  
 Mar-11 to Jun-11**

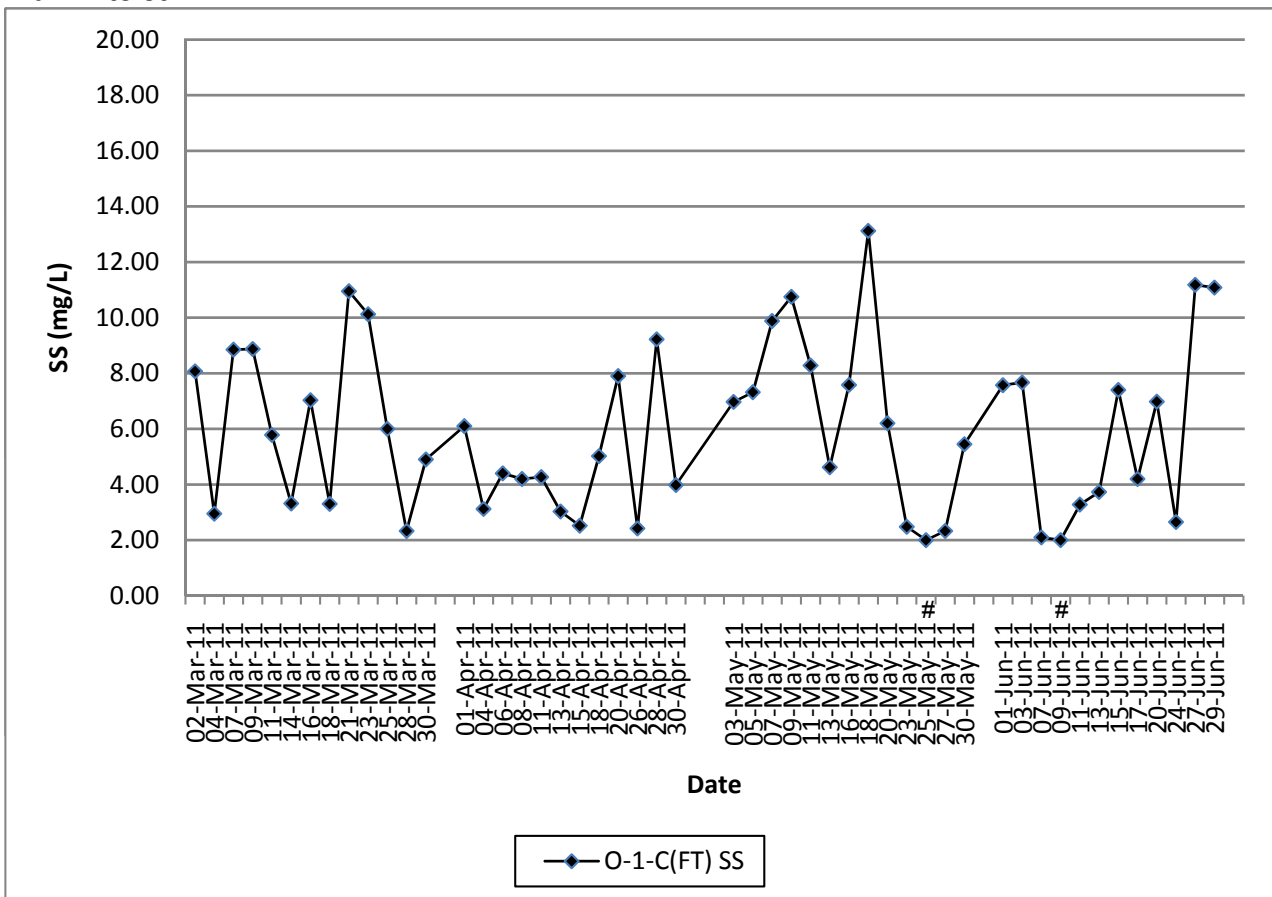
**Contract No. DC/2007/12 - Design and Construction of Tsuen Wan Drainage Tunnel  
 Water Quality Results at Control of Outfall 1 During Flood Tide (O-1-C(FT))  
 Mar-11 to Jun-11**

Note: # - For average SS level smaller than 2mg/L, the levels are plotted as 2mg/L in the graphs.

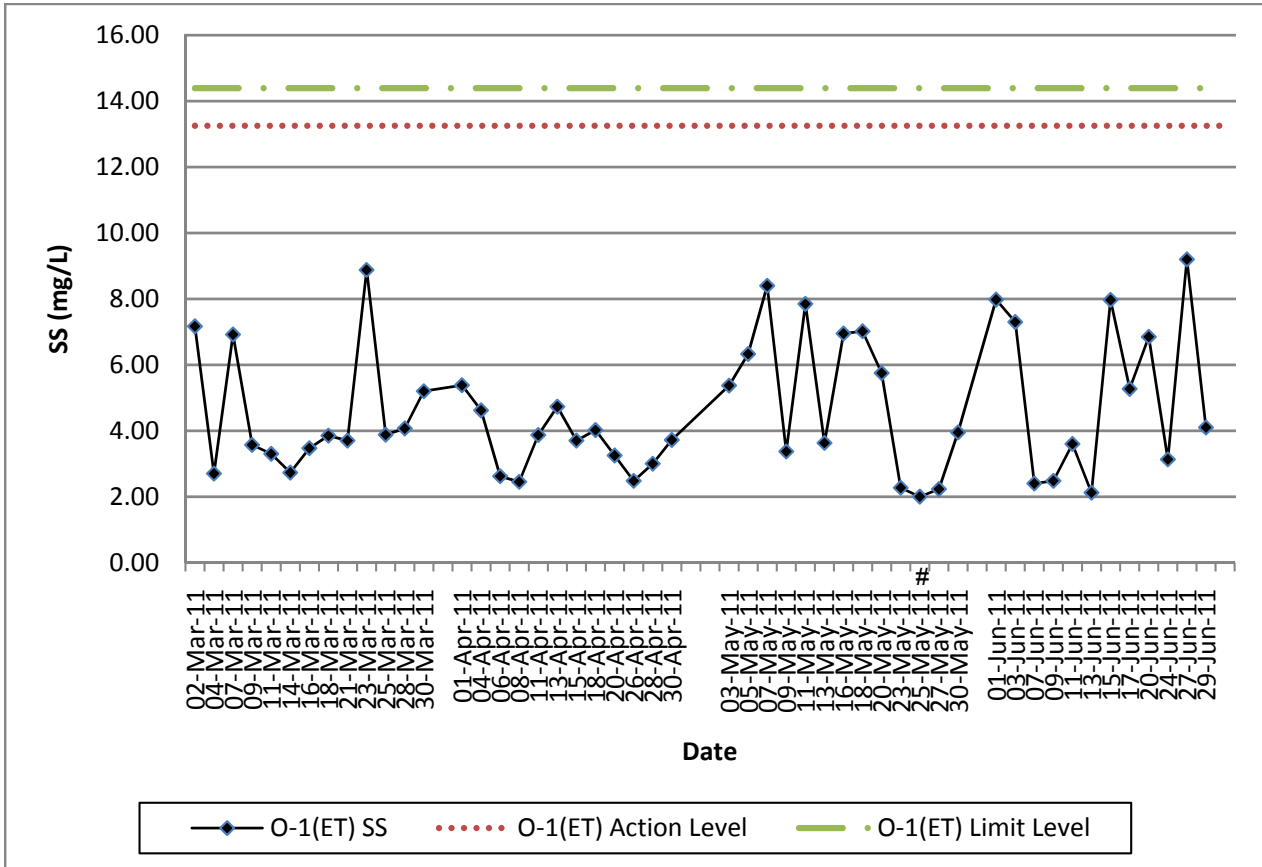
**Contract No. DC/2007/12 - Design and Construction of Tsuen Wan Drainage Tunnel  
Water Quality Results at Outfall 1 During Ebb Tide (O-1(ET))  
Mar-11 to Jun-11**

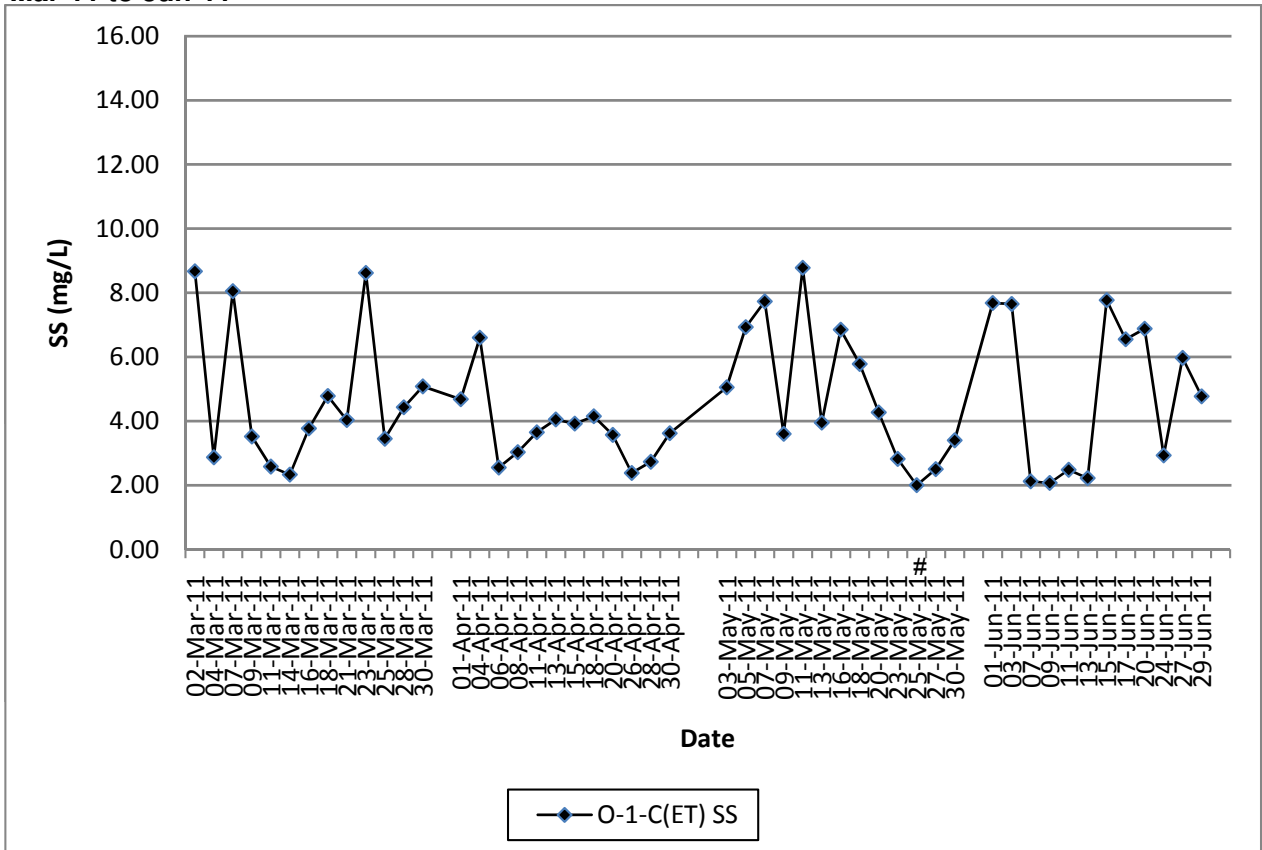
**Contract No. DC/2007/12 - Design and Construction of Tsuen Wan Drainage Tunnel  
Water Quality Results at Control of Outfall 1 During Ebb Tide (O-1-C(ET))  
Mar-11 to Jun-11**

Note: # - For average SS level smaller than 2mg/L, the levels are plotted as 2mg/L in the graphs.

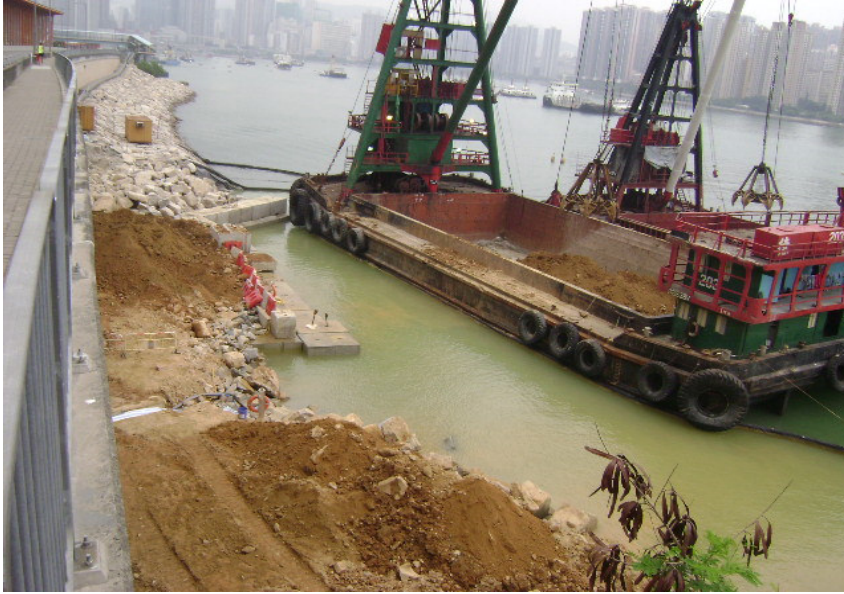
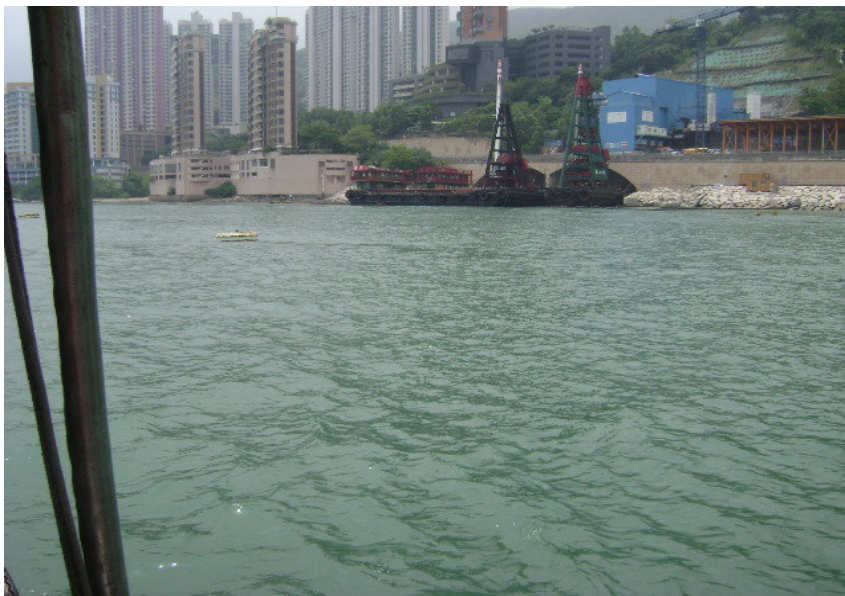
**Photographic record for exceedance of Dissolved Oxygen (marine mid-depth) recorded at O-1(ET) on 03-Jun-11**

Site photo

Site photo  
(Photo taken at location near the site)
