Maeda - CREC - SELI Joint Venture

Contract No. DC/2007/12 - Design and  
Construction of Tsuen Wan Drainage Tunnel

Monthly EM&A Report (June 2011)

Report No EB000364R0642

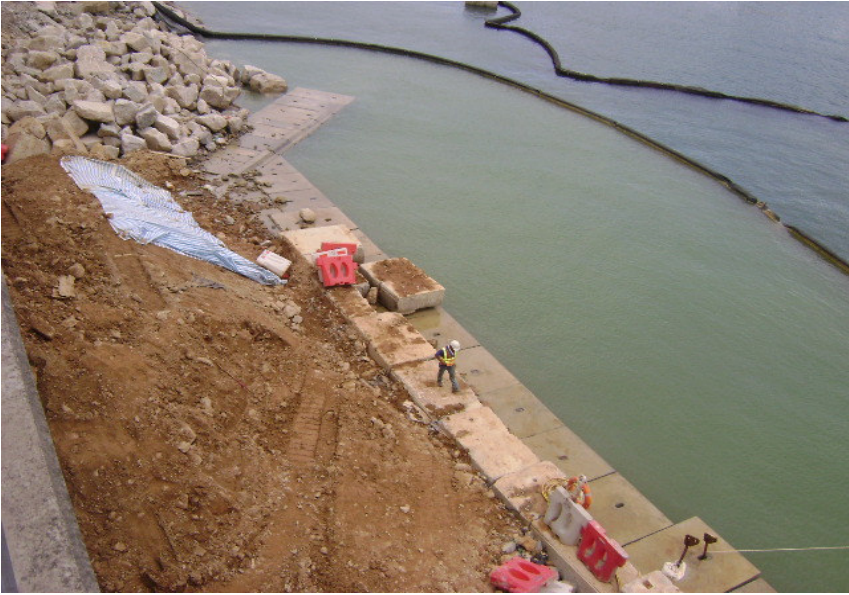
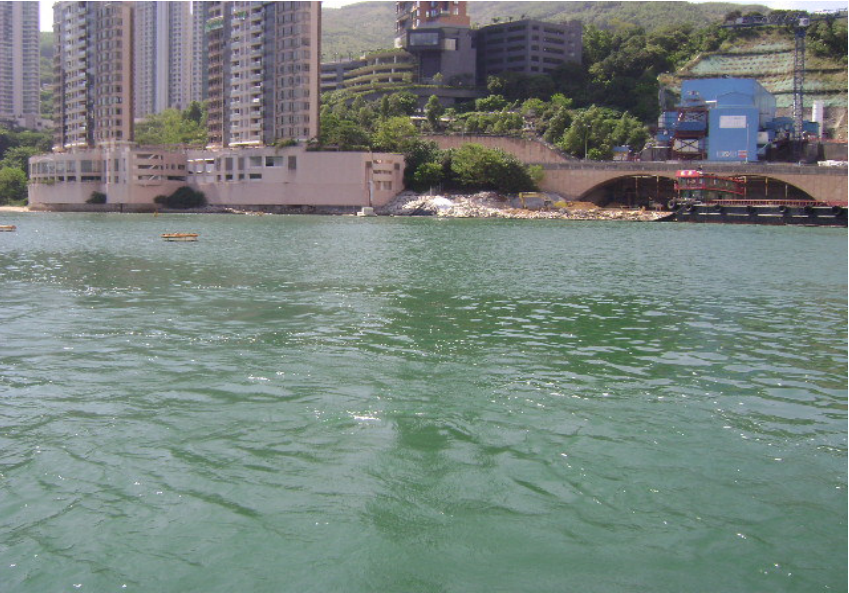
**Photographic record for exceedance of Dissolved Oxygen (marine surface) recorded at O-1(ET) on 09-Jun-11**

Site photo

Site photo  
(Photo taken at location near the site)

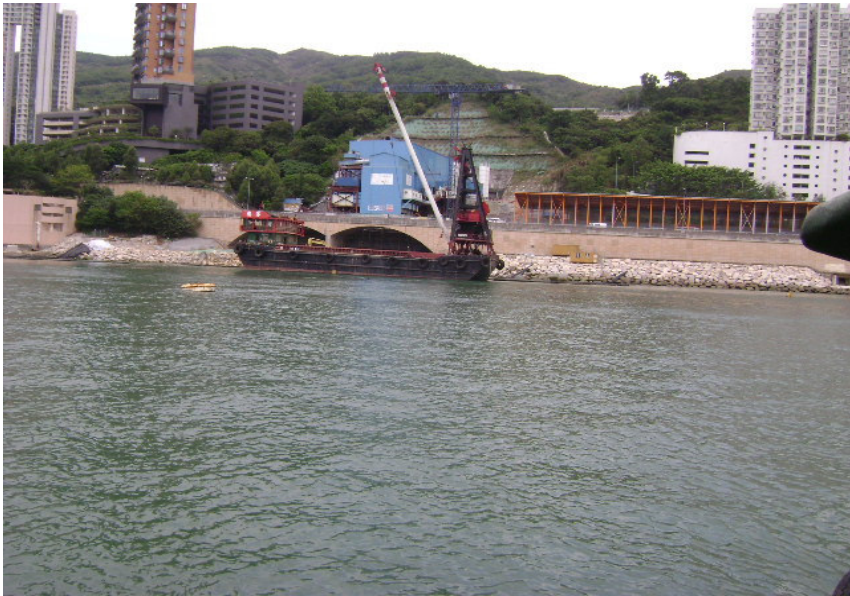
Project	Tsuen Wan Drainage Tunnel
Date	11-Jun-11
Time	1:22 PM
Monitoring Location	O-1(FT)
Parameter	Dissolved Oxygen (marine bottom)
Action & Limit Levels (mg/L)	6.99 / 6.96
Measured Level (mg/L)	6.83
Control Station	O-1-C(FT)
Measured Level at the Control Station (mg/L)	6.90
Possible reason for Action or Limit Level Non-compliance	The measured DO level (marine bottom) at the monitoring station was below the baseline limit level and slightly lower than DO level of the corresponding control station (about 1.0%). Only outer silt curtain maintenance and repairing was undertaken at the Outfall basin (Portion E) on the monitoring day. No other marine works was conducted. No direct disturbance from the site was observed during monitoring. Therefore, the exceedance was considered to be contributed by natural variation and no further action was required.
Actions taken / to be taken	(1) Silt curtain was provided along the Portion E boundary line and extended from seawater level to the bottom of seabed; (2) floating type silt curtain was employed at the inner side; (3) sufficient slack of silt curtain was allowed to cope with the wave and tidal action to ensure the curtains (outer and inner) were rested on seabed; (4) condition of silt curtains was checked by the supervisor daily; and (5) seawall blocks installation was undertaken within the inner silt curtain area only.

**Photographic record for exceedance of Dissolved Oxygen (marine bottom) recorded at O-1(FT) on 11-Jun-11**

Site photo  
(Photo taken at location near the site)

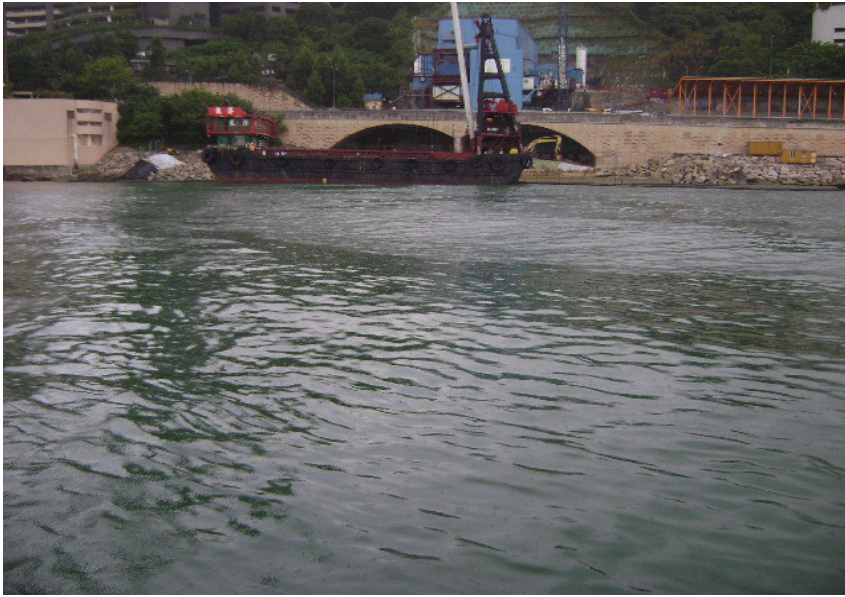
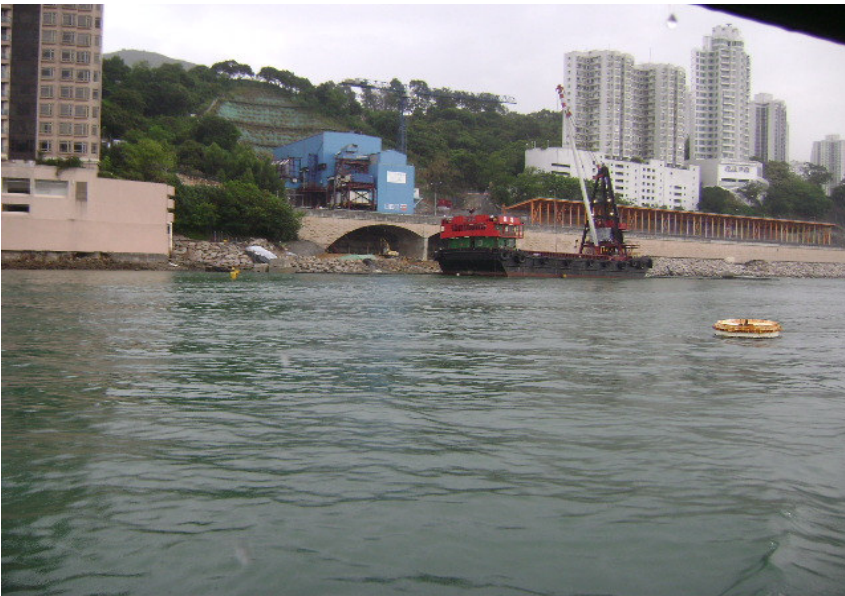
Project	Tsuen Wan Drainage Tunnel
Date	11-Jun-11
Time	9:33 AM
Monitoring Location	O-1(ET)
Parameter	Dissolved Oxygen (marine mid-depth)
Action & Limit Levels (mg/L)	7.02 / 6.94
Measured Level (mg/L)	6.89
Control Station	O-1-C(ET)
Measured Level at the Control Station (mg/L)	6.92
Possible reason for Action or Limit Level Non-compliance	The measured DO level (marine mid-depth) of the monitoring station was below the baseline limit level and slightly lower than DO level at the corresponding control station (less than 0.5%). Only outer silt curtain maintenance and repairing was undertaken at the Outfall basin (Portion E) on the monitoring day. No other marine works was conducted. No direct disturbance from the site was observed during monitoring. Therefore, the exceedance was considered to be contributed by natural variation and no further action was required.
Actions taken / to be taken	(1) Silt curtain was provided along the Portion E boundary line and extended from seawater level to the bottom of seabed; (2) floating type silt curtain was employed at the inner side; (3) sufficient slack of silt curtain was allowed to cope with the wave and tidal action to ensure the curtains (outer and inner) were rested on seabed; (4) condition of silt curtains was checked by the supervisor daily; and (5) seawall blocks installation was undertaken within the inner silt curtain area only.

**Photographic record for exceedance of Dissolved Oxygen (marine mid-depth) recorded at O-1(ET) on 11-Jun-11**

Site photo  
(Photo taken at location  
near O-1(ET))

Site photo  
(Photo taken at location  
near O-1-C(ET))

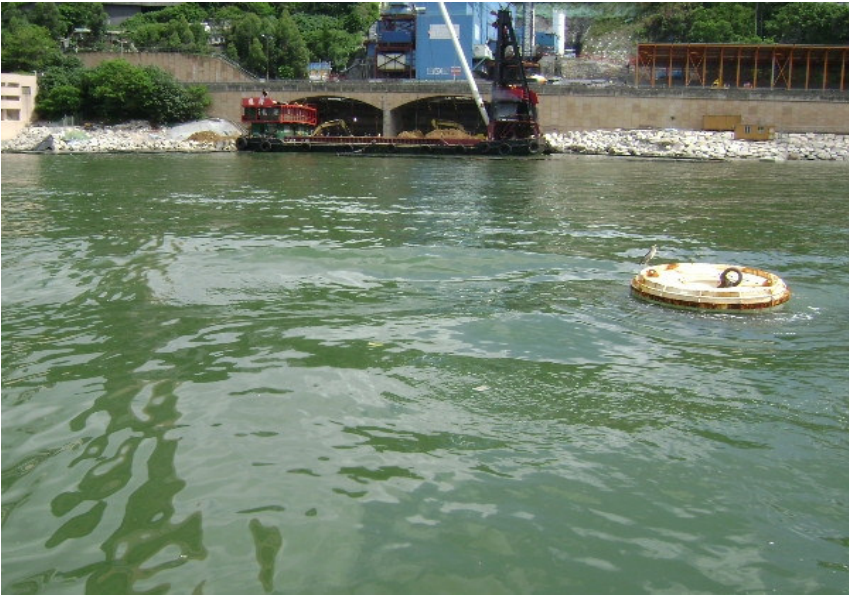
**Photographic record for exceedance of Dissolved Oxygen (marine surface) recorded at O-1(FT) on 20-Jun-11**

Site photo

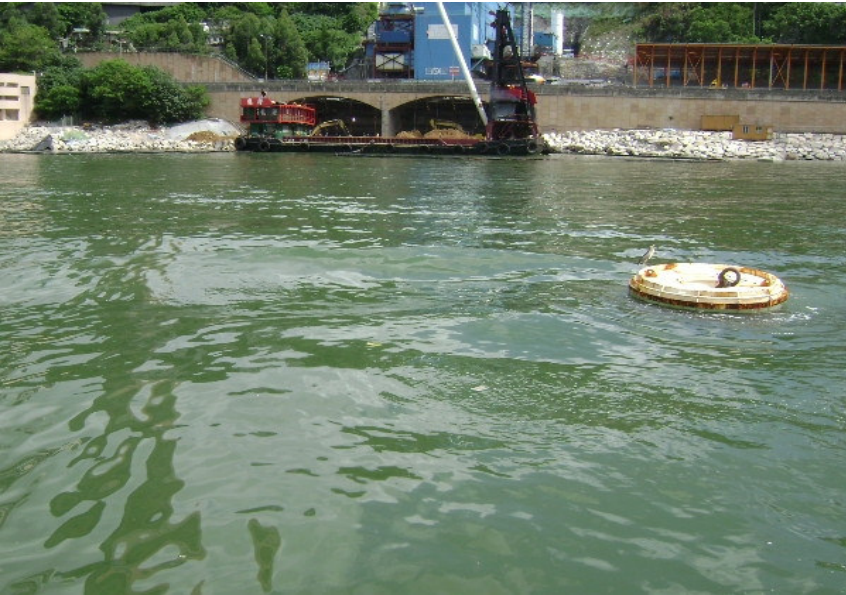
**Photographic record for exceedance of Dissolved Oxygen (marine mid-depth) recorded at O-1(FT) on 20-Jun-11**

Site photo

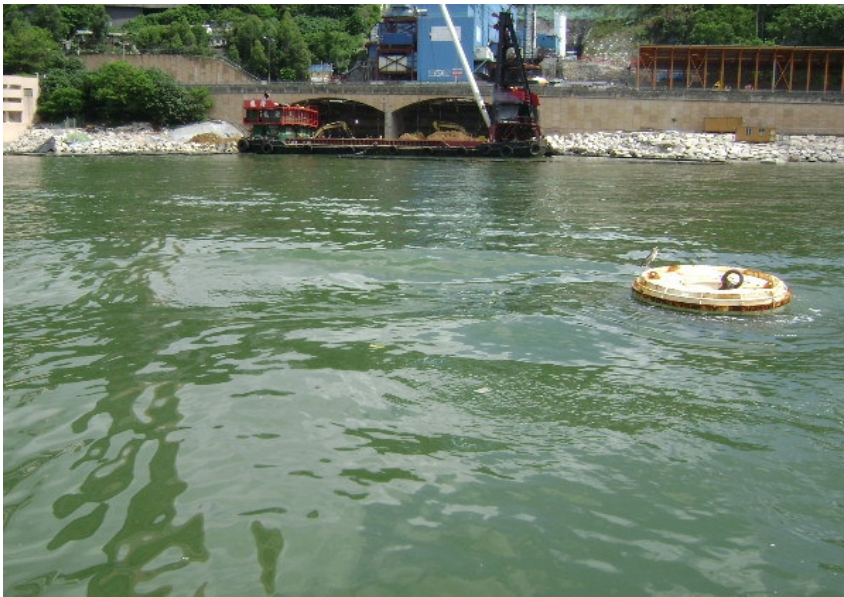
**Photographic record for exceedance of Dissolved Oxygen (marine bottom) recorded at O-1(FT) on 20-Jun-11**

Site photo

Actions taken / to be taken	(1) Silt curtain was provided along the Portion E boundary line and extended from seawater level to the bottom of seabed; (2) floating type silt curtain was employed at the inner side; (3) sufficient slack of silt curtain was allowed to cope with the wave and tidal action to ensure the curtains (outer and inner) were rested on seabed; (4) condition of silt curtains was checked by the supervisor daily; and (5) seawall blocks installation was undertaken within the inner silt curtain area only.
Remarks	None

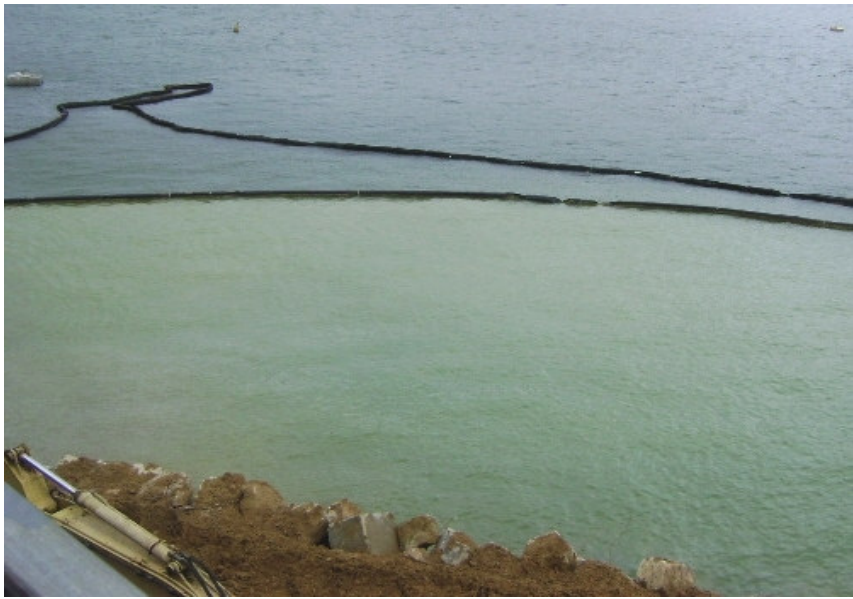
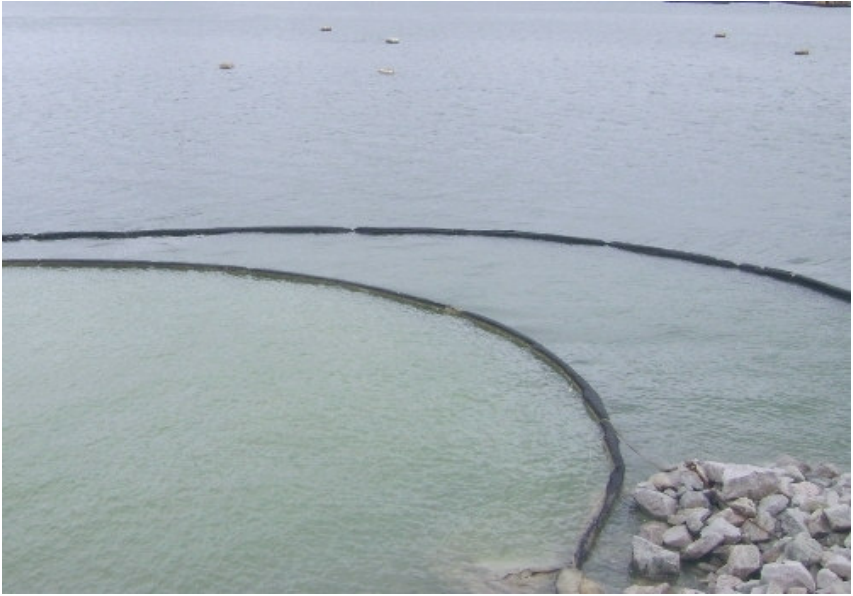
**Photographic record for exceedance of Dissolved Oxygen (marine surface) recorded at O-1(ET) on 20-Jun-11**

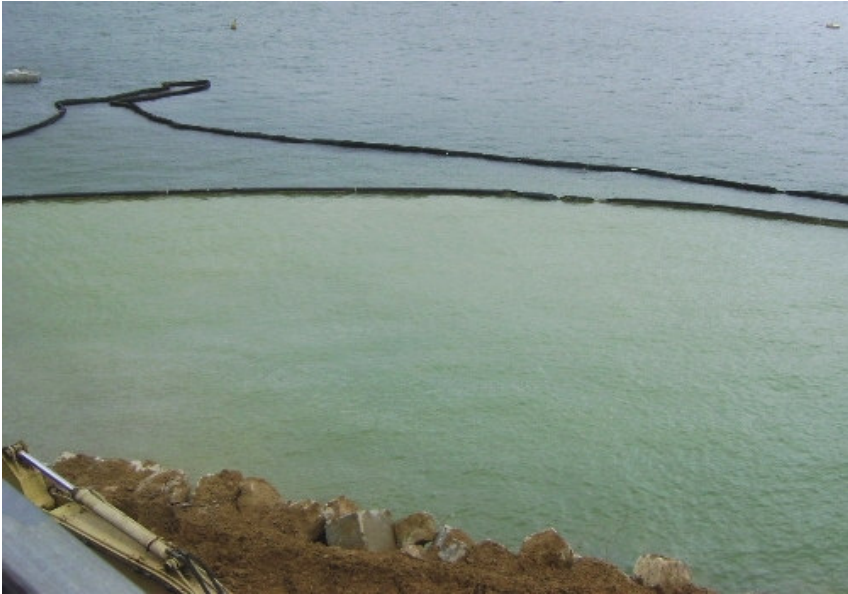
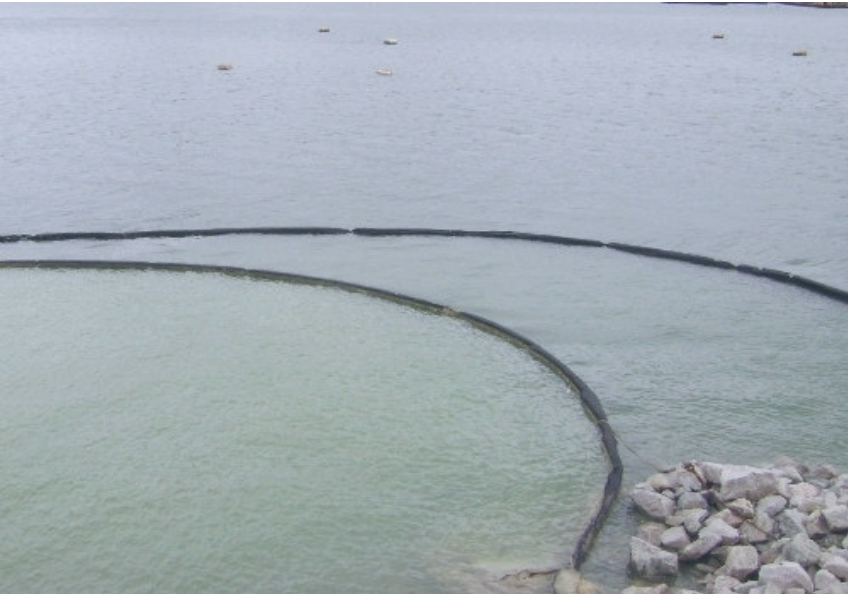
**Photographic record for exceedance of Dissolved Oxygen (marine mid-depth) recorded at O-1(ET) on 20-Jun-11**

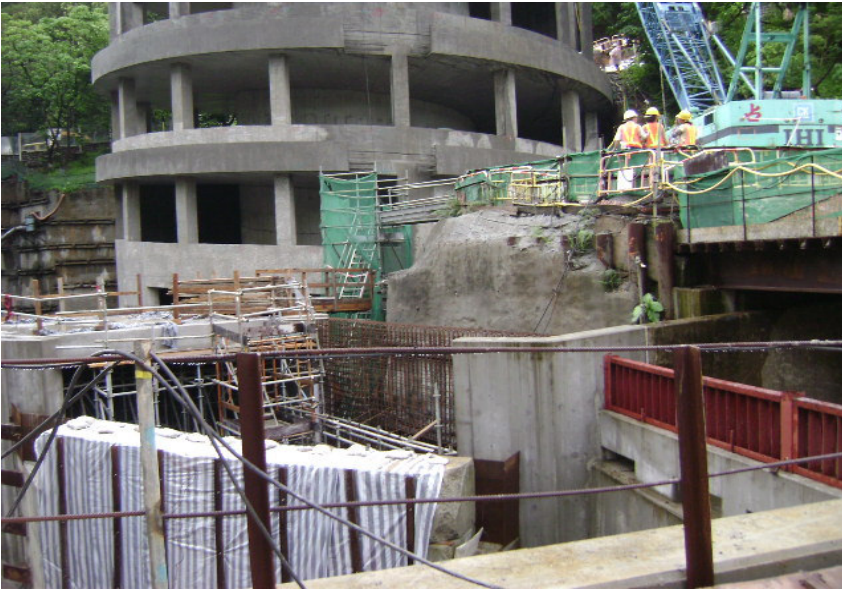
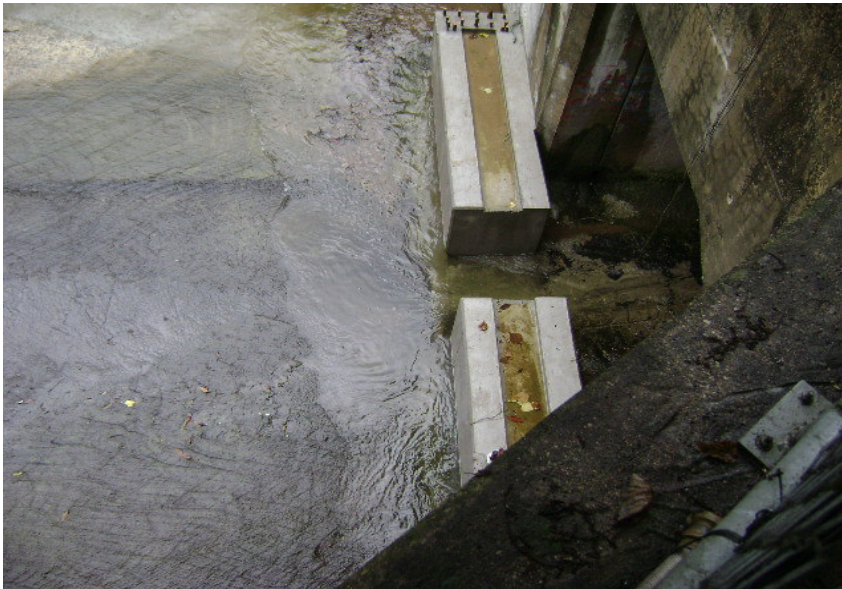
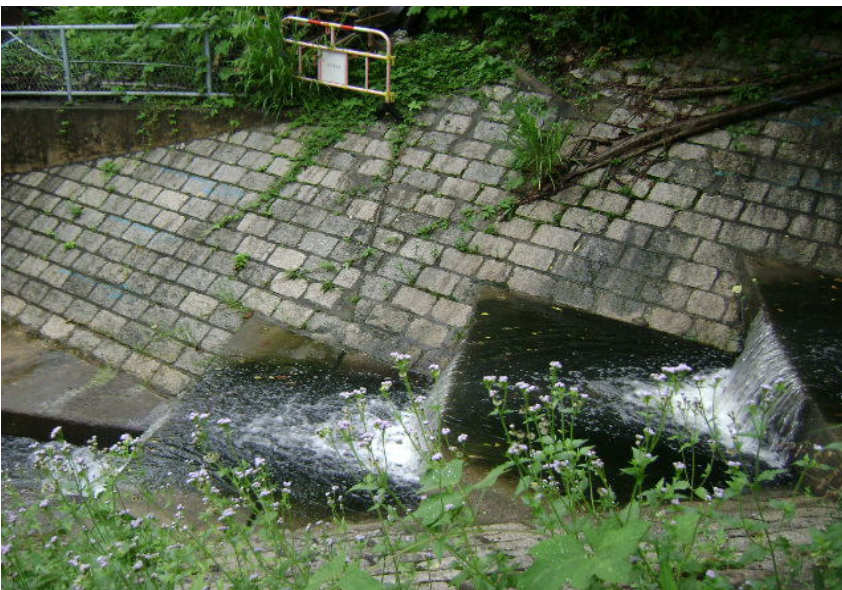
Photographic record for exceedance of Turbidity recorded at Sik Sik Yuen Ho Fung College (I-1)  
on 22-Jun-11

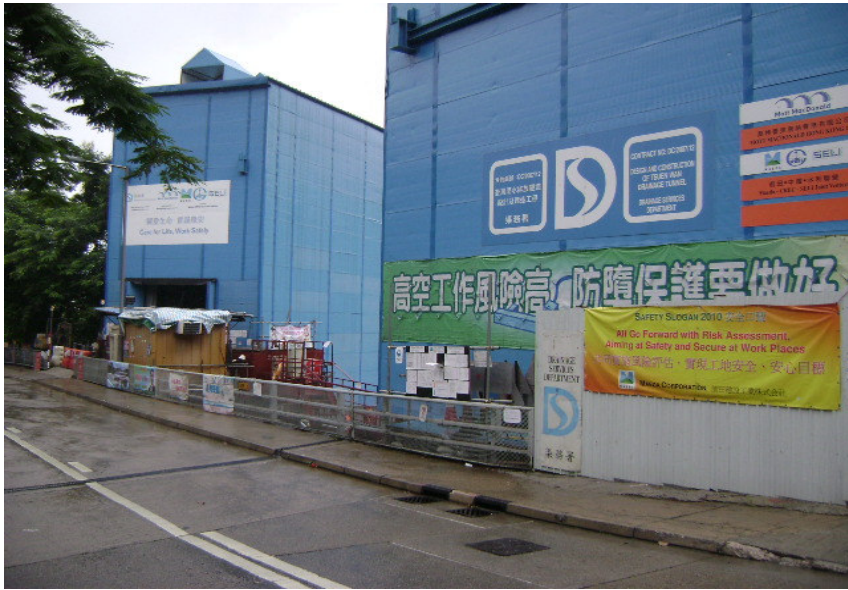
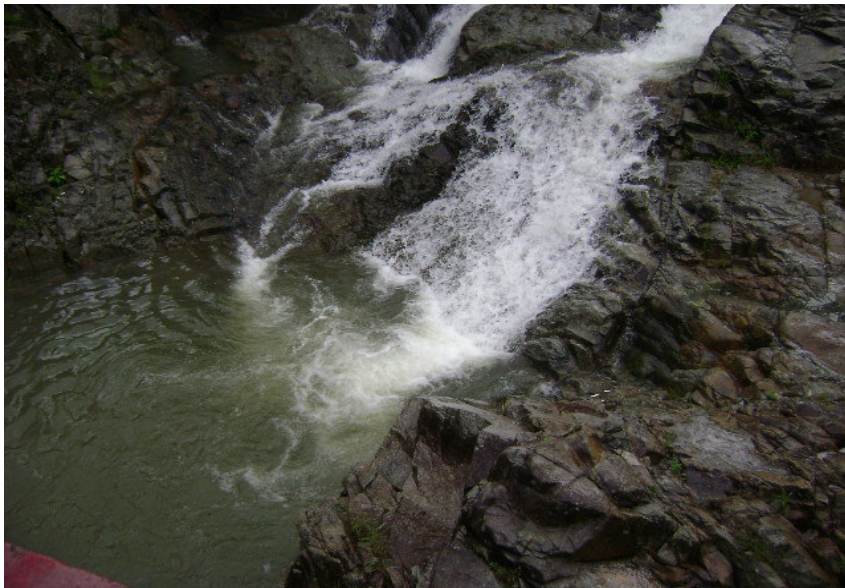
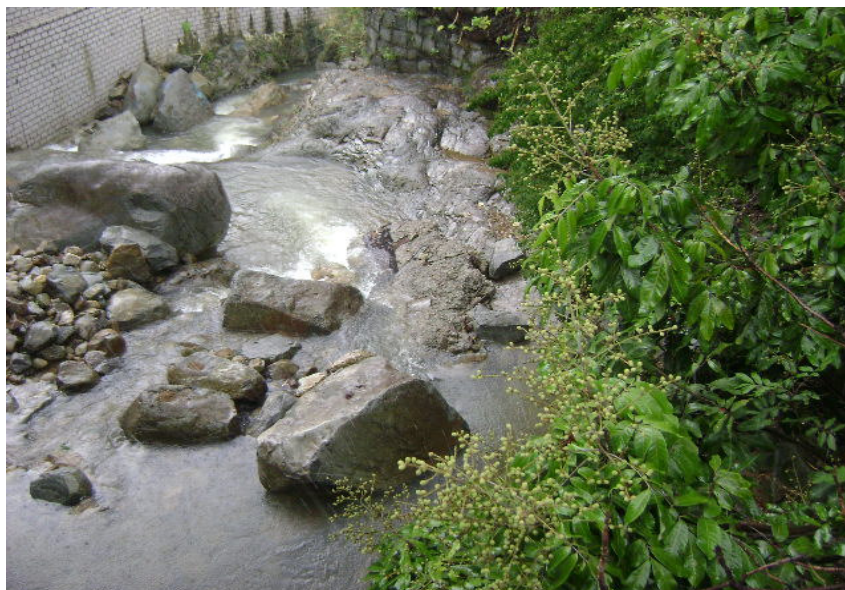
Photographic record for exceedance of Turbidity recorded at Hong Hoi Chee Hong Temple (I-2) on 22-Jun-11

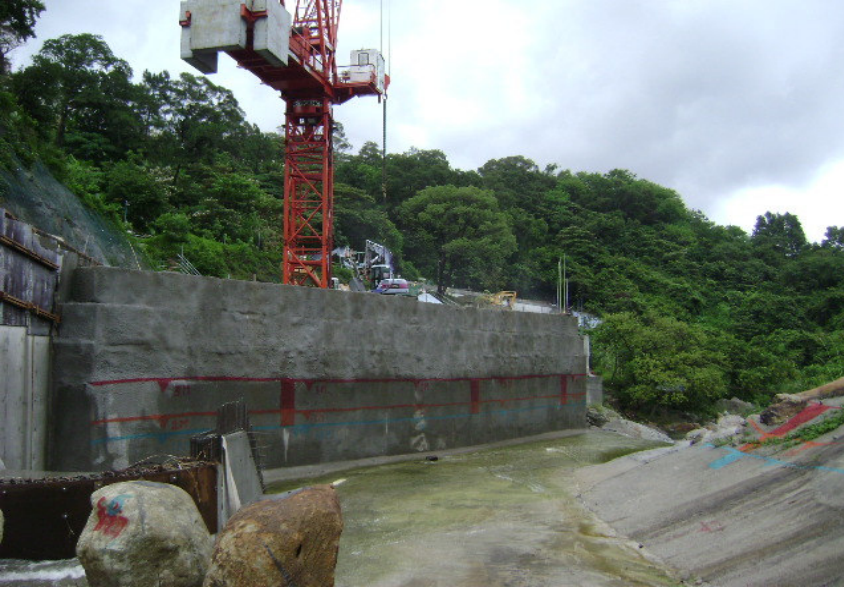
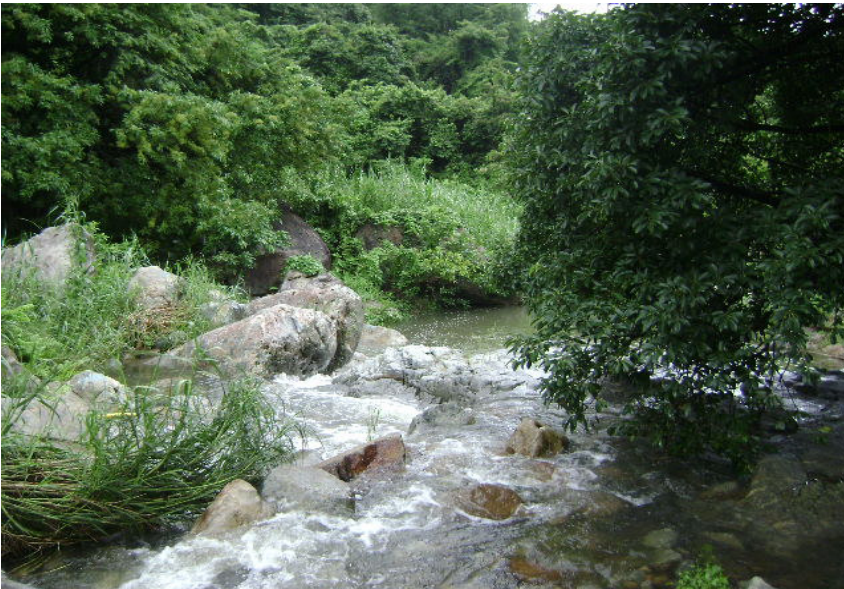
Photographic record for exceedance of Turbidity recorded at Squatters (I-3) on 22-Jun-11

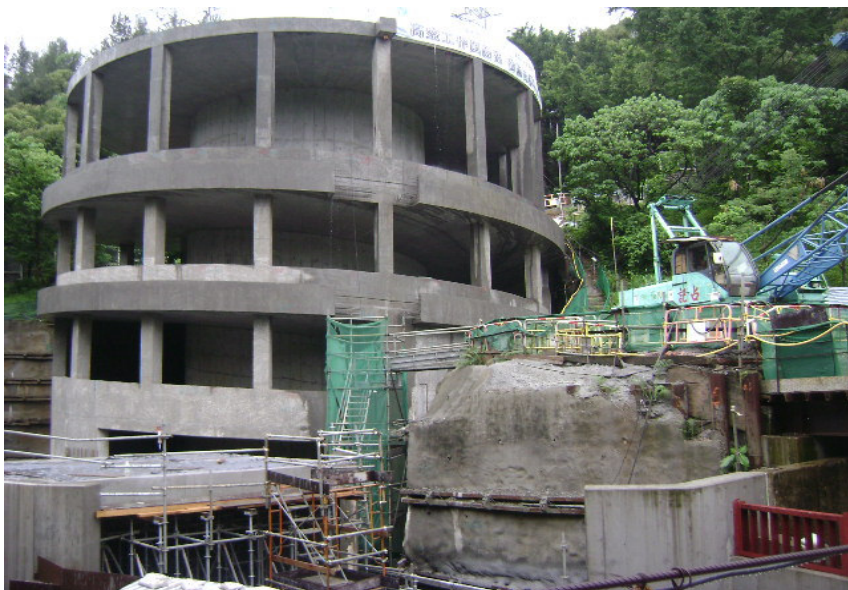
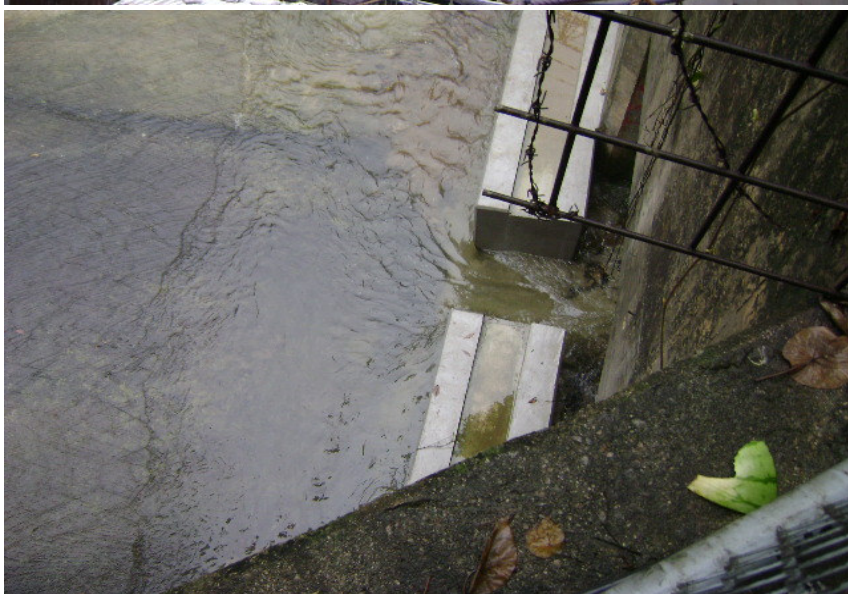
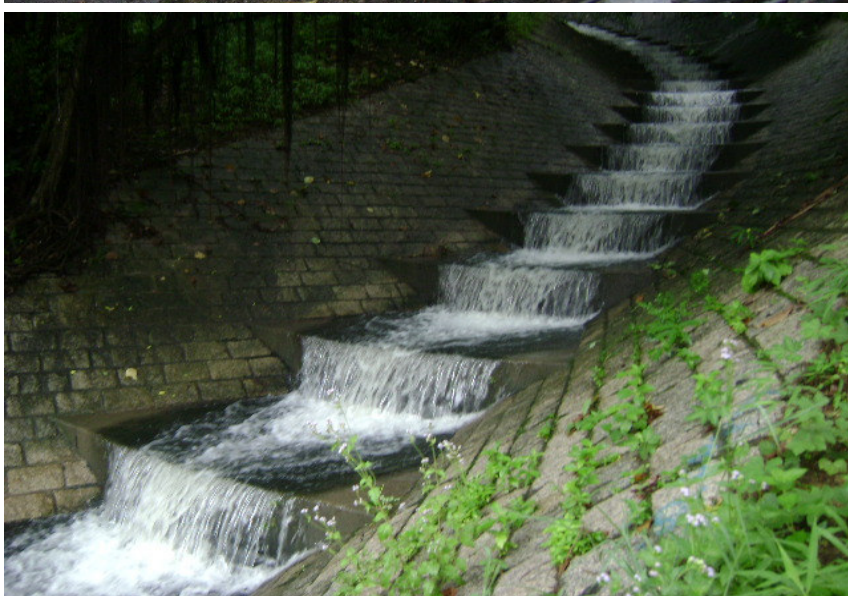
Photographic record for exceedance of Suspended Solids (SS) recorded at Sik Sik Yuen Ho Fung College (I-1) on 17-Jun-11

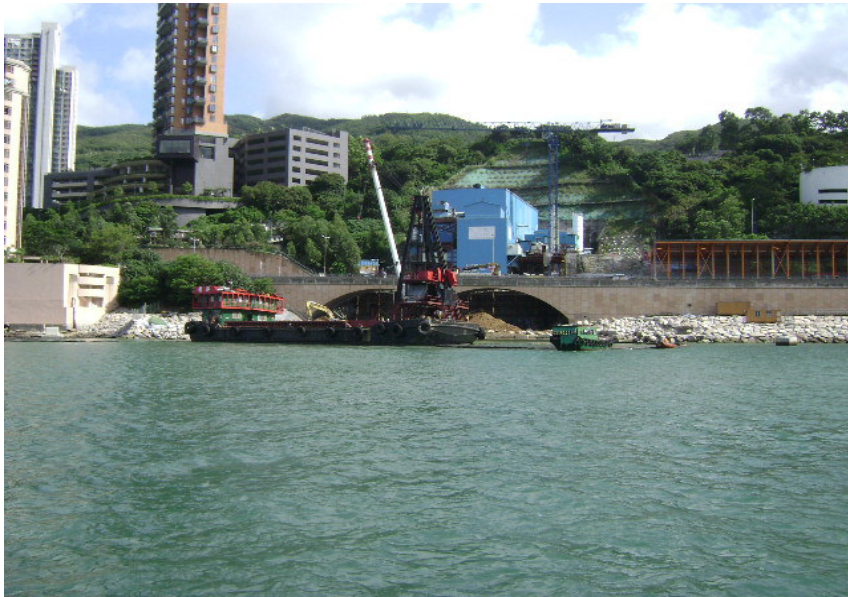
**Photographic record for exceedance of Dissolved Oxygen (marine surface) recorded at O-1(ET) on 24-Jun-11**

Site photo (Photo taken at location near O-1(ET))

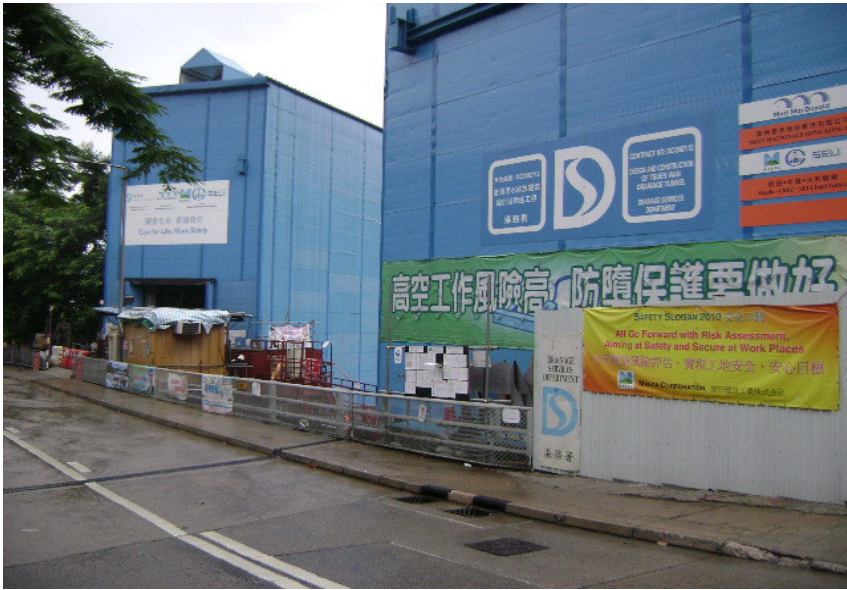
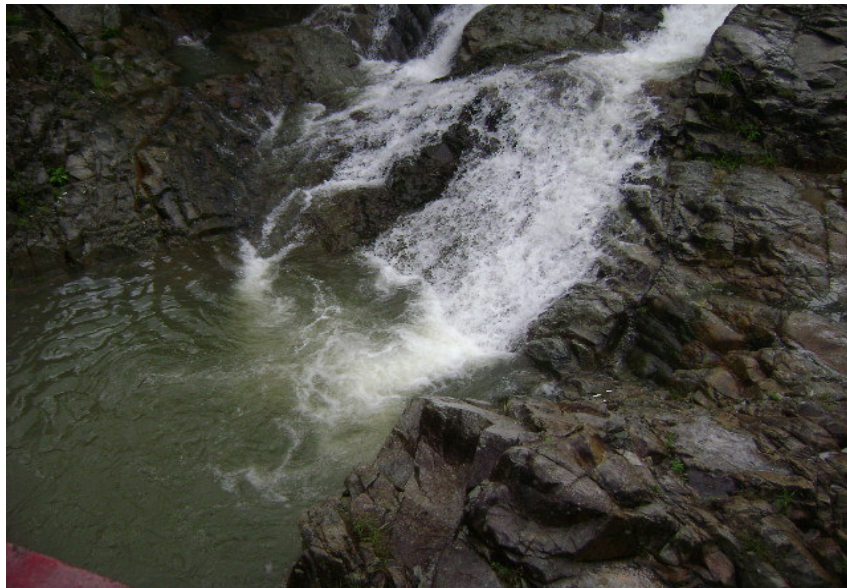
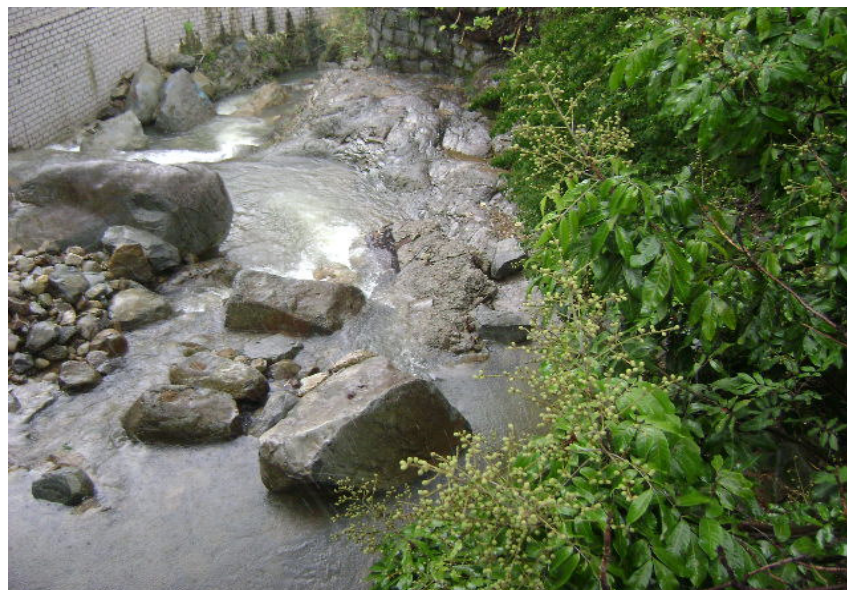
Photographic record for exceedance of Suspended Solids recorded at Hong Hoi Chee Hong Temple (I-2) on 22-Jun-11

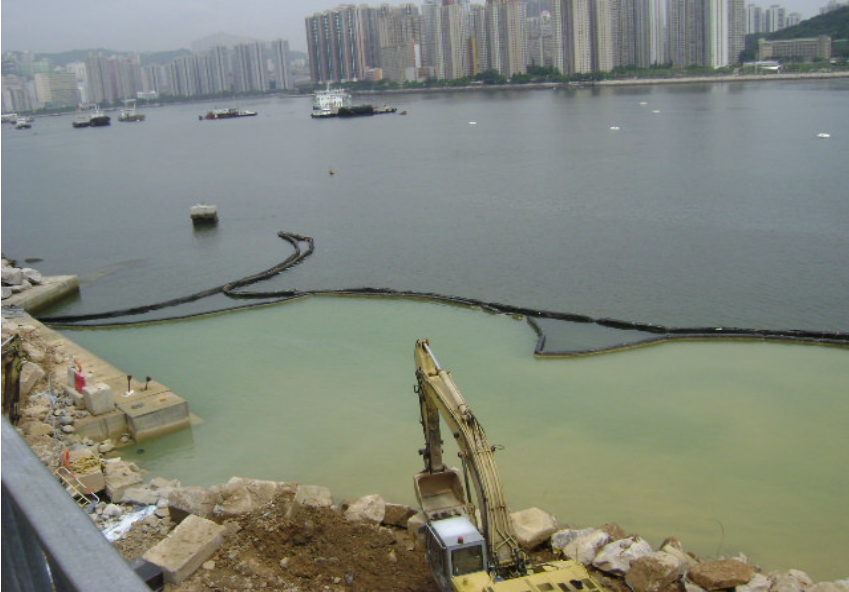
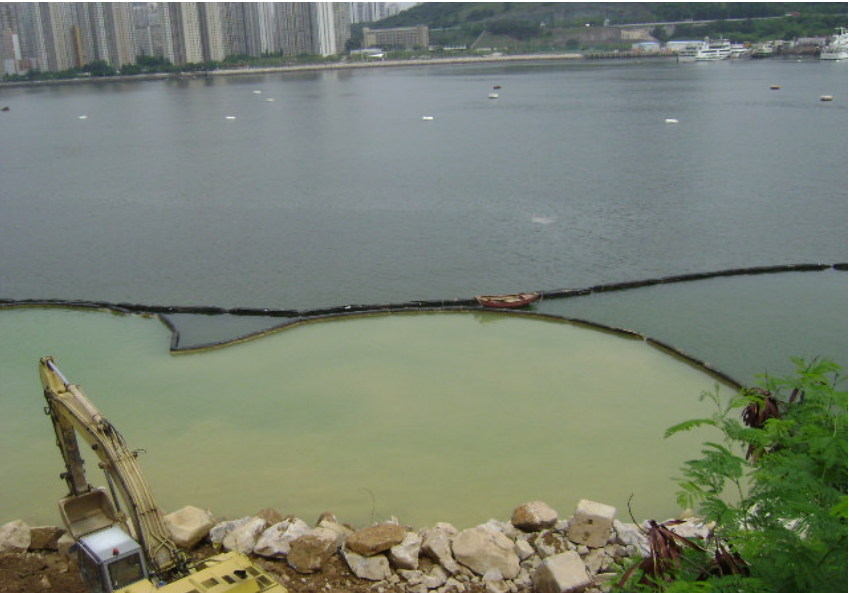
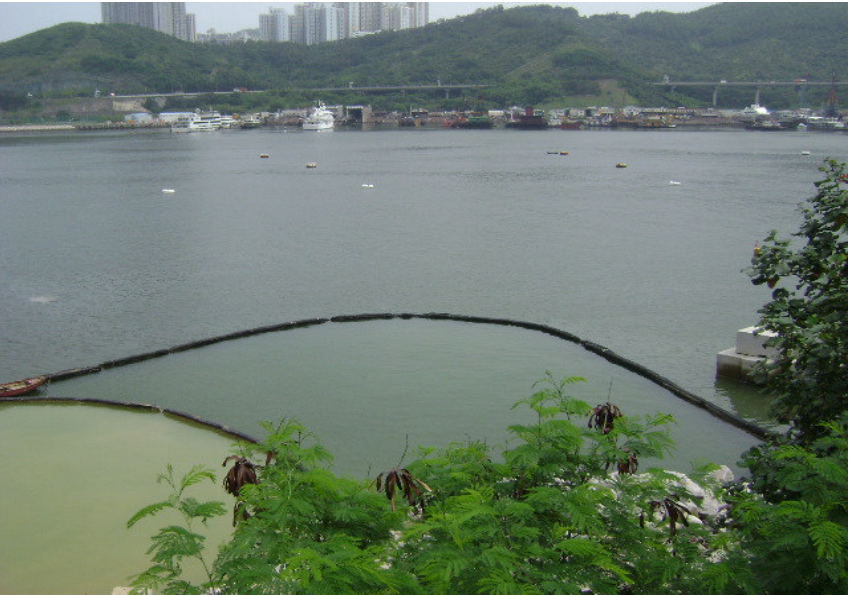
**Photographic record for exceedance of Dissolved Oxygen (marine surface) recorded at O-1(FT) on 27-Jun-11**

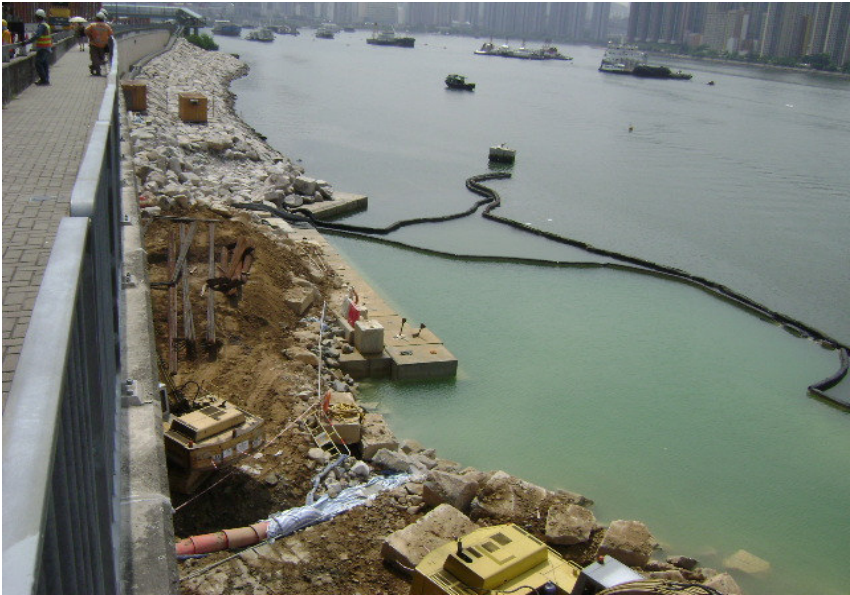
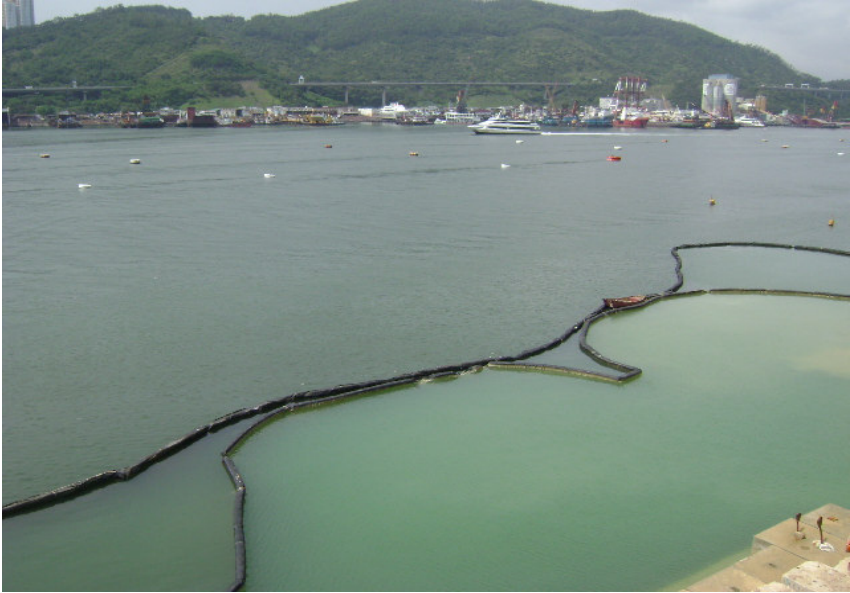
**Photographic record for exceedance of Dissolved Oxygen (marine surface) recorded at O-1(ET) on 27-Jun-11**

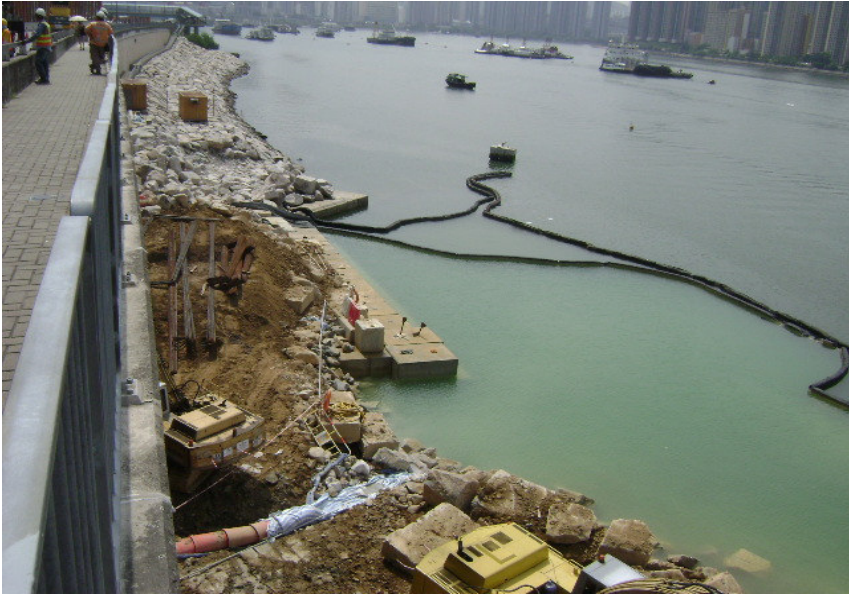
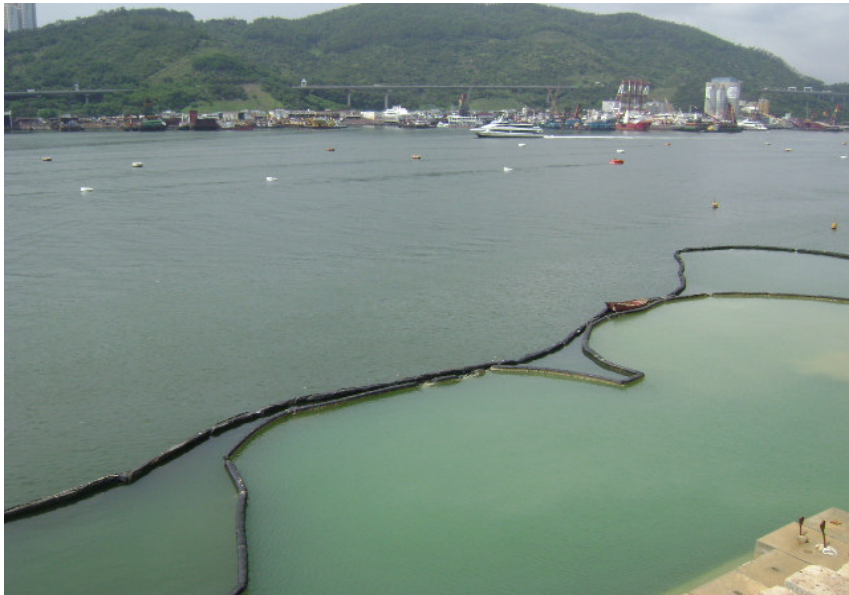
**Photographic record for exceedance of Dissolved Oxygen (marine mid-depth) recorded at O-1(ET) on 27-Jun-11**

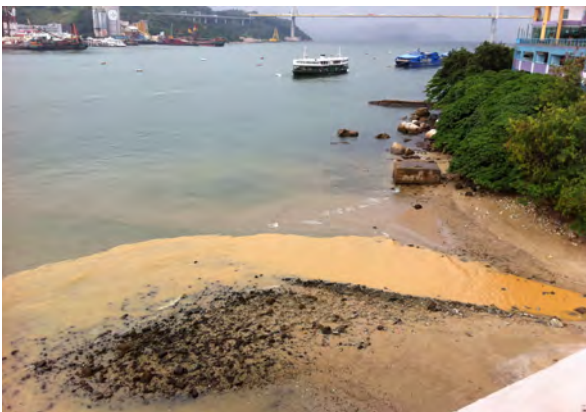
On 29 June 2011, 76.5 mm heavy rainfall was recorded. Huge amount of muddy water discharged from streams and drainage outfalls among the coast into marine water body was observed during monitoring and caused turbid sea surface.

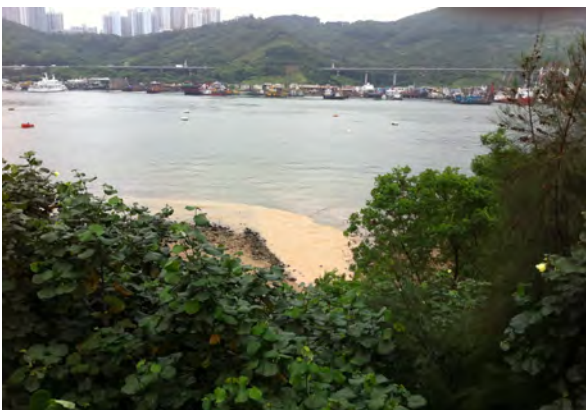
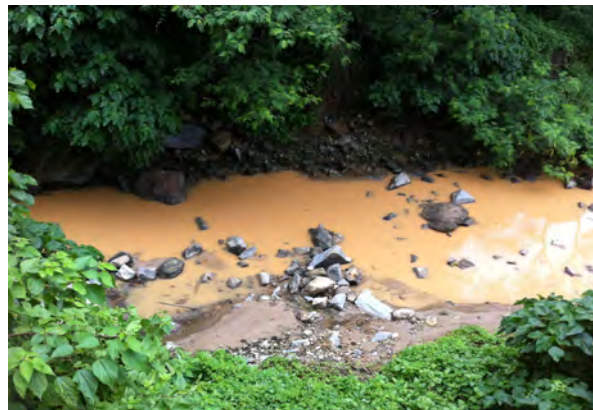
Photos of a stream between The Bay Bridge and Long Beach Garden

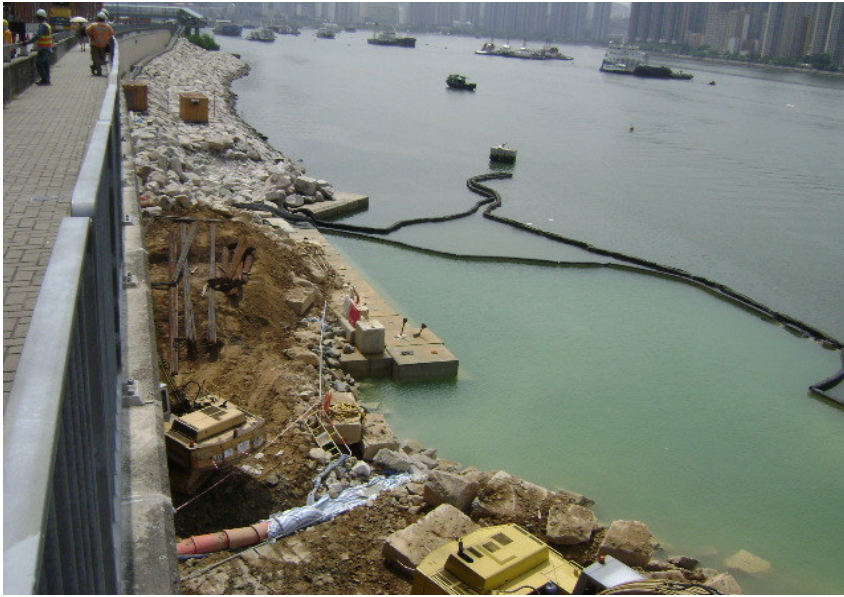
**Photographic record for exceedance of Suspended Solids (SS) recorded at O-1(ET) on 27-Jun-11**

Site photo

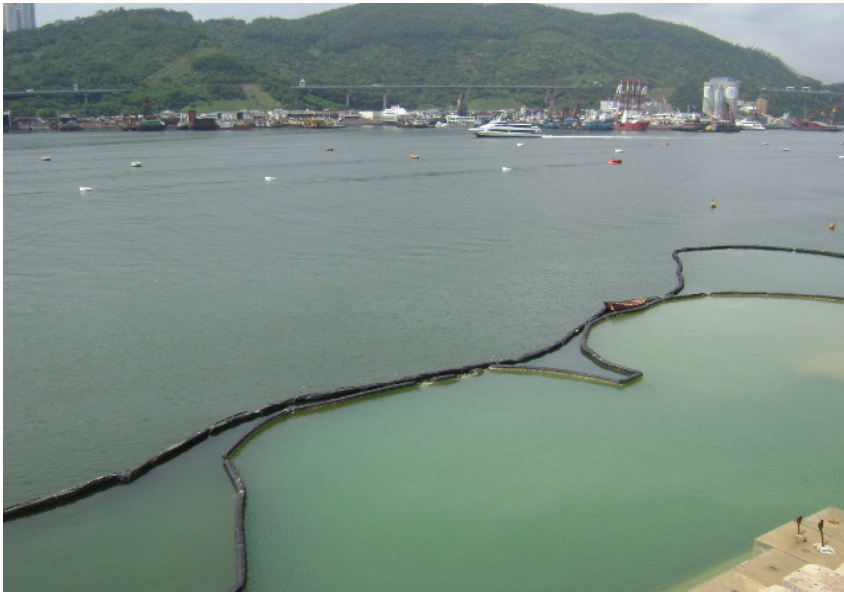
Site photo
