**Contract SCL1123 –
Exhibition Station & Western Approach
Tunnel**

Monthly EM&A Report No. 19

[Period from 1 to 31 July 2022]

Leighton – China State J.V.**Shatin to Central Link -
Hung Hom to Admiralty Section****Works Contract 1123 -
CEDD Entrusted Work for Road P2 & other roads and Slip Road 3****Monthly EM&A Report for
July 2022**

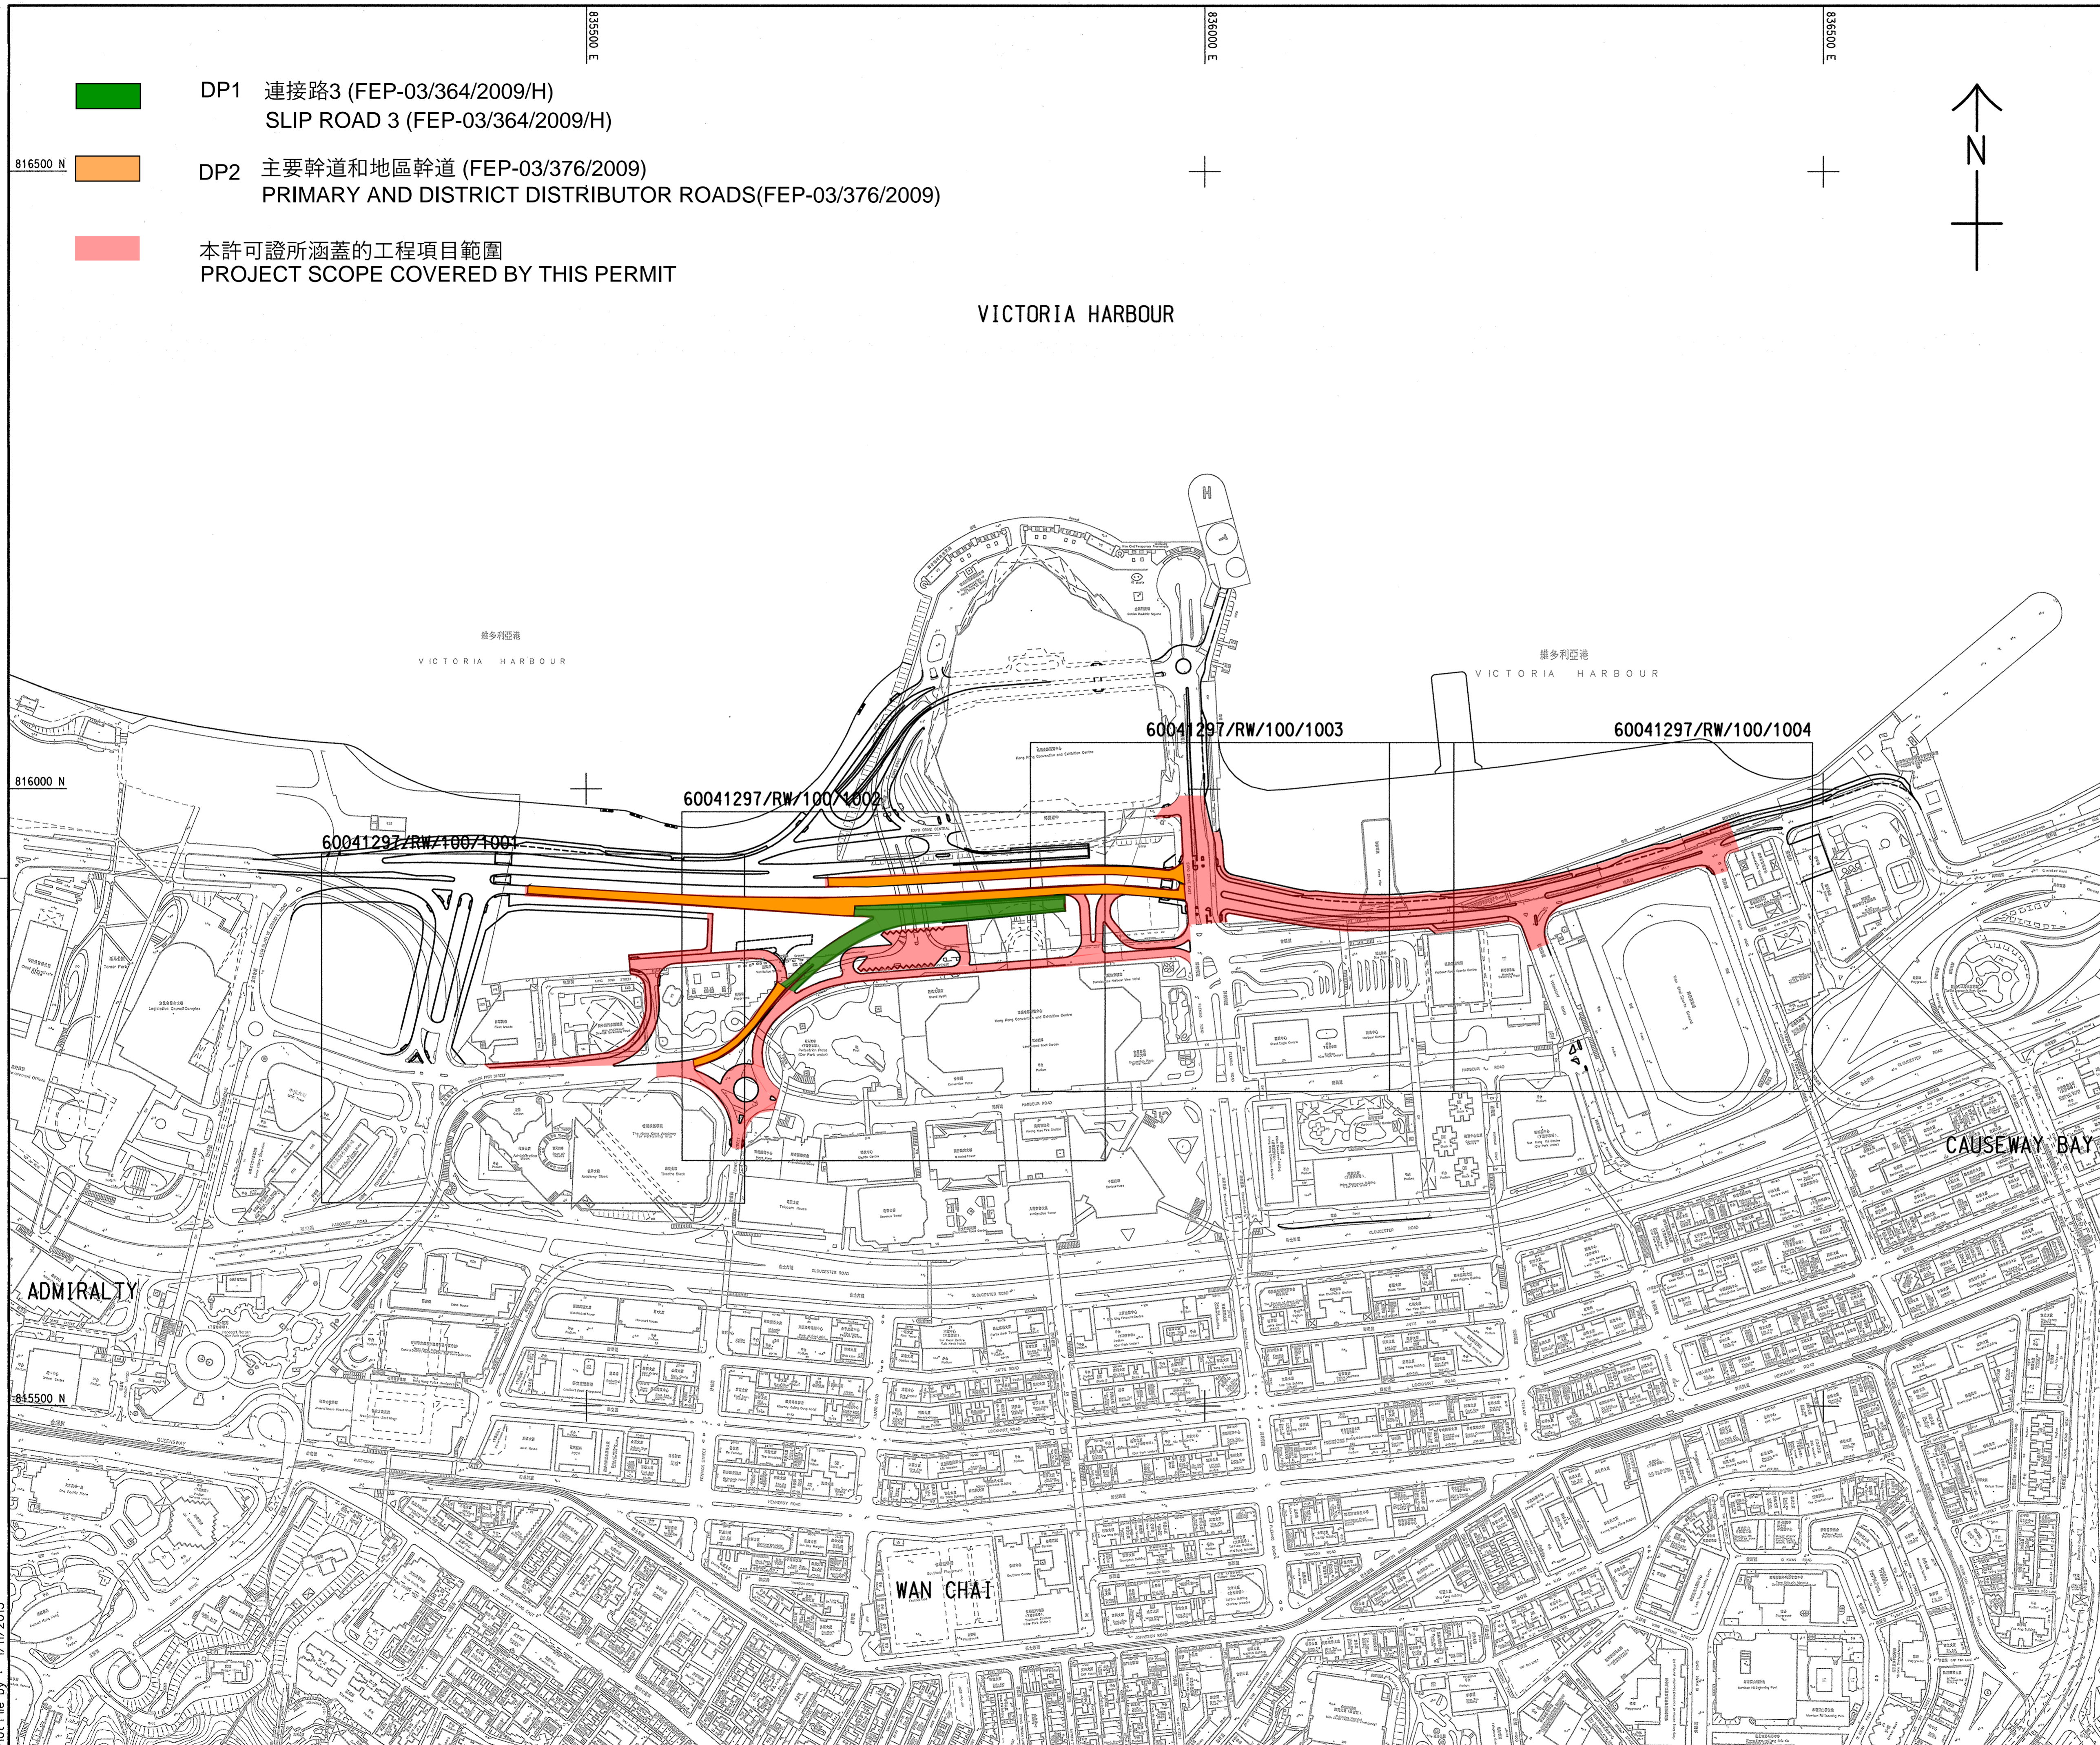
- DP1 連接路3 (FEP-03/364/2009/H)
SLIP ROAD 3 (FEP-03/364/2009/H)
- DP2 主要幹道和地區幹道 (FEP-03/376/2009)
PRIMARY AND DISTRICT DISTRIBUTOR ROADS(FEP-03/376/2009)
- 本許可證所涵蓋的工程項目範圍
PROJECT SCOPE COVERED BY THIS PERMIT

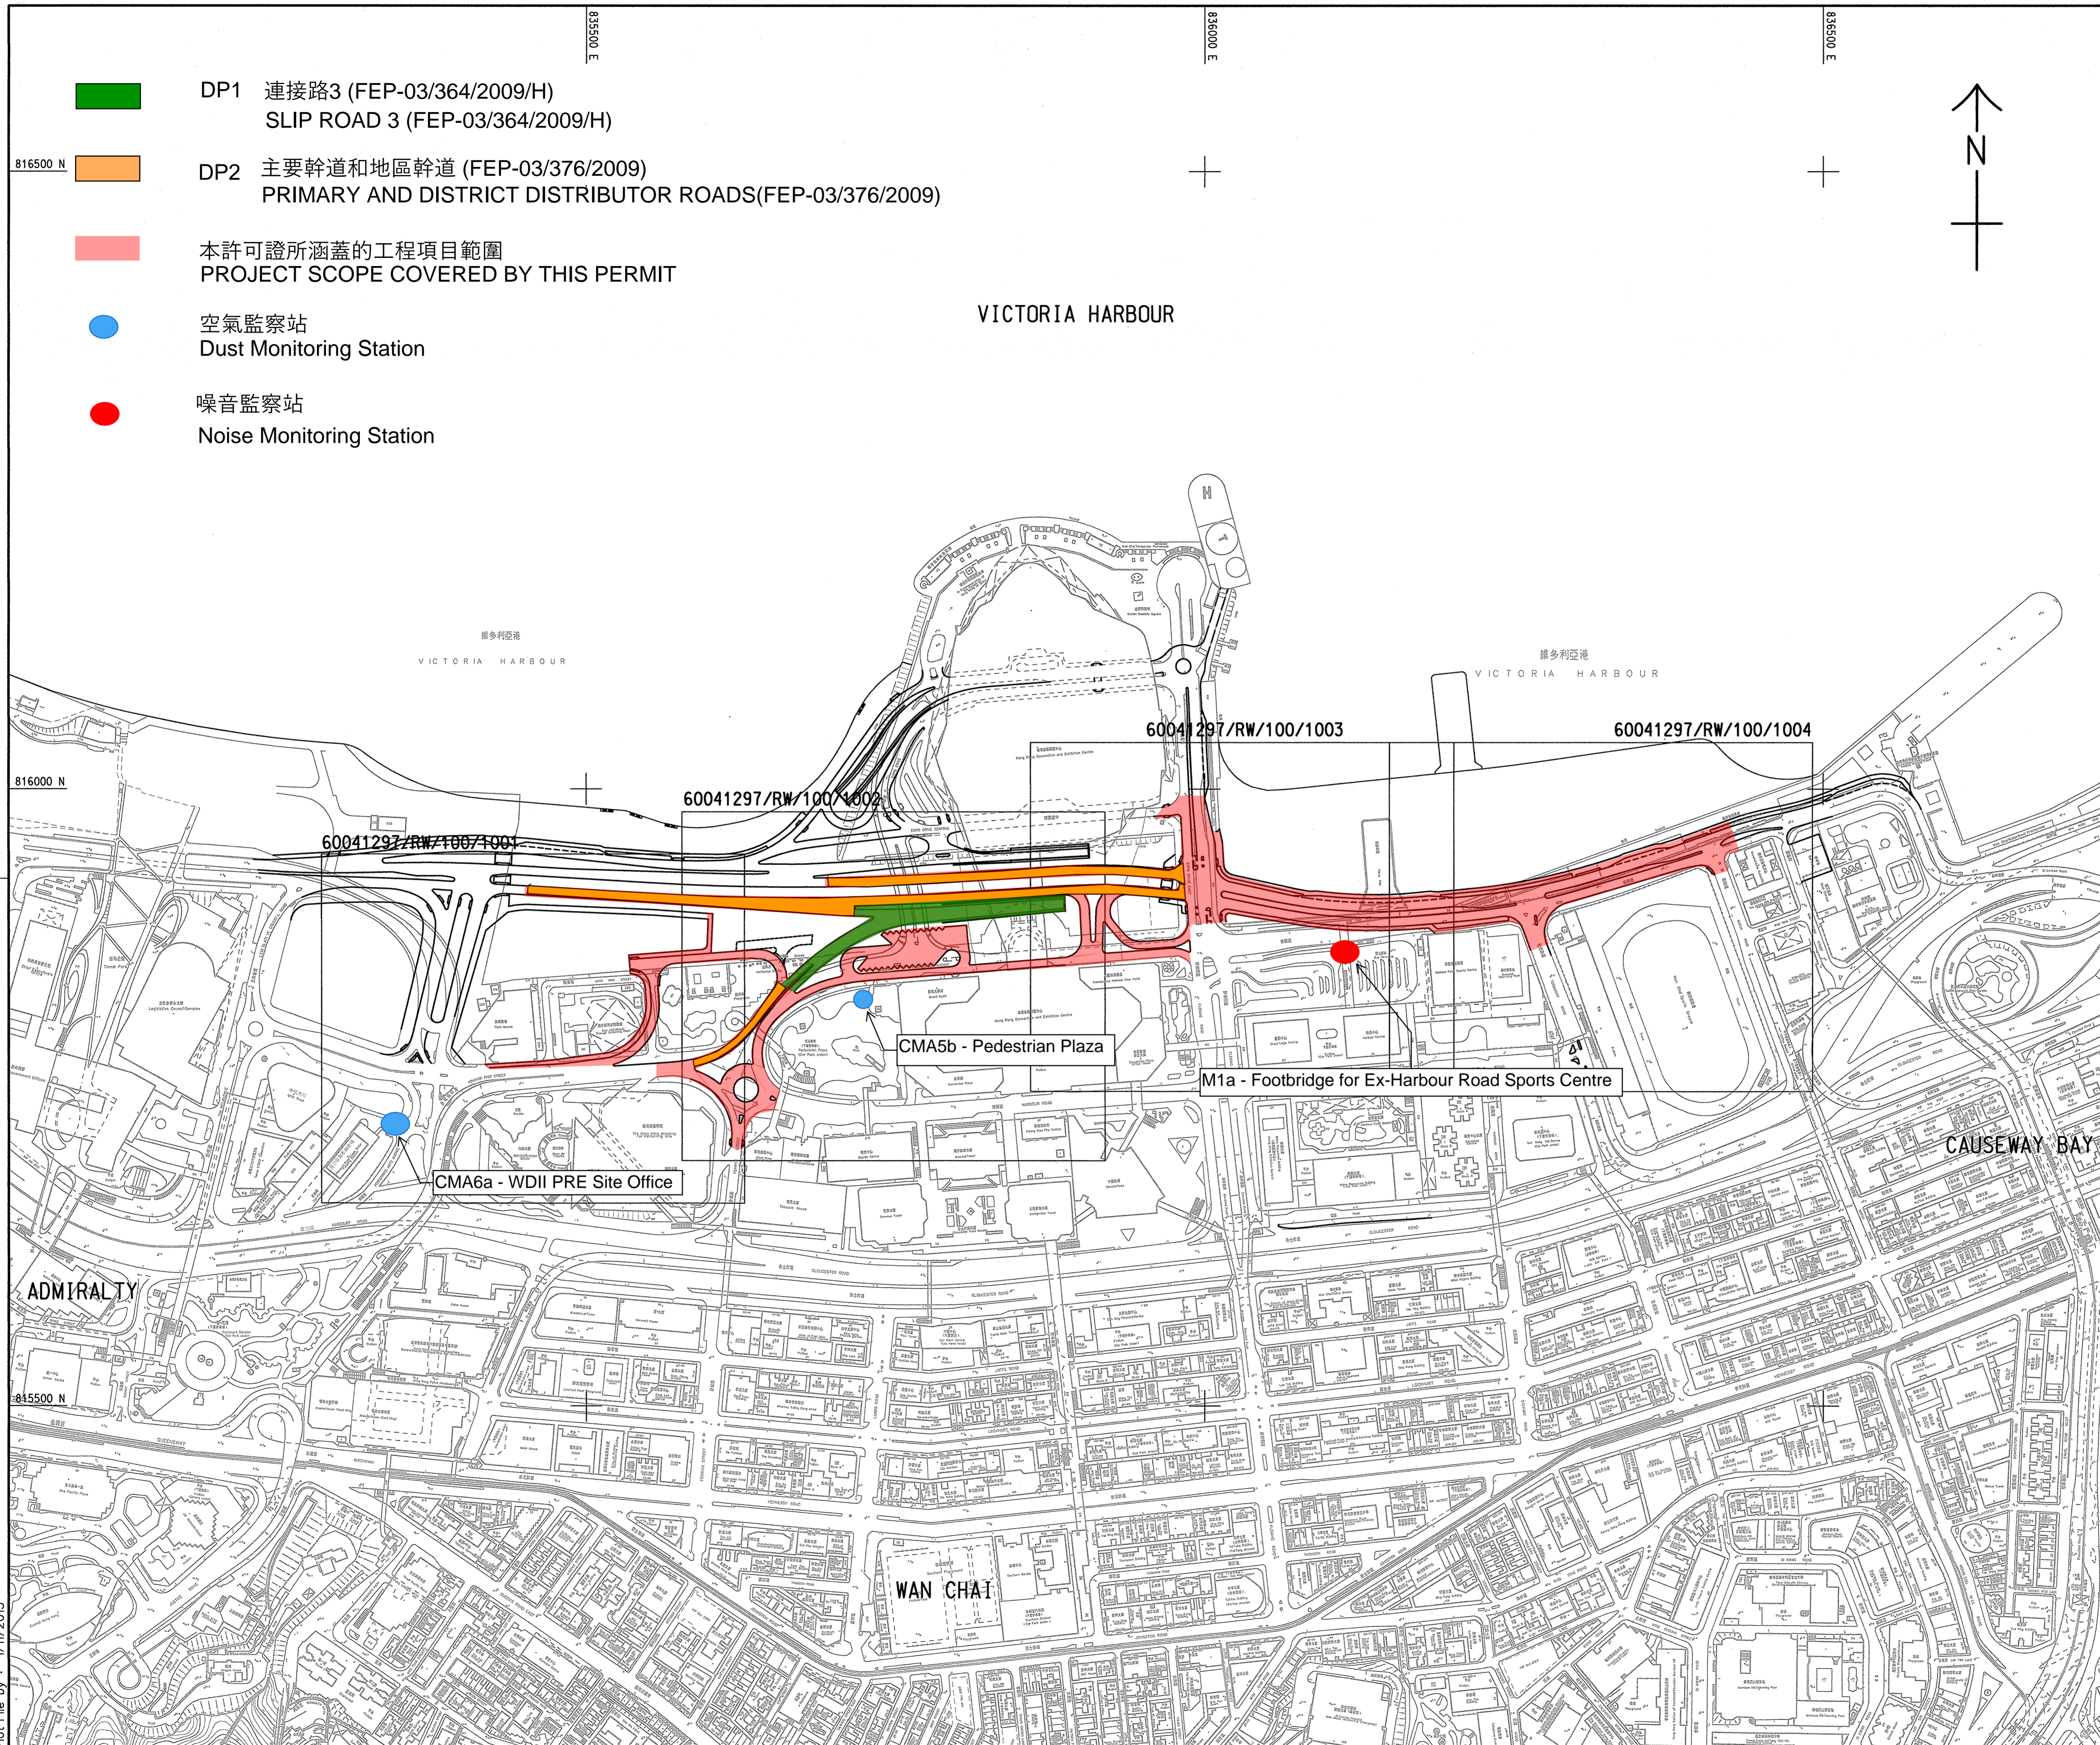
- DP1 連接路3 (FEP-03/364/2009/H)
SLIP ROAD 3 (FEP-03/364/2009/H)
- DP2 主要幹道和地區幹道 (FEP-03/376/2009)
PRIMARY AND DISTRICT DISTRIBUTOR ROADS(FEP-03/376/2009)
- 本許可證所涵蓋的工程項目範圍
PROJECT SCOPE COVERED BY THIS PERMIT
- 空氣監察站
Dust Monitoring Station
- 噪音監察站
Noise Monitoring Station

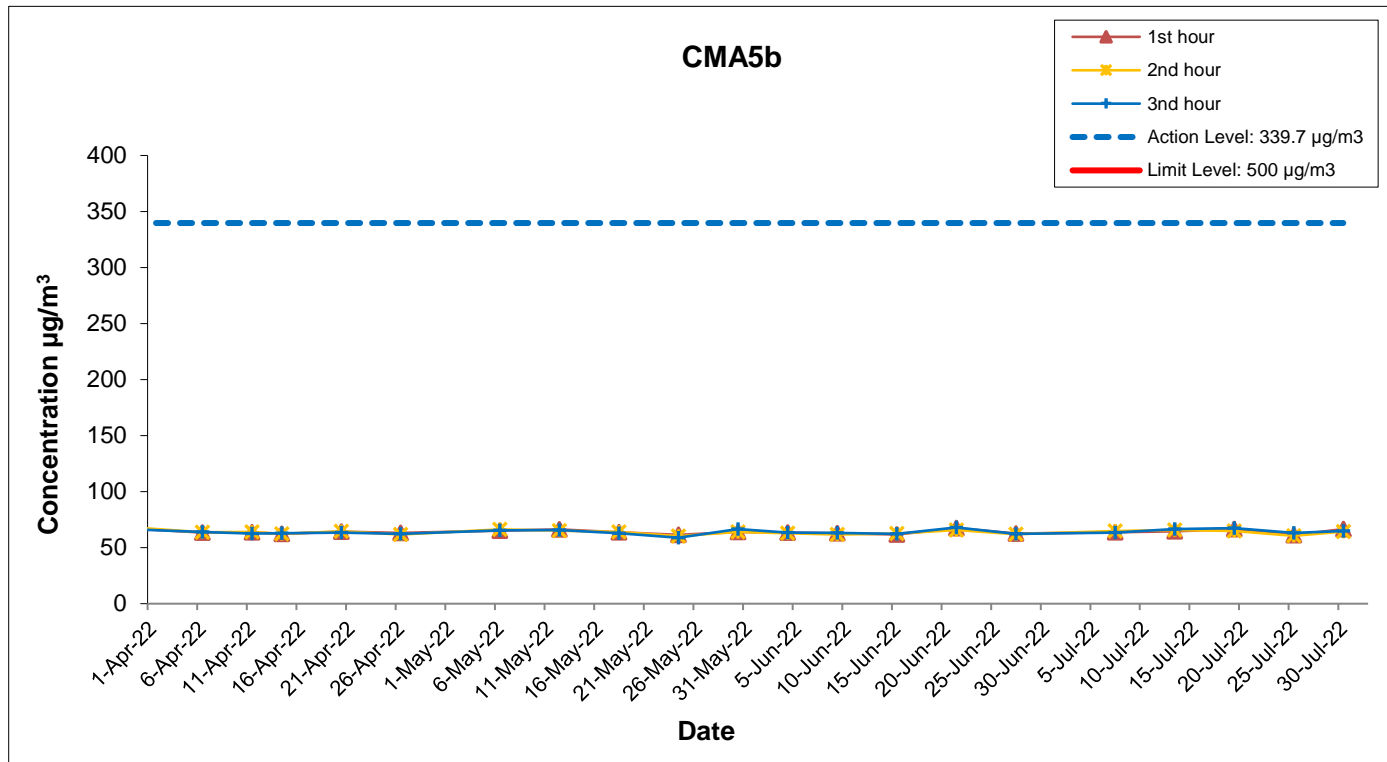
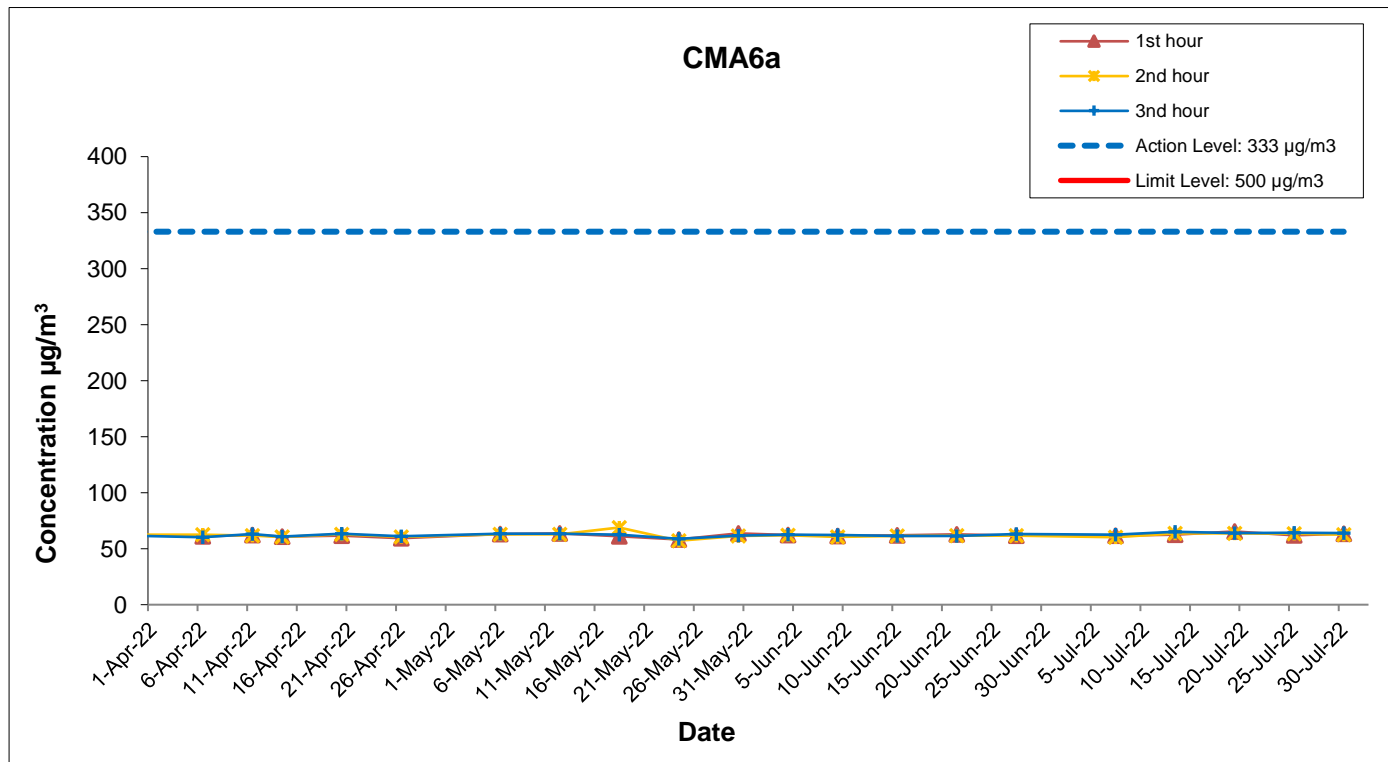
*Monitoring on 2 July 2022 was cancelled due to Typhoon Signal No.8 was hoisted on the day.

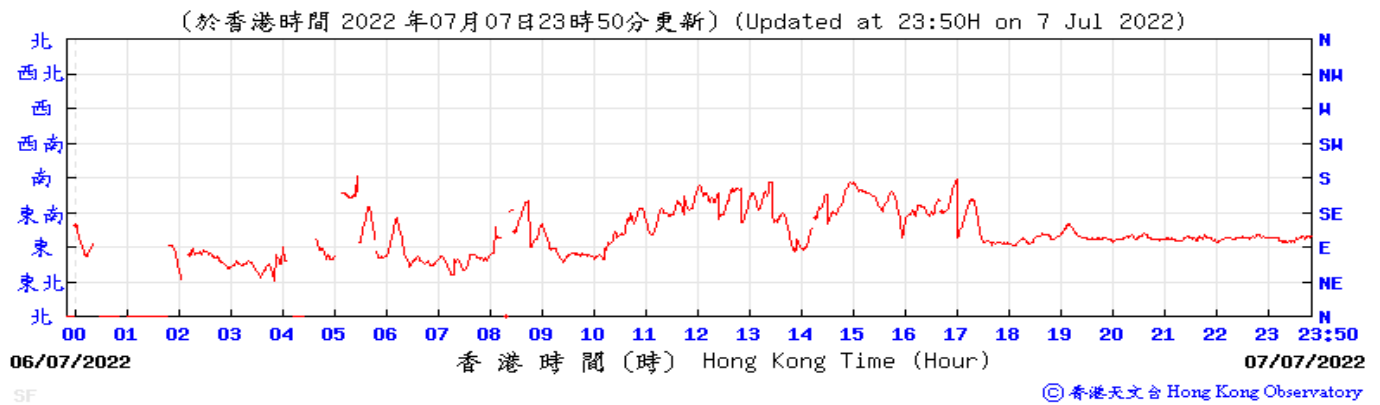
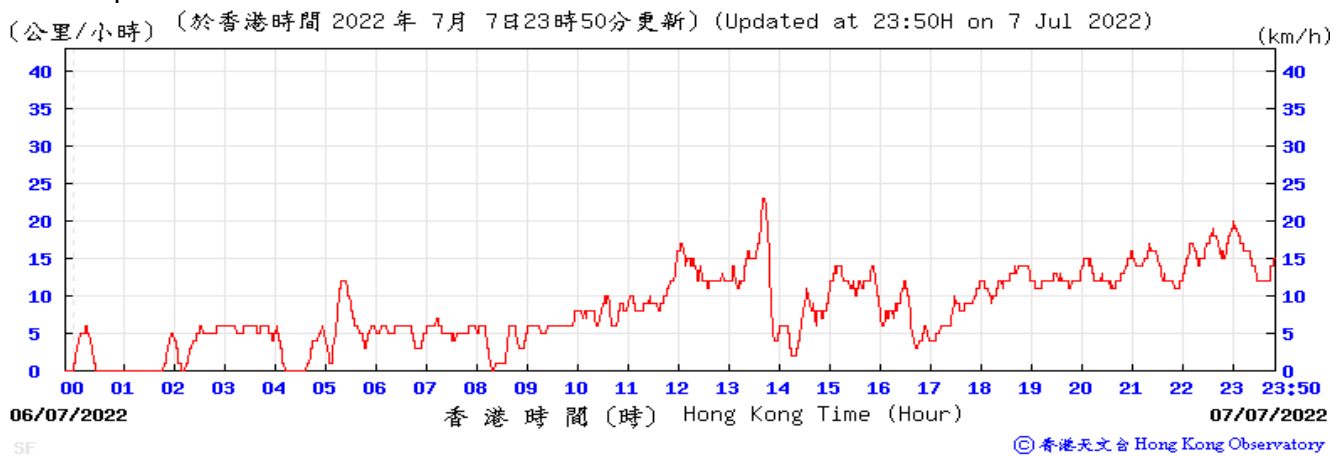
Appendix G – Extract of Meteorological Observations for Star Ferry Automatic Weather Station
July 2022

Wind Direction:

Wind Speed:

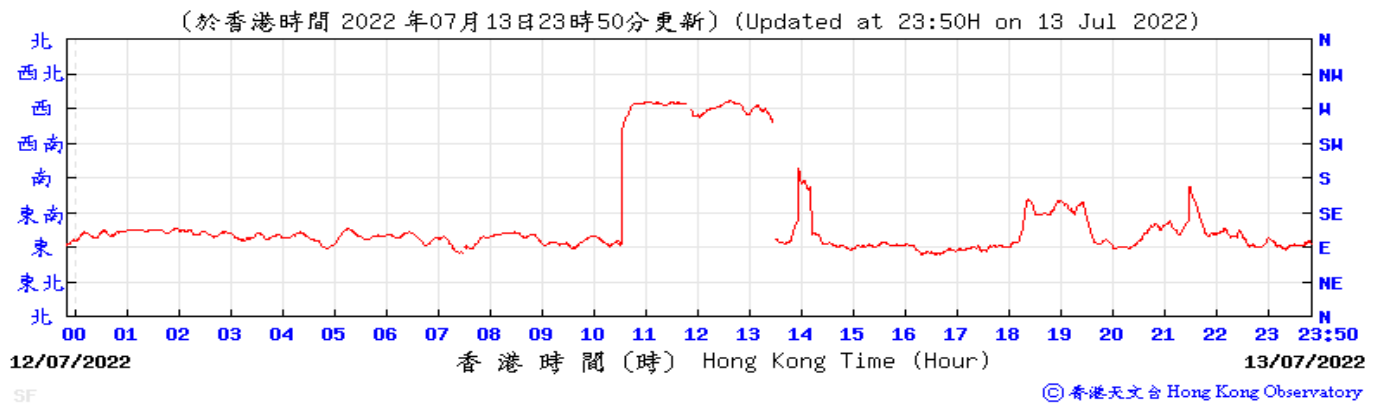
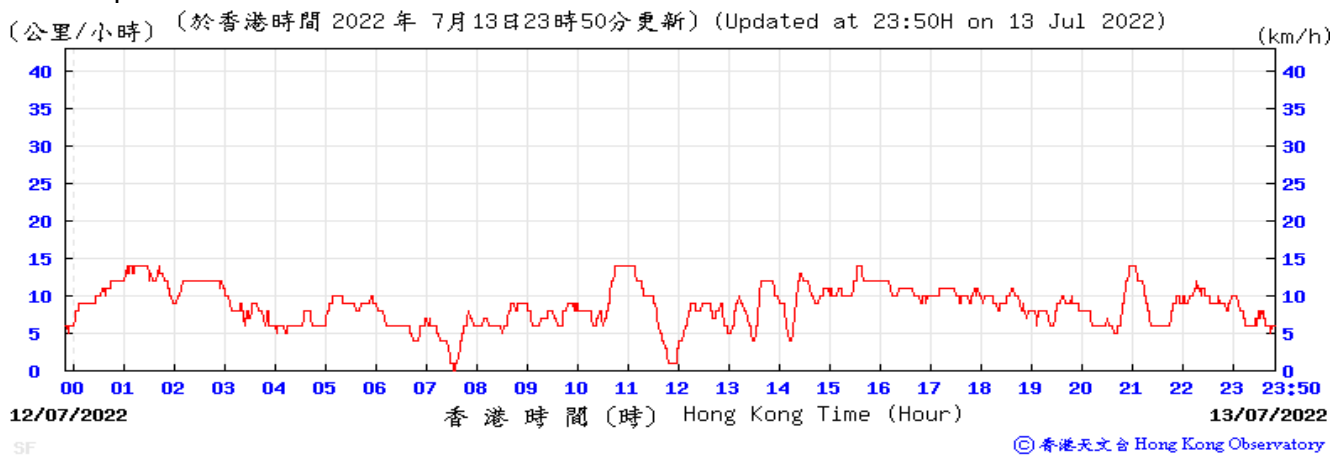
Appendix G – Extract of Meteorological Observations for Star Ferry Automatic Weather Station
July 2022

Wind Direction:

Wind Speed:

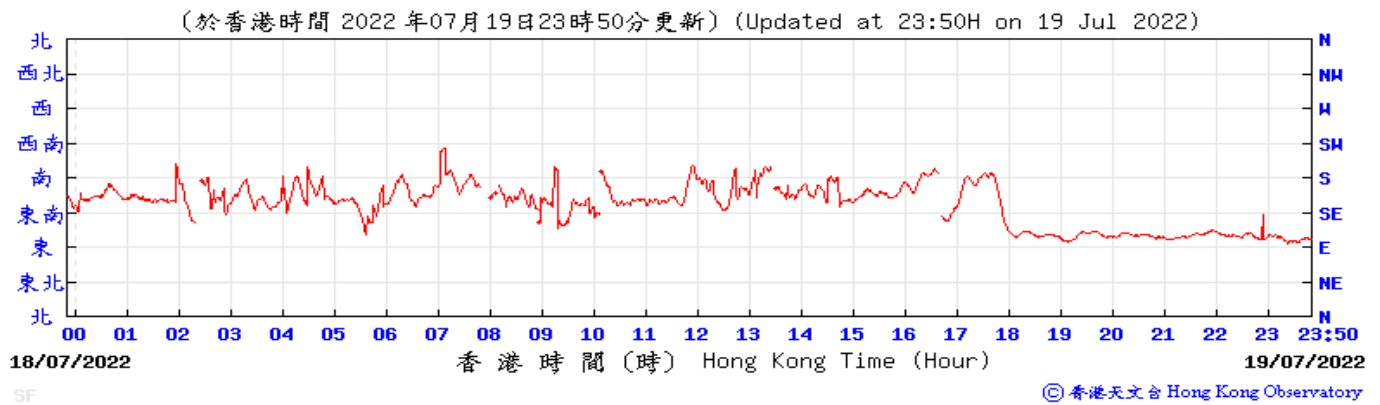
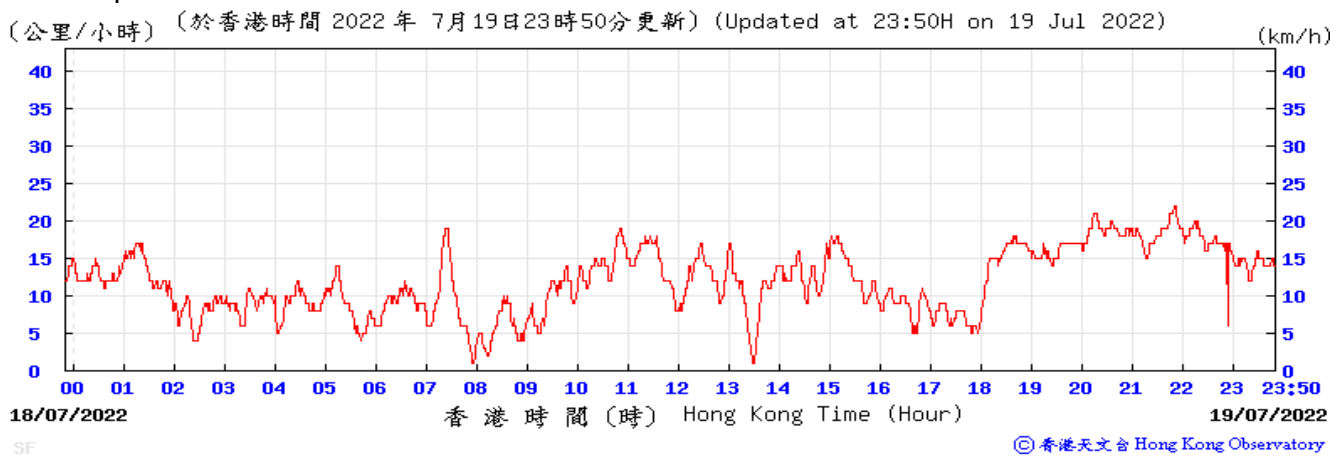
Appendix G – Extract of Meteorological Observations for Star Ferry Automatic Weather Station July 2022

Wind Direction:

Wind Speed:

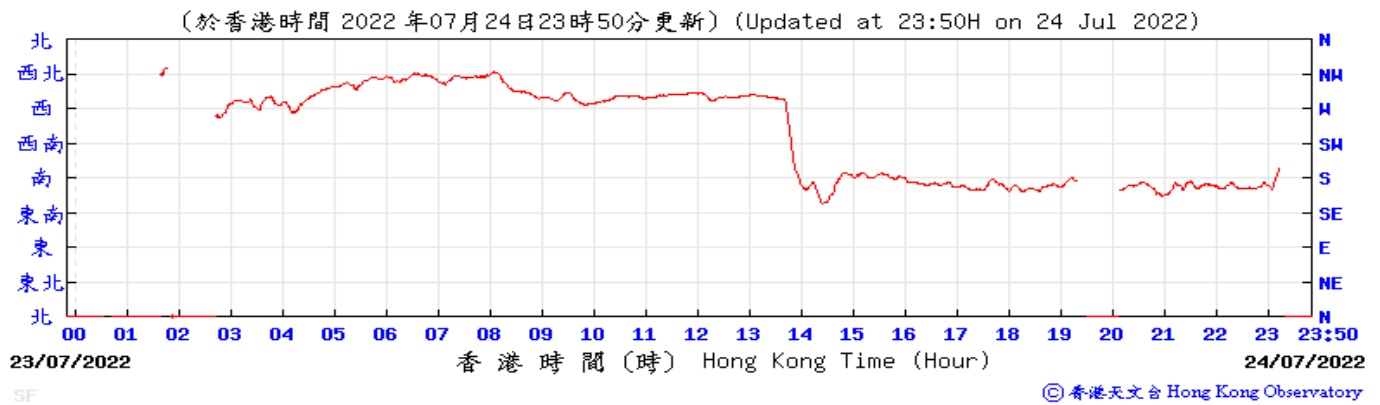
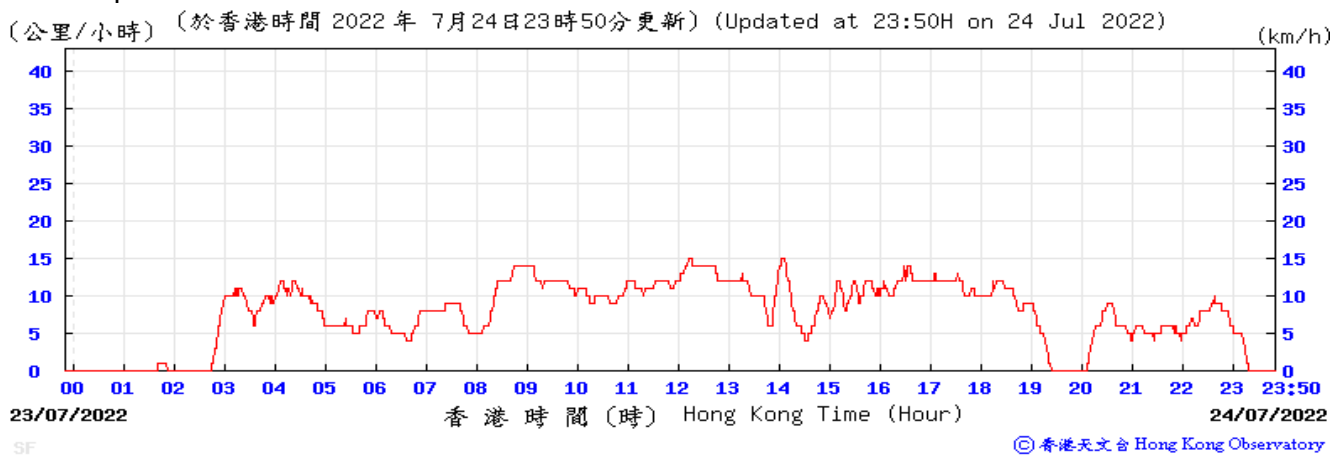
Appendix G – Extract of Meteorological Observations for Star Ferry Automatic Weather Station July 2022

Wind Direction:

Wind Speed:

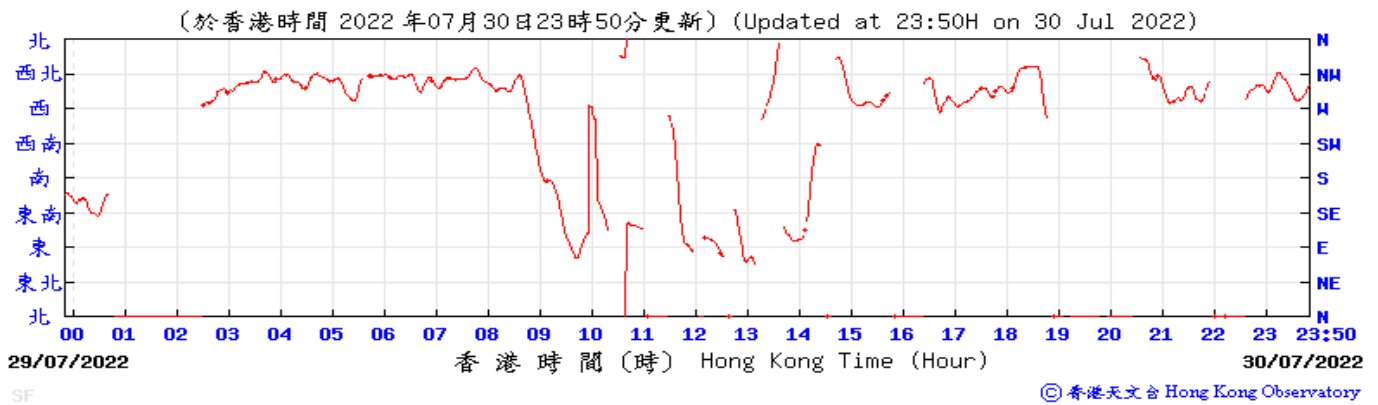
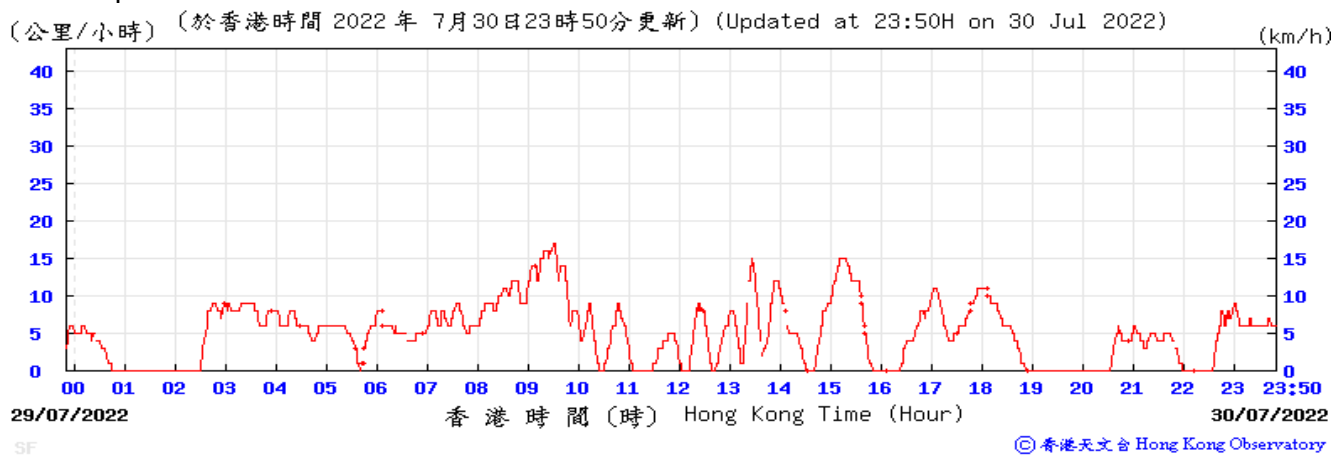
Appendix G – Extract of Meteorological Observations for Star Ferry Automatic Weather Station
July 2022

Wind Direction:

Wind Speed:
