# Contract SCL1123 – Exhibition Station & Western Approach Tunnel

# Shatin to Central Link - Hung Hom to Admiralty Section

# Works Contract 1123 - CEDD Entrusted Work for Road P2 & other roads and Slip Road 3

### Monthly EM&A Report for August 2022

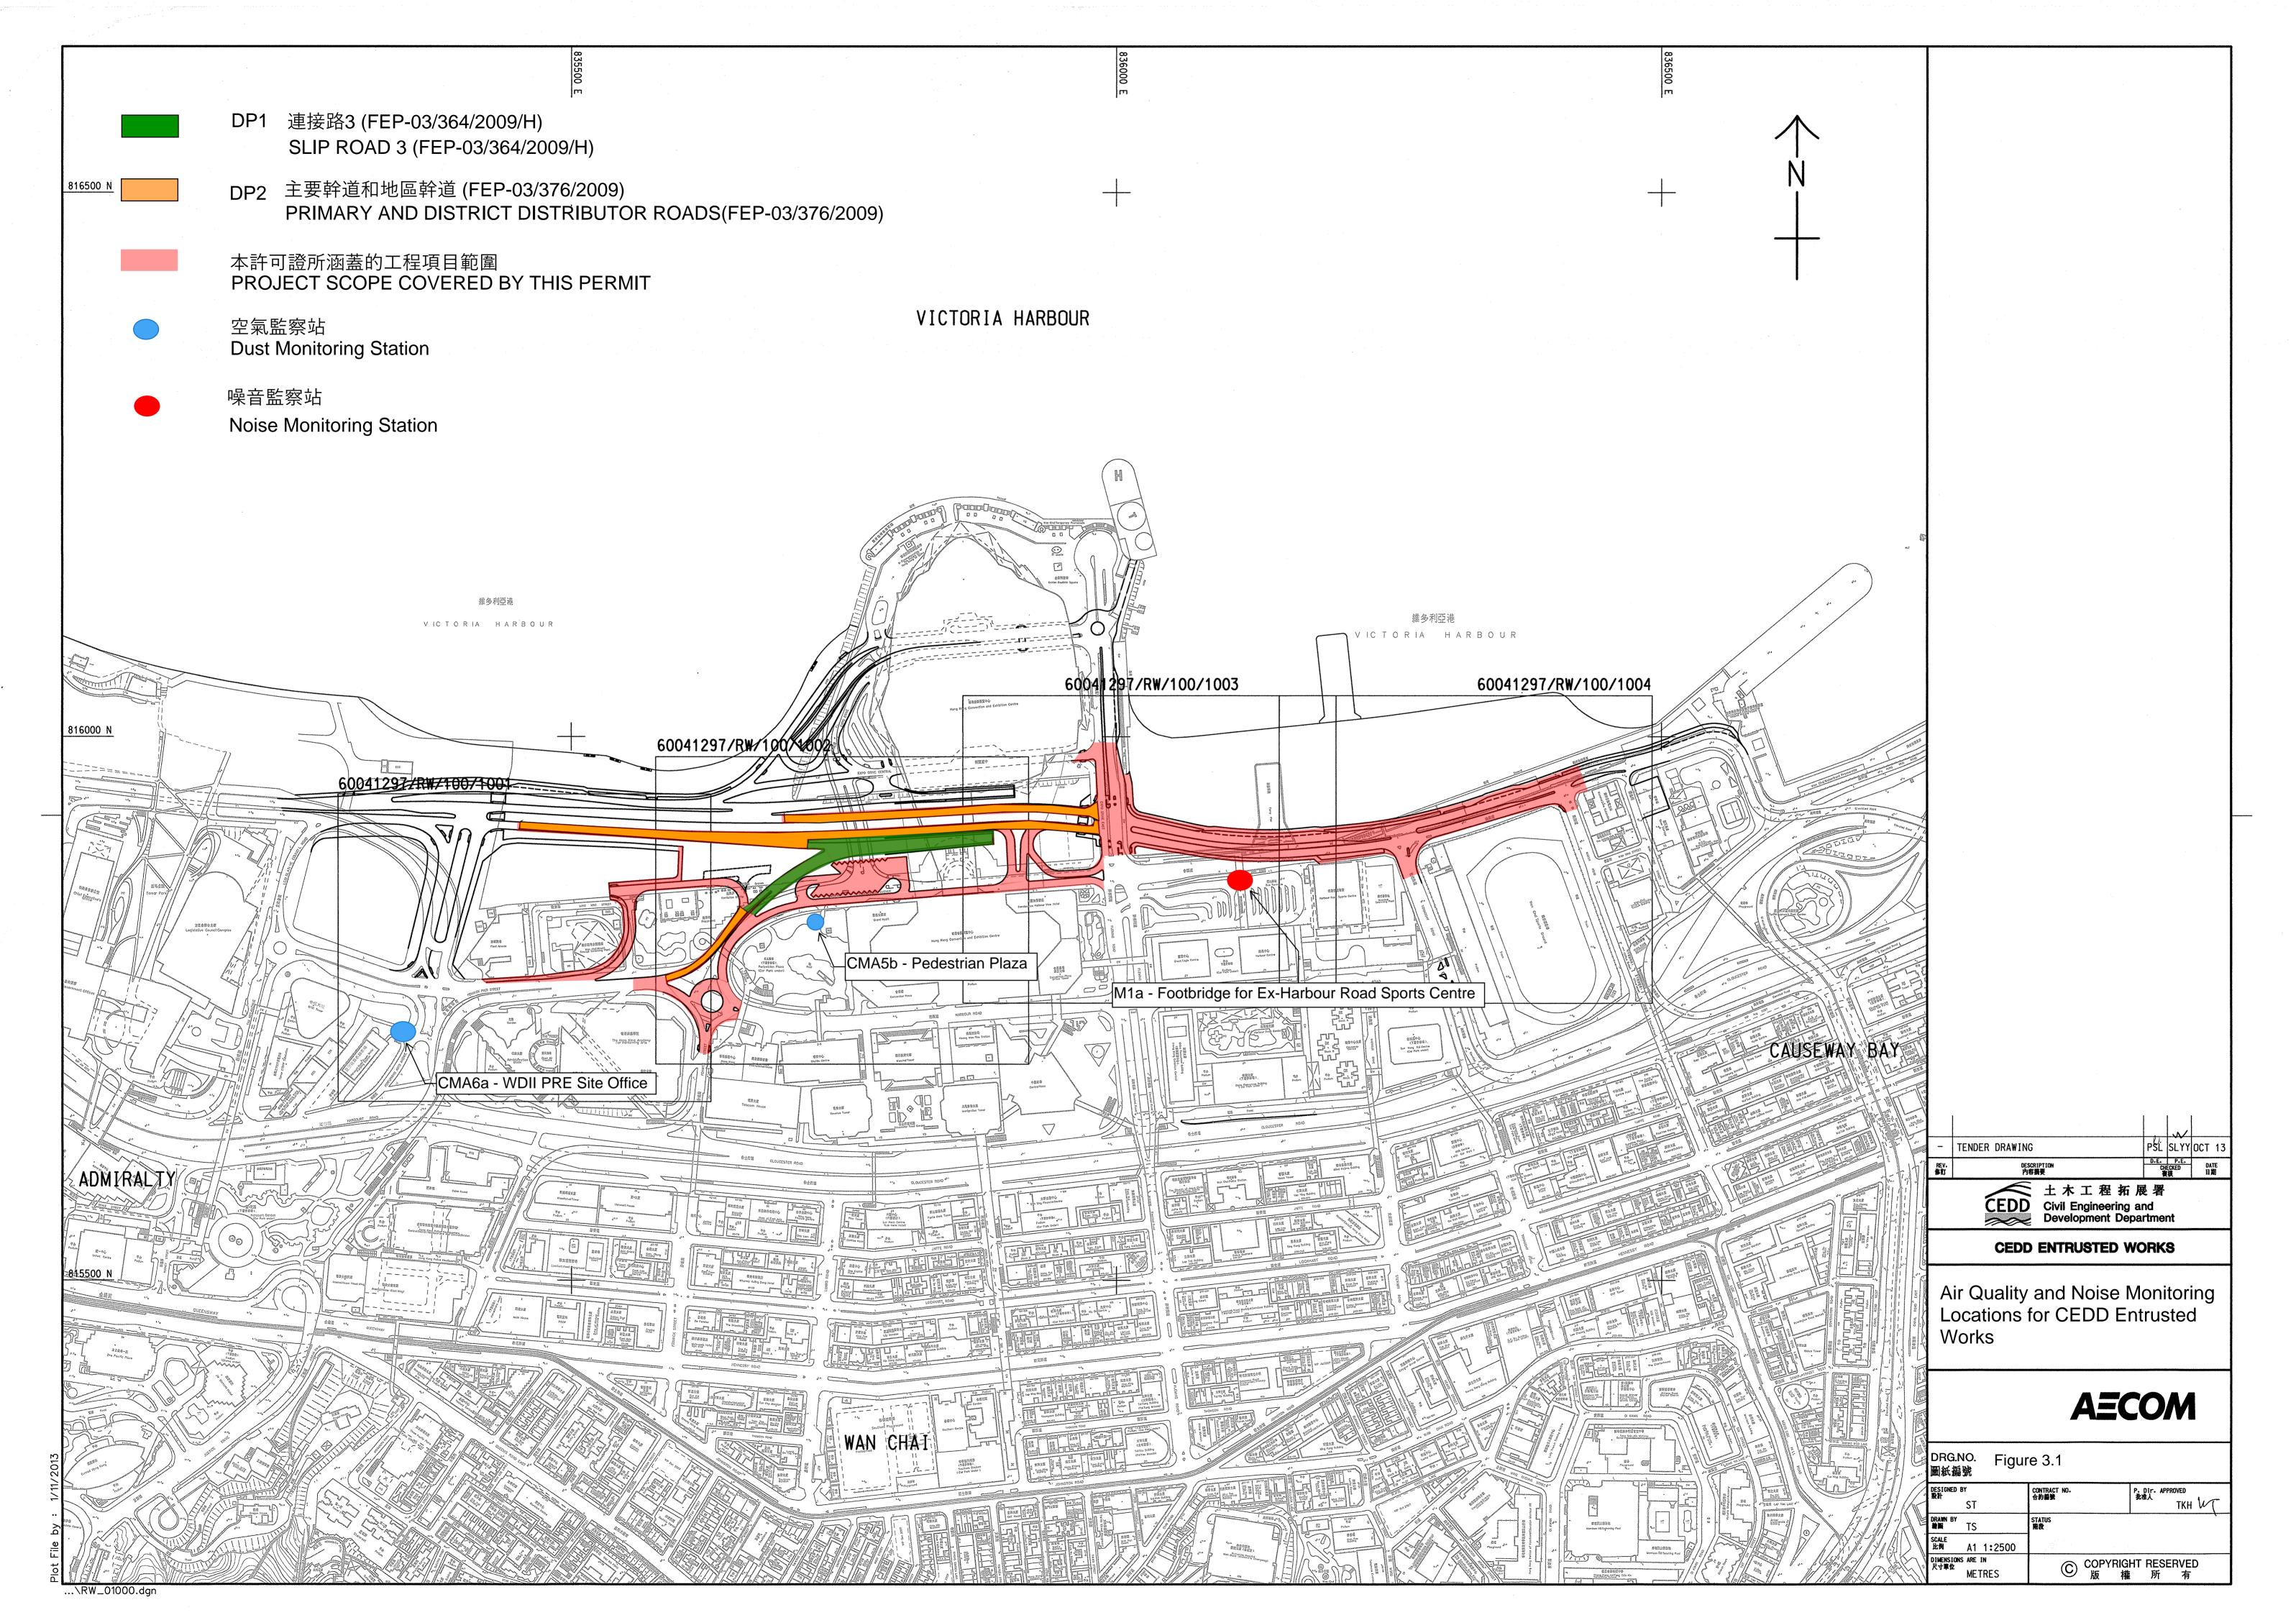
Figure 1.1	Site Layout Plan of CEDD Entrusted Works under Contract 1123
Figure 3.1	Air Quality and Noise Monitoring Locations for CEDD Entrusted Works
