**Contract SCL1123 –
Exhibition Station & Western Approach
Tunnel**

Monthly EM&A Report No. 25

[Period from 1 to 31 January 2023]

Leighton – China State J.V.**Shatin to Central Link -
Hung Hom to Admiralty Section****Works Contract 1123 -
CEDD Entrusted Work for Road P2 & other roads and Slip Road 3****Monthly EM&A Report for
January 2023**

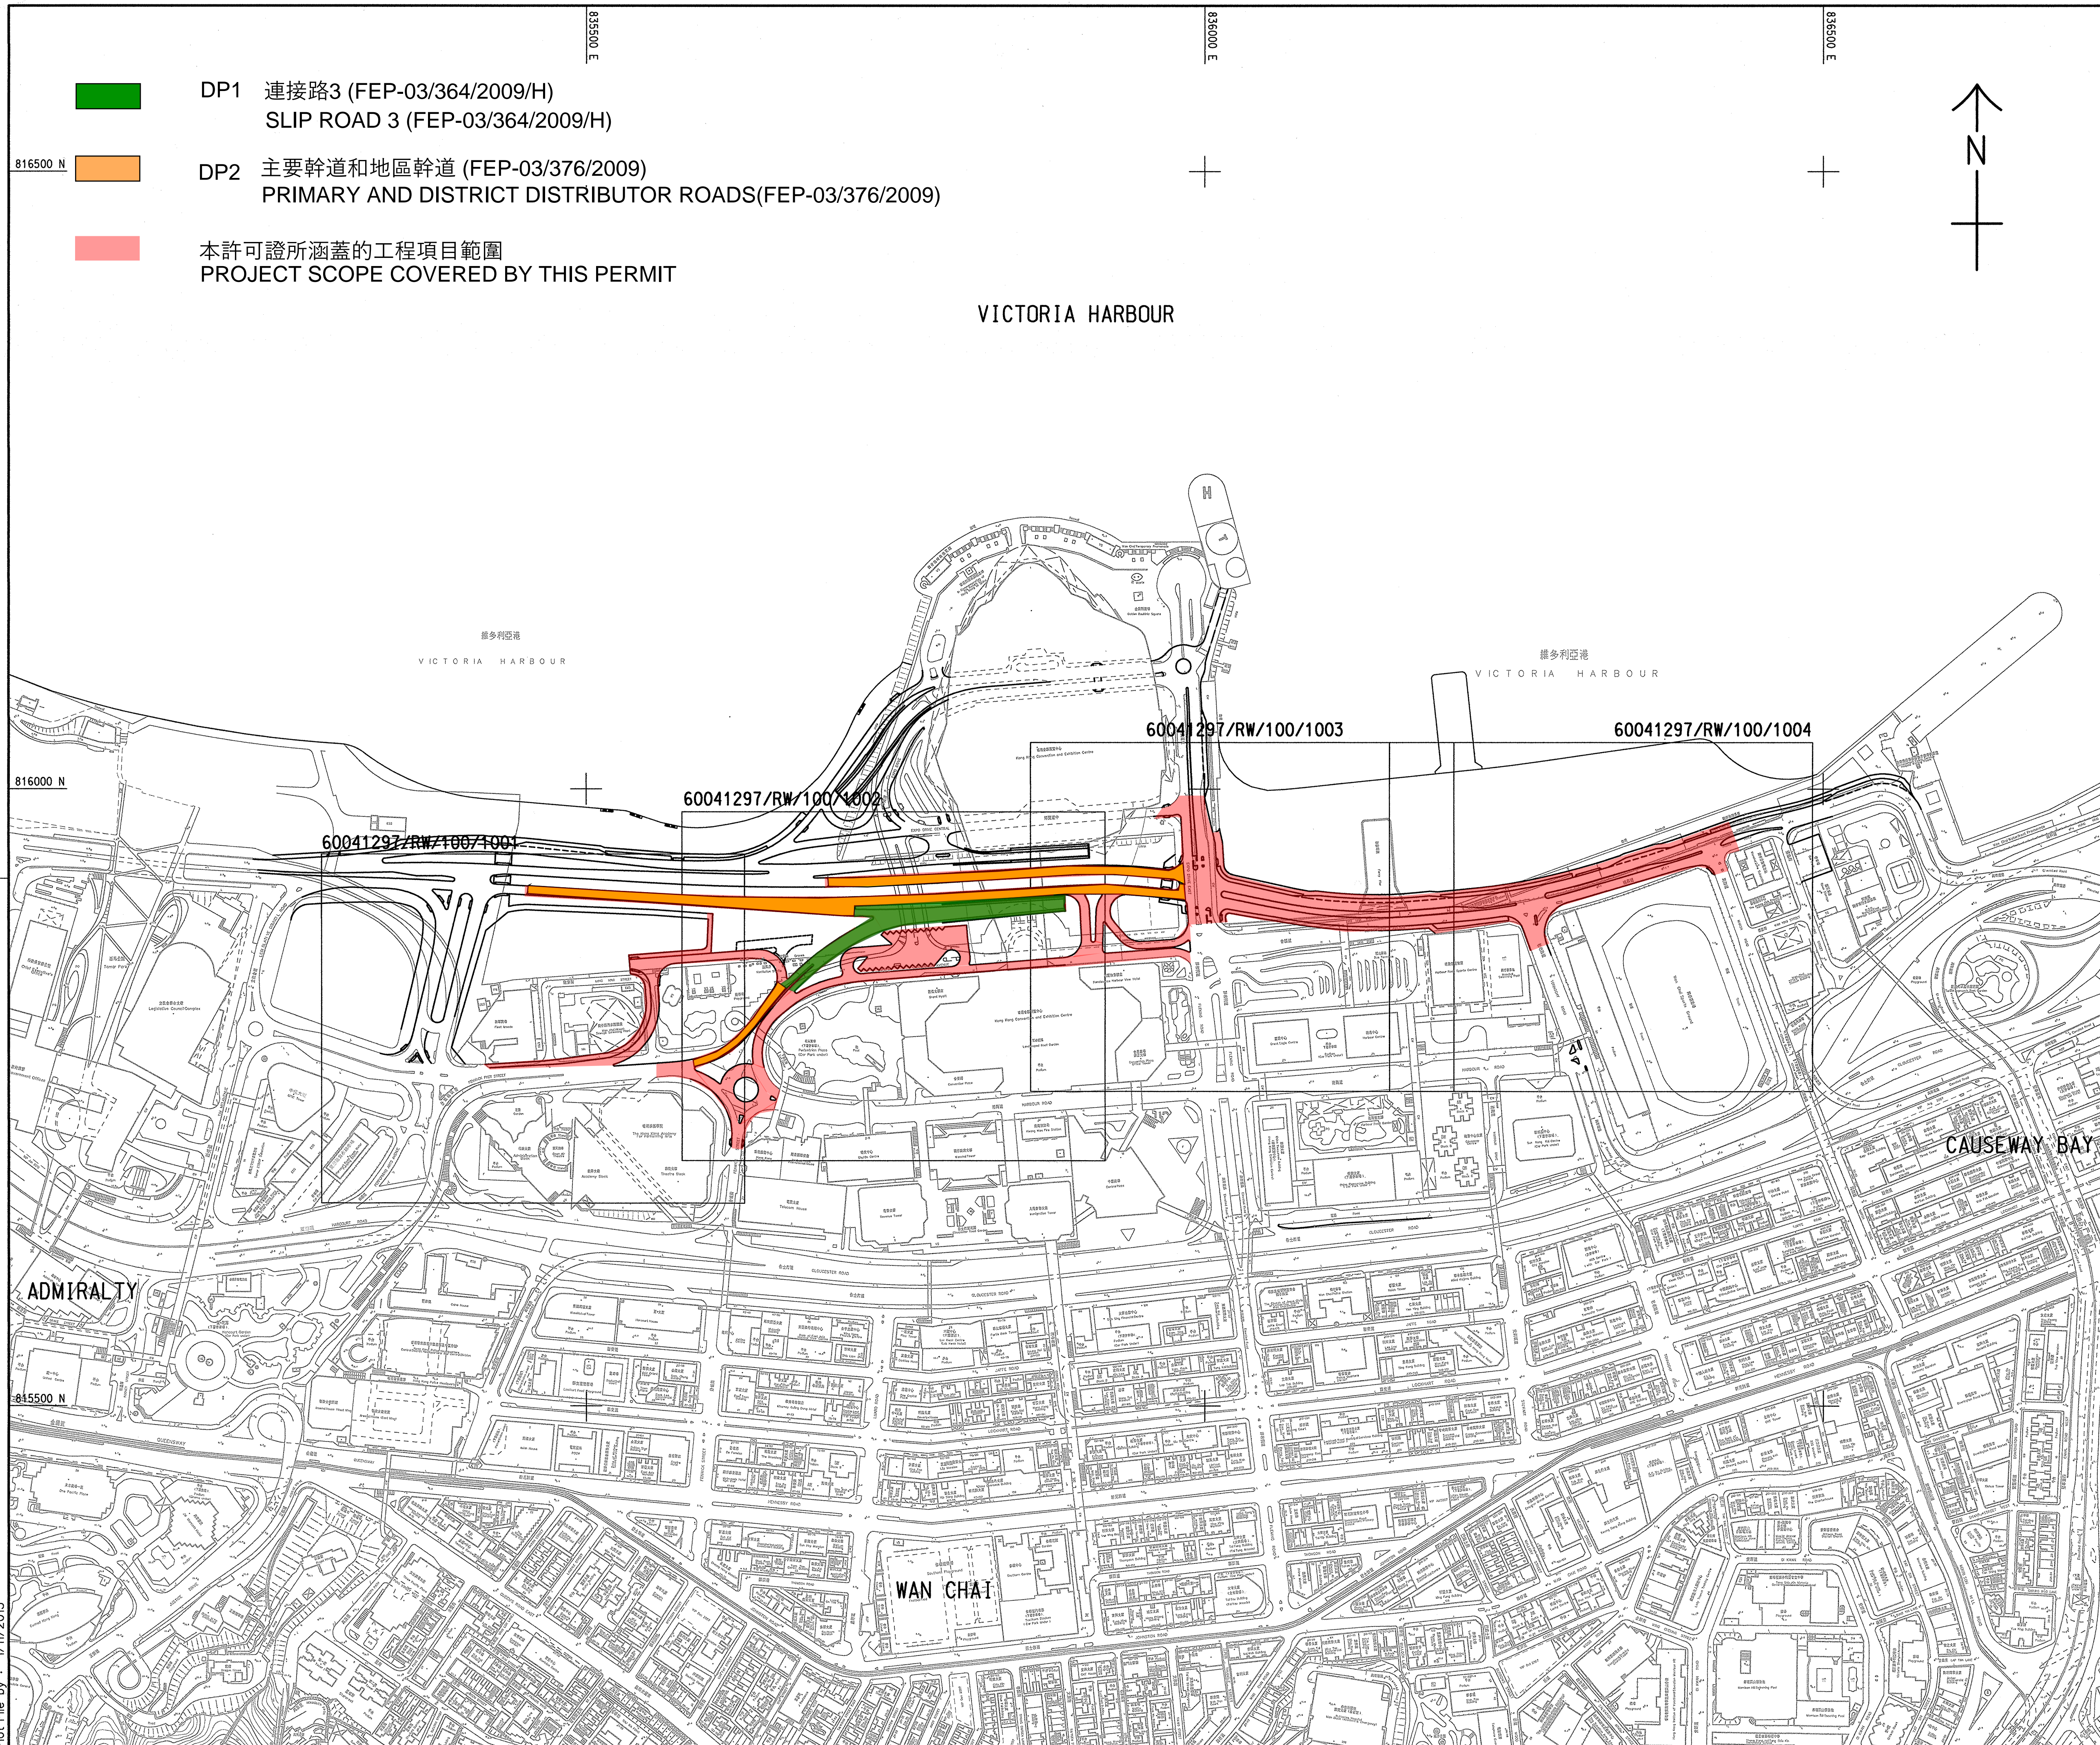
- DP1 連接路3 (FEP-03/364/2009/H)
SLIP ROAD 3 (FEP-03/364/2009/H)
- DP2 主要幹道和地區幹道 (FEP-03/376/2009)
PRIMARY AND DISTRICT DISTRIBUTOR ROADS(FEP-03/376/2009)
- 本許可證所涵蓋的工程項目範圍
PROJECT SCOPE COVERED BY THIS PERMIT

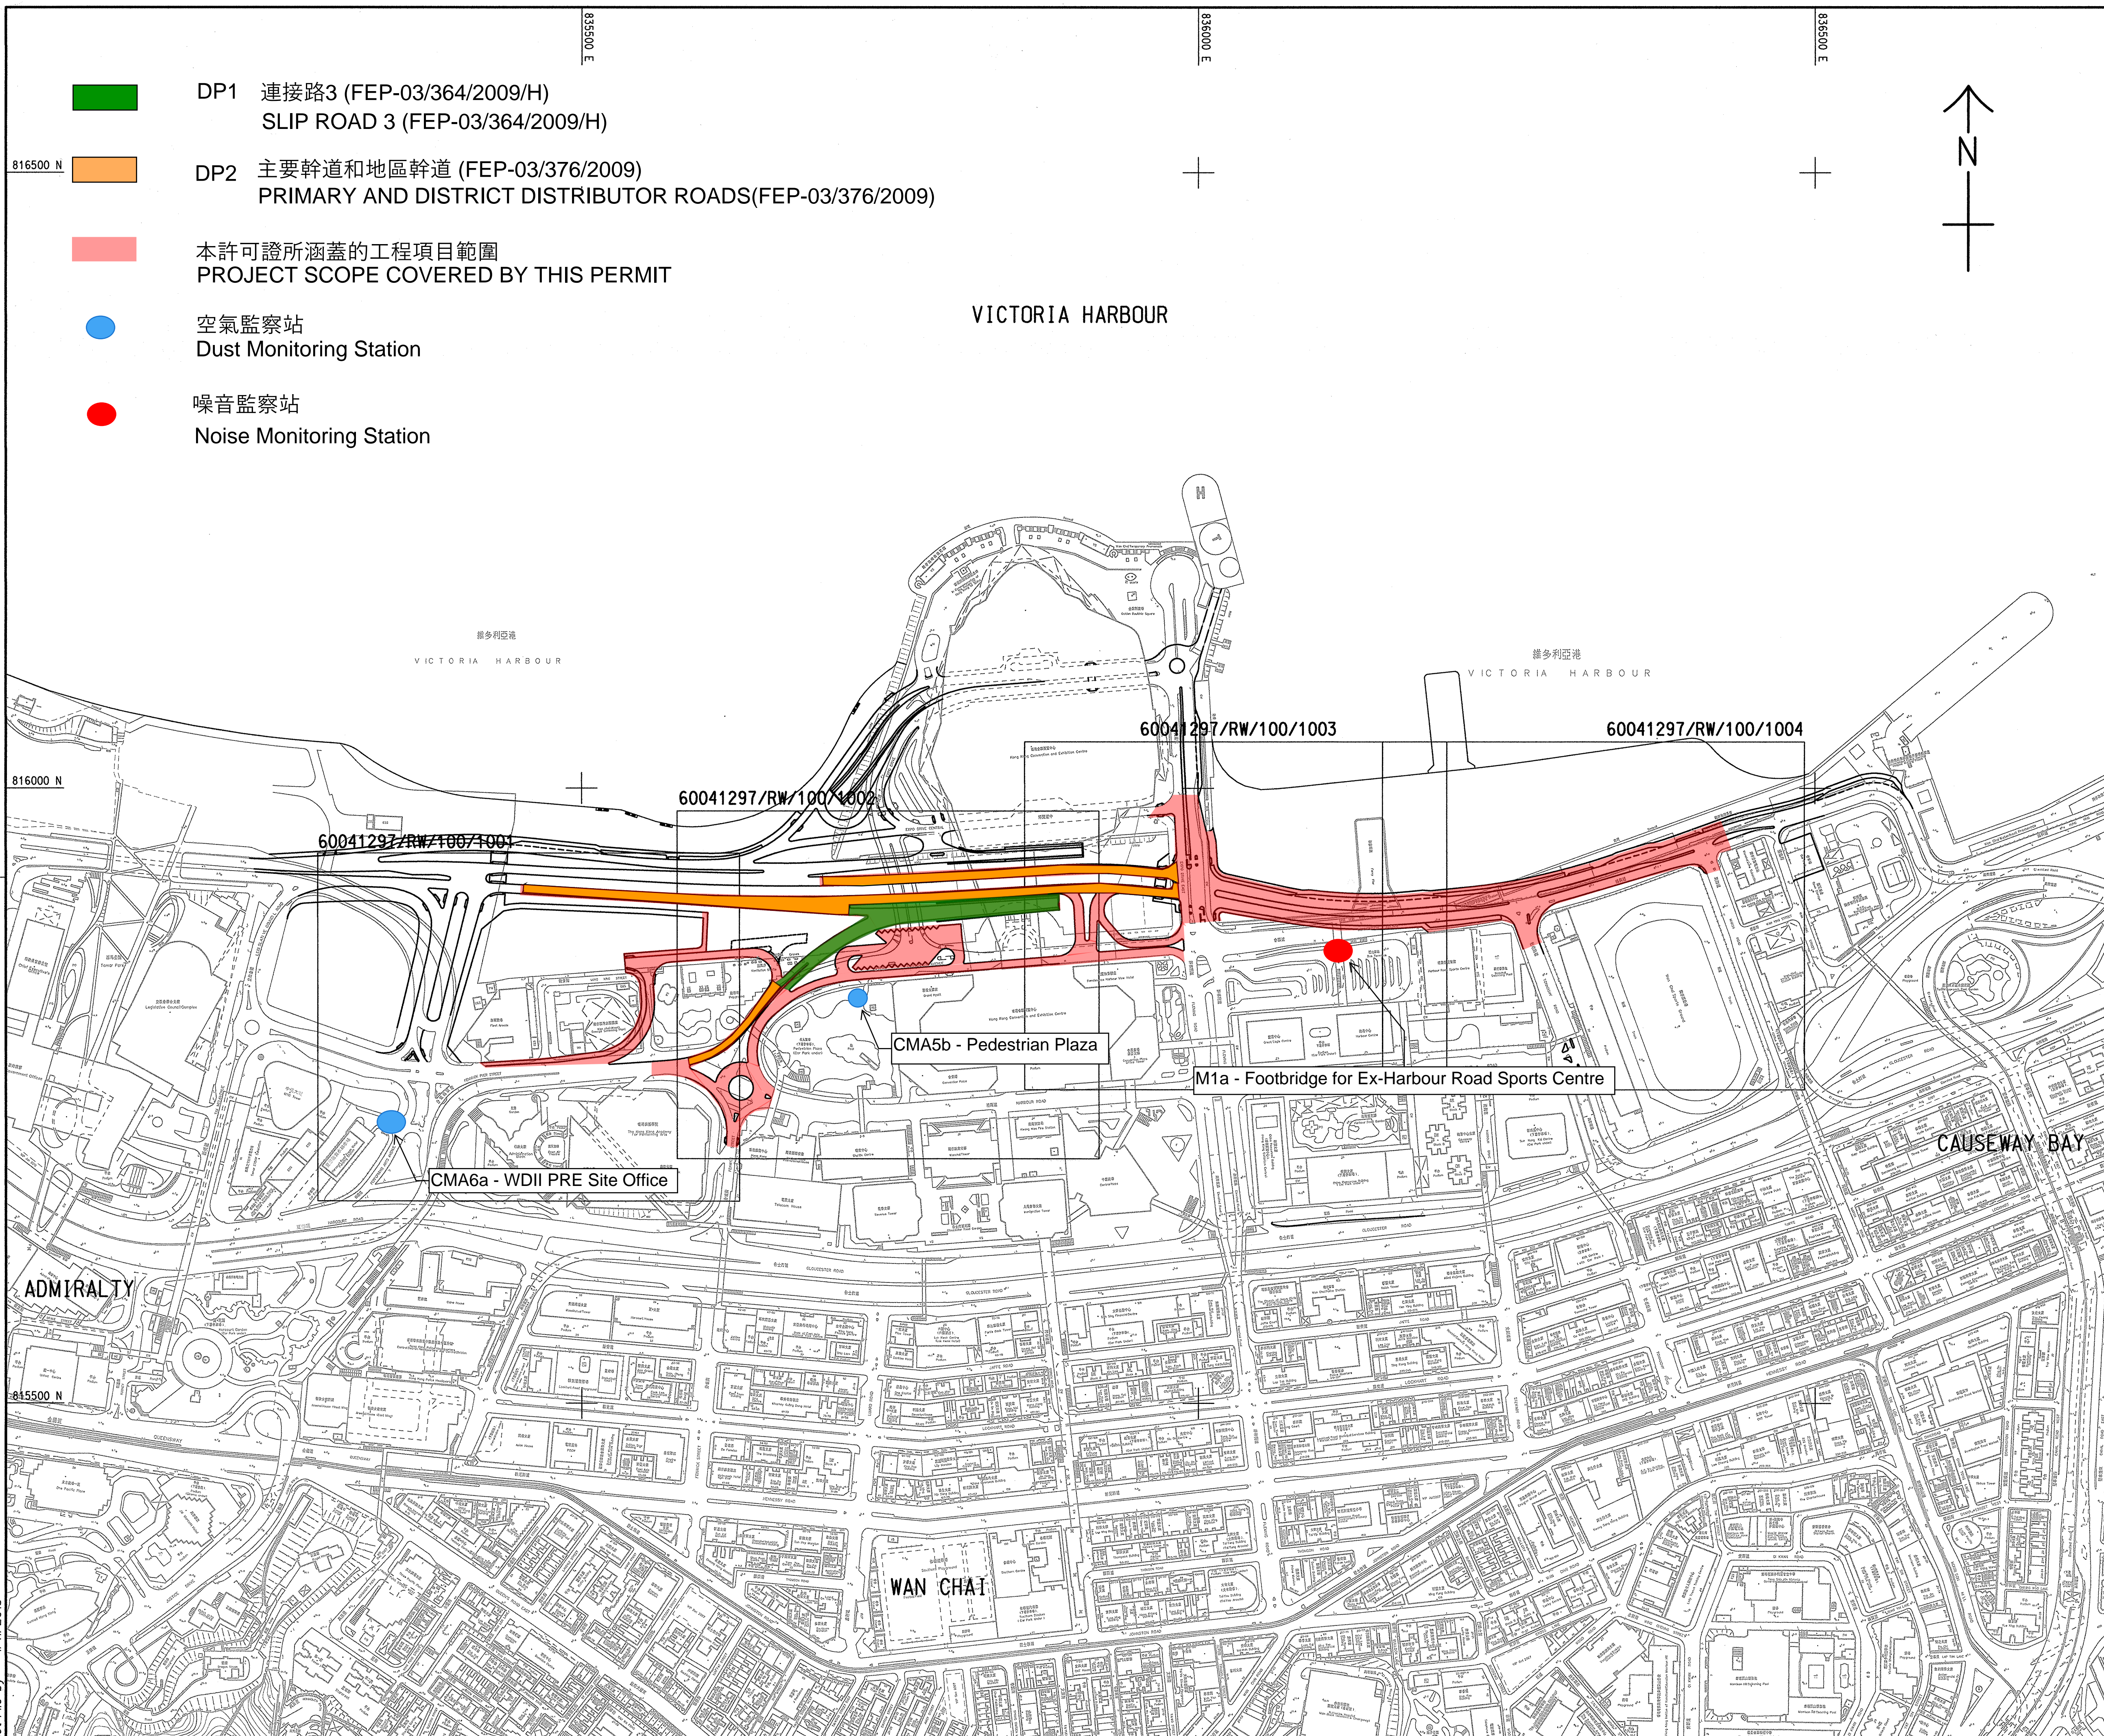
- DP1 連接路3 (FEP-03/364/2009/H)
SLIP ROAD 3 (FEP-03/364/2009/H)
- DP2 主要幹道和地區幹道 (FEP-03/376/2009)
PRIMARY AND DISTRICT DISTRIBUTOR ROADS(FEP-03/376/2009)
- 本許可證所涵蓋的工程項目範圍
PROJECT SCOPE COVERED BY THIS PERMIT
- 空氣監察站
Dust Monitoring Station
- 噪音監察站
Noise Monitoring Station
