**Contract SCL1123 –  
Exhibition Station & Western Approach  
Tunnel**

Monthly EM&A Report No. 28

[Period from 1 to 30 April 2023]

**Leighton – China State J.V.****Shatin to Central Link -  
Hung Hom to Admiralty Section****Works Contract 1123 -  
CEDD Entrusted Work for Road P2 & other roads and Slip Road 3****Monthly EM&A Report for  
April 2023**

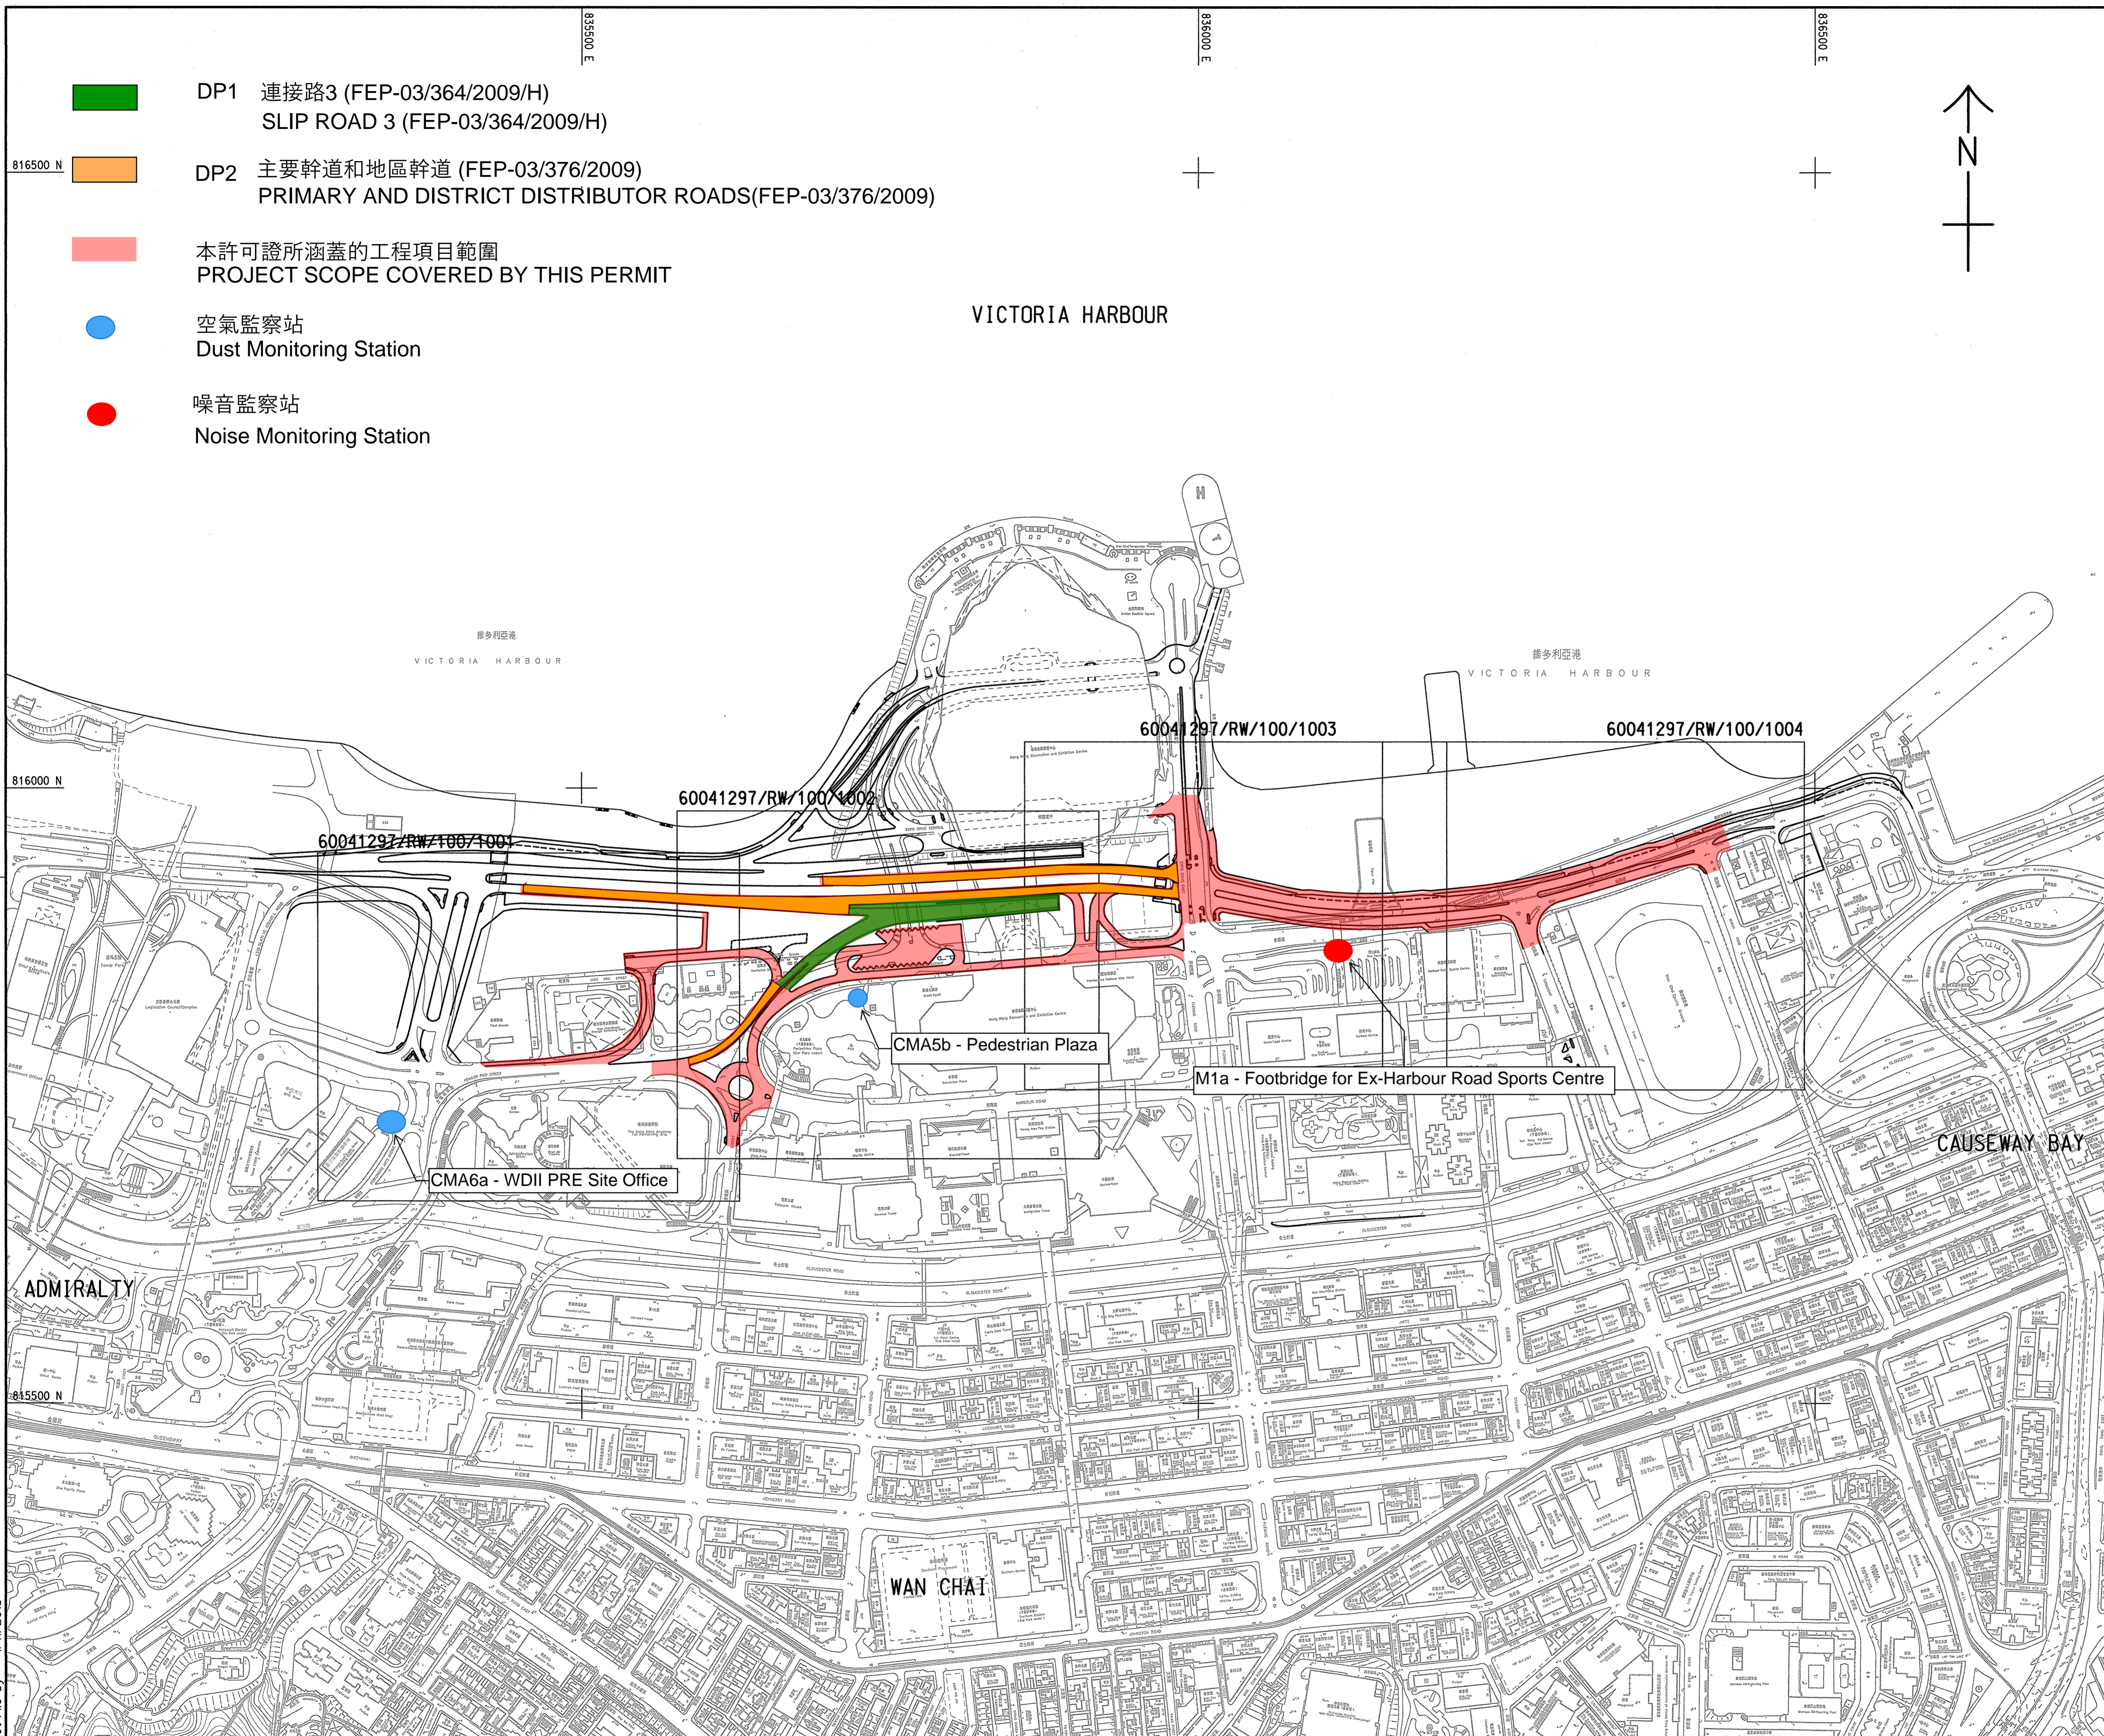
DRG. NO. Figure 3.1  
圖紙編號

- DP1 連接路3 (FEP-03/364/2009/H)  
SLIP ROAD 3 (FEP-03/364/2009/H)
- DP2 主要幹道和地區幹道 (FEP-03/376/2009)  
PRIMARY AND DISTRICT DISTRIBUTOR ROADS(FEP-03/376/2009)
- 本許可證所涵蓋的工程項目範圍  
PROJECT SCOPE COVERED BY THIS PERMIT
- 空氣監察站  
Dust Monitoring Station
- 噪音監察站  
Noise Monitoring Station

Air Quality and Noise Monitoring  
Locations for CEDD Entrusted  
Works
