Contract SCL1123 – Exhibition Station & Western Approach Tunnel

Monthly EM&A Report No.12

Works Contract 1123 - CEDD Entrusted Work for Road P2 & other roads and Slip Road 3

Monthly EM&A Report for December 2021

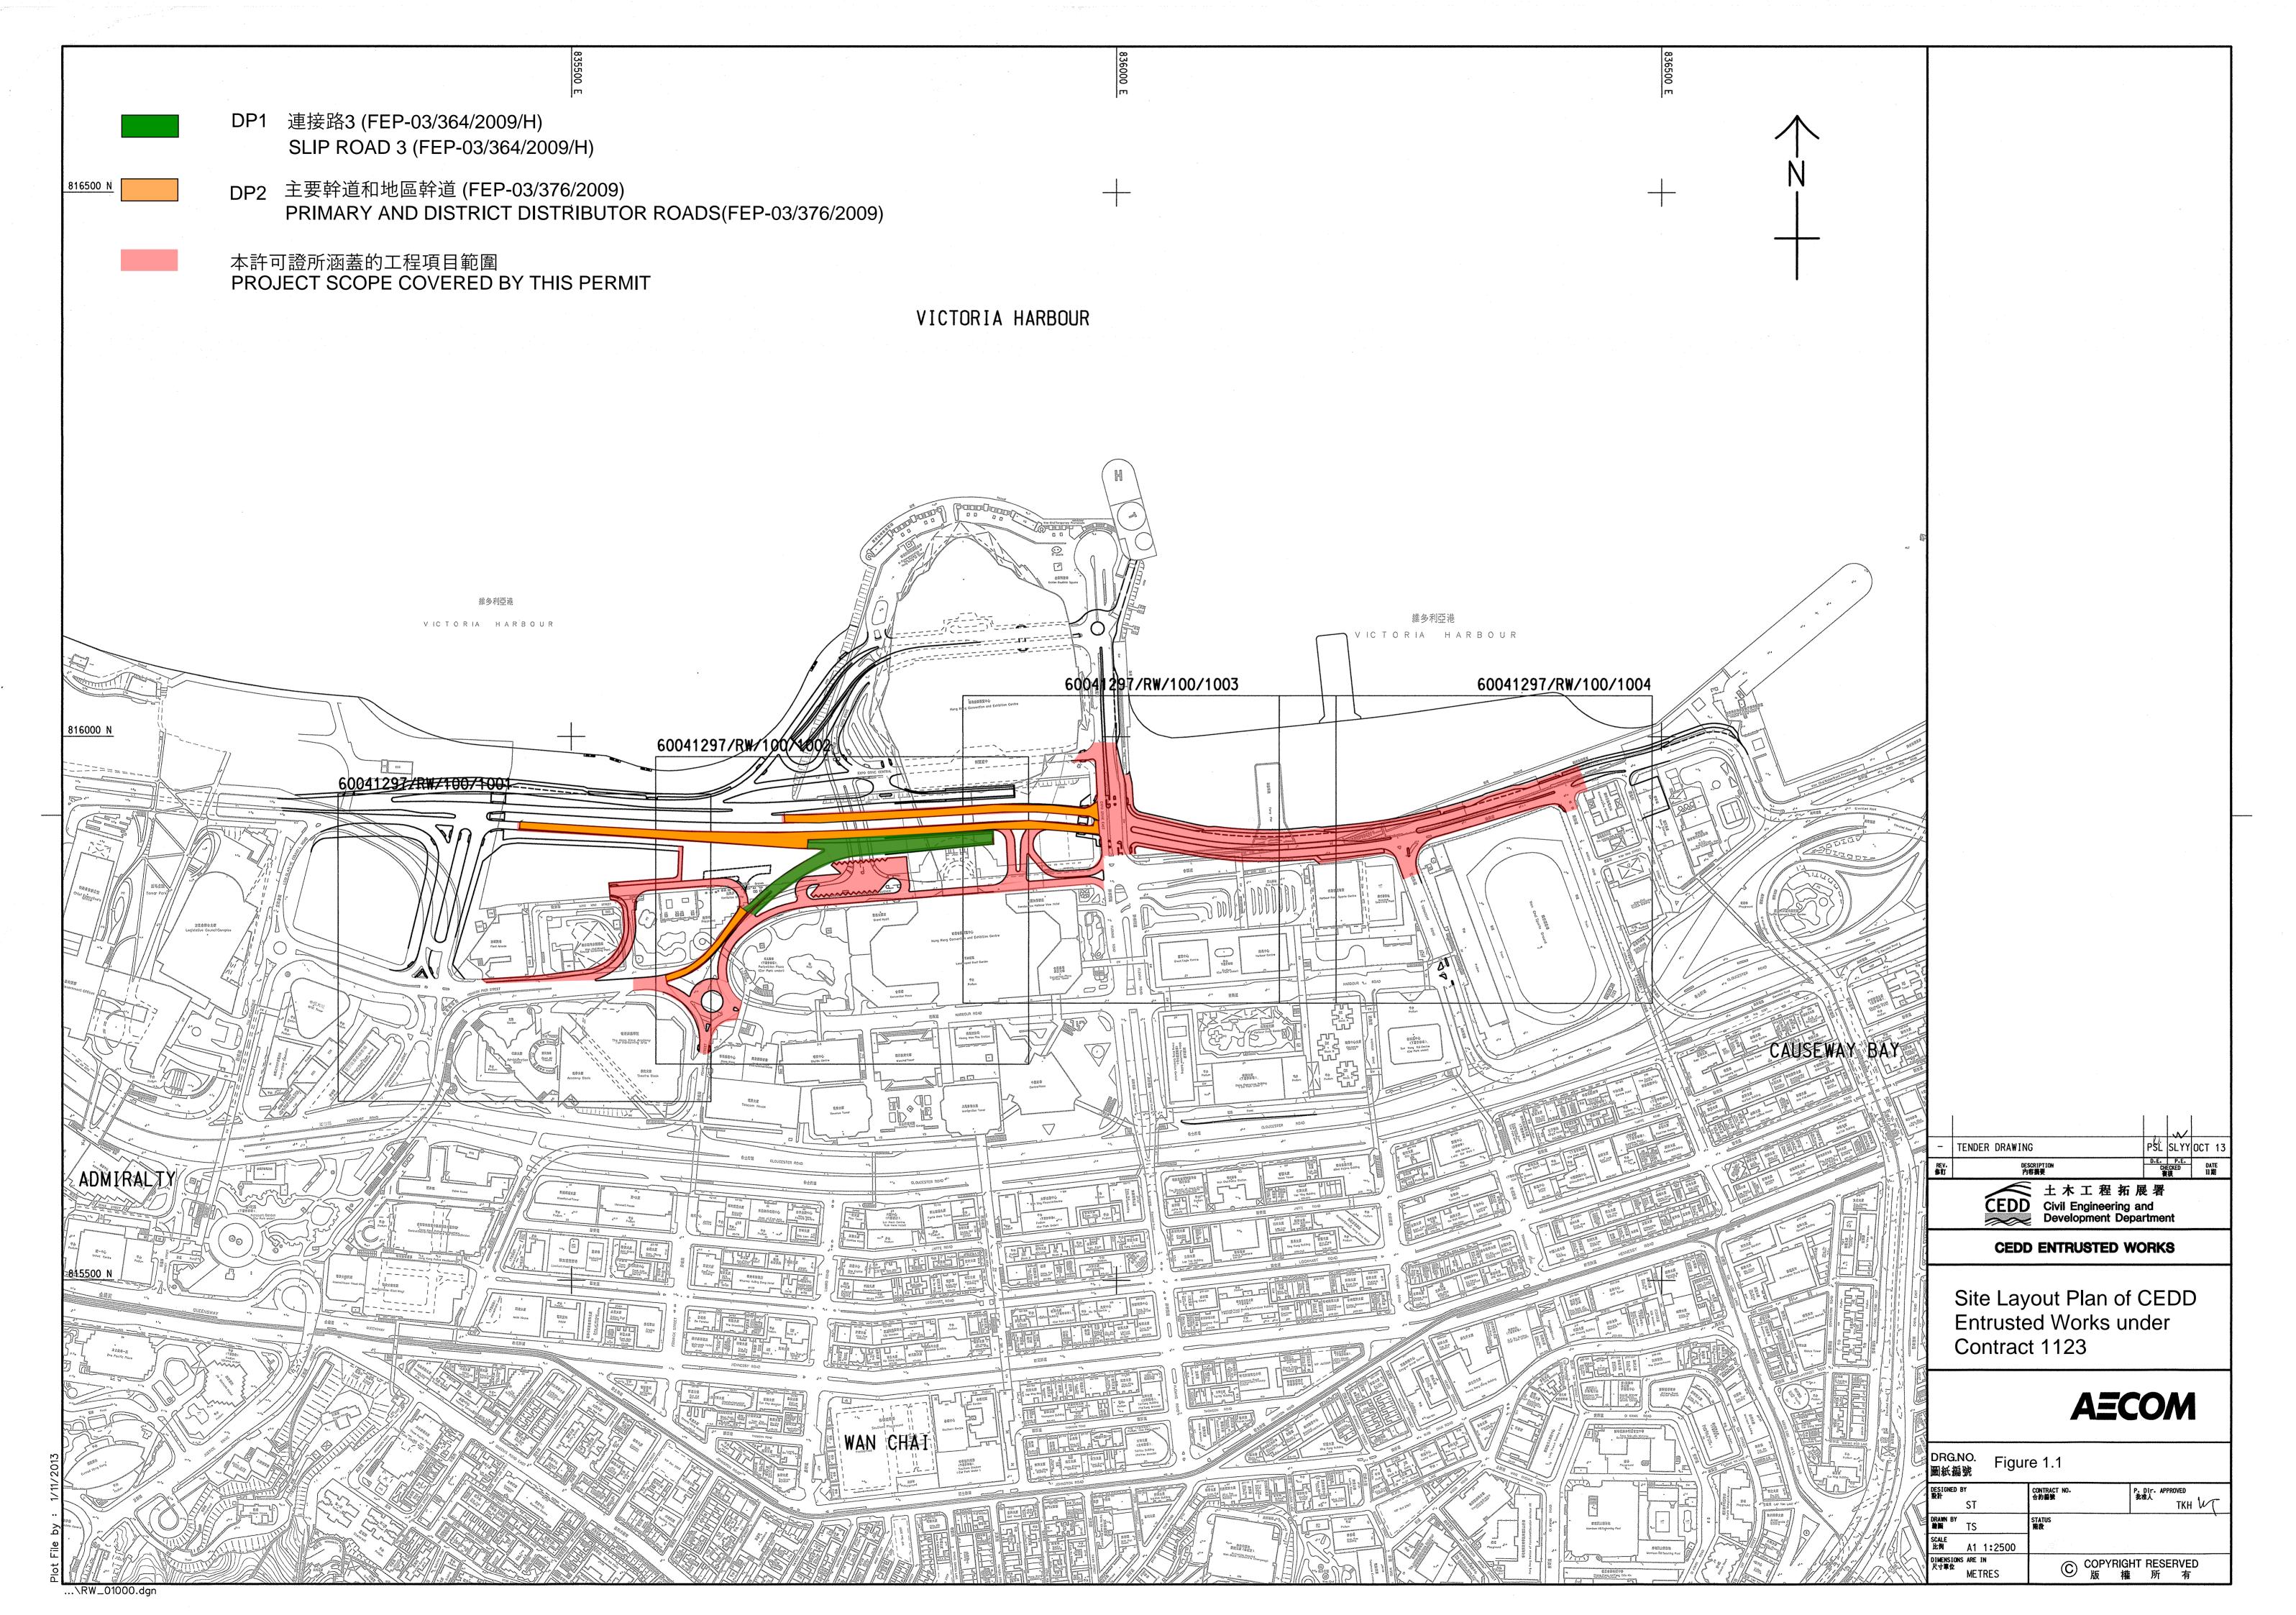
| Figure 1.1 | Site Layout Plan of CEDD Entrusted Works under Contract 1123 |

- 2.1.4 The site layout plan of the Project is shown in **Figure 1.1**.
