**DELIVERY OF RECLAMATION MATERIAL
TO MAINLAND –
ENVIRONMENTAL MONITORING AND AUDIT
(CONTRACT NO.: CV/2005/01)**

TSEUNG KWAN O AREA 137 FILL BANK

MONTHLY EM&A REPORT

(JANUARY 2007)

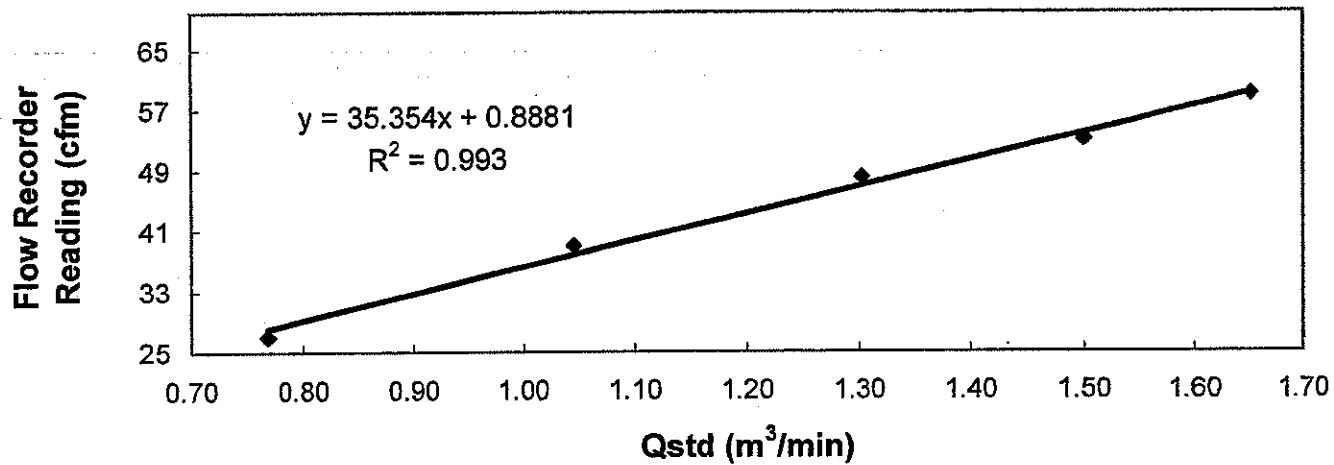
**Air Sampler 10347 Calibration Curve
Site: Tseung Kwan O (AA1)
Date of Calibration: 24 November 2006**

Acceptance Criteria : Correlation coefficient (*r*) of the calibration curve greater than 0.990 after a 5 point calibration

The high volume sampler complies * / does not comply * with the specified requirements and is deemed acceptable */ unacceptable * for use.

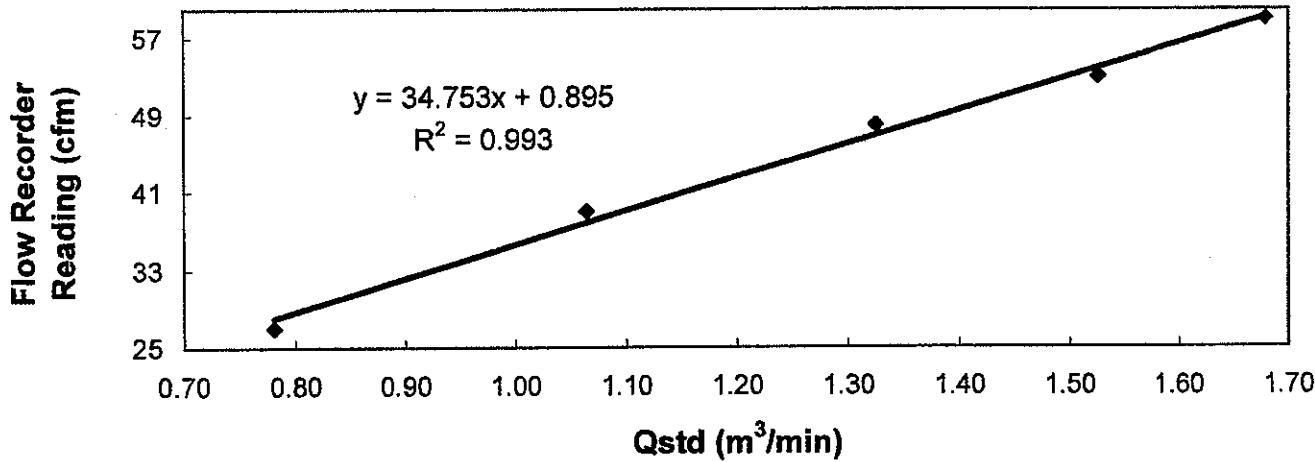
**Sampler 10347 Calibration Curve
Site: Tseung Kwan O (AA-1)
Date of Calibration: 24 January 2007**

Acceptance Criteria : Correlation coefficient (*r*) of the calibration curve greater than 0.990 after a 5-point calibration

The high volume sampler complies * / does not comply * with the specified requirements and is deemed acceptable */ unacceptable * for use.

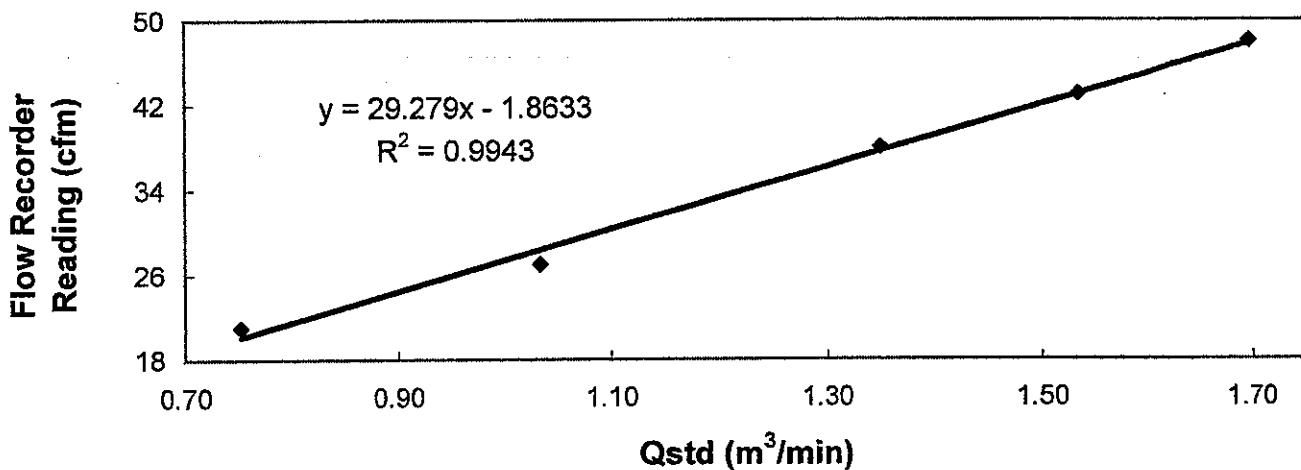
**Air Sampler 1176 Calibration Curve
Site: Tseung Kwan O (AA2)
Date of Calibration: 24 November 2006**

Acceptance Criteria : Correlation coefficient (*r*) of the calibration curve greater than 0.990 after a 5 point calibration

The high volume sampler complies * / does not comply * with the specified requirements and is deemed acceptable * / unacceptable * for use.

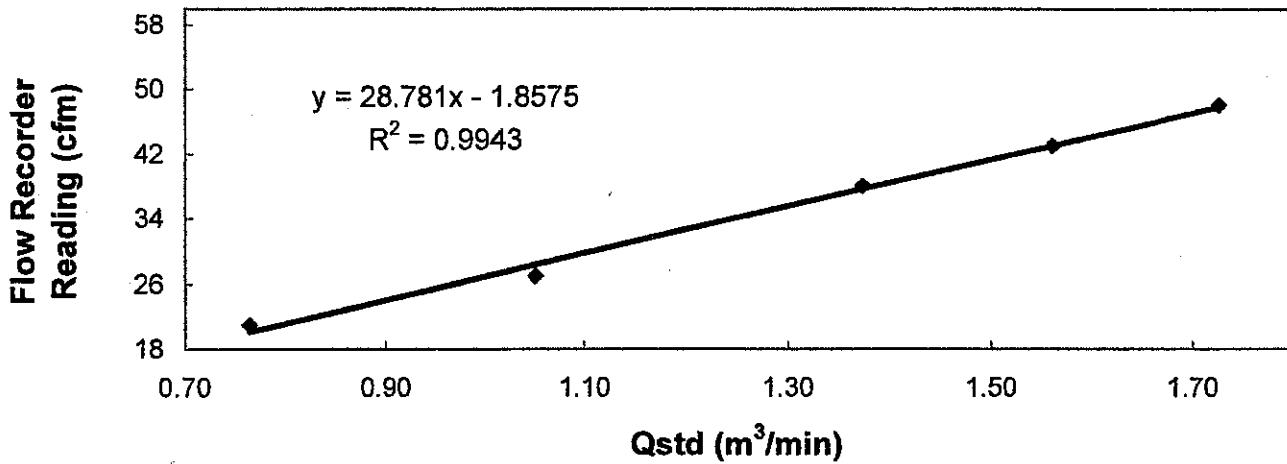
Sampler 1176 Calibration Curve
Site: Tseung Kwan O (AA-2)
Date of Calibration: 24 January 2007

Acceptance Criteria : Correlation coefficient (*r*) of the calibration curve greater than 0.990 after a 5-point calibration

The high volume sampler complies * / does not comply * with the specified requirements and is deemed acceptable */ unacceptable * for use.
