**DELIVERY OF RECLAMATION MATERIAL
TO MAINLAND –
ENVIRONMENTAL MONITORING AND AUDIT
(CONTRACT NO.: CV/2005/01)**

TSEUNG KWAN O AREA 137 FILL BANK

MONTHLY EM&A REPORT

(OCTOBER 2007)

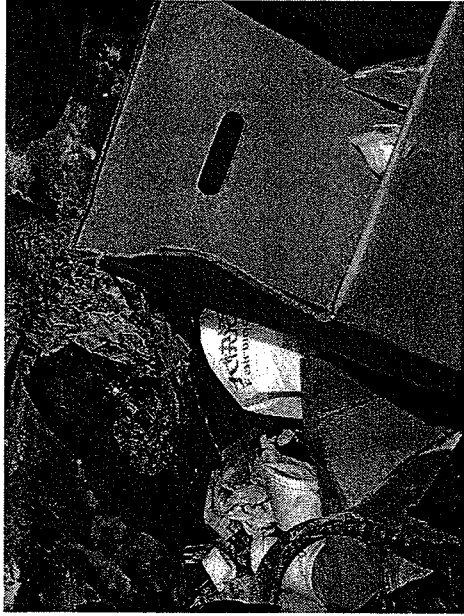
Photo 071004_001

Issue	Action
Previous Observations	
NIL	NIL
New Observations	
1. Stagnant water and refuses were observed in container near Tipping Hall No. 2.	To drain away stagnant water and clean up refuse as soon as possible.

Issue	Action
Previous Observations	
1. Stagnant water and refuses were observed in container near Tipping Hall No. 2.	Stagnant water has been drained away and refuse has been cleaned up.
New Observations	
NIL	NIL
