**DELIVERY OF RECLAMATION MATERIAL
TO MAINLAND –
ENVIRONMENTAL MONITORING AND AUDIT
(CONTRACT NO.: CV/2005/01)**

TSEUNG KWAN O AREA 137 FILL BANK

MONTHLY EM&A REPORT

(MAY 2009)

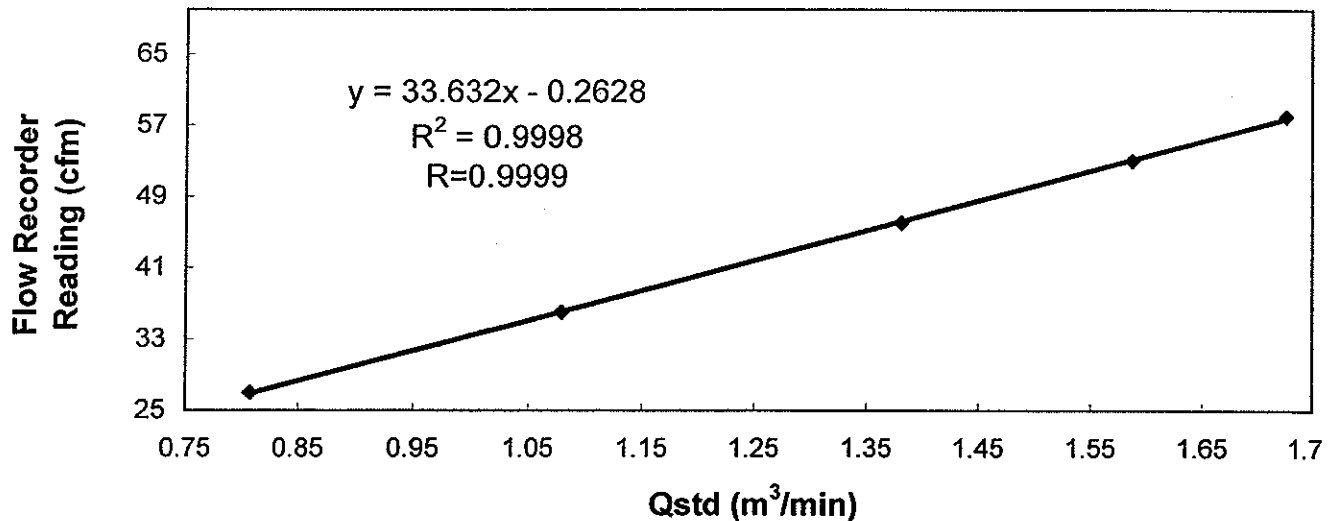
Sampler 10347 Calibration Curve
Site: Tseung Kwan O (A-1)

Results	Flow recorder reading (cfm)	58	53	46	36	27
	Qstd (Actual flow rate, m ³ /min)	1.73	1.59	1.38	1.08	0.81
	Pressure : 764.31 mm Hg	Temp. : 293 K

Acceptance Criteria : Correlation coefficient (r) of the calibration curve greater than 0.990 after a 5-point calibration

The high volume sampler complies* / does not comply* with the specified requirements and is deemed acceptable* / unacceptable* for use.

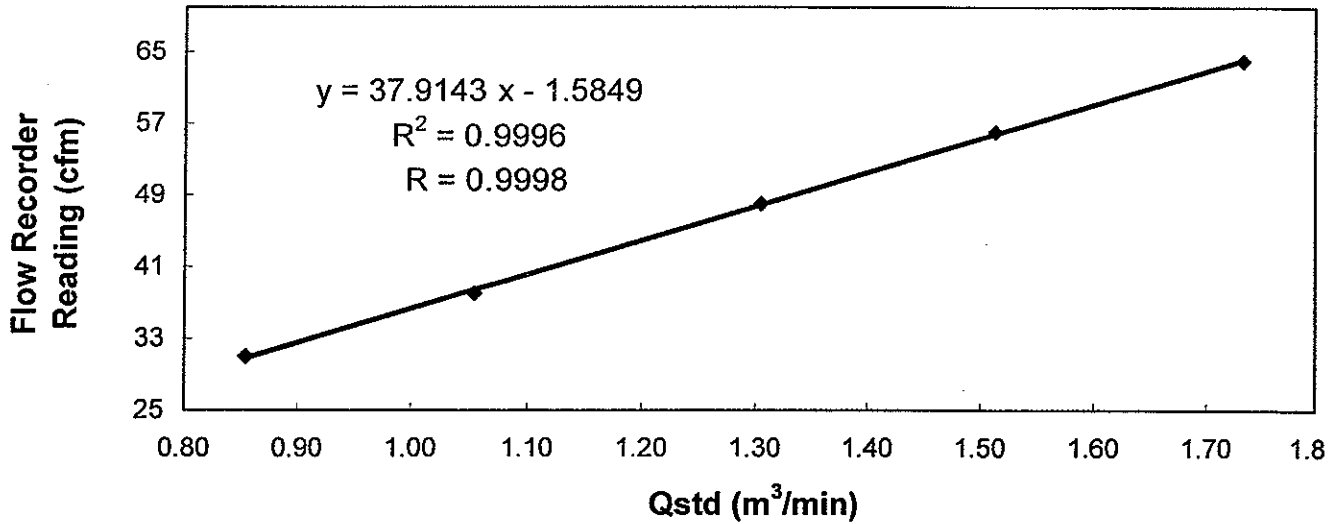
Sampler 1176 Calibration Curve
Site: Tseung Kwan O (A-2)

Flow recorder reading (cfm)	64	56	48	38	31
Qstd (Actual flow rate, m ³ /min)	1.73	1.51	1.30	1.06	0.85
Pressure :	764.31 mm Hg			Temp. :	293 K

Acceptance Criteria : Correlation coefficient (r) of the calibration curve greater than 0.990 after a 5-point calibration

The high volume sampler complies* / does not comply* with the specified requirements and is deemed acceptable*/ unacceptable* for use.

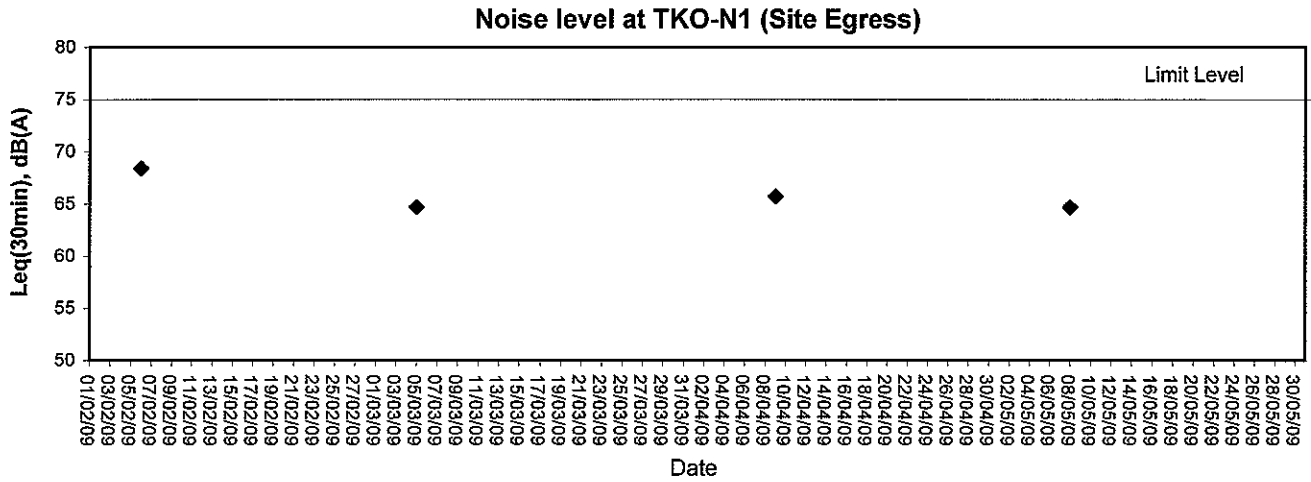
Noise Monitoring (Day-time)

Date	Start Sampling Time (hh:mm)	Noise Level dB (A)			Wind Speed (m/s)	Weather Condition
		L _{eq} (30min)	L ₁₀	L ₉₀		
08/05/09	14:00	64.7	68.0	61.2	0.8	Cloudy
