Permanent Aviation Fuel Facility (EP-262/2007/B)

Forty-second Monthly Environmental Monitoring and Audit Report – April 2010

Permanent Aviation Fuel Facility for Hong Kong International Airport

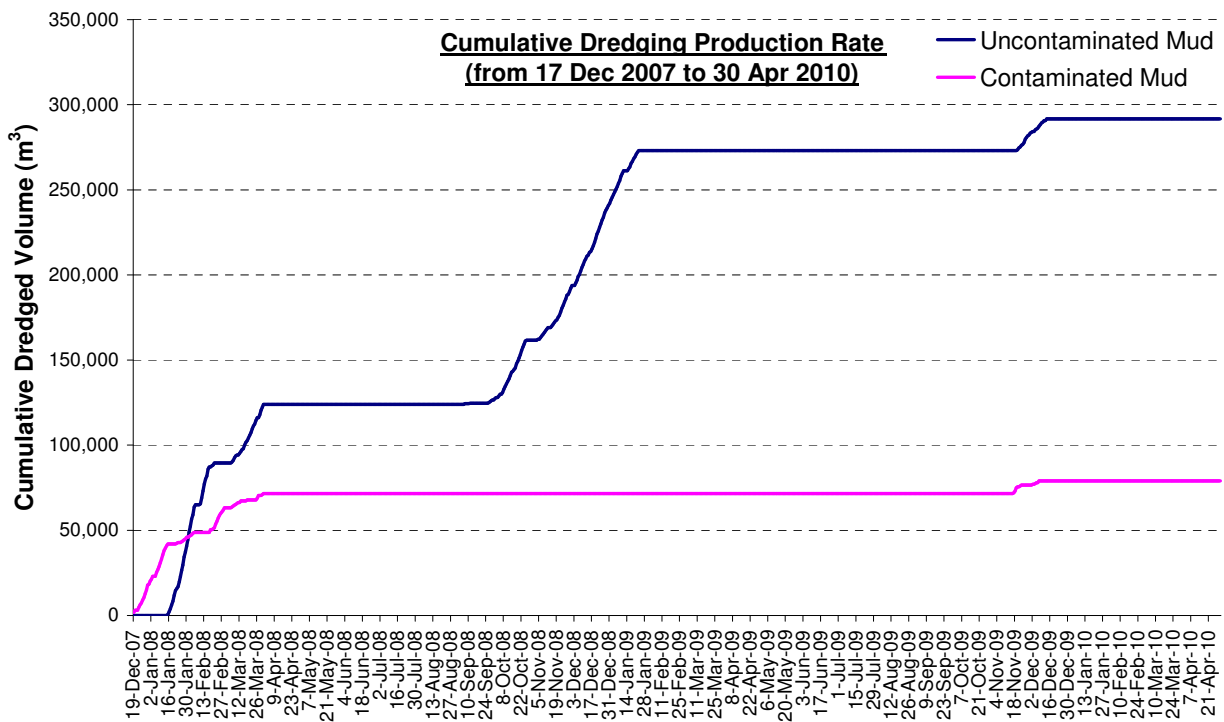
Figure 2.1 Daily and cumulative volumes (m³) of excavated materials (both contaminated and uncontaminated mud) from 19 December 2007 to 30 April 2010

A summary of the major works undertaken in this reporting period is shown in *Table 2.1*. Initial marine dredging operations were completed on 23 January 2009 and resumed on 13 November 2009 for pipeline repair works that were completed on 11 December 2009. No dredging operations were carried out during the reporting period. *Table 2.2* presents the cumulative quantity of excavated materials from December 2007 up to 30 April 2010. Daily and cumulative dredging production rates from December 2007 to 30 April 2010 are illustrated in *Figure 2.1*.

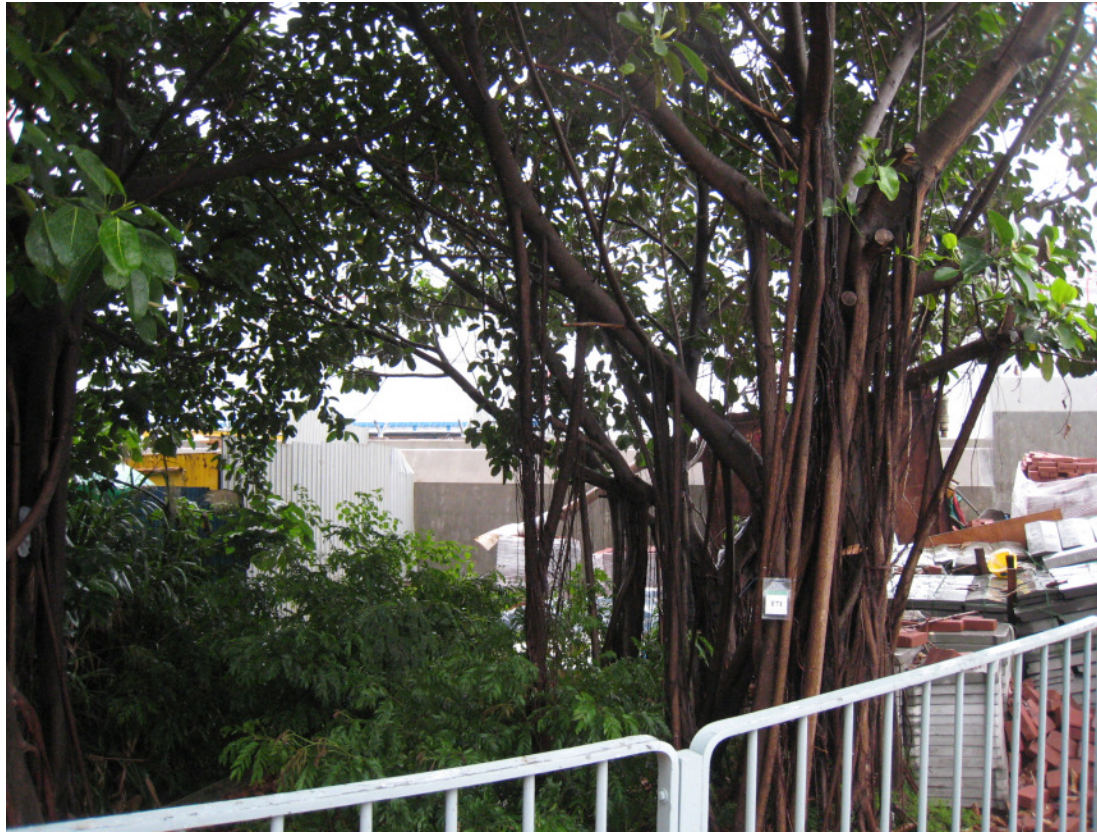
All landscape and visual mitigation measures have been implemented with the exception of the observation of a stockpile of construction material near a retained tree individual within Phase 1b site (refer to *Annex E*). The Contractor was recommended to remove any construction material stored near retained trees and keep root zones clear.

Photo 1 – Stockpile of construction material near Retained Tree T71 at Phrase 1b.

Area of Works	Items to be Monitored	Phase 1a (Operational)		Phase 1b (Construction)	
		Observation	Recommendation	Observation	Recommendation
Advance planting	Monitoring of implementation and maintenance of planting, and against possible incursion, physical damage, fire, pollution, surface erosion, etc.	Planting has been maintained and no possible incursion, physical damage, fire, pollution, surface erosion is observed.	Not required.	New tree planting has been maintained. Stakes are present to provide adequate support. No incursion, physical damage, fire, pollution, surface erosion is observed.	Not required.
Protection of all trees to be retained	Identification and demarcation of trees / vegetation to be retained, erection of physical protection (e.g. fencing), monitoring against possible incursion, physical damage, fire, pollution, surface erosion, etc.	Not applicable as there are no retained trees present in Phase 1a.	Not applicable.	Retained trees have been fenced off and protected. Stockpile of construction material is observed near Retained Tree T71 (<i>Photo 1</i>).	The Contractor is recommended to remove construction material stored near Retained Tree T71 and keep the root zone clear.
