**CONTRACT NO. DC/2007/06 –  
RIVER IMPROVEMENT WORKS IN UPPER LAM  
TSUEN RIVER, SHE SHAN RIVER AND UPPER TAI PO  
RIVER**

**57<sup>TH</sup> MONTHLY ENVIRONMENTAL MONITORING AND  
AUDIT REPORT FOR UPPER TAI PO RIVER –  
MAY 2013**

PREPARED FOR  
**CHIU HING CONSTRUCTION AND TRANSPORTATION  
COMPANY LIMITED**

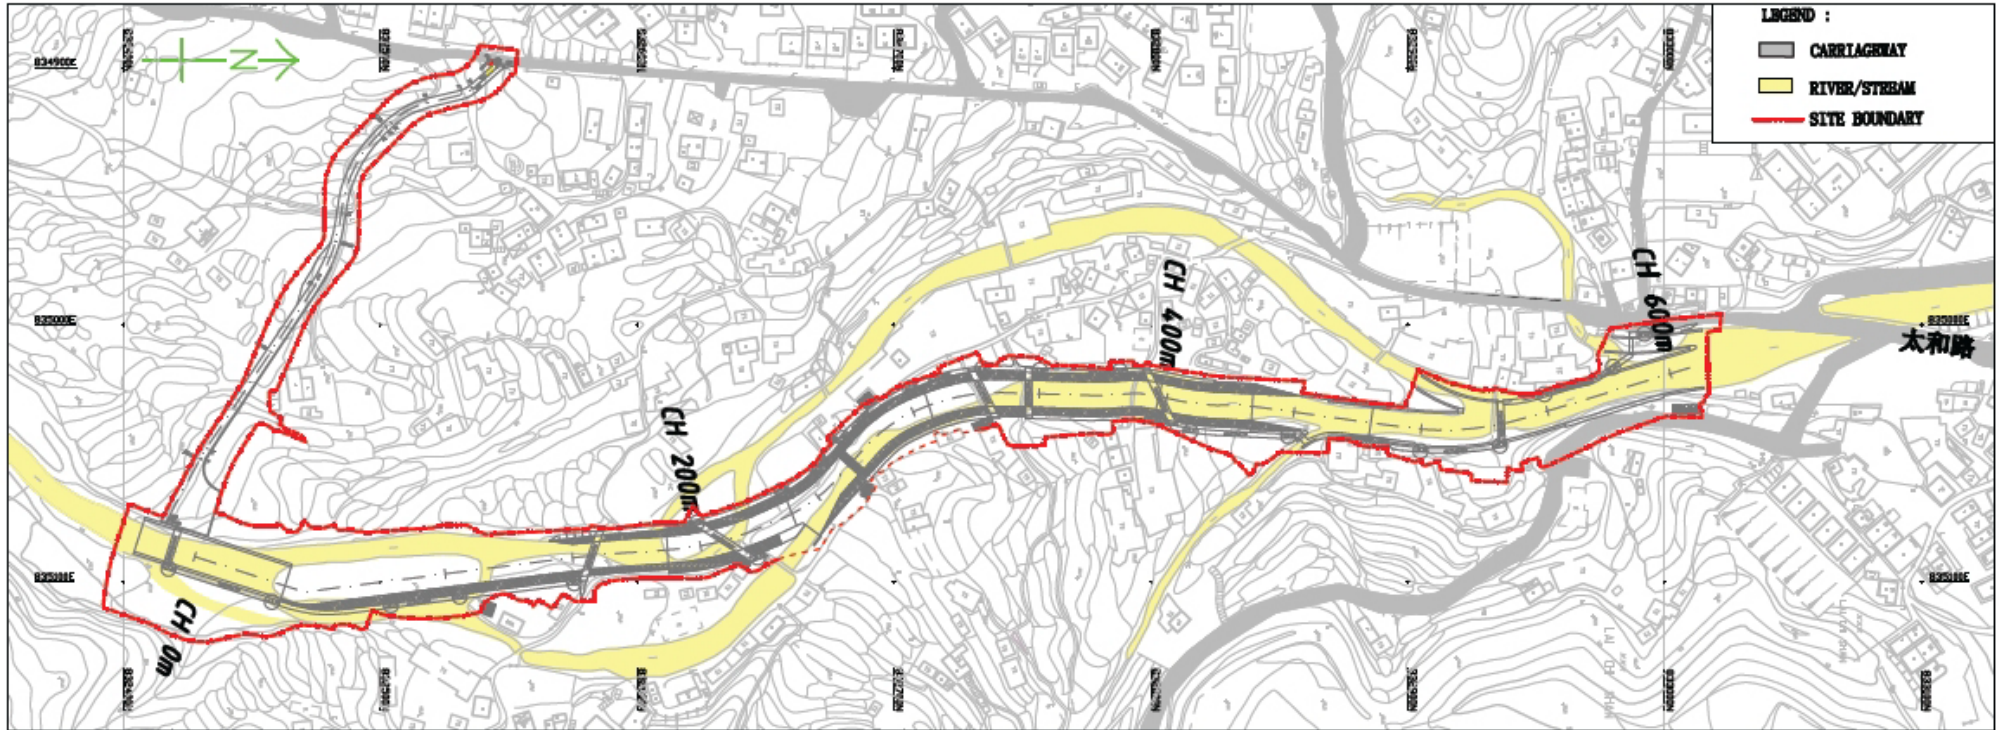
### **Site Layout Plan of the Upper Tai Po River**

- 1.02 Site layout plan of Upper Tai Po River is shown in **Appendix A**. Approximately 0.6km of Upper Tai Po River will be improved to enhance the hydraulic performance of the river. The location of the project site at Upper Tai Po River starts from Ta Tit Yan of Tai Mo Shan, flows from southeast to northeast alongside Wilson Trail, turning northward before joining the Lam Tsuen River and then runs towards Tai Po Market. To the east of the river, there are active and abandoned cultivated lands. Village settlements are mainly located on the west and northeast side of the river bank, where the San Uk Ka and Lai Chi Shan establishment also lie. The construction of the proposed improvement works for Upper Tai Po River has commenced on 15<sup>th</sup> September 2008 and substantially completed on 31 December 2012. The improvement works comprise of the following:

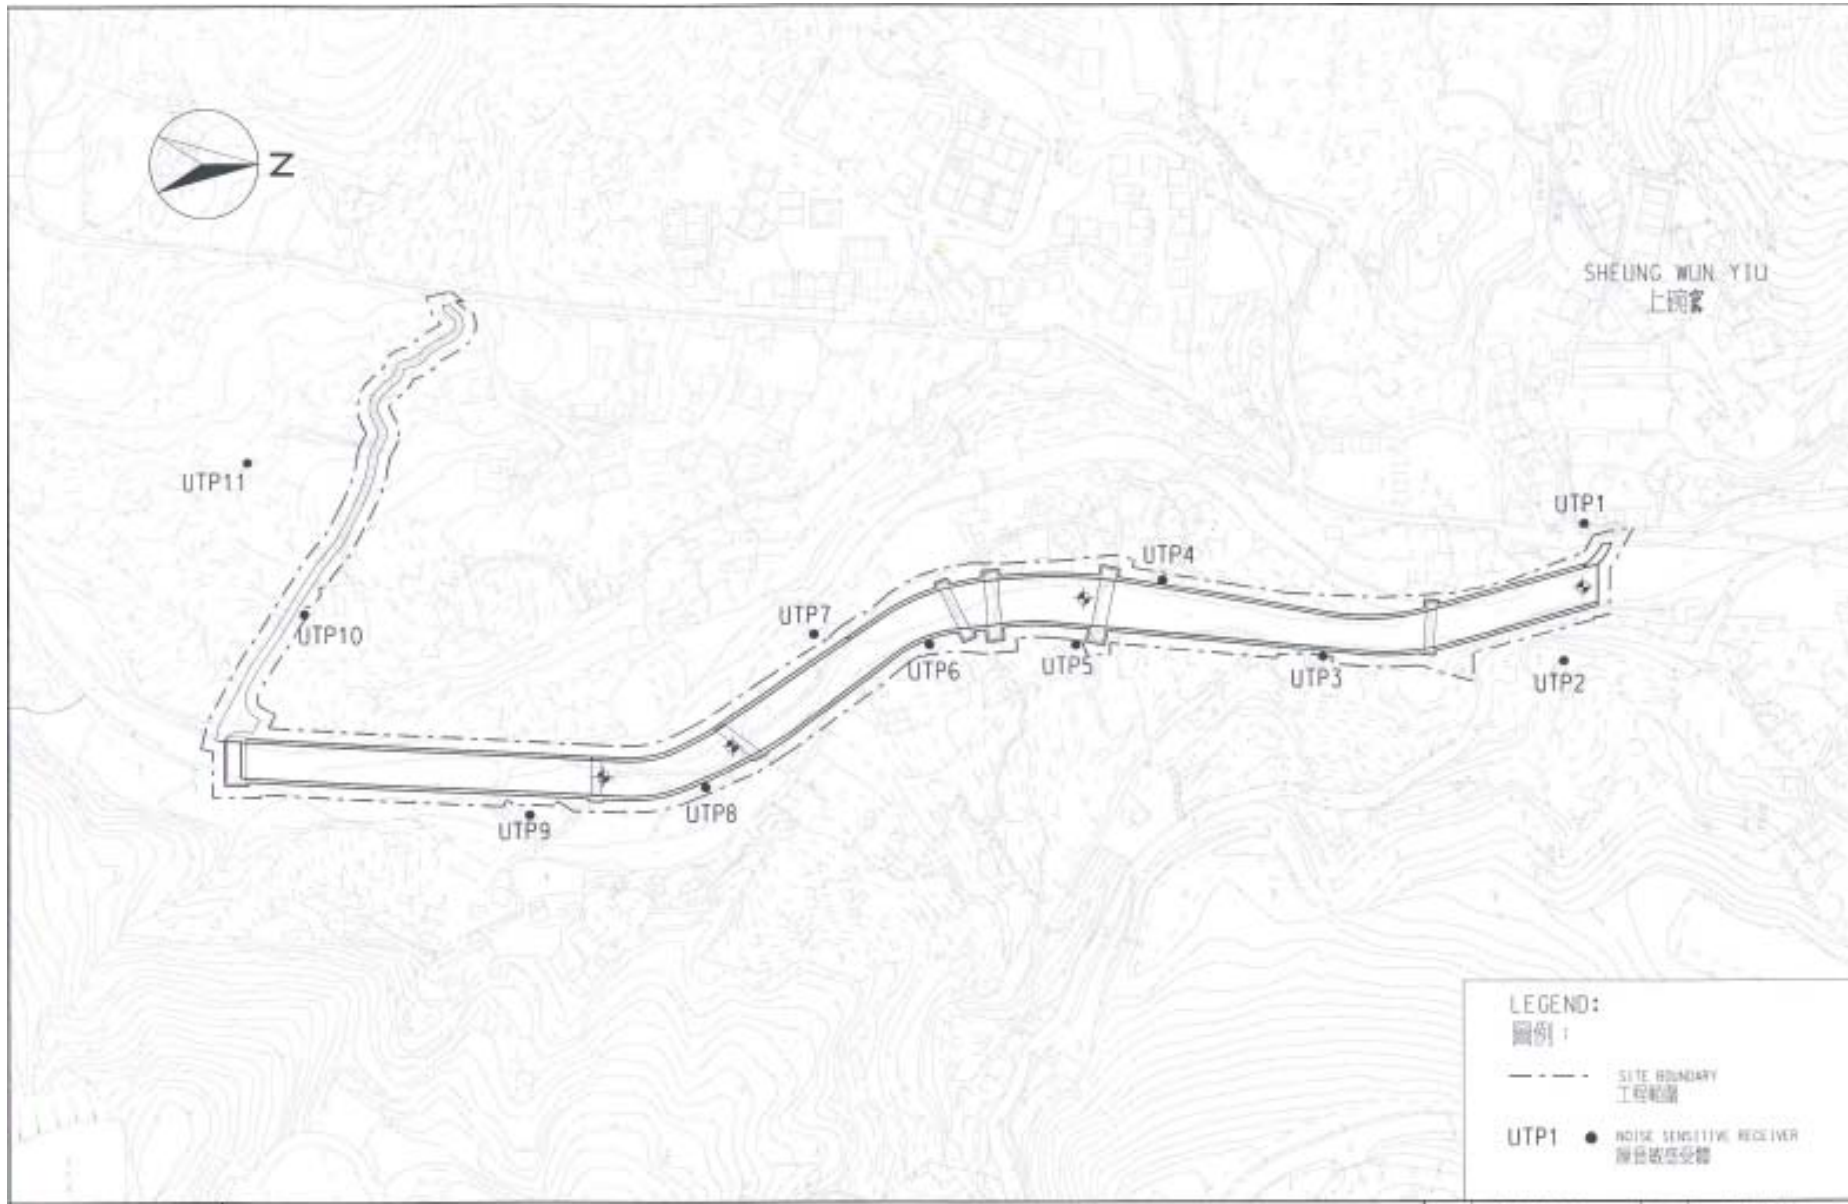
**Construction Noise Monitoring Location**

3.03 Monitoring locations have been proposed in EM&A Manual. Graphic plot is shown in *Appendix C* and summarized in *Table 3-2*.

Aspect	Location ID	Address
Construction Noise	UTP1	54B, Sheung Wun Yiu
	UTP2	Village House in Lai Chi Shan
	UTP3	Village House near Upper Tai Po River
	UTP4	Village House near Upper Tai Po River
	UTP5	Village House near Upper Tai Po River
	UTP6	Village House near Upper Tai Po River
	UTP7	Village House near Upper Tai Po River
	UTP8	Village House near Upper Tai Po River
	UTP9	49A, Pun Shan Chau
	UTP10	Village House near the proposed access road
	UTP11	49G, San Uk Ka
Ecology	As within and adjacent to Upper Tai Po River of construction works areas

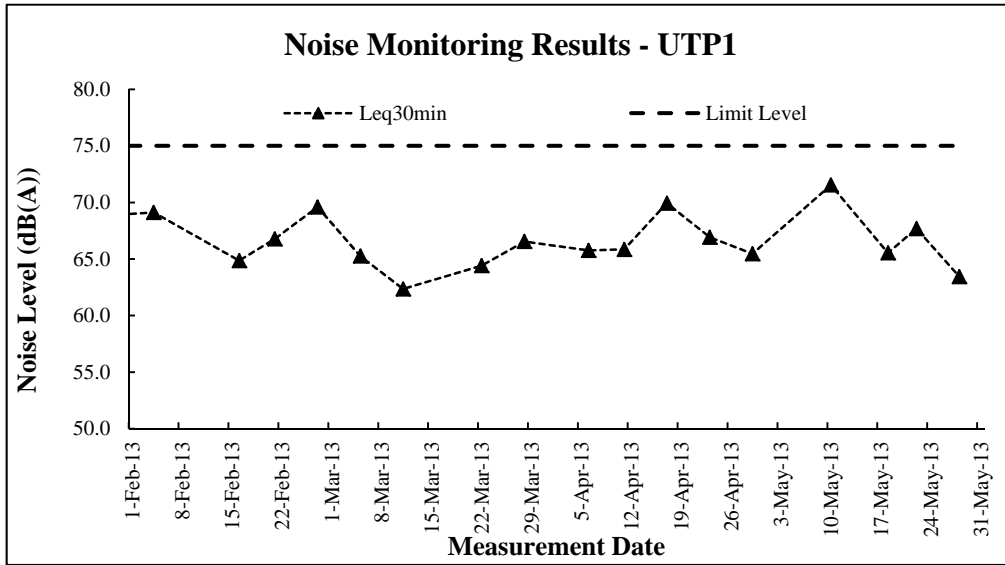
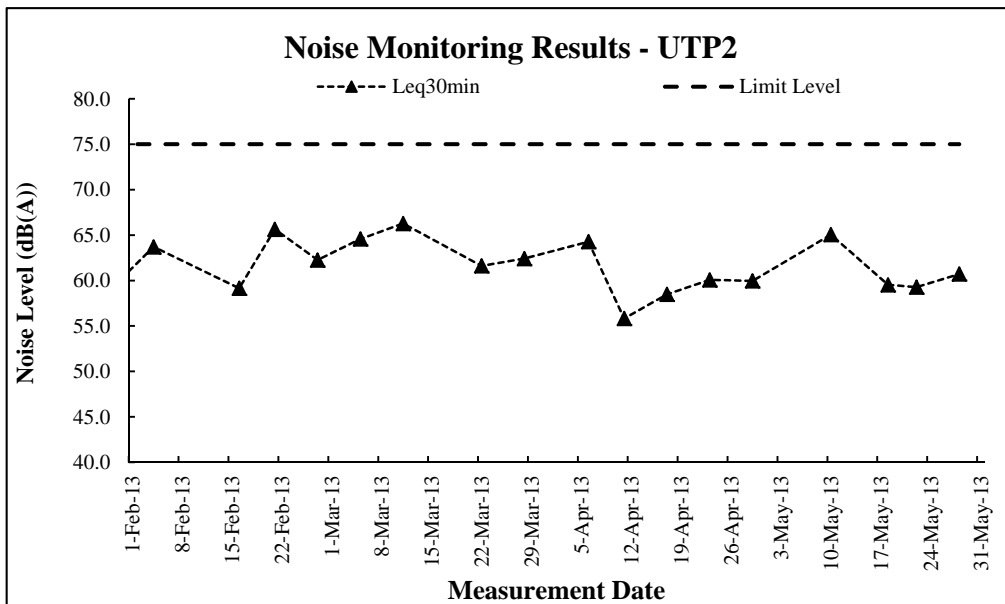
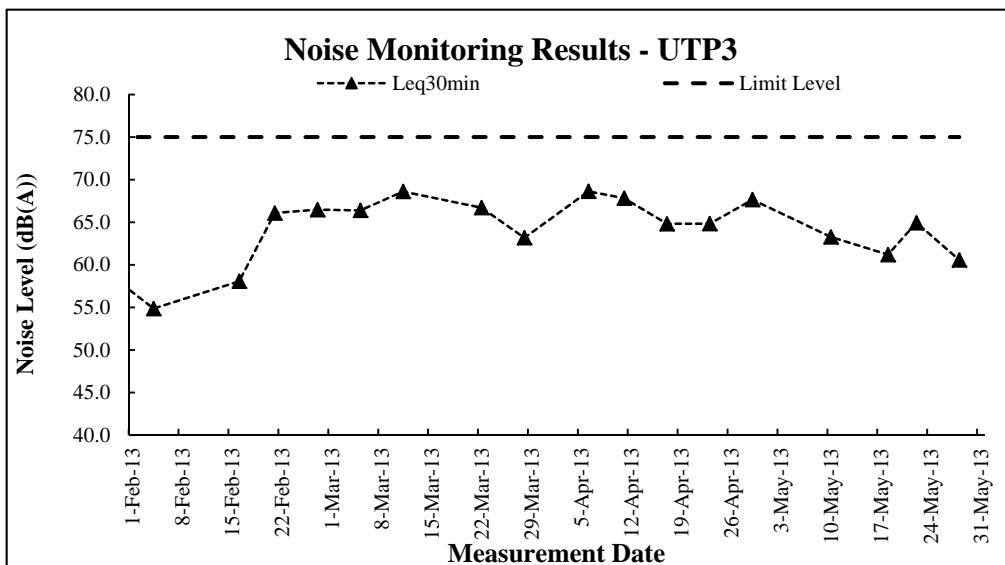
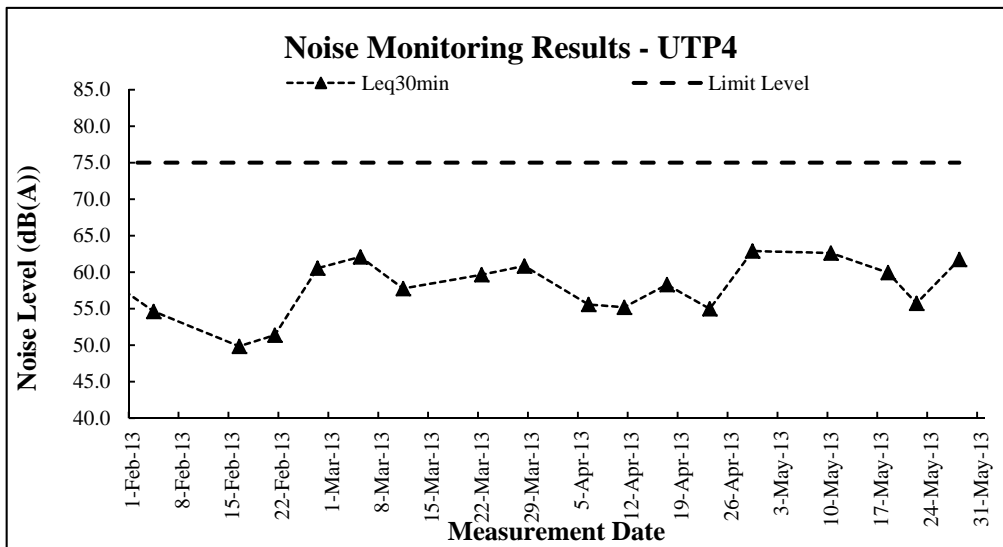
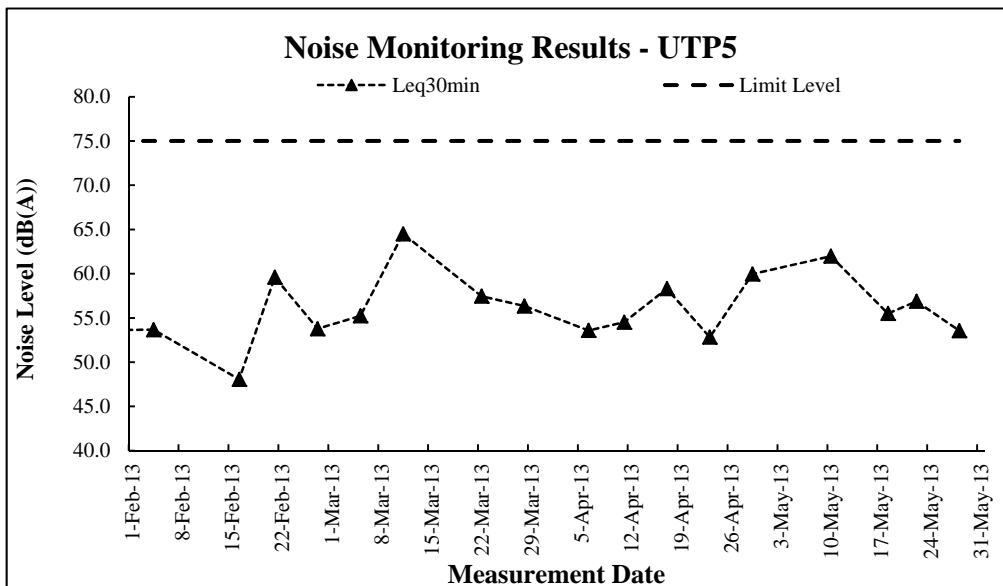
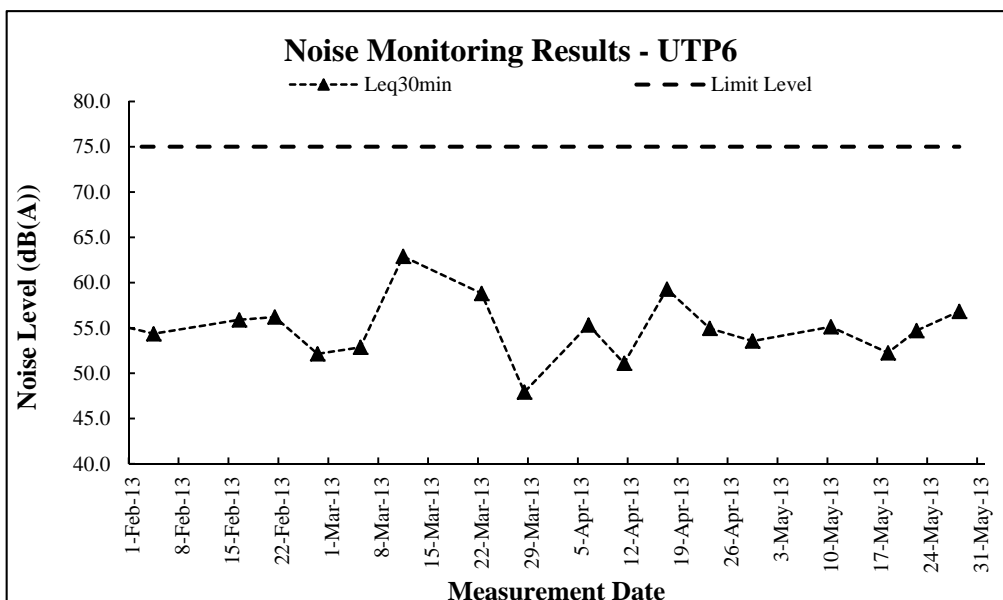
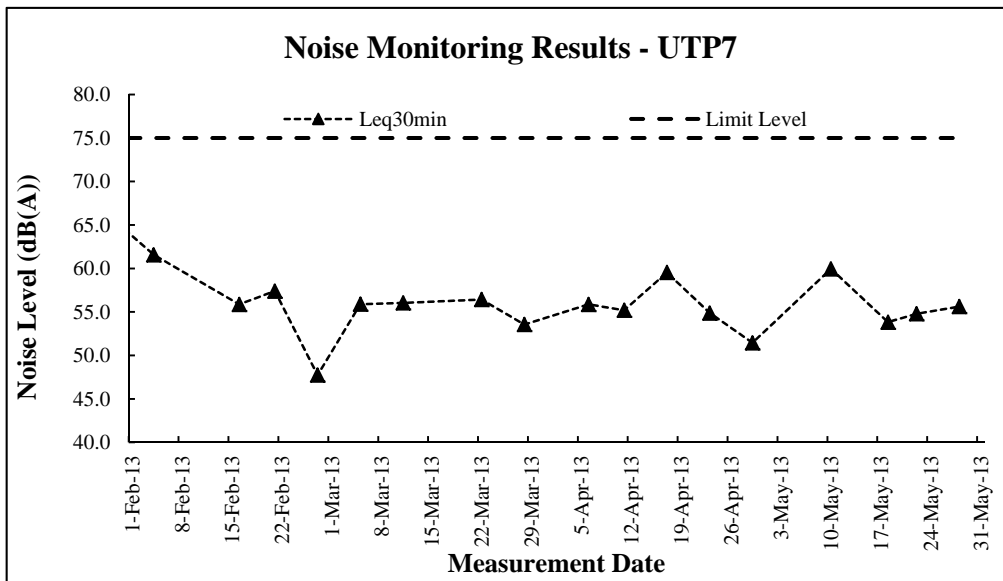
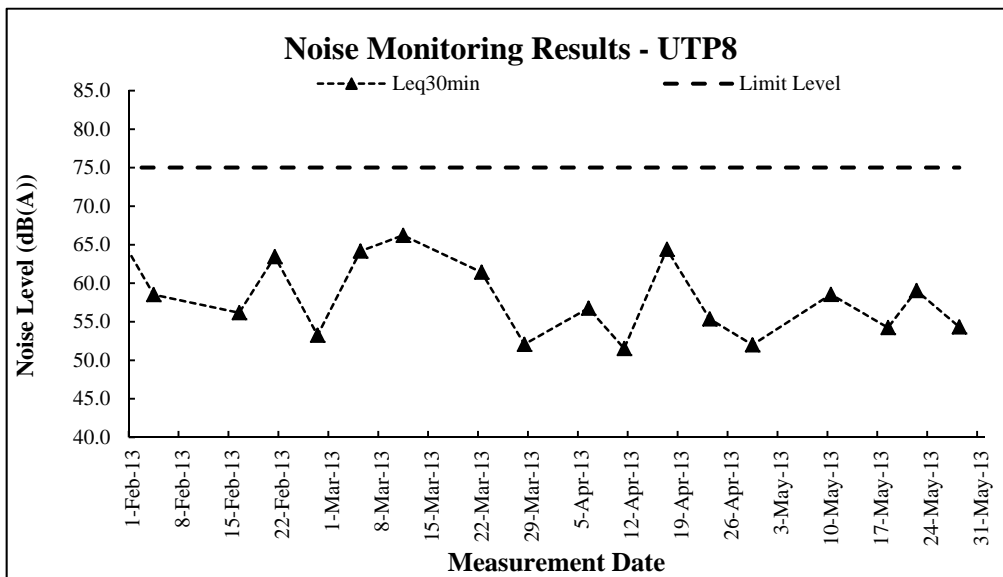
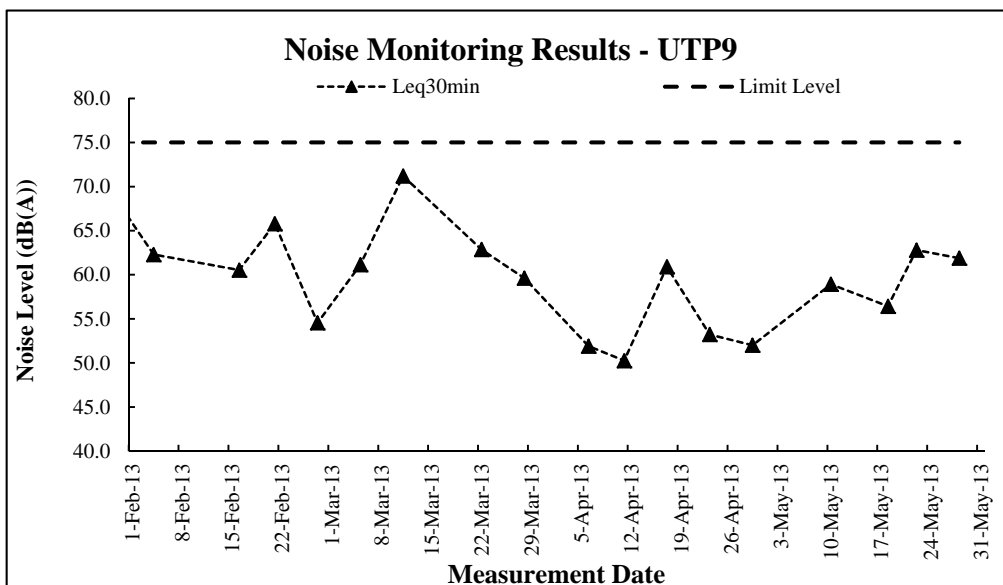
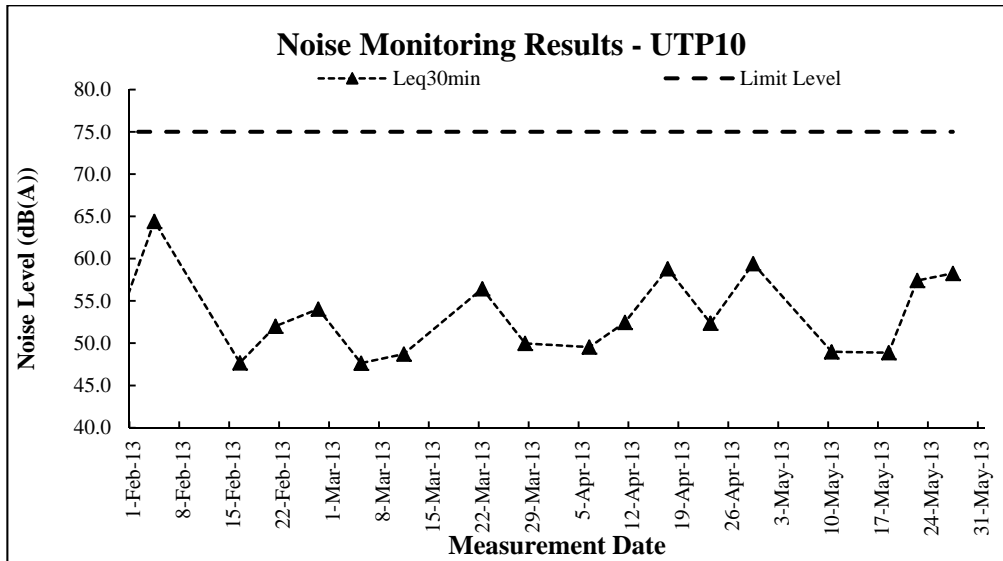
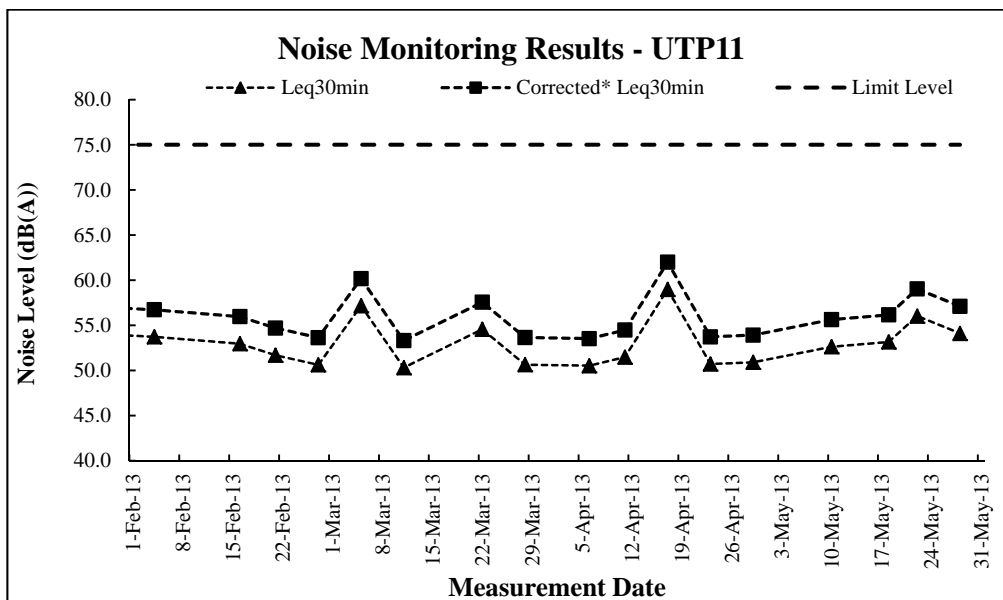
### **Graphical Plots of Noise Monitoring**

4.02 In the Reporting Period, the noise monitoring results at the designated locations are presented in *Tables 4-1 to 4-11* and the graphical plot is shown in *Appendix H*. The observed noise sources during the course of noise monitoring are summarized in in *Appendix J*
