PROJECT NO.: TCS/00394/12

**CONTRACT NO. DC/2007/06 –
RIVER IMPROVEMENT WORKS IN UPPER LAM
TSUEN RIVER, SHE SHAN RIVER AND UPPER TAI PO
RIVER**

**59TH MONTHLY ENVIRONMENTAL MONITORING AND
AUDIT REPORT FOR UPPER TAI PO RIVER –
JULY 2013**

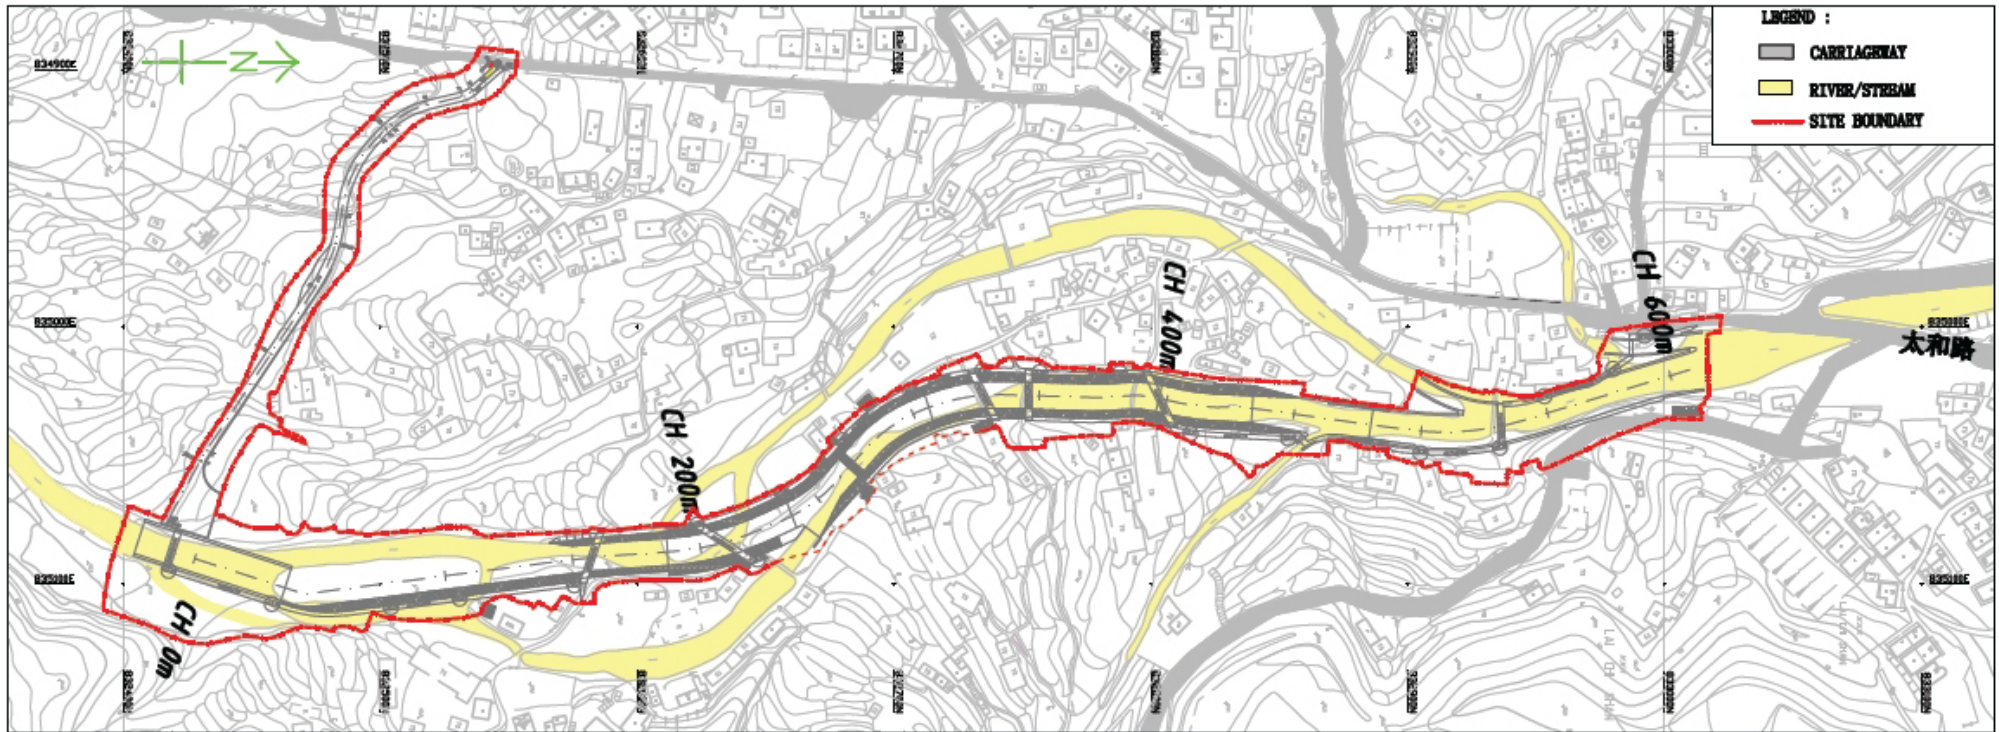
Site Layout Plan of the Upper Tai Po River

- 1.02 Site layout plan of Upper Tai Po River is shown in **Appendix A**. Approximately 0.6km of Upper Tai Po River will be improved to enhance the hydraulic performance of the river. The location of the project site at Upper Tai Po River starts from Ta Tit Yan of Tai Mo Shan, flows from southeast to northeast alongside Wilson Trail, turning northward before joining the Lam Tsuen River and then runs towards Tai Po Market. To the east of the river, there are active and abandoned cultivated lands. Village settlements are mainly located on the west and northeast side of the river bank, where the San Uk Ka and Lai Chi Shan establishment also lie. The construction of the proposed improvement works for Upper Tai Po River has commenced on 15th September 2008 and substantially completed on 31 December 2012. The improvement works comprise of the following:

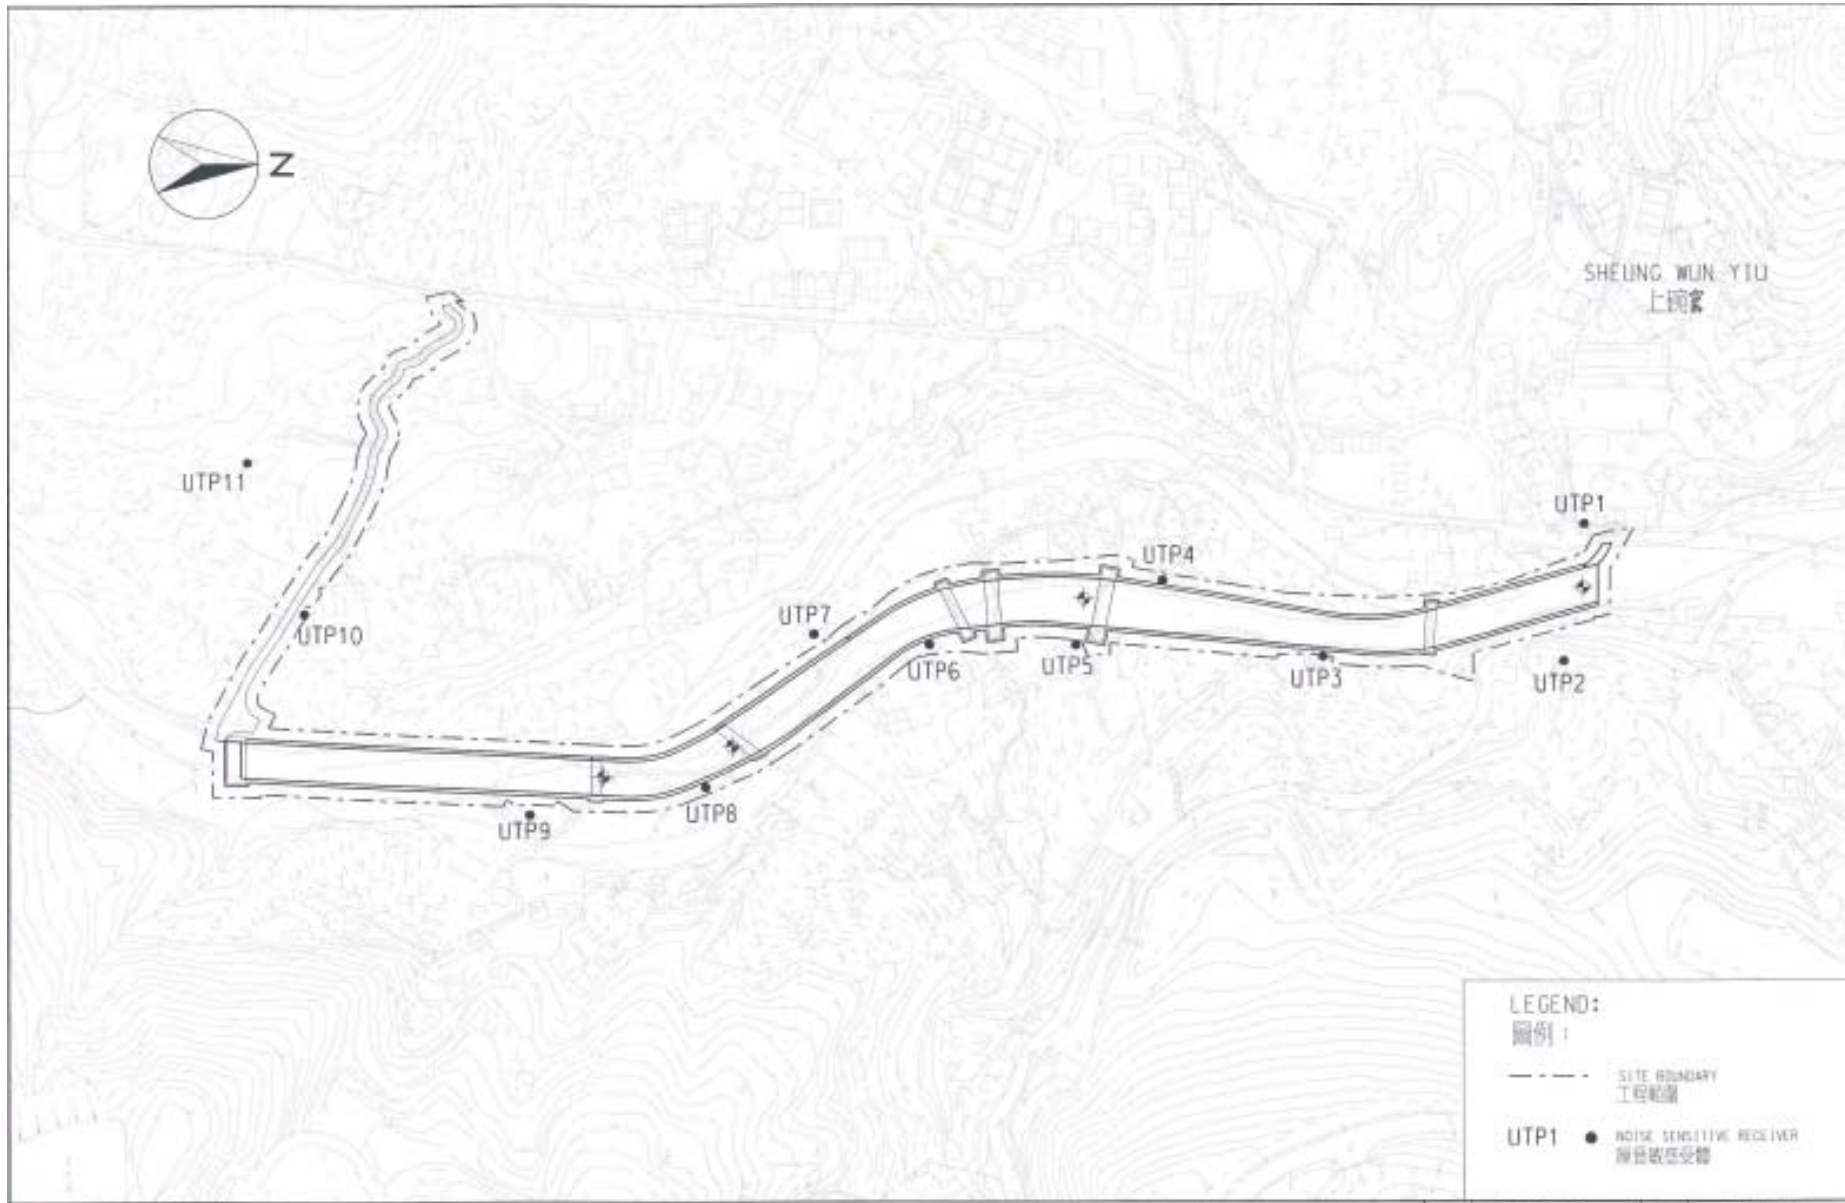
Construction Noise Monitoring Location

3.03 Monitoring locations have been proposed in EM&A Manual. Graphic plot is shown in **Appendix C** and summarized in **Table 3-2**.

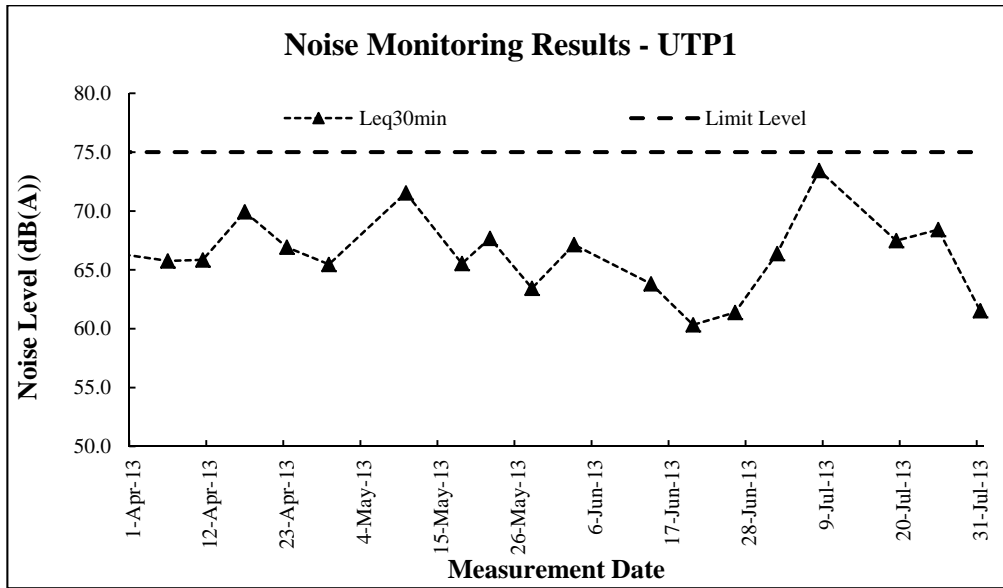
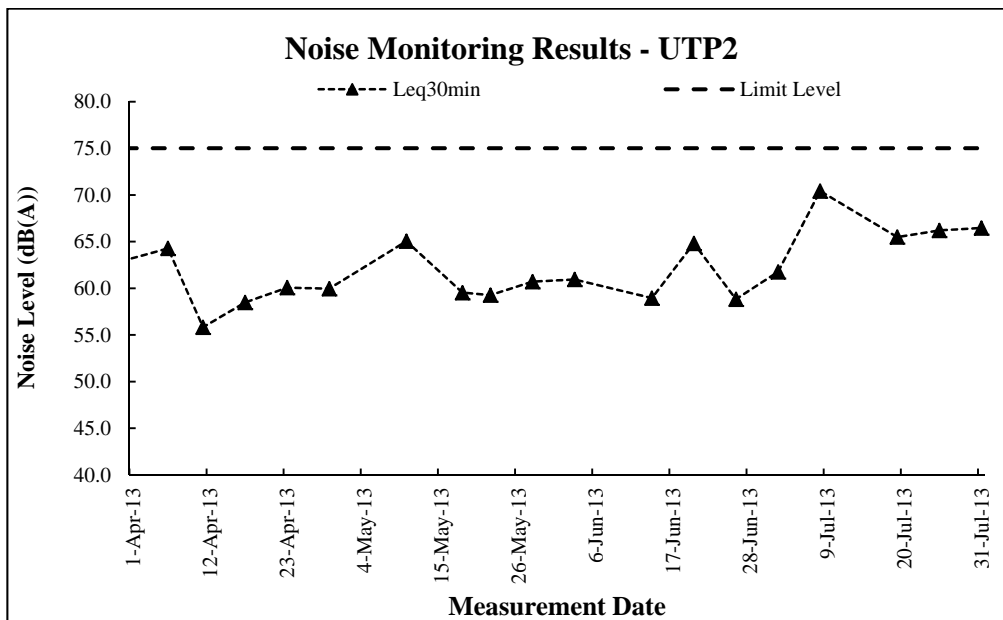
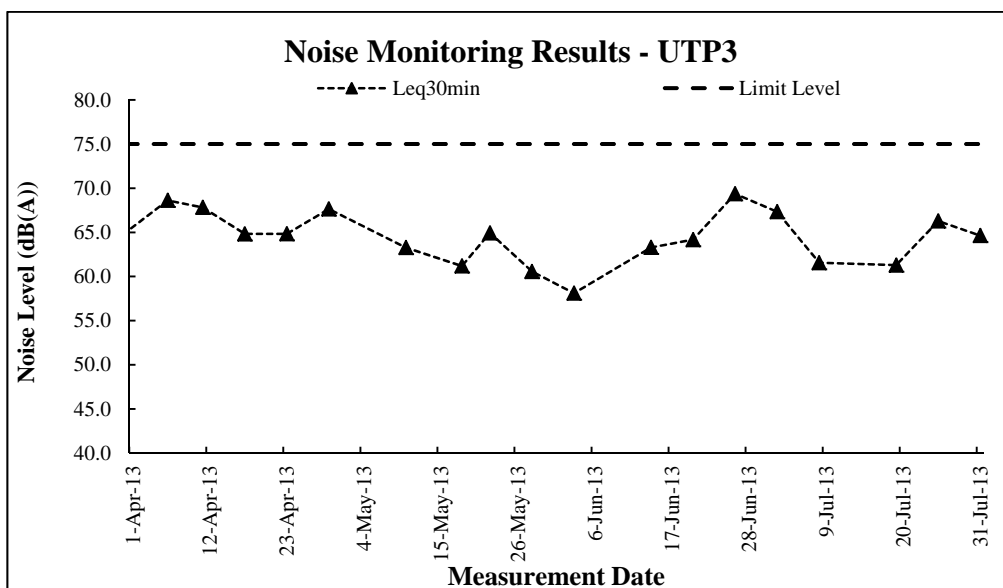
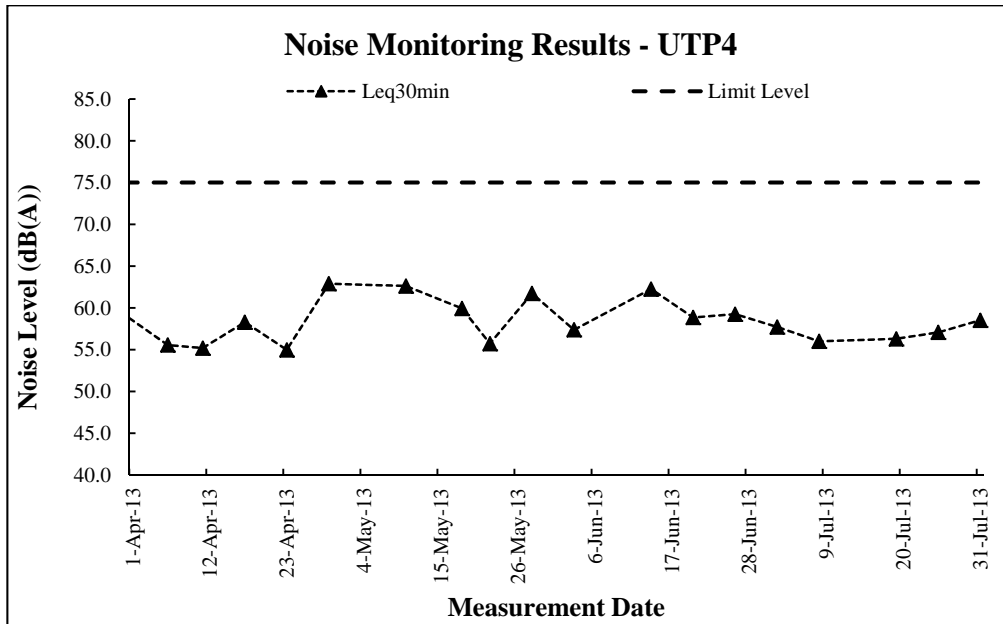
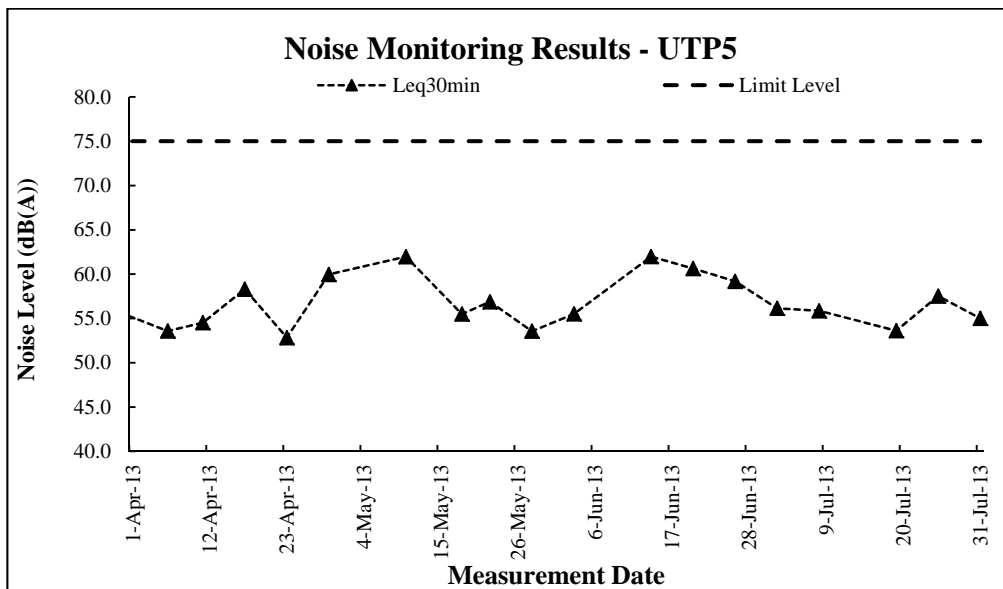
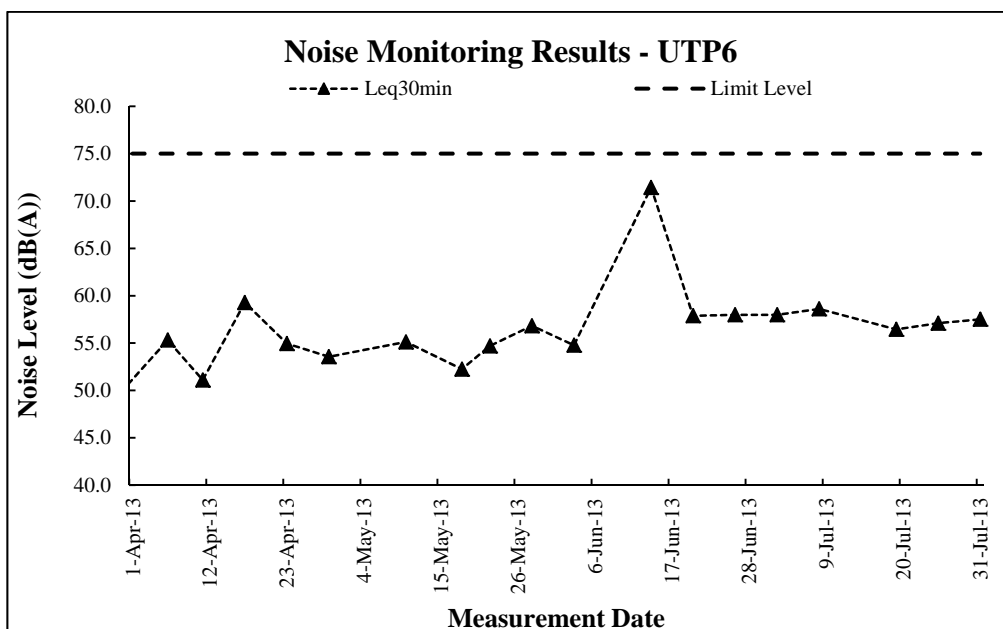
Graphical Plots of Noise Monitoring

4.02 In the Reporting Period, the noise monitoring results at the designated locations are presented in *Tables 4-1 to 4-11* and the graphical plot is shown in *Appendix H*. The observed noise sources during the course of noise monitoring are summarized in in *Appendix J*
