TEST REPORT

CONTRACT NO. CV/2009/02

HANDLING OF SURPLUS PUBLIC FILL

MONTHLY EM&A REPORT NO.3

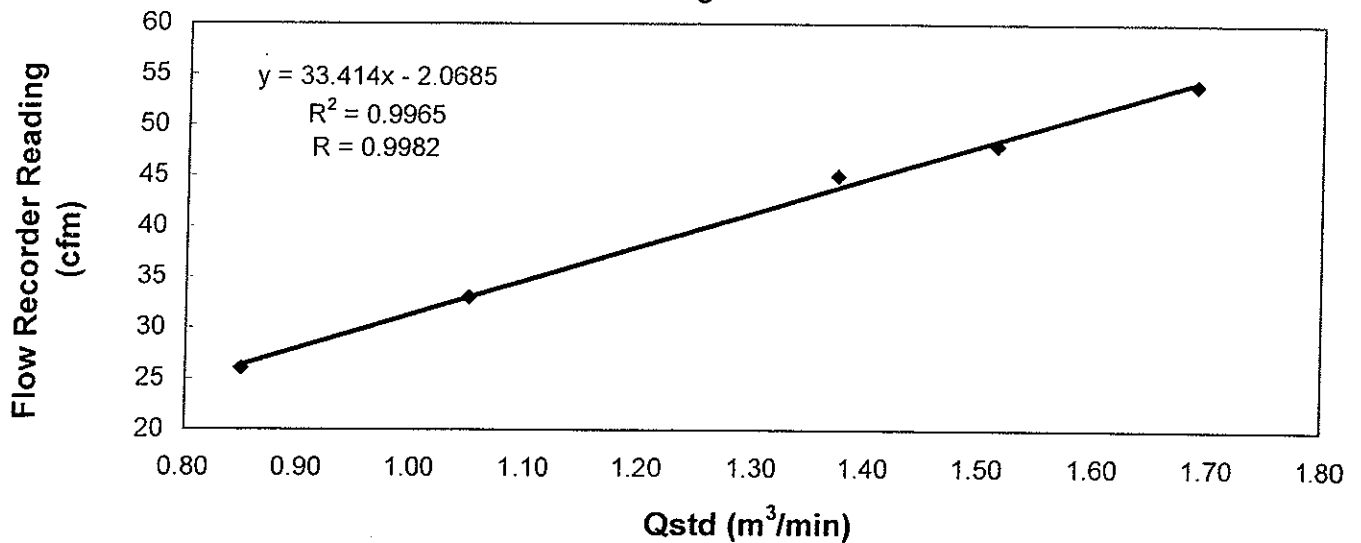
Flow recorder reading (cfm)	54	48	45	33	26
Qstd (Actual flow rate, m ³ /min)	1.69	1.51	1.37	1.05	0.85
Pressure :	764.31	mm Hg	Temp. :	296	K

**Sampler 10581 Calibration Curve
Site: Tseung Kwan O A-1**

Acceptance Criteria : Correlation coefficient (r) of the calibration curve greater than 0.990 after a 5-point calibration.

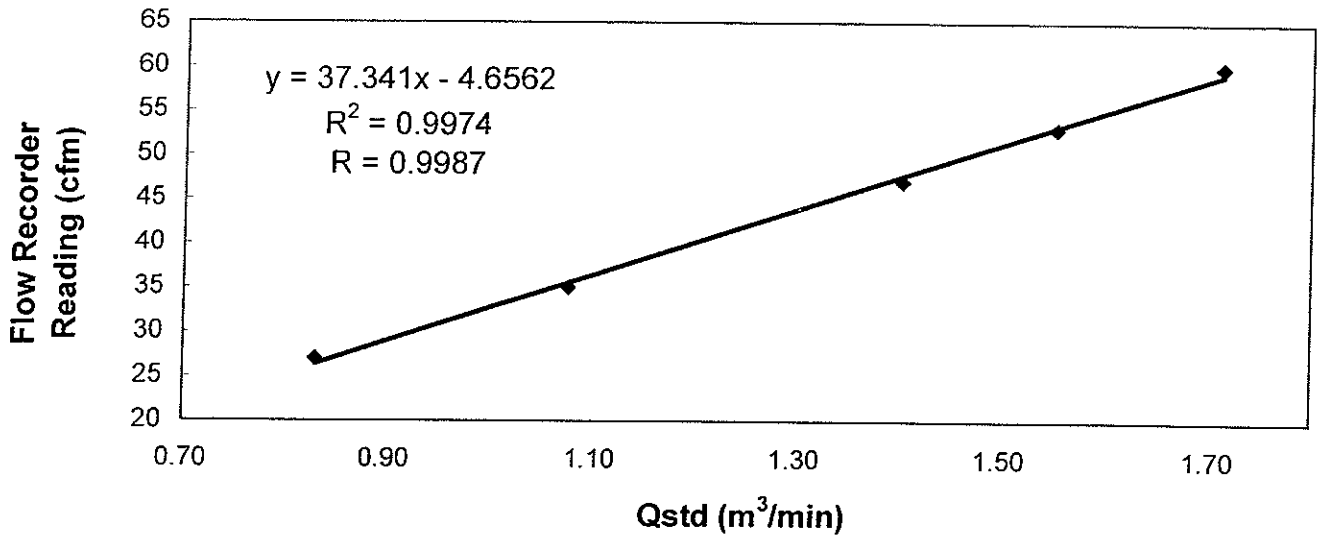
Results :	Flow recorder reading (cfm)	60	53	47	35	27
	Qstd (Actual flow rate, m ³ /min)	1.71	1.55	1.40	1.08	0.83
	Pressure : 766.56 mm Hg	Temp. : 289 K

**Sampler 1172 Calibration Curve
Site: Tseung Kwan O A-2**

Acceptance Criteria : Correlation coefficient (r) of the calibration curve greater than 0.990 after a 5-point calibration.

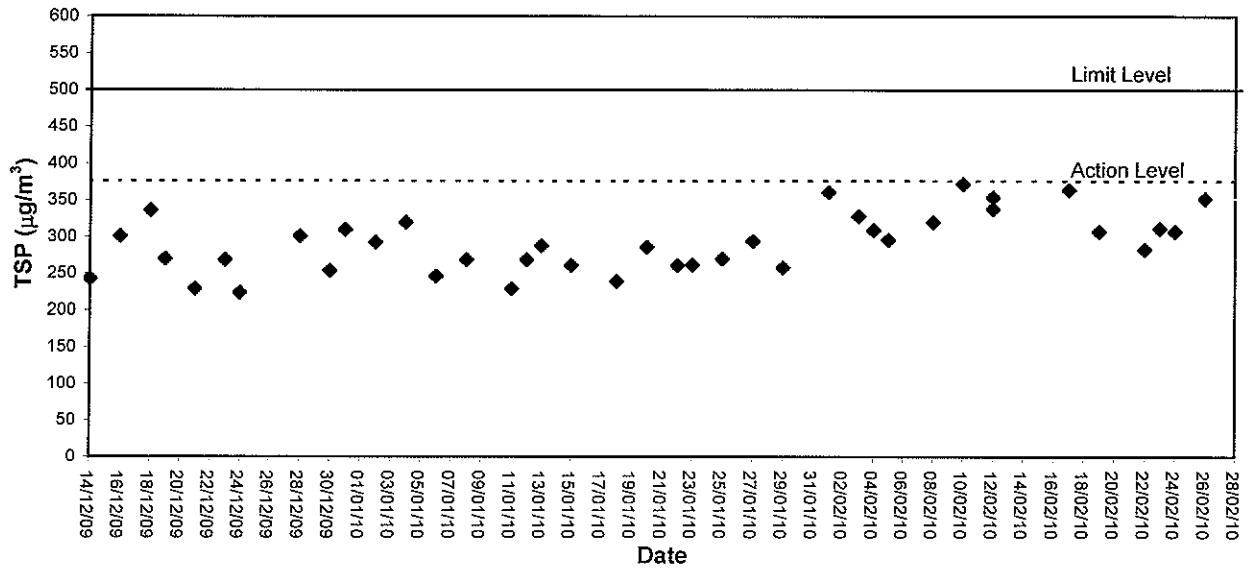
1-hour TSP level at TKO-A1 (Outside CEDD Site Office)

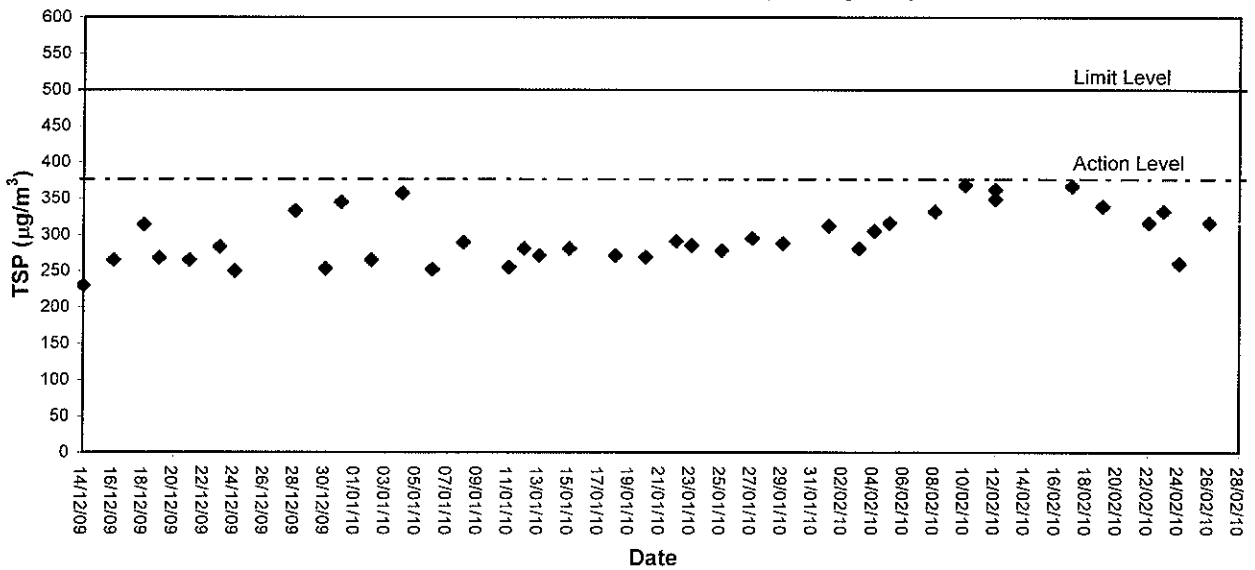
1-hour TSP level at TKO-A2 (Site Egress)

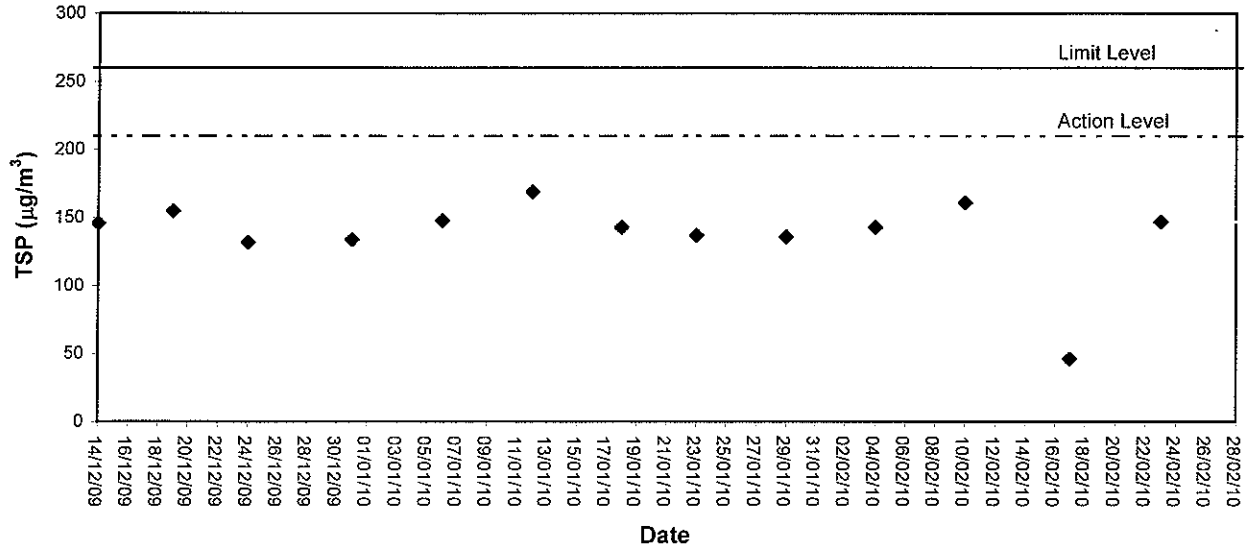
24-hour TSP level at TKO-A1 (Outside CEDD Site Office)

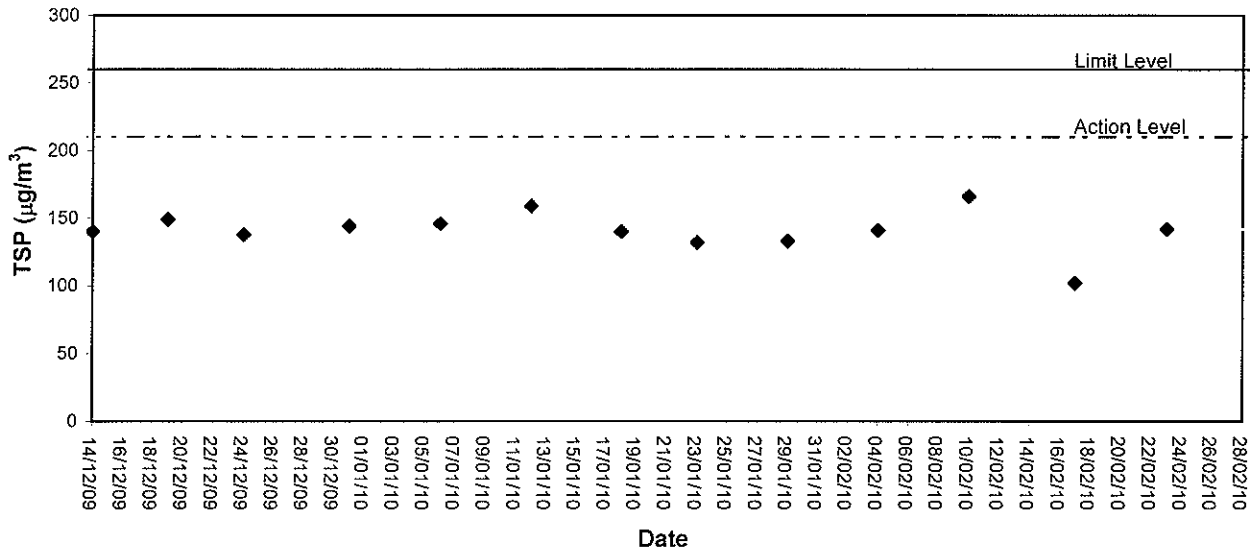
24-hour TSP level at TKO-A2 (Site Egress)

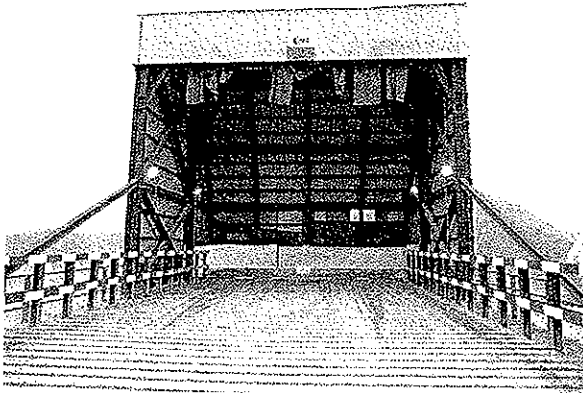
Photo 1
Pier No. 2

* steel enclosure at Pier 2 was observed damaged.
 The Contractor should rectify the situation asap.

Steel enclosure at Pier No. 2 was observed damaged. .

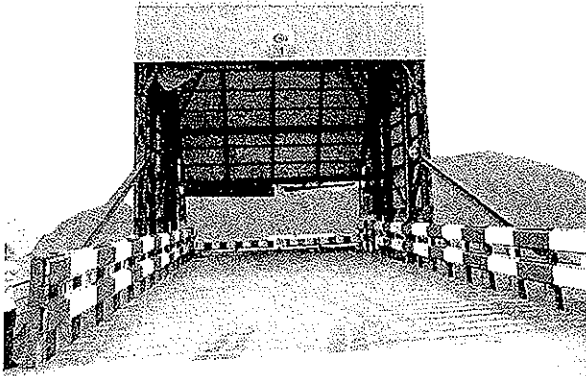
Photo 3
Pier No. 1

* As reported by the Contractor during the site inspection,
 water spraying facility at Pier 1 will be well repaired
 as soon as possible.

As reported by the Contractor during the site inspection, the water spraying facility at Pier No. 1 will be well repaired.

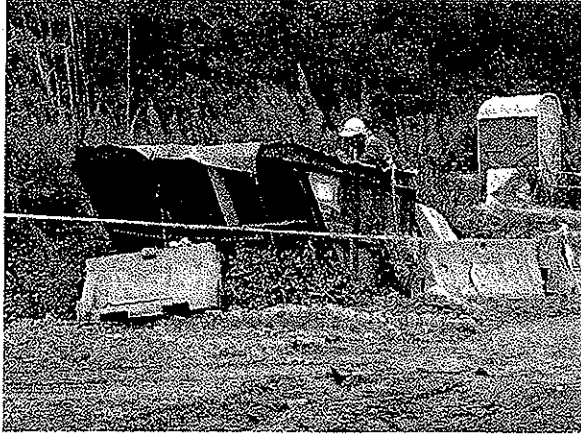
Photo 1

A little waste oil were found inside the waste skip. The Contractor was reminded to segregate the contaminated wastes as soon as possible and to treat them as Chemical wastes for disposal.

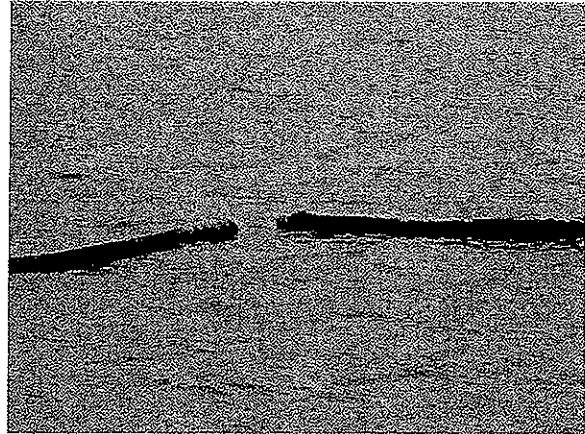
Photo 2

- The left-hand side of silt curtain at BHA was found loosed during the weekly site inspection on 24 February 2010. The Contractor was reminded to repair and maintain the silt curtain properly. Since the finding was observed at the last weekly site inspection in this reporting month, it will be verified in the coming month.

Silt curtain was observed not fully enclosed.
