# Dragages-Nishimatsu Joint Venture

**Contract No. DC/2007/10**  
**Design and Construction of**  
**Hong Kong West Drainage Tunnel**

Monthly EM&A Report  
(version 1.0)

September 2010

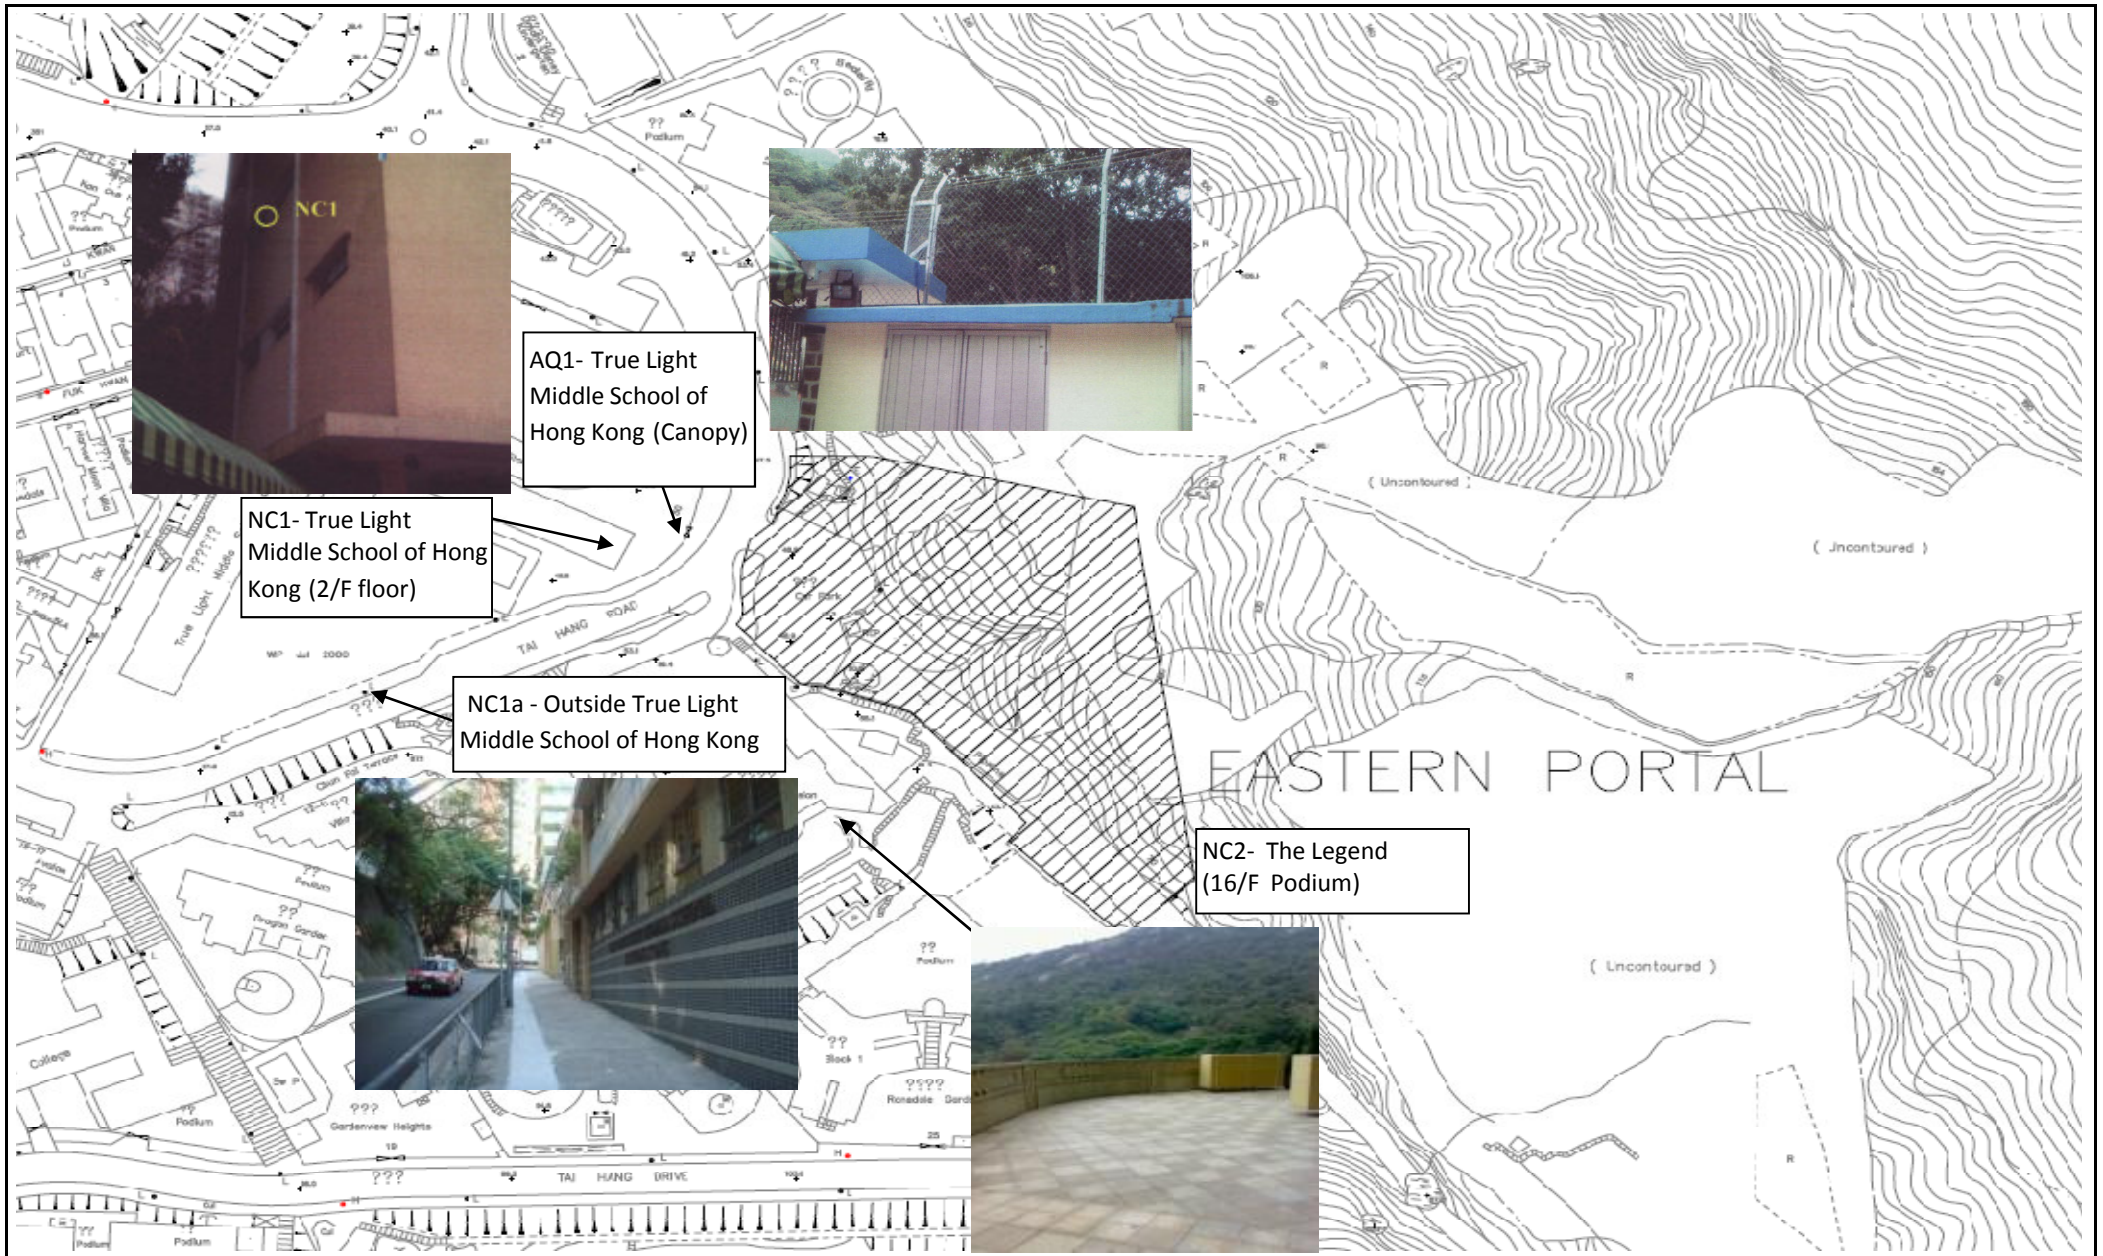
Project  
 No. MA 8001  
 Figure  
 3.1a

Title  
 Contract No. DC/2007/10  
 Design and Construction of Hong Kong West Drainage Tunnel  
 (Eastern Portal)  
 Locations of Air Quality and Noise Monitoring Station

- 2.2 Three designated monitoring stations, AQ1, AQ2 and AQ3 were selected for impact dust monitoring. Table 2.1 describes the air quality monitoring locations, which are also depicted in **Figure 3.1a-b**.

3.2 Noise monitoring was conducted at ten designated monitoring stations as listed in Table 3.1. **Figure 3.1a-n** shows the locations of these stations.

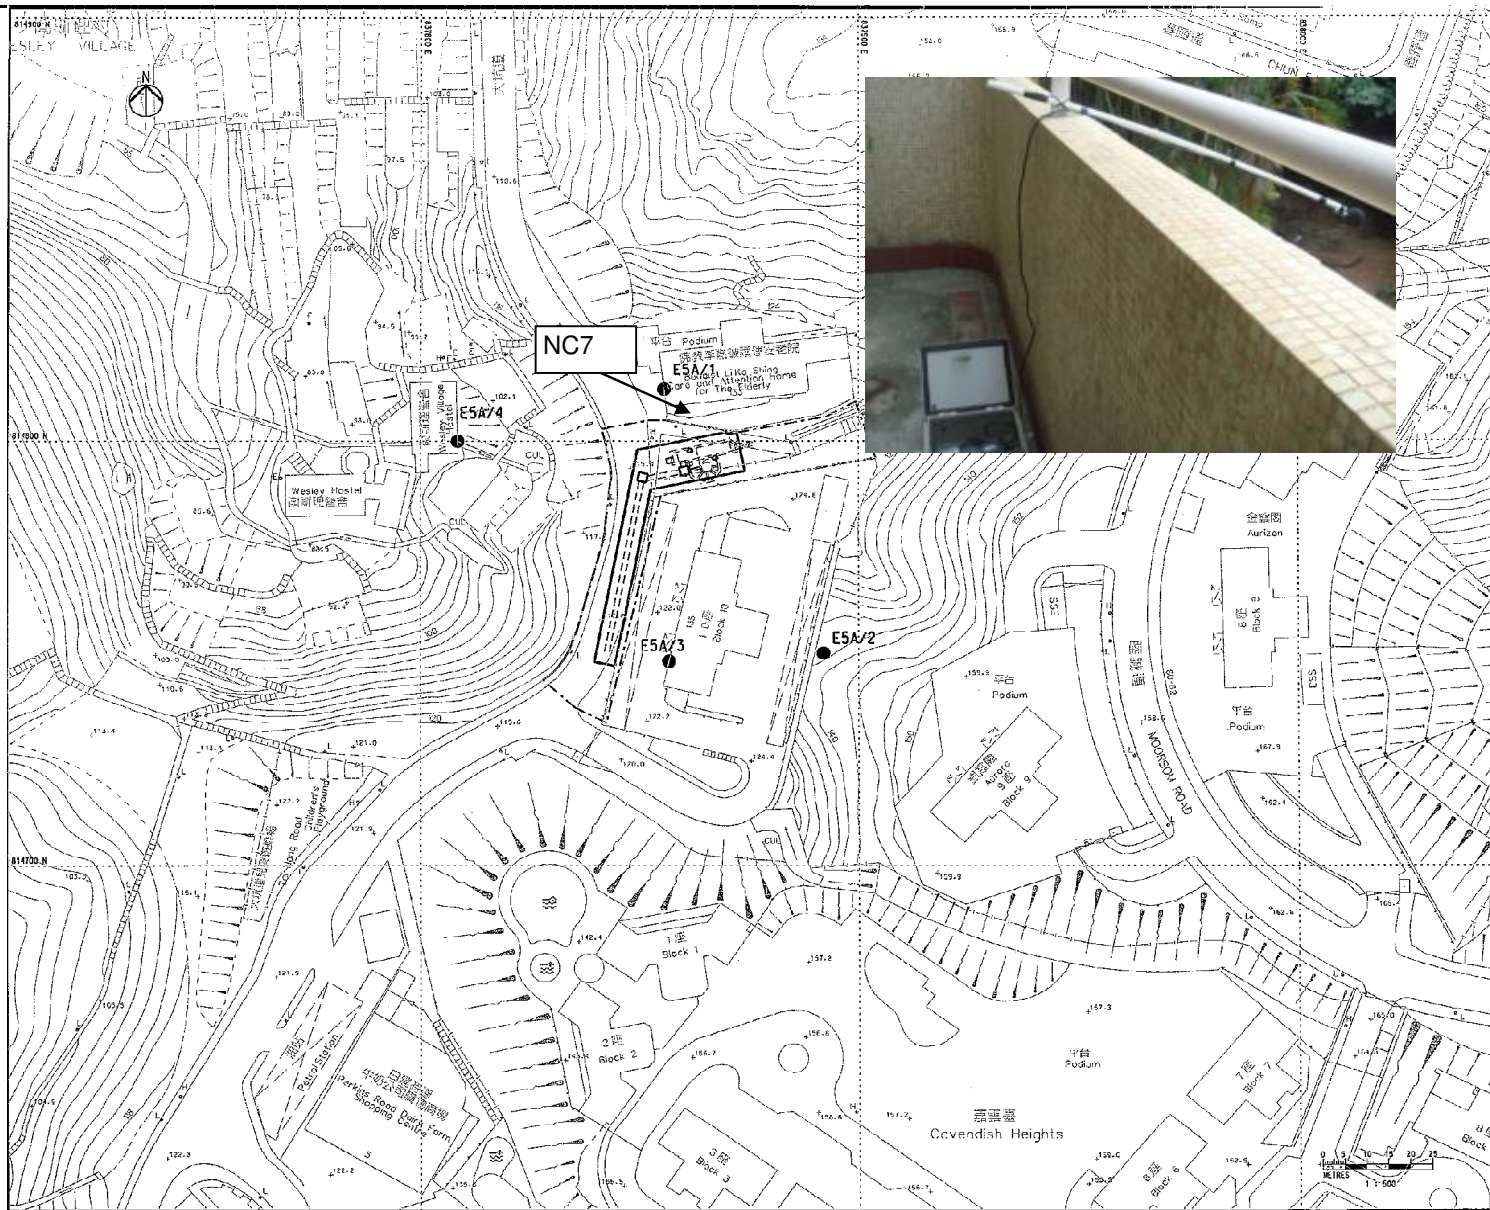
Project  
 No. **MA 8001**  
 Figure  
**3.1h**

Title  
**Contract No. DC/2007/10**  
**Design and Construction of Hong Kong West Drainage Tunnel**  
**(Intakes E5A)**  
**Locations of Noise Monitoring Stations**

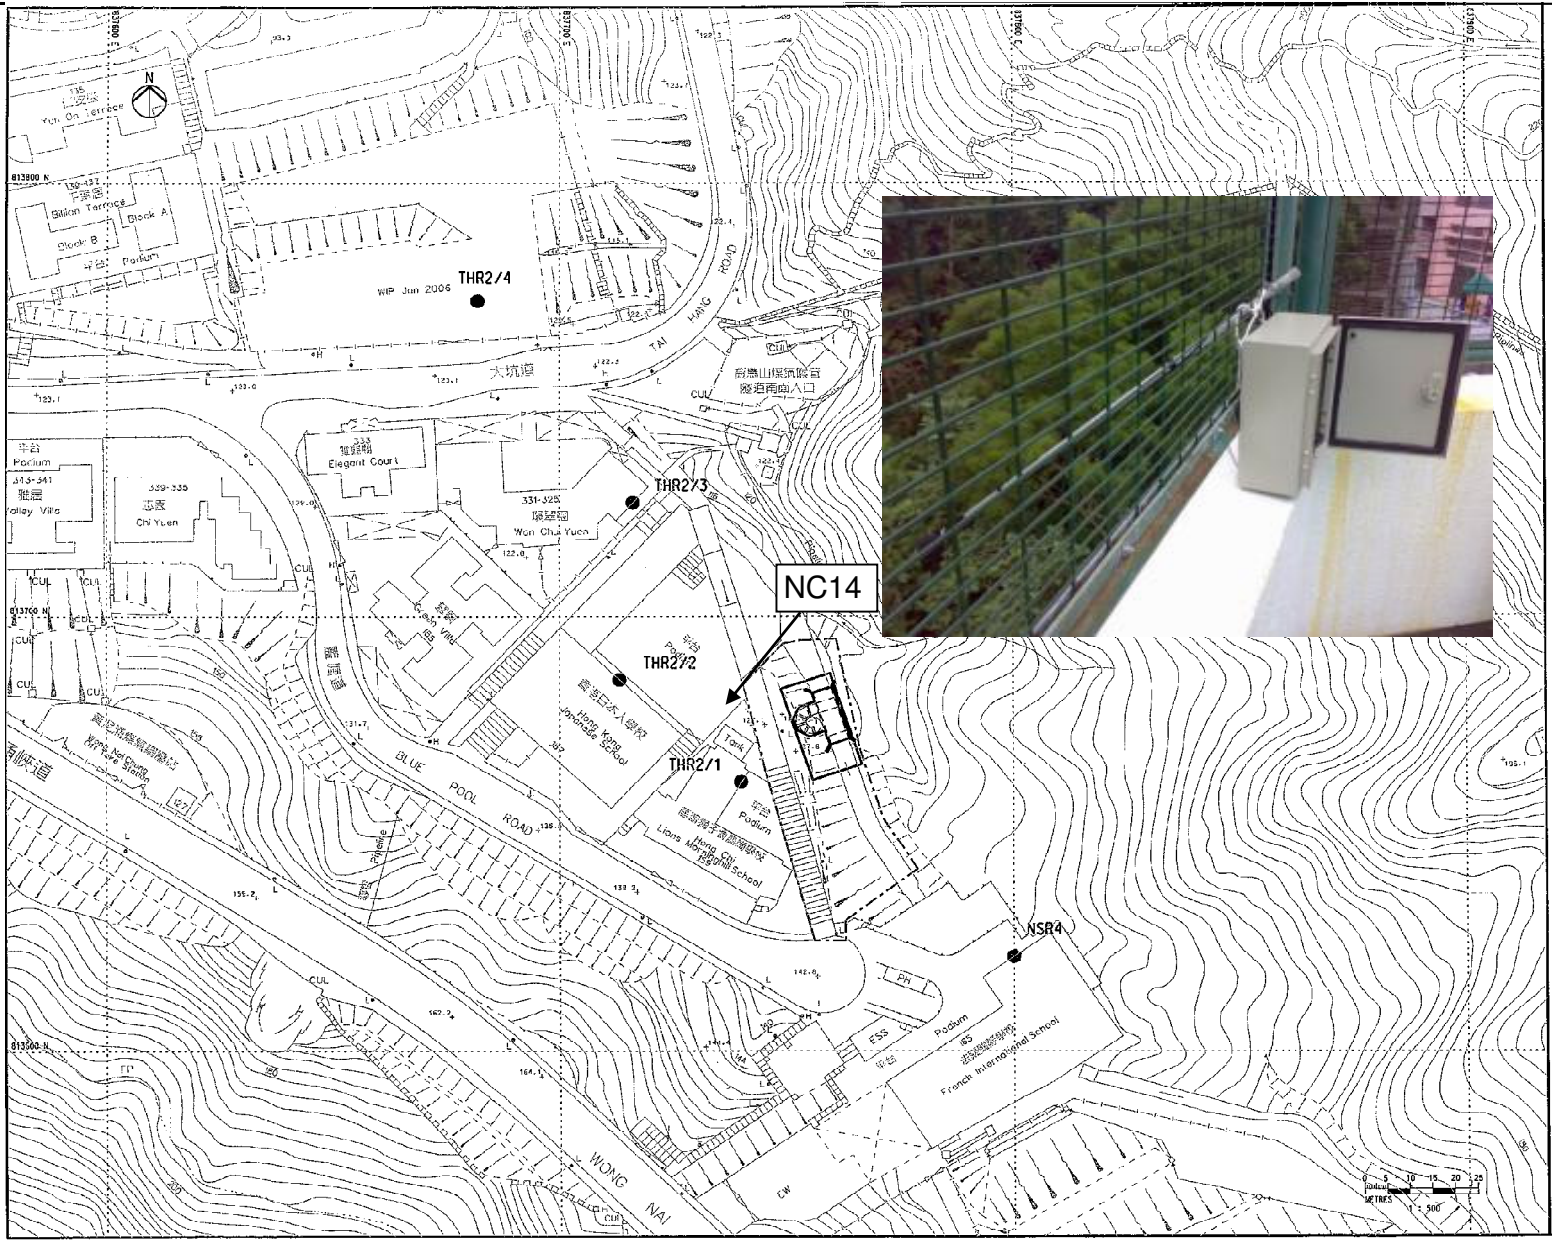
Title	Contract No. DC/2007/10		Scale	Project
	Design and Construction of Hong Kong West Drainage Tunnel (Intake THR2)		N.T.S	No. MA 8001
	Locations of Noise Monitoring Stations		Date	Figure
			Feb-10	3.1i

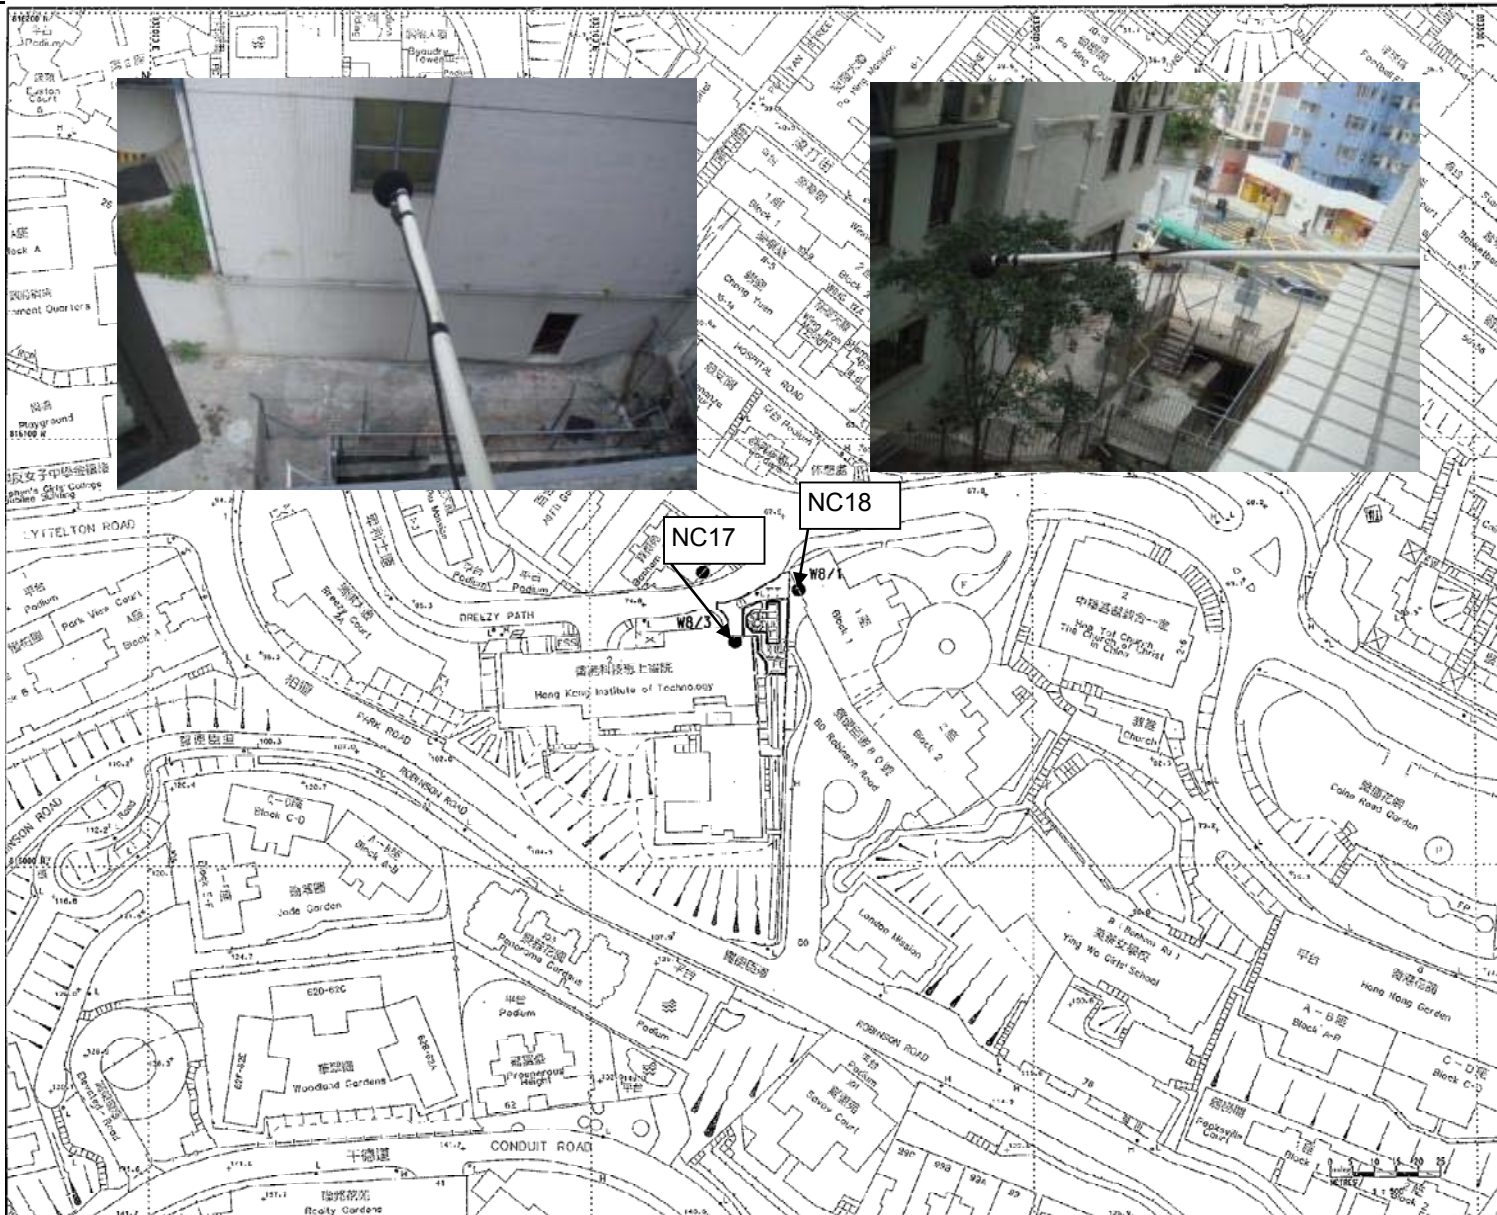
3.1k

Contract No. DC/2007/10  
 Design and Construction of Hong Kong West Drainage Tunnel  
 (Intake W8)  
 Locations of Noise Monitoring Stations

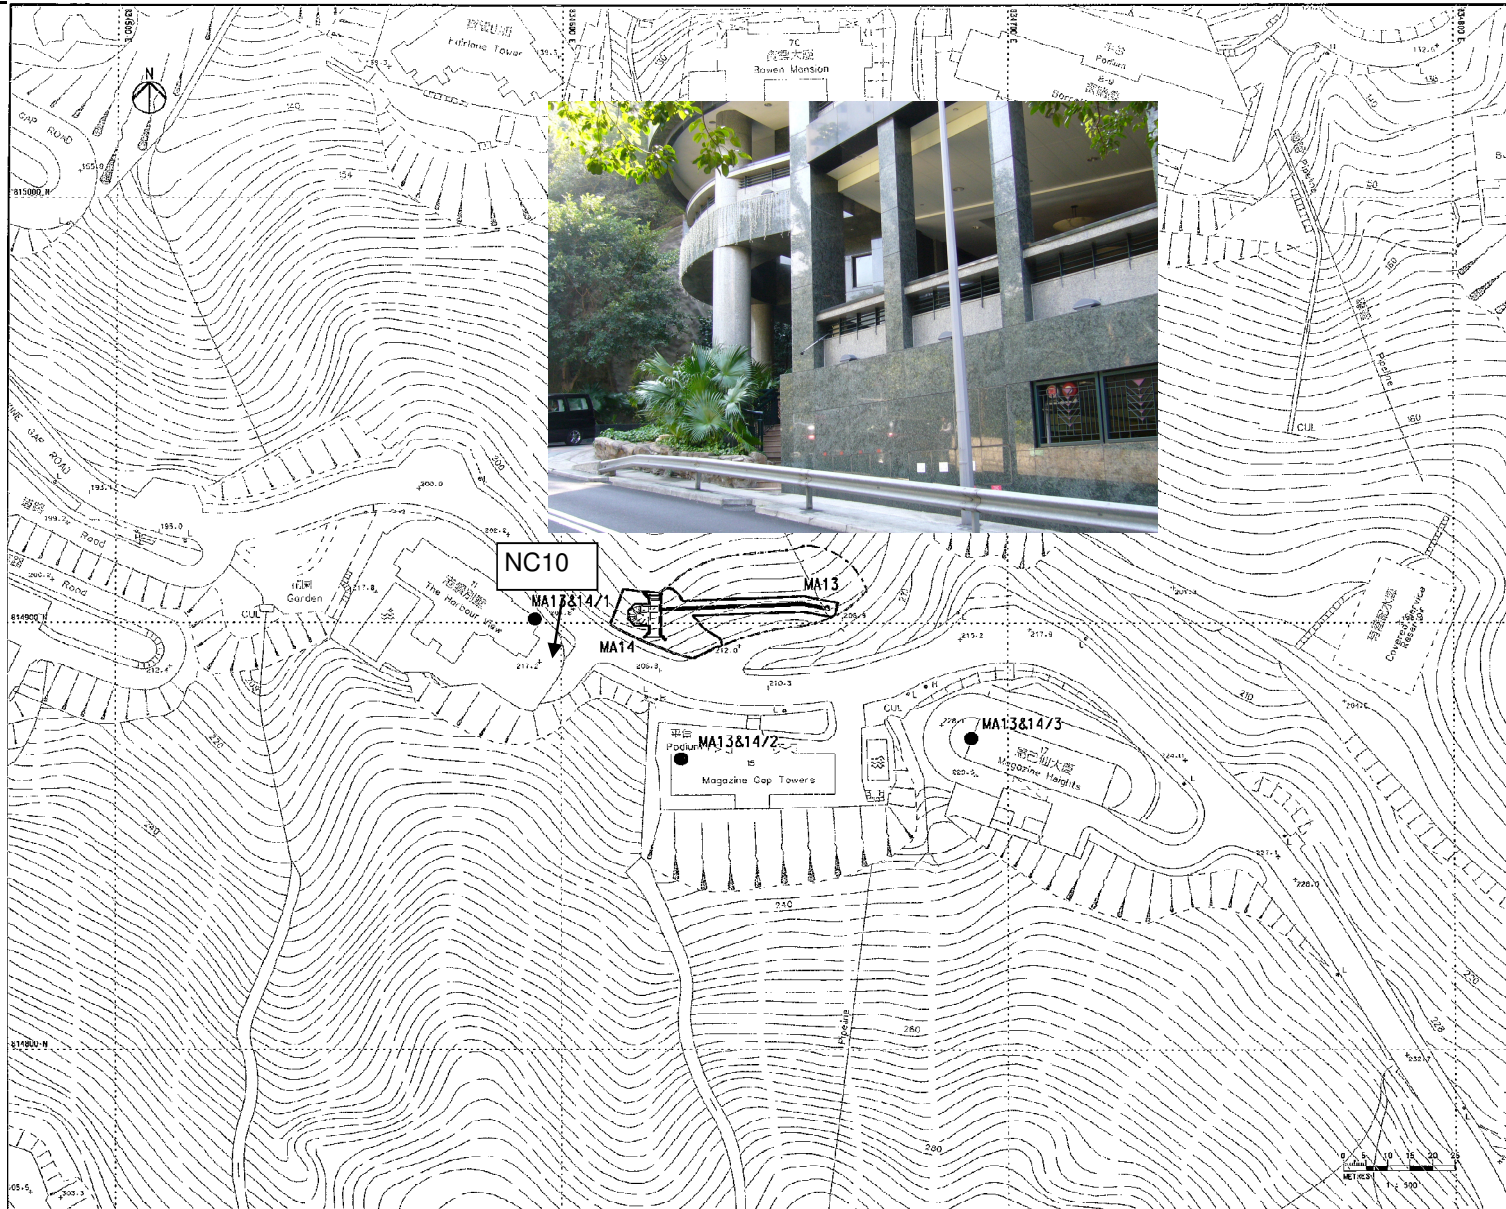
Title	Contract No. DC/2007/10		Scale	Project
	Design and Construction of Hong Kong West Drainage Tunnel (Intake MA14)		N.T.S	No. MA8001
Locations of Noise Monitoring Stations			Date	Figure
			Aug-10	3.1m

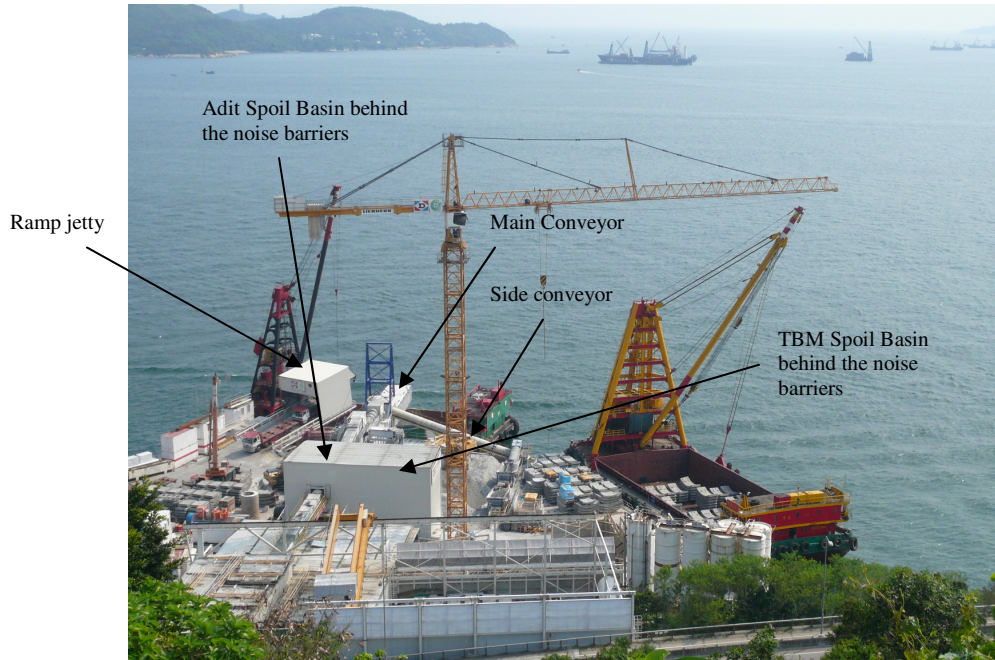
**Photo 1: View of the Western Portal**

When the next barge comes during daytime, the materials stored in the TBM Spoil Basin will be picked up by a backhoe and are transferred into a side conveyor. The side conveyor carried the materials to the main conveyor for discharge onto the barge (*Photo 1*).

The Main Conveyor and the Side Conveyor are fully enclosed by sound absorptive panels.

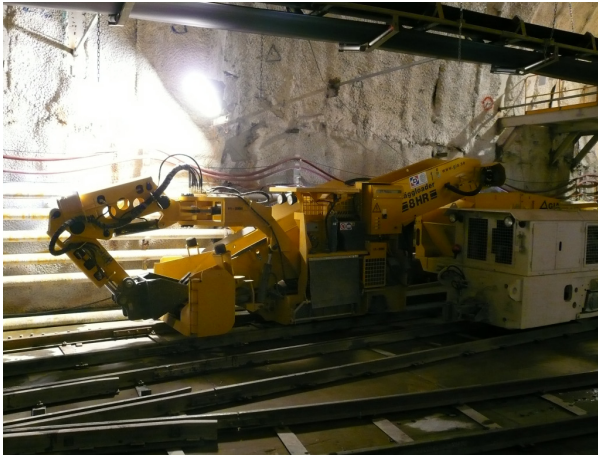
**Photo 2: Hägglöader**

The materials are picked up by either the Häggloader (*Photo 2*) or the John Deere skid loader (*Photo 3*) at the adit face; and they are then transferred onto train cars (Shuttle Cars as in *Photo 4*). These Shuttle Cars will be brought to the Adit Spoil Basin at the tunnel portal (*Photo 5*). A backhoe is deployed at the surface adjacent to the Adit Spoil Basin transferring the excavated materials from the Adit Spoil Basin onto a 24-T dump truck that travels less than 100m within the Site from the Adit Spoil to the ramp jetty and vice versa.

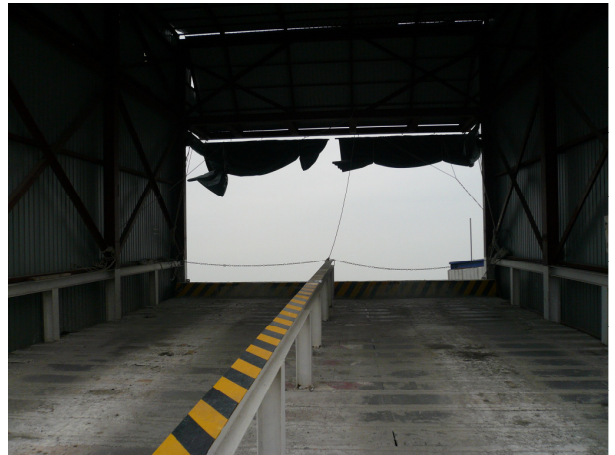
**Photo 6: The Ramp Jetty**

The ramp jetty is enclosed at 3 sides – the top and the lateral sides. It is equipped with curtains and water sprinkler system for dust suppression. (*Photo 6 & 7*)

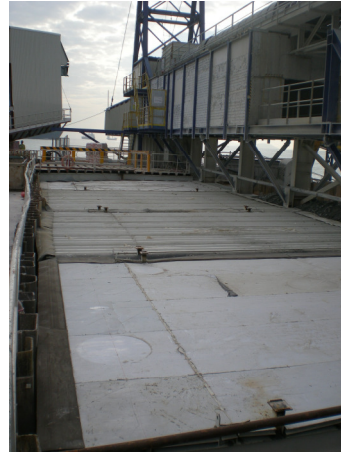
**Photo 11:** Noise covers at the Adit Spoil Basin

All logistics movements take place inside a sophisticated and purposely-built acoustic enclosure. Mobile plant such as locomotives and train cars are travelling inside the noise enclosure and into the tunnel under construction. In addition, movable noise covers (*Photo 11*) were provided in the Adit Spoil basin to block noise propagation during the unloading of excavated materials from the shuttle cars.

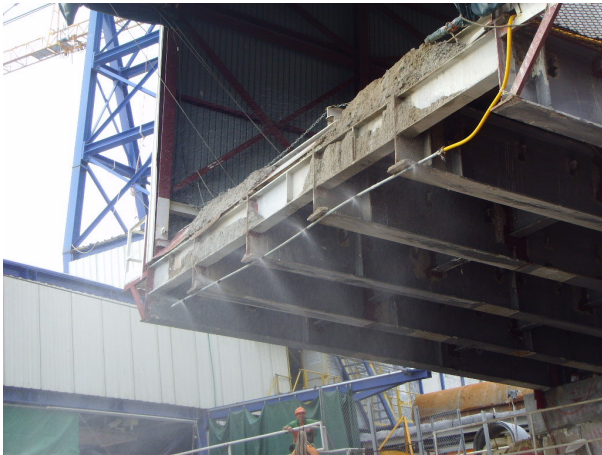
**Photo 9:** Sprinkler system installed at the ramp jetty

- A sprinkler system (*Photo 9*) was installed underneath the ramp jetty for dust suppression when excavated materials are being loaded onto the barge.
- Dust curtains (*Photo 10*) were also installed at the outer rims of the conveyor enclosure in order to shield fugitive dust, if any, arising from the discharge of excavated materials from the conveyor.
- The 24T dump truck transporting materials from the Adit Spoil Basin to the ramp jetty is fitted with mechanical covers.

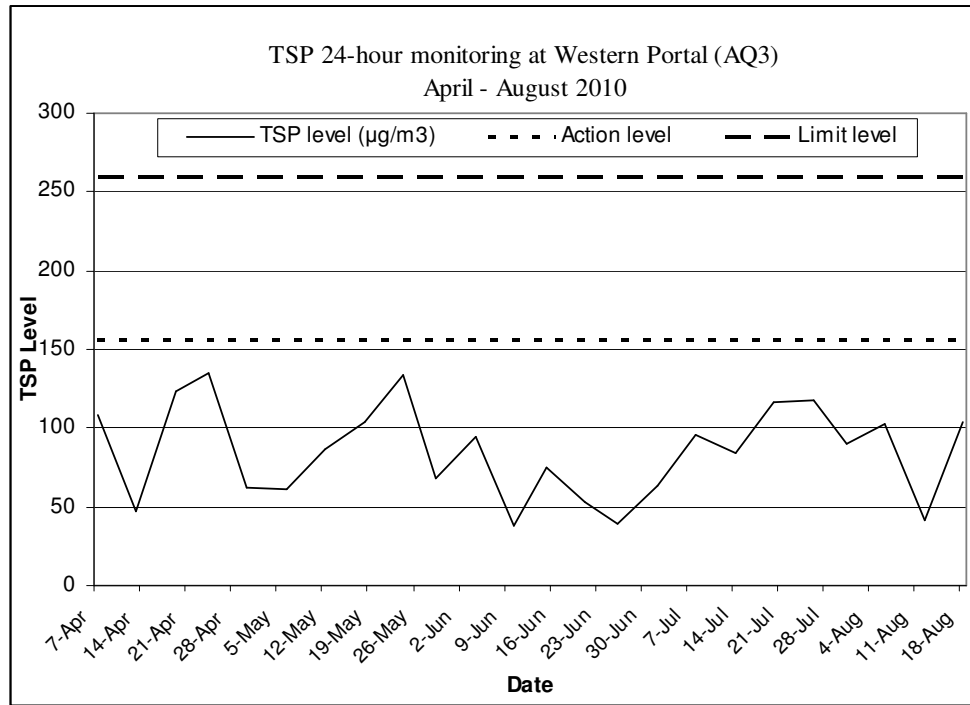
Date	TSP level ( $\mu\text{g}/\text{m}^3$ )
7-Apr	108
13-Apr	47.6
19-Apr	123.9
24-Apr	135.5
30-Apr	62.2
6-May	60.7
12-May	86.5
18-May	103.6
24-May	133.5
29-May	68.5
4-Jun	94.9
10-Jun	38.0
15-Jun	74.5
21-Jun	53.4
26-Jun	39.0
2-Jul	63.9
8-Jul	95.9
14-Jul	84.6
20-Jul	116.6
26-Jul	117.8
31-Jul	89.7
6-Aug	102.8
12-Aug	42.0
18-Aug	103.8

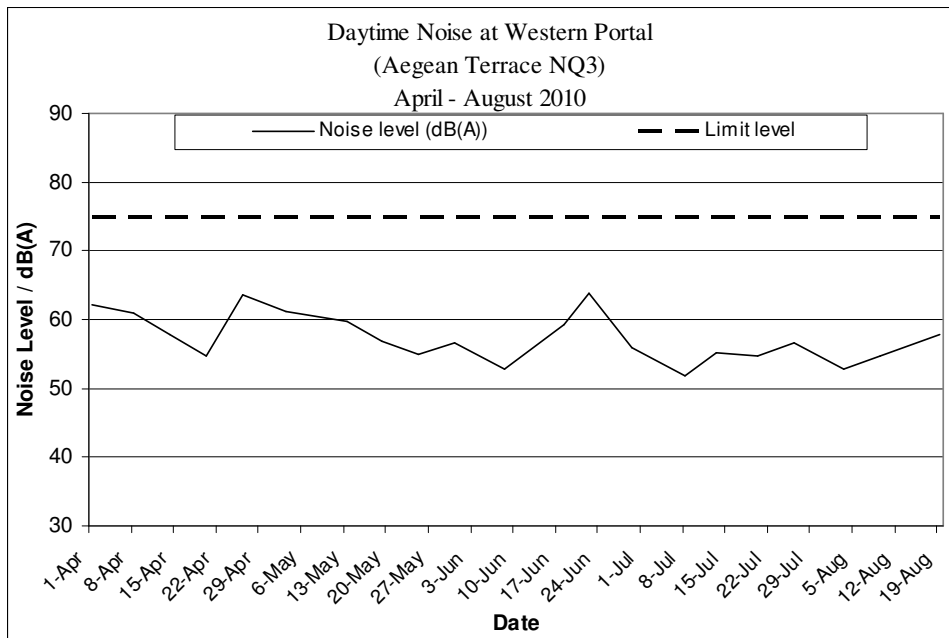
Date	Noise level (dB(A))
1-Apr	62.2
8-Apr	61.0
14-Apr	57.9
20-Apr	54.8
26-Apr	63.6
3-May	61.3
13-May	59.8
19-May	56.9
25-May	54.9
31-May	56.7
8-Jun	52.7
18-Jun	59.3
22-Jun	63.9
29-Jun	55.9
8-Jul	51.8
13-Jul	55.3
20-Jul	54.7
26-Jul	56.7
3-Aug	52.7
9-Aug	54.8
19-Aug	57.8

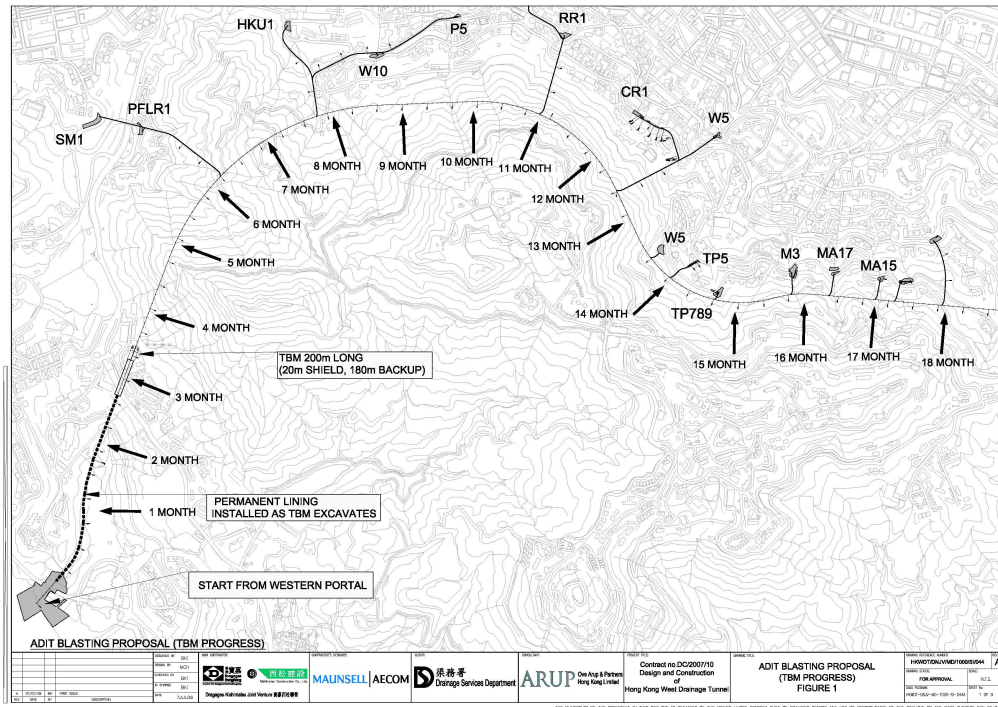
Figure 1 illustrates the alignment of the West Tunnel and West Adits and the progress of TBM excavation in the West Tunnel.

Figure 1: West Tunnel/Adit Alignment and TBM Progress

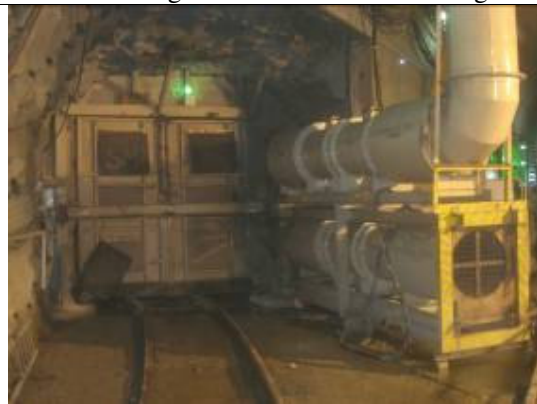
Blast door at tunnel and adit junction

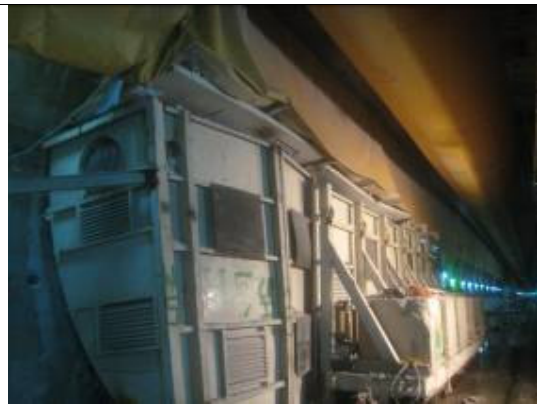
Blast door at tunnel and adit junction for micro-blasting

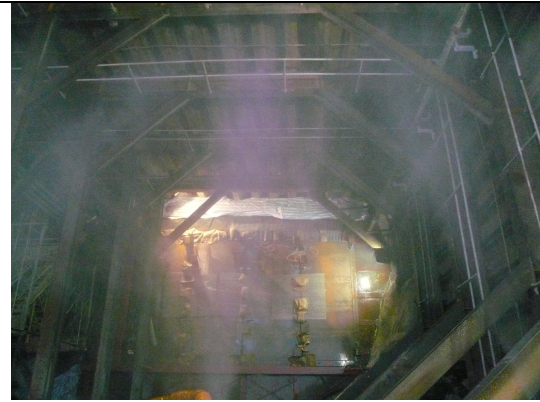
Water sprinkler system for dust & fumes suppression

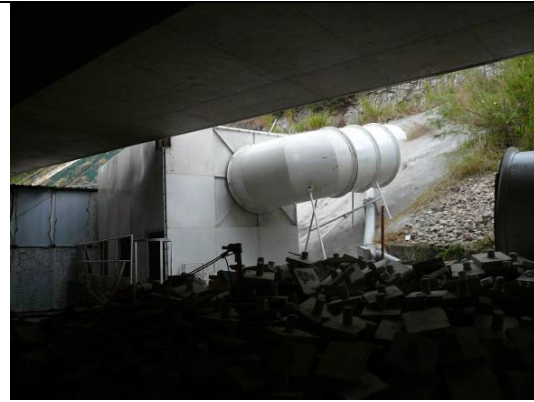
Fume scrubber in the Western Portal
