**Contract No. DC/2007/10**  
**Design and Construction of**  
**Hong Kong West Drainage Tunnel**

Monthly EM&A Report

March 2011  
(version 1.0)

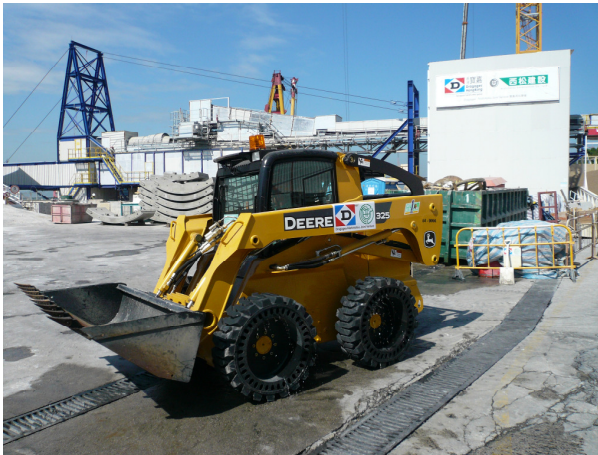
**Photo 3: John Deere Skid Loader**

The materials are picked up by either the Häggloader (*Photo 2*) or the John Deere skid loader (*Photo 3*) at the adit face; and they are then transferred onto train cars (Shuttle Cars as in *Photo 4*). These Shuttle Cars will be brought to the Adit Spoil Basin at the tunnel portal (*Photo 5*). A backhoe is deployed at the surface adjacent to the Adit Spoil Basin transferring the excavated materials from the Adit Spoil Basin onto a 24-T dump truck that travels less than 100m within the Site from the Adit Spoil to the ramp jetty and vice versa.

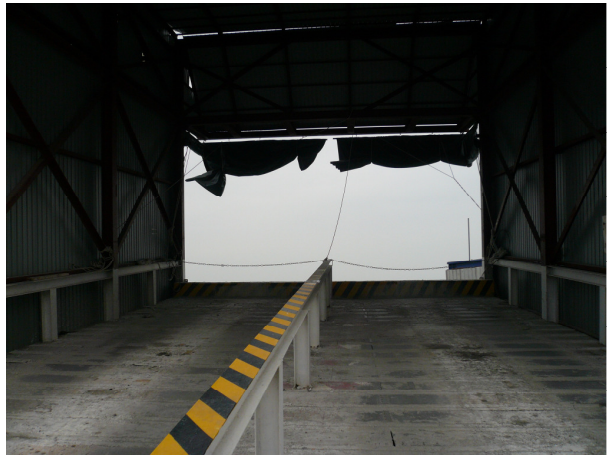
**Photo 6: The Ramp Jetty**

The ramp jetty is enclosed at 3 sides – the top and the lateral sides. It is equipped with curtains and water sprinkler system for dust suppression. (*Photo 6 & 7*)

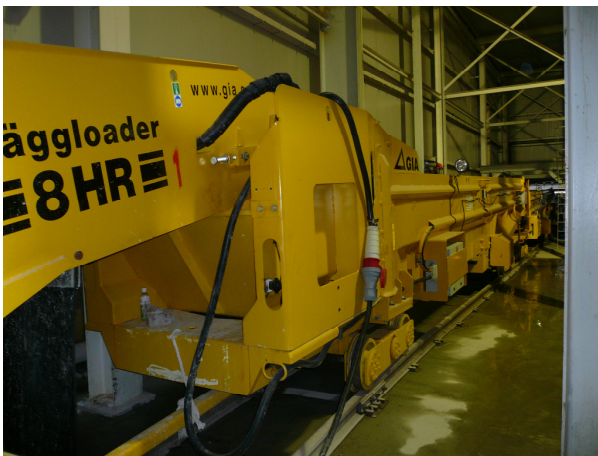
**Photo 4: Shuttle Car**

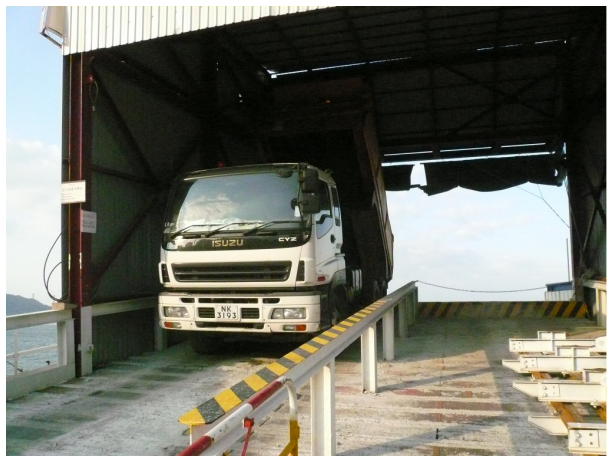
**Photo 7: Dump truck discharging excavated materials onto the barge at the ramp jetty**

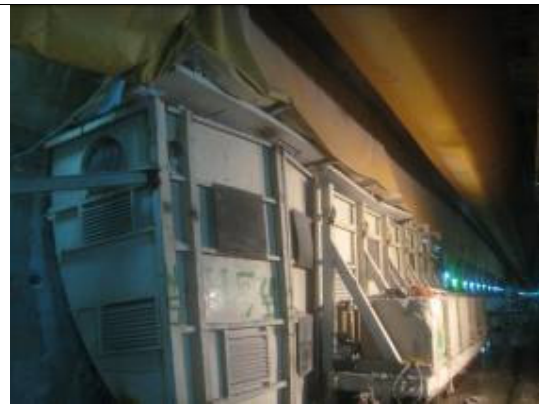
Blast door at tunnel and adit junction for micro-blasting
