Contract No. DC/2007/10
Design and Construction of
Hong Kong West Drainage Tunnel

Monthly EM&A Report

June 2011
(version 1.0)

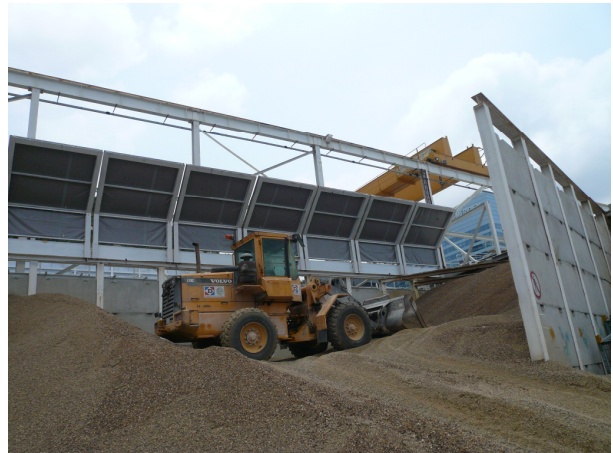
Photo 12: Noise barrier at the pea gravel storage yard at the side facing Aegean Terrace

In addition to the noise enclosure erected at the Western Portal, a row of noise barrier was built in the Western Portal adjacent the pea gravel storage yard (*Photo 12*). The barrier does not only screen the mobile plant at the pea gravel storage yard from the views of the Aegean Terrace residents, but it shields part of the noise generated from the operation of such plant. There is another row of barriers erected at the side abutting the Cyberport Road (*Photo 13*).
