**Contract No. DC/2007/10**  
**Design and Construction of**  
**Hong Kong West Drainage Tunnel**

Monthly EM&A Report

July 2012  
(version 2.0)

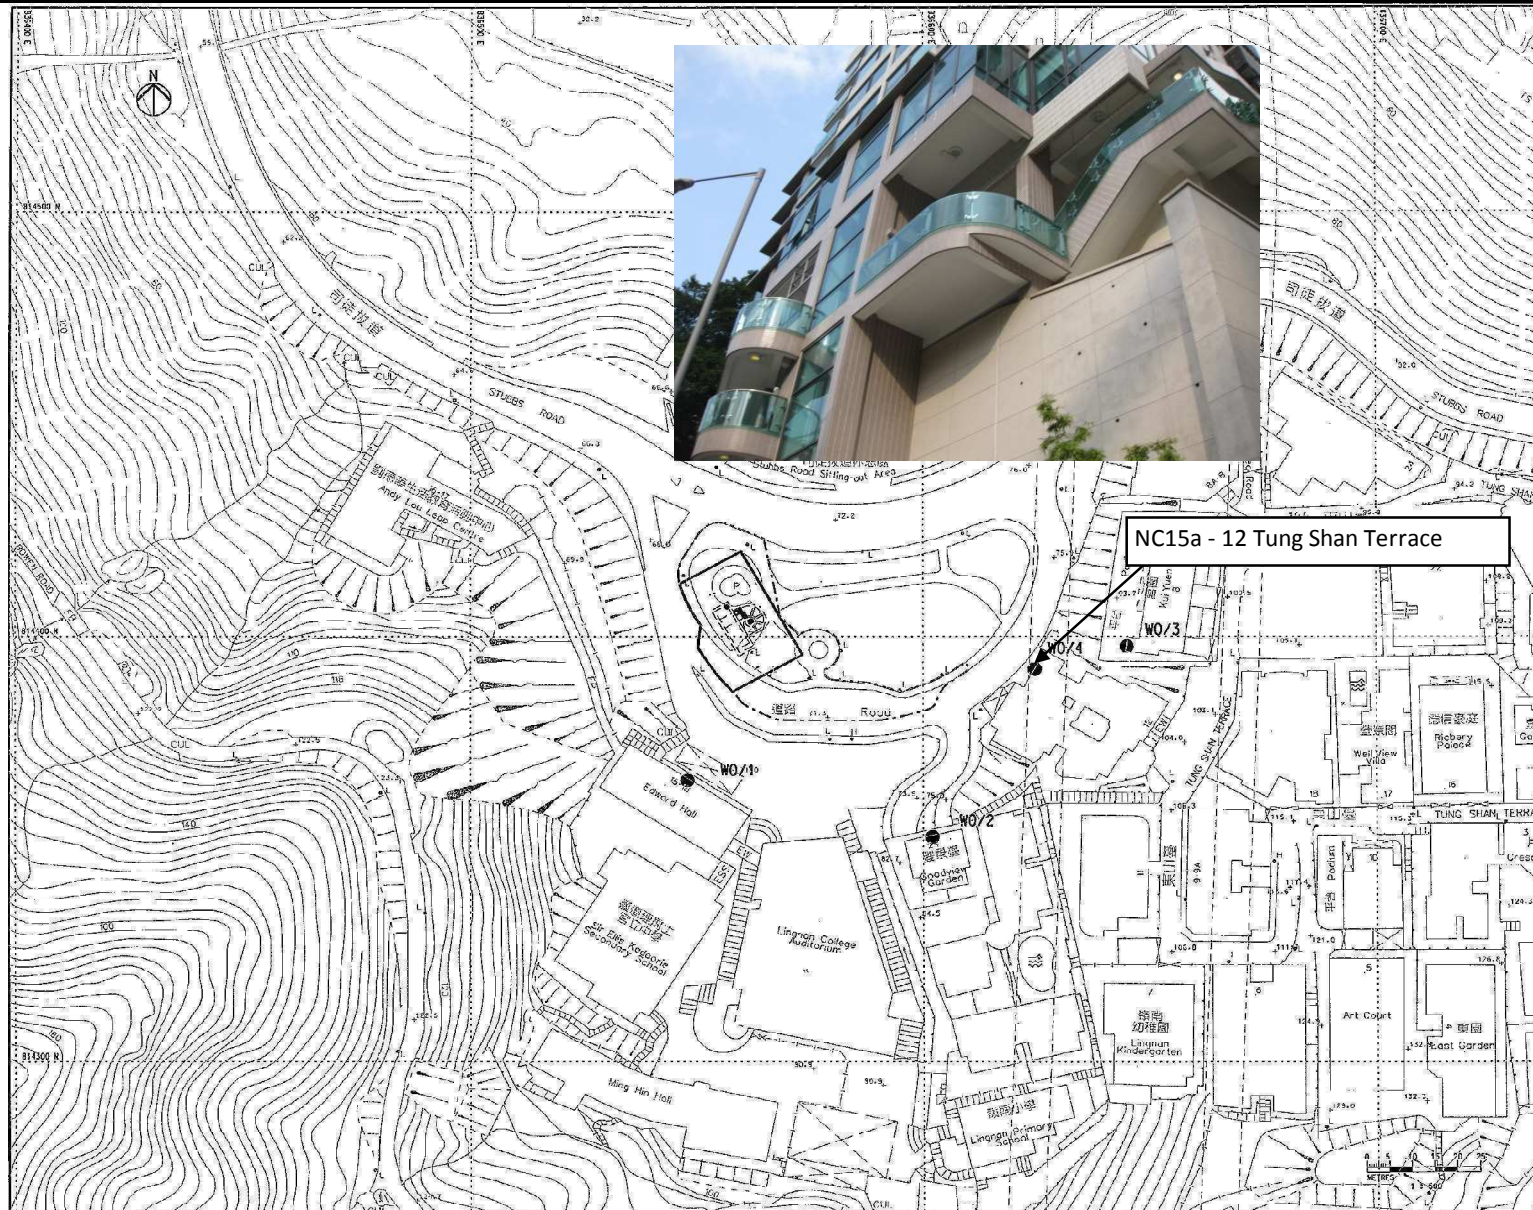
Title	Contract No. DC/2007/10		Scale	Project
	Design and Construction of Hong Kong West Drainage Tunnel (Intake W0)			
	Locations of Noise Monitoring Stations		Date	Figure
			Oct-11	3.1e

- 3.2 Noise monitoring was conducted at 19 designated monitoring stations as listed in Table 3.1. **Figure 3.1a-n** shows the locations of these stations.
- 3.3 The location of Hong Kong Academy, the noise monitoring station (NC15) at nearby the construction site (Intake W0), has been removed. The existing location has become a temporarily vacancy for future purpose. Therefore, the proposed location (NC15a) is shifted to the 12 Tung Shan Terrace from the original location.

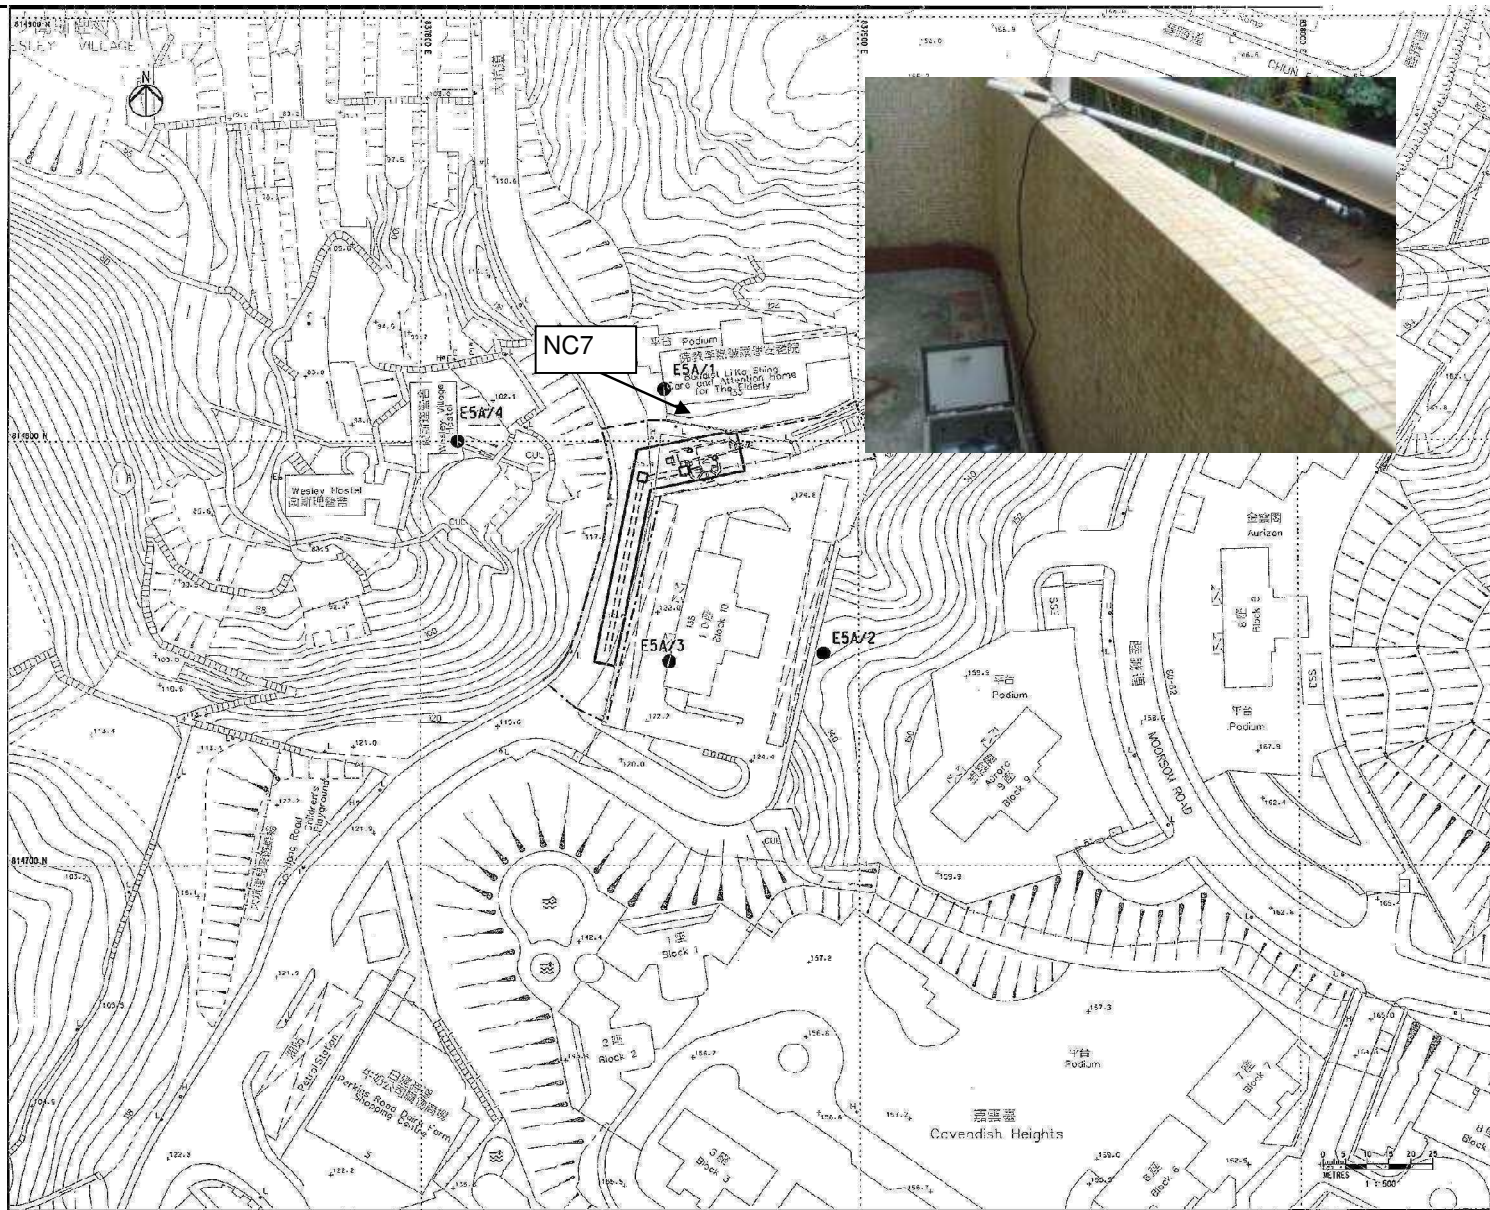
Project  
 No. MA 8001  
 Figure  
 3.1h

Title  
 Contract No. DC/2007/10  
 Design and Construction of Hong Kong West Drainage Tunnel  
 (Intakes E5A)  
 Locations of Noise Monitoring Stations

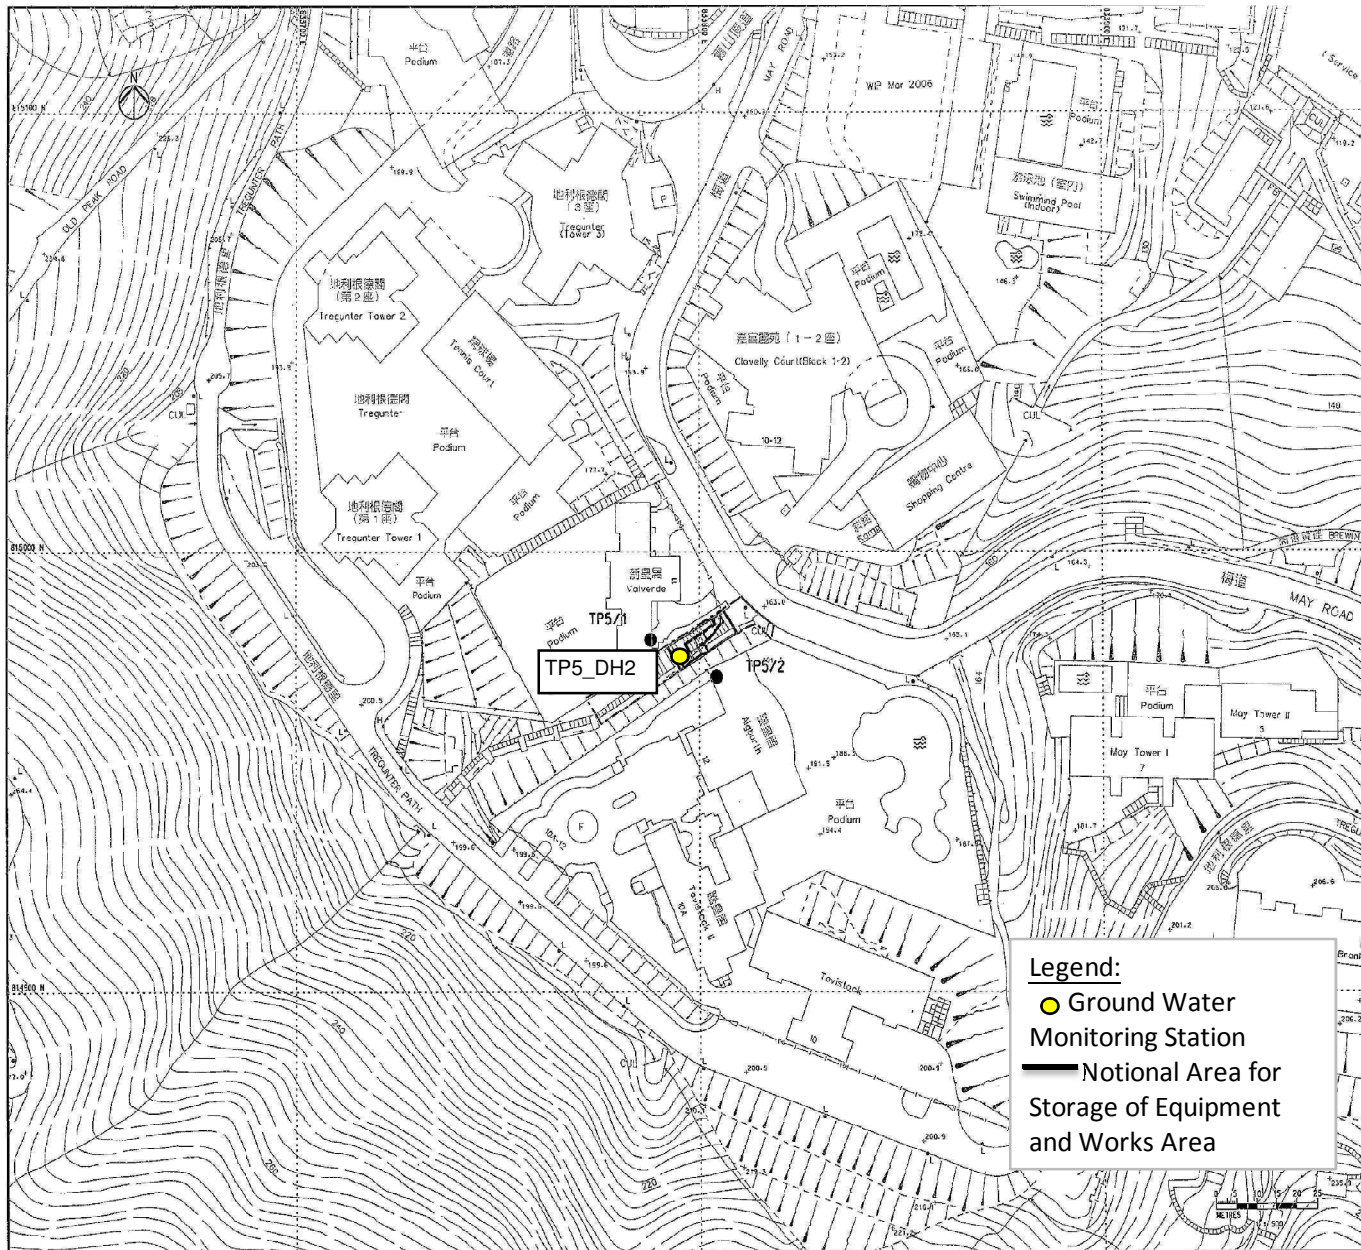
Scale	N.T.S	Project No.	MA8001
Date	Mar-10	Figure	4.2c

- 4.15 Ground water levels were measured once per month during the construction phase in order to ensure the water levels at those intakes near to the natural stream courses and thus on the surrounding habitats will not be significantly affected.
- 4.16 Locations of designated ground water level (borehole with piezometer) monitoring station UC1 at Eastern Portal has been changed to ADH48 which was verified by IEC on 5<sup>th</sup> June 2008. The updated ground water level monitoring stations, TP789\_DH2, TP5\_DH2, THR2\_DH7 and PFLR1\_DH2 were also verified by IEC on 19<sup>th</sup> June 2010.
- 4.17 Ground water level monitoring location is shown in **Figure 4.2a-e** and the Monitoring data are shown in Table 4.4.

Contract No. DC/2007/10  
 Design and Construction of Hong Kong West Drainage Tunnel  
 (Intake TP5)  
 Location of ground water level Monitoring Station

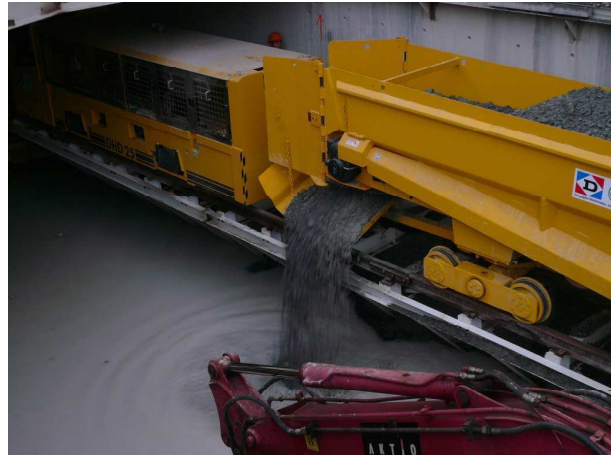
The materials are picked up by either the Häggloader (*Photo 2*) or the John Deere skid loader (*Photo 3*) at the adit face; and they are then transferred onto train cars (Shuttle Cars as in *Photo 4*). These Shuttle Cars will be brought to the Adit Spoil Basin at the tunnel portal (*Photo 5*). A backhoe is deployed at the surface adjacent to the Adit Spoil Basin transferring the excavated materials from the Adit Spoil Basin onto a 24-T dump truck that travels less than 100m within the Site from the Adit Spoil to the ramp jetty and vice versa.

**Photo 5: Shuttle car discharging excavated materials at the Adit Spoil Basin**

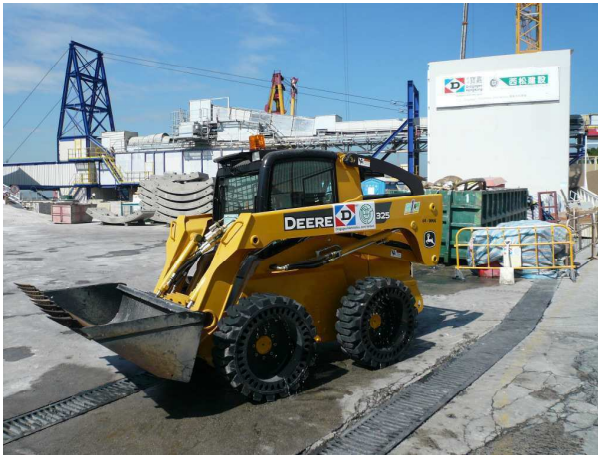
**Photo 3: John Deere Skid Loader**

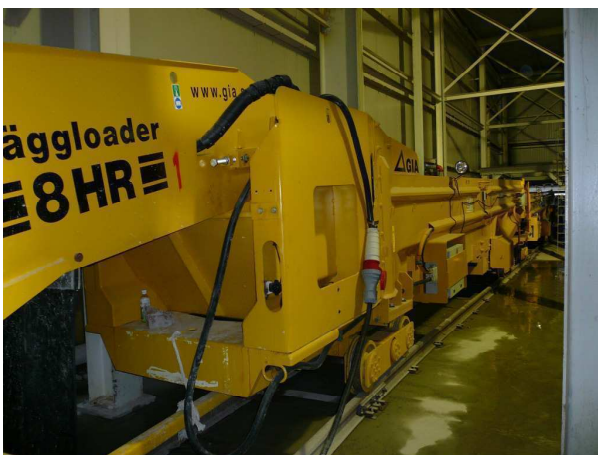
**Photo 4: Shuttle Car**

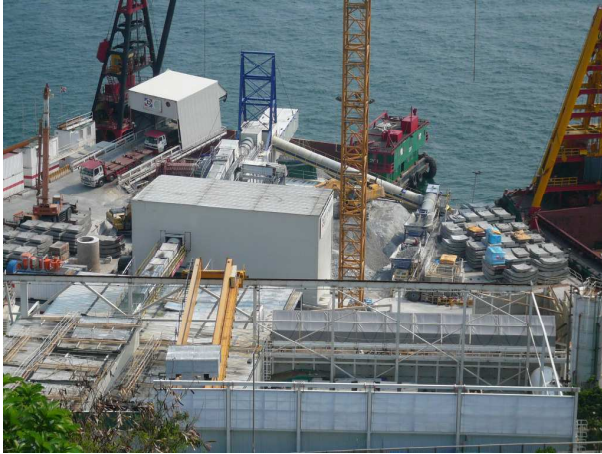
Both the main and side conveyors (*Photo 8*) are entirely covered to mitigate noise propagation and avoid fugitive dust during the transportation of excavated materials.

**Photo 8:** Covered Conveyors

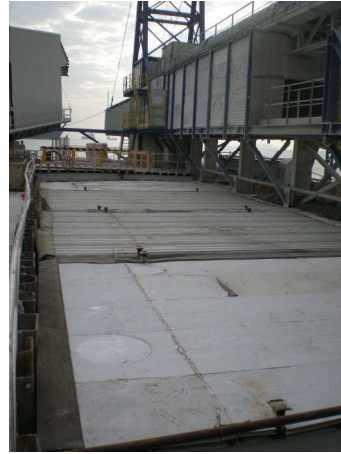
All logistics movements take place inside a sophisticated and purposely-built acoustic enclosure. Mobile plant such as locomotives and train cars are travelling inside the noise enclosure and into the tunnel under construction. In addition, movable noise covers (*Photo 11*) were provided in the Adit Spoil basin to block noise propagation during the unloading of excavated materials from the shuttle cars.

**Photo 11:** Noise covers at the Adit Spoil Basin

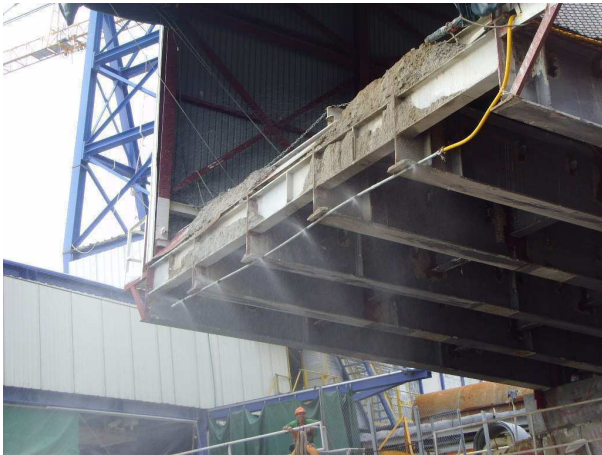
- A sprinkler system (*Photo 9*) was installed underneath the ramp jetty for dust suppression when excavated materials are being loaded onto the barge.
- Dust curtains (*Photo 10*) were also installed at the outer rims of the conveyor enclosure in order to shield fugitive dust, if any, arising from the discharge of excavated materials from the conveyor.
- The 24T dump truck transporting materials from the Adit Spoil Basin to the ramp jetty is fitted with mechanical covers.

**Photo 9:** Sprinkler system installed at the ramp jetty

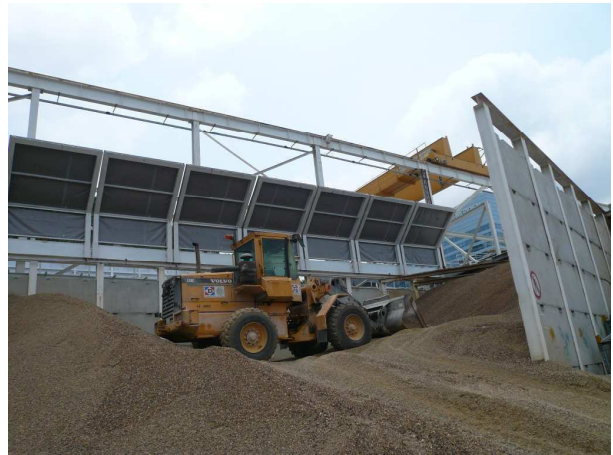
In addition to the noise enclosure erected at the Western Portal, a row of noise barrier was built in the Western Portal adjacent the pea gravel storage yard (*Photo 12*). The barrier does not only screen the mobile plant at the pea gravel storage yard from the views of the Aegean Terrace residents, but it shields part of the noise generated from the operation of such plant. There is another row of barriers erected at the side abutting the Cyberport Road (*Photo 13*).

**Photo 12:** Noise barrier at the pea gravel storage yard at the side facing Aegean Terrace

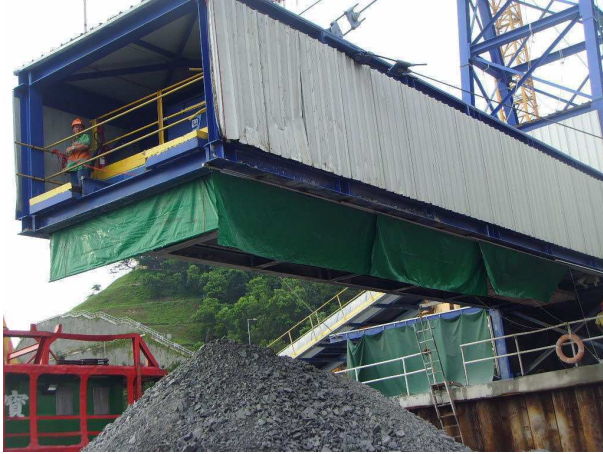
**Photo 10: Dust curtains at the discharge point**

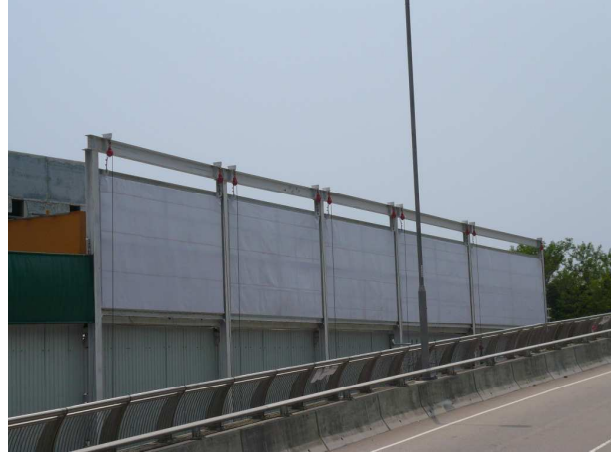
**Photo 13: Noise barrier along Cyberport Road**
