**Contract No. DC/2007/10**  
**Design and Construction of**  
**Hong Kong West Drainage Tunnel**

Monthly EM&A Report

March 2013  
(version 1.0)

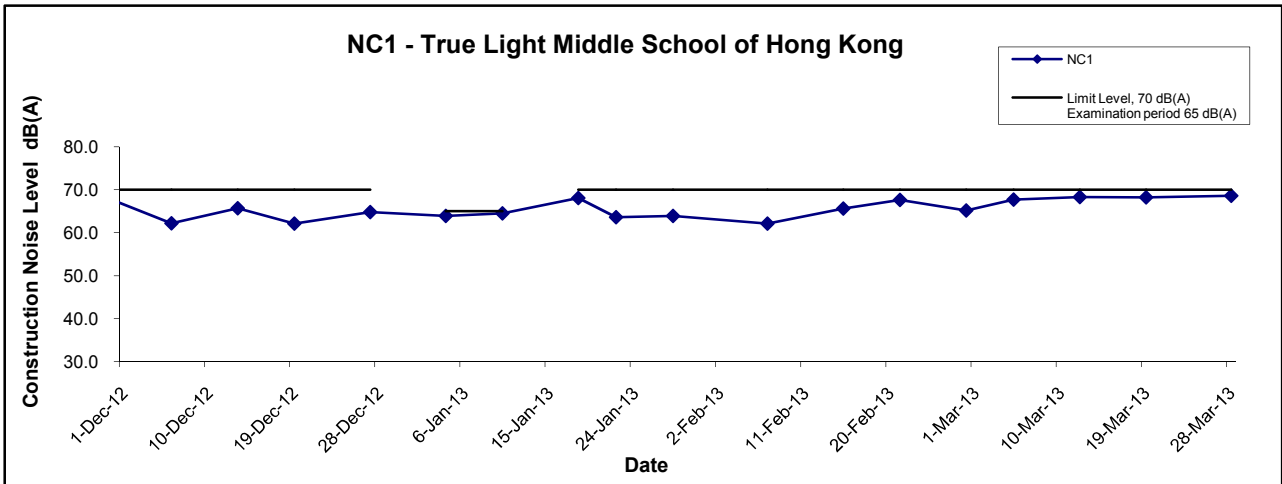
Title Contract No. DC/2007/10 Design and Construction of Hong Kong West Drainage Tunnel Graphical Presentation of Construction Noise Monitoring Results	Scale	N.T.S	Project No.	MA8001	CINOTECH
	Date	Mar 13	Appendix	G

Location NC19 - Villa Veneto								
Date	Time	Weather	Unit: dB (A) (30-min)					
			Measured Noise Level			Limit Level	Corresponding Baseline Level <sup>(1)</sup>	Corrected Measured Noise Level <sup>(2)</sup>
			L <sub>eq</sub>	L <sub>10</sub>	L <sub>90</sub>	L <sub>eq</sub>	L <sub>eq</sub>	L <sub>eq</sub>
5-Mar-13	09:07	Sunny	70.2	73.8	65.1	75.0	N/A	N/A
12-Mar-13	09:07	Sunny	71.3	74.8	68.2	75.0	N/A	N/A
19-Mar-13	11:20	Cloudy	68.9	73.6	64.7	75.0	N/A	N/A
28-Mar-13	09:50	Cloudy	68.6	71.2	60.2	75.0	N/A	N/A

3.30 Noise monitoring results and graphical presentations are shown in **Appendix G**. In accordance with Condition 4.2 of the EP, all environmental monitoring data was made available to the public via internet access at the website <http://www.cinotech.com.hk/projects/WestDrainageTunnel/>.
