MTR Corporation Limited

Kwun Tong Line Extension (KTE)

Monthly EM&A Report (May 2012)

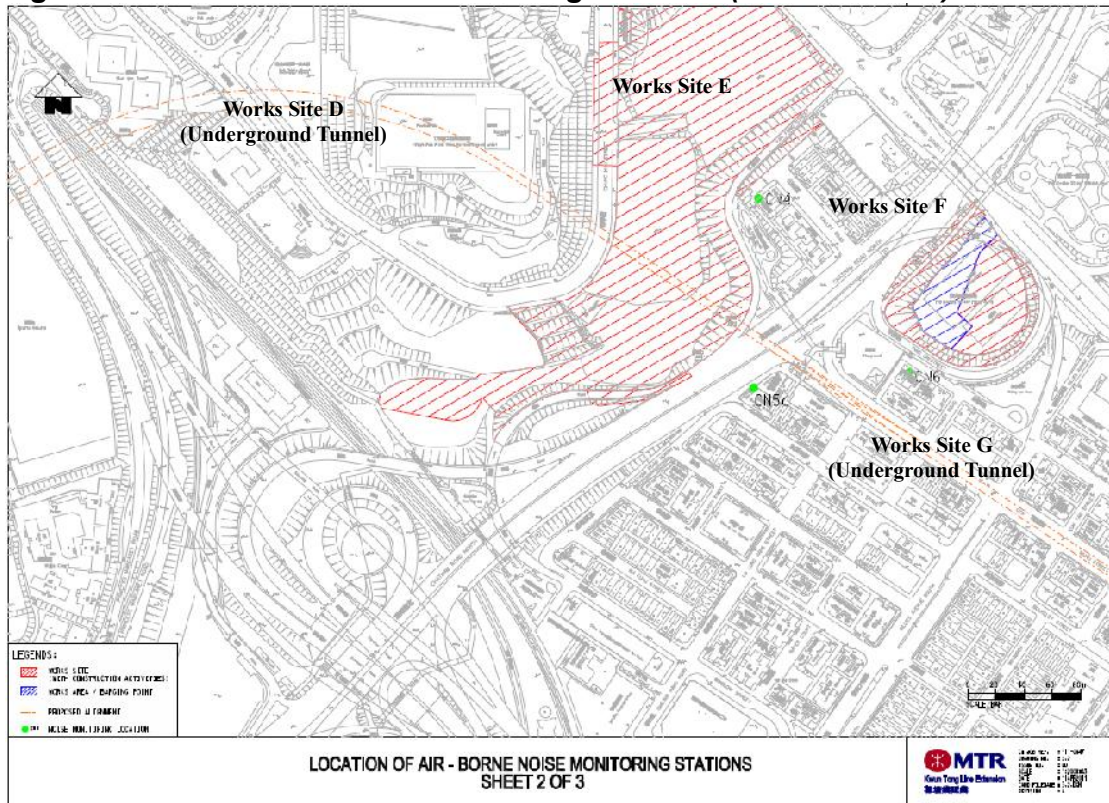
Figure 7. Location of Noise Monitoring Stations (CN4 and CN6)

Four noise exceedances were found at Yee Fu Building (CN4), which exceeded the respective Limit Level, but not exceeding the predicted construction noise level as anticipated in the EIA report. For G.C.E Whampoa Primary School (CN12), one noise exceedance was recorded which exceeded the residual level as anticipated in the EIA report. Follow up actions have been taken by the contractor and ET in accordance with the Event and Action Plan. Remedial noise mitigation measures were taken by the contractor to prevent further exceedance to the residual level. The noise monitoring frequency was increased to twice a week to monitor the effectiveness of the remedial measures. No exceedance to the residual level was recorded after the rectification. As such, the monitoring frequency resumed to once a week. The IEC was informed the remedial actions and results.

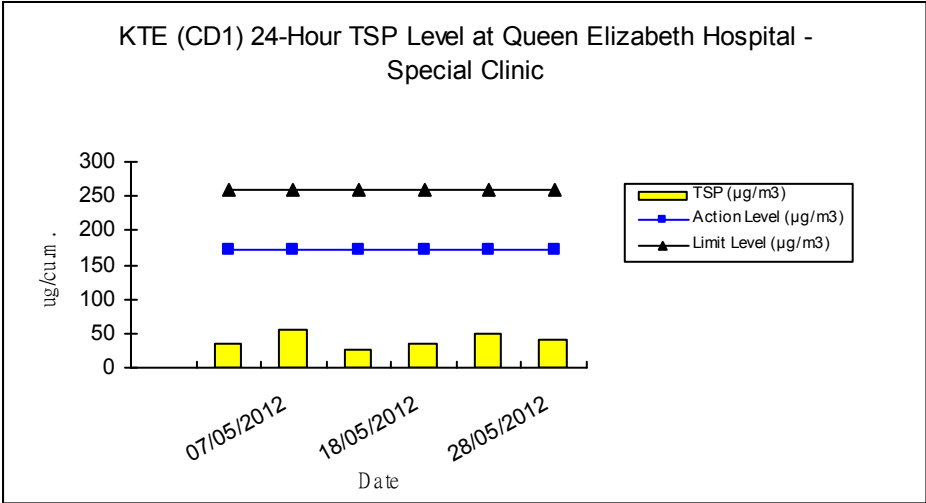
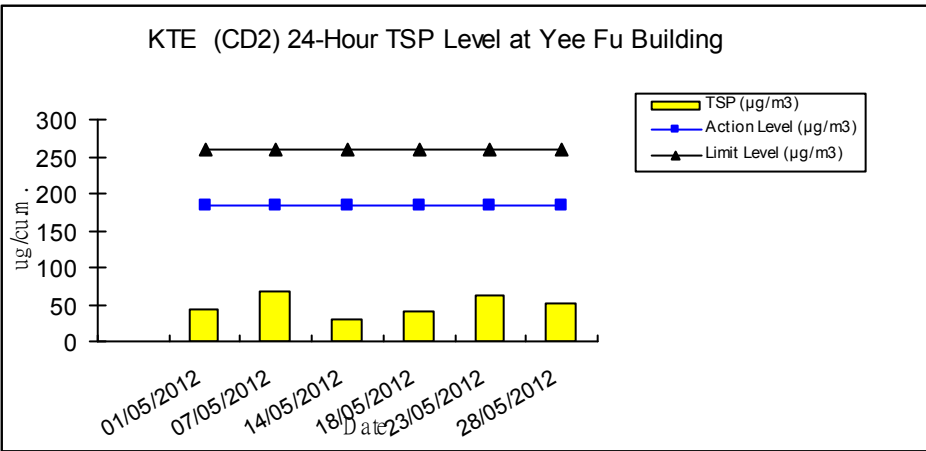
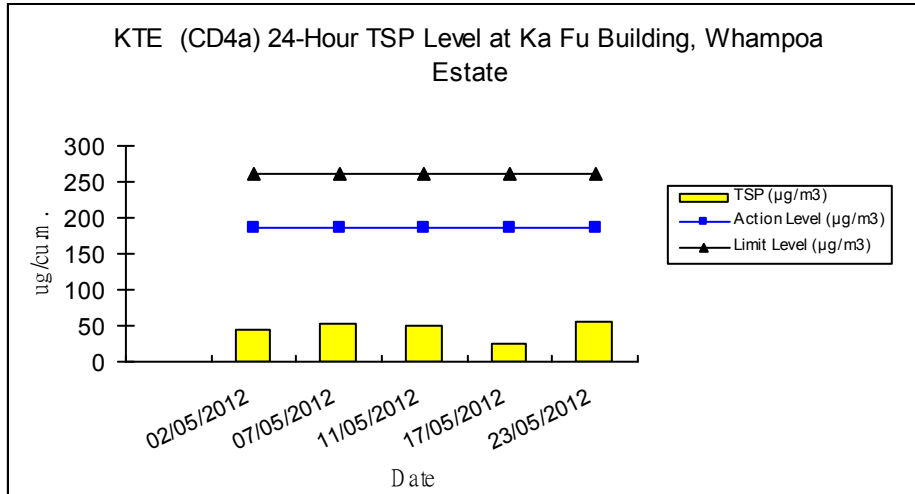
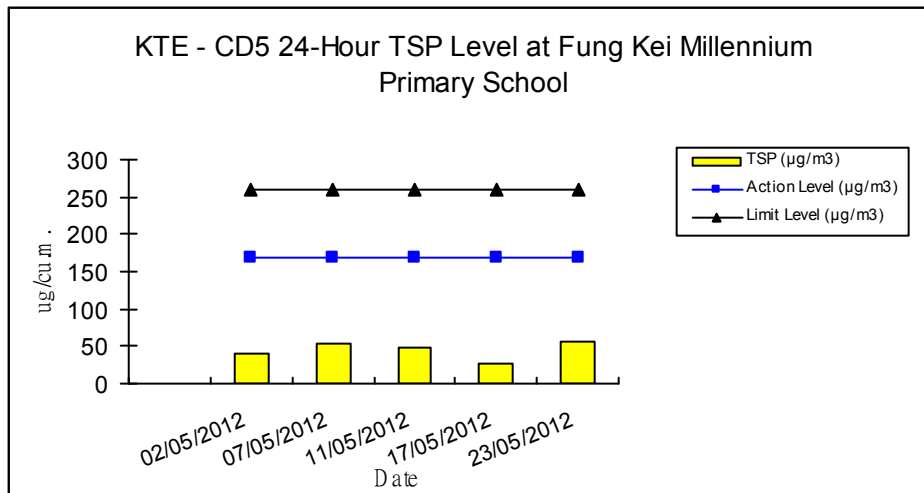
Impact Monitoring Graphical Plots

As some of the measured Leq is lower than the baseline level, correction against baseline level cannot be applied.
