TEST REPORT

China Harbour – China State Joint Venture

CONTRACT NO. CV/2009/02
HANDLING OF SURPLUS PUBLIC FILL
TSEUNG KWAN O AREA 137 FILL BANK
MONTHLY EM&A REPORT NO.42
(MAY 2013)

Report No.: ENA31188

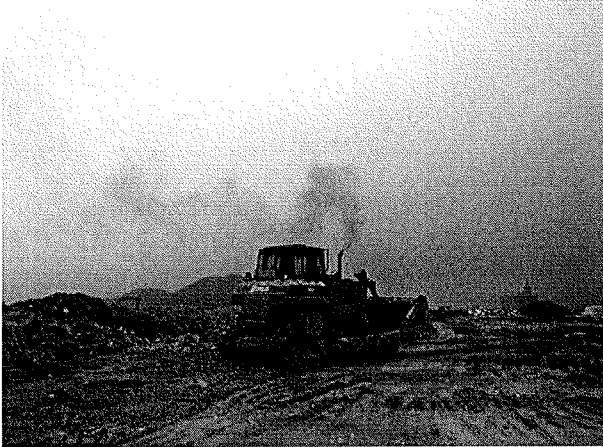
Photo 1

Dry Soil Deposition Area

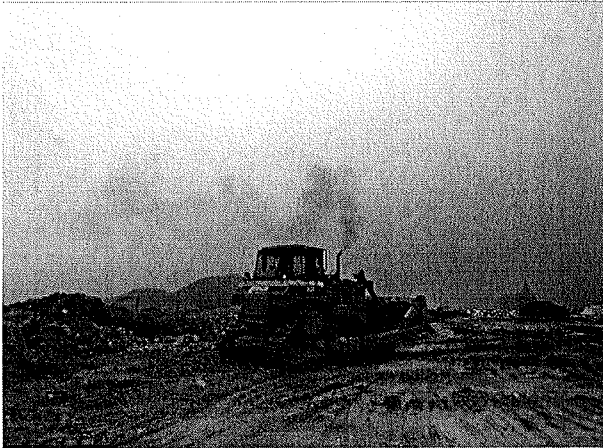
Photo 1

Dry Soil Deposition Area

The Contractor is reminded to conduct regular maintenance for all plants in order to prevent dark smoke emission.

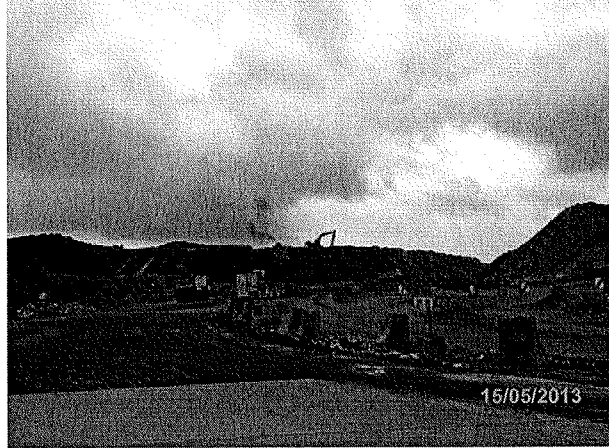
Photo 2

Dry Soil Deposition Area

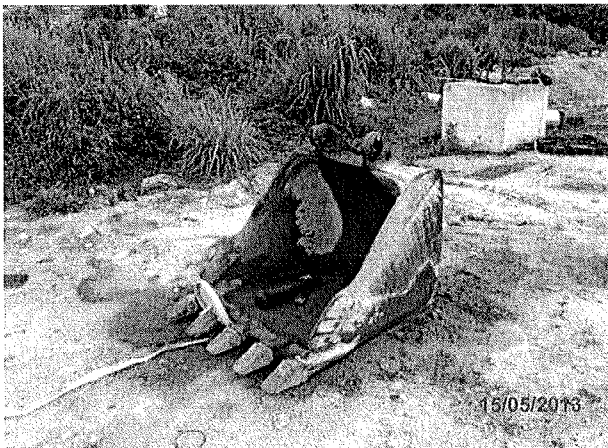
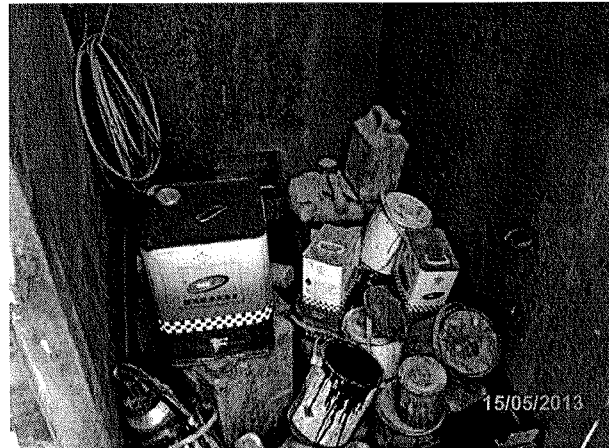
Photo 3 and 4

Workshop

Stagnant water accumulated inside the shovel and chemical waste storage area shall be cleaned up.

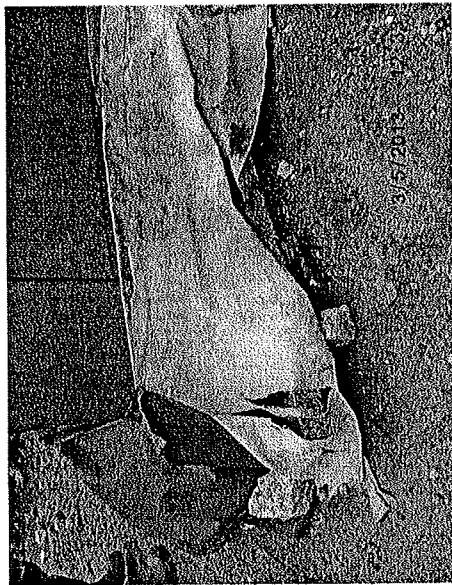
Photo 130503_002 (Dry soil deposition area in Section A4)

Black smoke was emitted from a bulldozer near dry soil deposition area in Section A4. (New item)	The Contractor was reminded to stop to use the defect bulldozer until repaired properly.	---	Follow-up
15 May 2013	Black smoke was emitted from a bulldozer near dry soil deposition area in Section A4. (Previous item)	The Contractor was reminded to stop to use the defect bulldozer until repaired properly.	---	Follow-up
	Stagnant water was noted inside the bucket of an excavator at the road side near work shop. (New item)	The Contractor was reminded to clear the stagnant water or apply pesticide to avoid mosquito breeding.	---	Follow-up
	Standing water was found inside the drip tray in the chemical waste storage area. (New item)	The Contractor was reminded to clear the standing water or apply pesticide to avoid mosquito breeding.	---	Follow-up
22 May 2013	Black smoke was emitted from a bulldozer near dry soil deposition area in Section A4. (Previous item)	The Contractor was reminded to stop to use the defect bulldozer until repaired properly.	No black smoke was found emitted from a bulldozer near dry soil deposition area in Section A4.	Closed

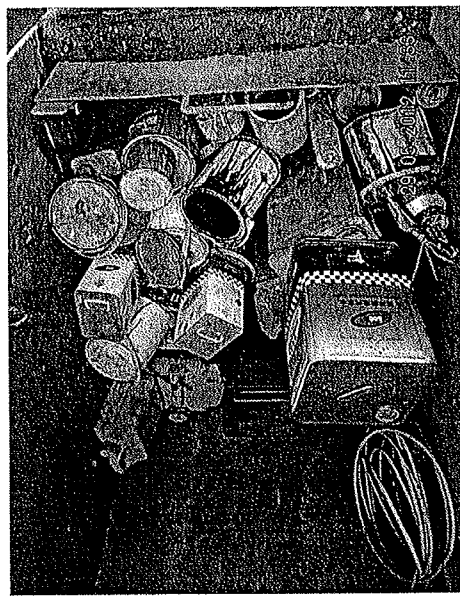
<p>Photo 130522_001 (Chemical waste storage area)</p>

Date	Key Findings	Action(s) Taken recommended by ET	Action(s) Taken by the Contractor during the ET weekly site audit	Rectification Status by ET
29 May 2013	Standing water was found inside the drip tray in the chemical waste storage area. (Previous item)	The Contractor was reminded to clear the standing water or apply pesticide to avoid mosquito breeding.	---	Follow-up
	Silt curtain near tipping hall No.1 were found damaged. (Previous item)	The Contractor was reminded to repair the silt curtain as soon as possible.	---	Follow-up
	Standing water was noted at check point. (New item)	The Contractor was reminded to clear the standing water or apply pesticide to avoid mosquito breeding.	---	Follow-up
