**Contract No.: CV/2013/06**  
**Handling of Surplus Public Fill**  
**(2014-2016)**

**TSEUNG KWAN O AREA 137 FILL BANK**  
**MONTHLY EM&A REPORT NO.3**  
**(MARCH 2014)**

Report No.: ENA40525

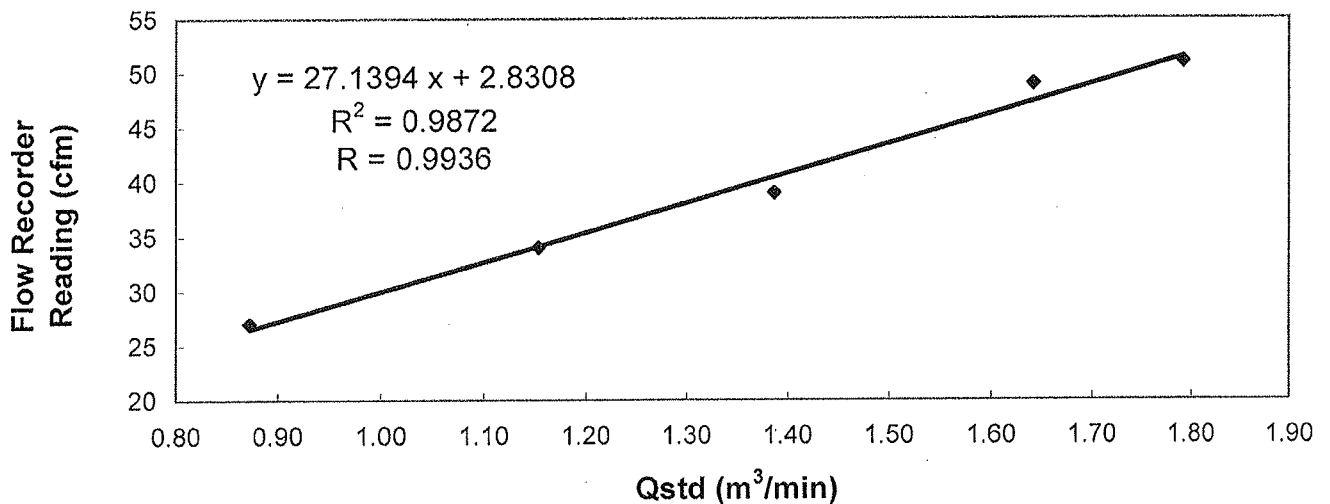
**Sampler 1172 Calibration Curve**  
Site: Tseung Kwan O 137 (TKO-A2a)

Flow recorder reading (cfm)	51	49	39	34	27
Qstd (Actual flow rate, m <sup>3</sup> /min)	1.79	1.64	1.39	1.15	0.87
Pressure :	763.56	mm Hg	Temp. :	290	K

Acceptance Criteria : Correlation coefficient (r) of the calibration curve greater than 0.990 after a 5-point calibration.

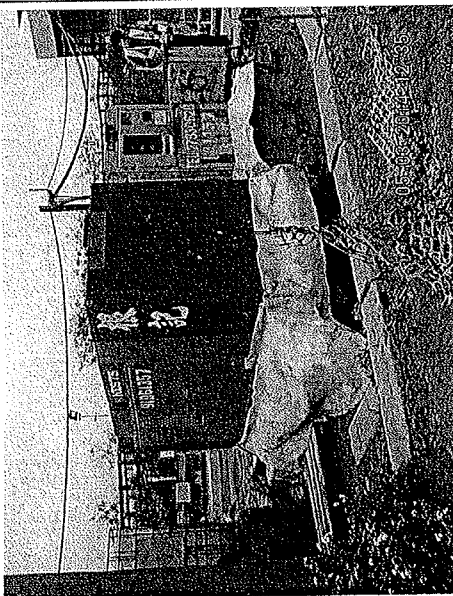
<p>Photo 140305_001 (Near tipping hall No.2) (Improved)</p>

Date	Key Findings	Action(s) Taken recommended by ET	Action(s) Taken by the Contractor during the ET weekly site audit	Rectification Status by ET
05 March 2014	No skirt curtain was provided for the generator near tipping hall No.2. (Previous item)	To provide suitable skirt curtain for all generator.	New skirt curtain was provided for the generator near tipping hall No.2.	Closed
	The position of silt curtain near CEDD site office was found shifted. (New item)	To re-located the shifted silt curtain properly.	---	Follow-up
	The floating booms of silt curtain near the tipping hall No.1 was found damaged. (New item)	To repair the damaged silt curtain properly.	---	Follow-up
12 March 2014	The position of silt curtain near CEDD site office was found shifted. (Previous item)	To re-located the shifted silt curtain properly.	---	Follow-up
	The floating booms of silt curtain near the tipping hall No.1 was found damaged. (Previous item)	To repair the damaged silt curtain properly.	---	Follow-up

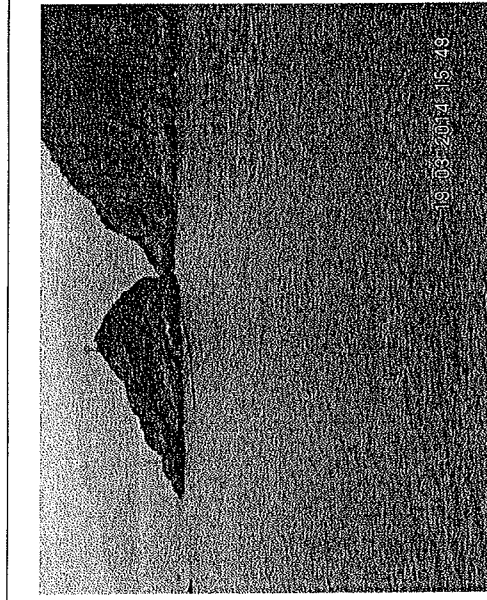
Photo 140319\_002 (Silt curtain near CEDD site office)

19 March 2014	The position of silt curtain near CEDD site office was found shifted. (Previous item)	To re-located the shifted silt curtain properly.	---	Follow-up
	The floating booms of silt curtain near the tipping hall No.1 was found damaged. (Previous item)	To repair the damaged silt curtain properly.	---	Follow-up
	Oil stain was noted from a generator at CREO. (New item)	To clean up the oil stain and treat the contaminated material as chemical waste, and check / repair the generator to avoid oil leakage.	---	Follow-up
	The enclosure of tipping hall No.3 was found damaged. (New item)	To repair the damaged parts of tipping hall properly.	---	Follow-up
26 March 2014	The position of silt curtain near CEDD site office was found shifted. (Previous item)	To re-located the shifted silt curtain properly.	---	Follow-up
	The floating booms of silt curtain near the tipping hall No.1 was found damaged. (Previous item)	To repair the damaged silt curtain properly.	The floating booms of silt curtain near the tipping hall No.1 were repaired.	Closed

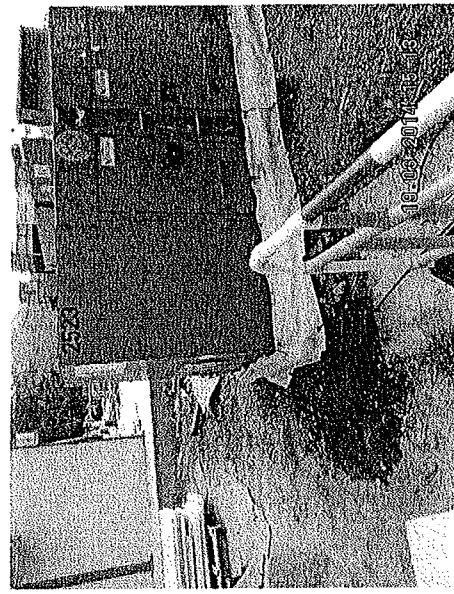
Photo 140319\_003 (CREO)

Oil stain was noted from a generator at CREO. (Previous item)	To clean up the oil stain and treat the contaminated material as chemical waste, and check / repair the generator to avoid oil leakage.	Oil stain from a generator at CREO was cleaned up.	Closed

The Contractor should provide sufficient preventive measures during equipment maintenance works so as to avoid oil leakage on the ground. In the event of any oil leakage, the Contractor should clean up the polluted soil and handle all the materials used for this cleaning works as chemical waste.

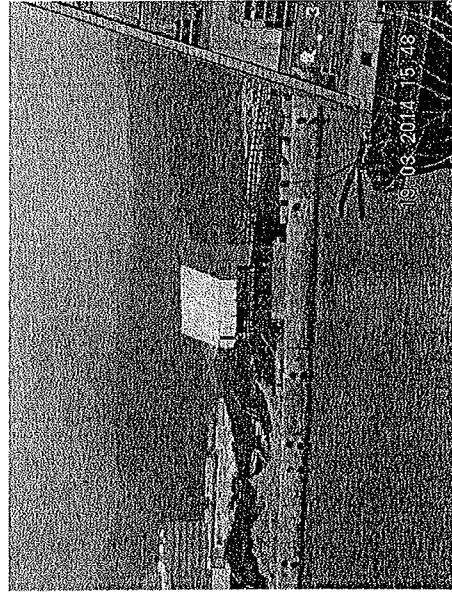
Photo 140319\_004 (Tipping hall No.3)

Date	Key Findings	Action(s) Taken recommended by ET	Action(s) Taken by the Contractor during the ET weekly site audit	Rectification Status by ET
26 March 2014	The enclosure of tipping hall No.3 was found damaged. (Previous item)	To repair the damaged parts of tipping hall properly.	The enclosure of tipping hall No.3 was repaired.	Closed
	Mud and silt were found accumulated inside the drainage near the entrance of sorting facilities.	To clear the accumulated mud and silt inside the drainage.	---	Follow-up
