Contract No.: CV/2013/06
Handling of Surplus Public Fill
(2014-2016)

TSEUNG KWAN O AREA 137 FILL BANK

MONTHLY EM&A REPORT NO.4

(APRIL 2014)

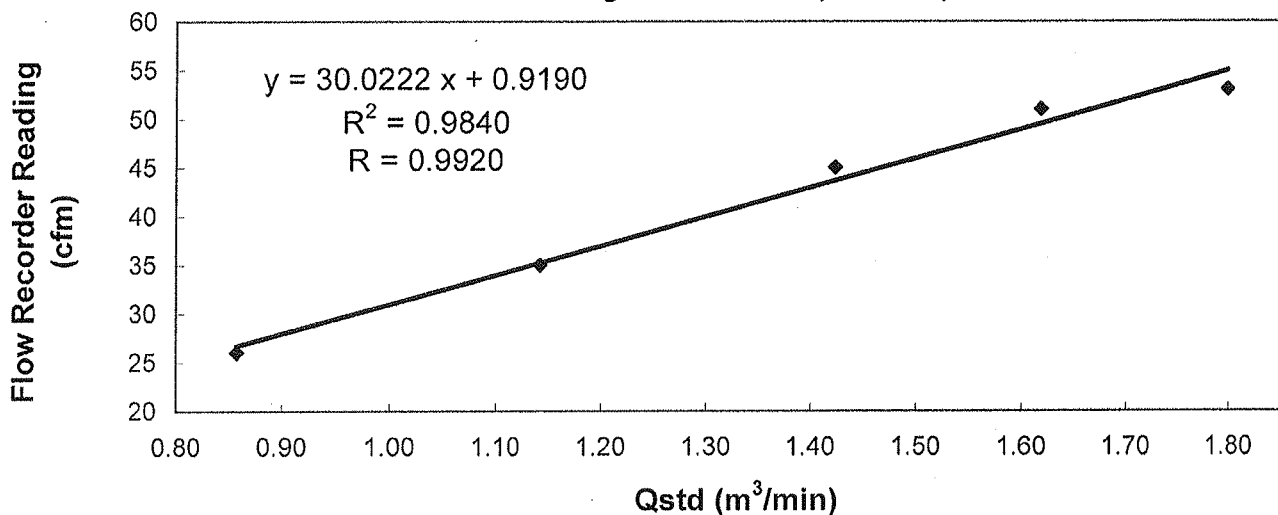
Sampler 10581 Calibration Curve
Site: Tseung Kwan O 137 (TKO-A1)

Results :	Flow recorder reading (cfm)	53	51	45	35	26
	Qstd (Actual flow rate, m ³ /min)	1.80	1.62	1.42	1.14	0.86
	Pressure : 763.56 mm Hg	Temp. : 290 K

Acceptance Criteria : Correlation coefficient (r) of the calibration curve greater than 0.990 after a 5-point calibration.

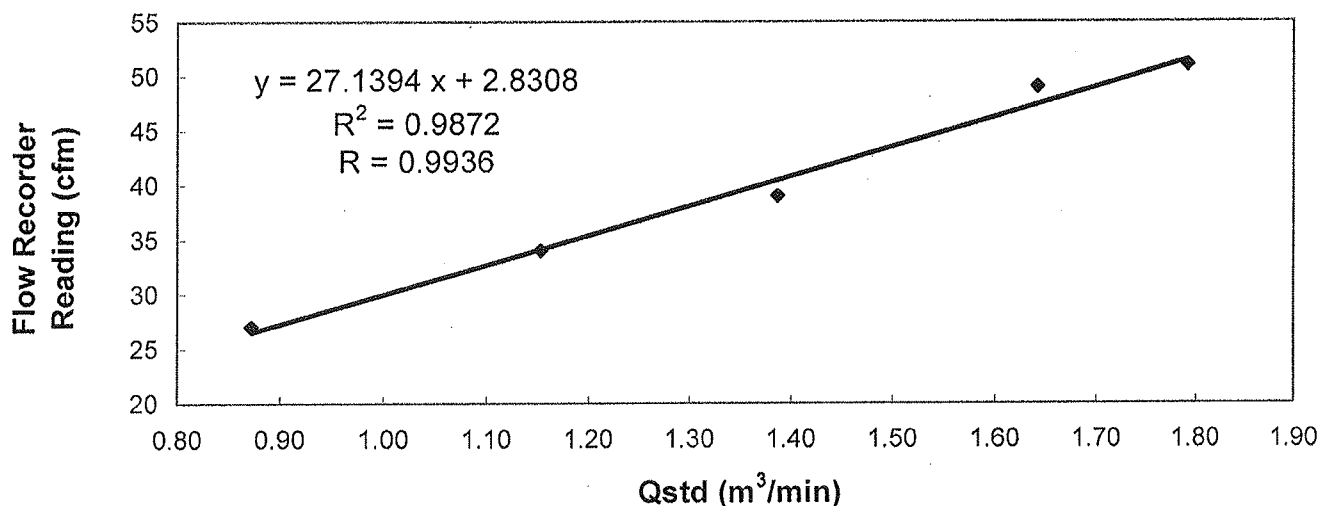
Sampler 1172 Calibration Curve
Site: Tseung Kwan O 137 (TKO-A2a)

Flow recorder reading (cfm)	51	49	39	34	27
Qstd (Actual flow rate, m ³ /min)	1.79	1.64	1.39	1.15	0.87
Pressure :	763.56	mm Hg	Temp. :	290	K

Acceptance Criteria : Correlation coefficient (r) of the calibration curve greater than 0.990 after a 5-point calibration.

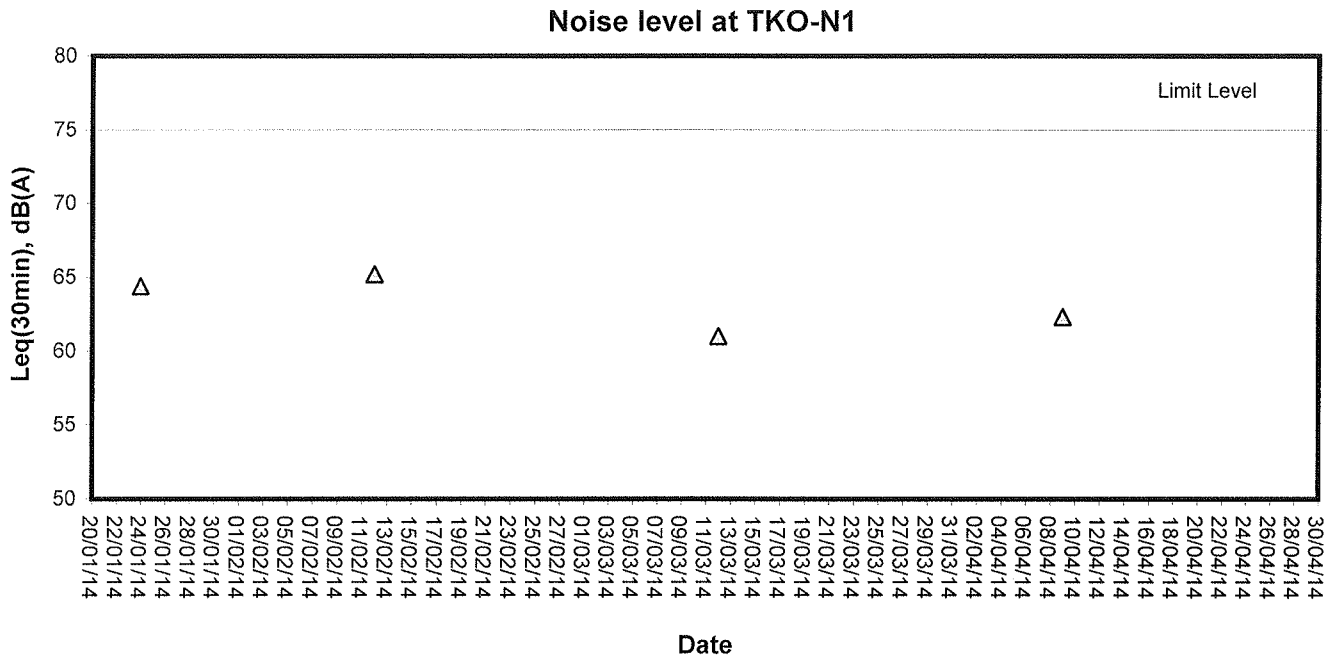
Noise Monitoring (Day-time)

Date	Start Sampling Time (hh:mm)	Noise Level dB (A)			Wind Speed (m/s)	Weather Condition
		L _{eq} (30min)	L ₁₀	L ₉₀		
09/04/14	08:44	62.3	64.8	58.9	0.3	Fine

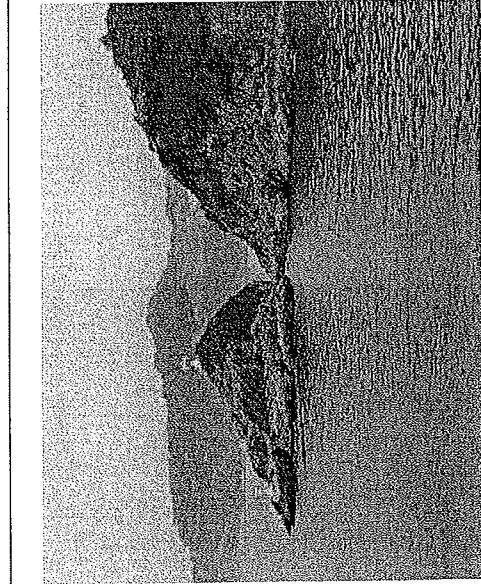
Photo 140402_002 (Silt curtain near CEDD site office)

Date	Key Findings	Action(s) Taken recommended by ET	Action(s) Taken by the Contractor during the ET weekly site audit	Rectification Status by ET
02 April 2014	The position of silt curtain near CEDD site office was found shifted. (Previous item)	To re-located the shifted silt curtain properly.	---	Follow-up
	Mud and silt were found accumulated inside the drainage near the entrance of sorting facilities. (Previous item)	To clear the accumulated mud and silt inside the drainage.	mud and silt accumulated inside the drainage near the entrance of sorting facilities were cleared.	Closed
	A generator near Contractor's site office was found without skirt curtain. (New item)	To provide appropriate skirt curtain as soon as possible.	---	Follow-up
	A generator near wet mud zone was found without skirt curtain. (New item)	To provide appropriate skirt curtain as soon as possible.	---	Follow-up
09 April 2014	The position of silt curtain near CEDD site office was found shifted. (Previous item)	To re-located the shifted silt curtain properly.	---	Follow-up

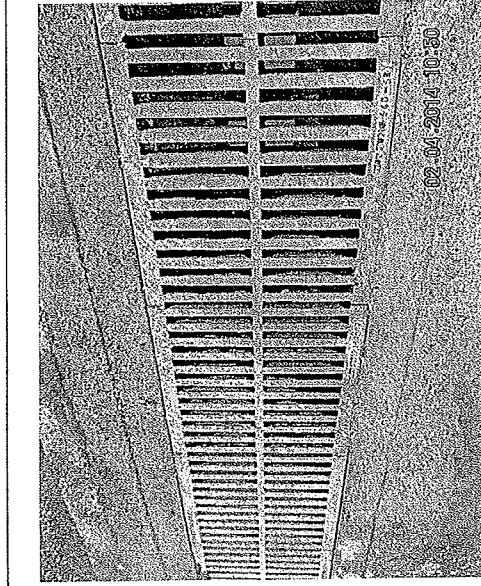
Photo 140402_003 (Near the entrance of sorting facilities) (Improved)

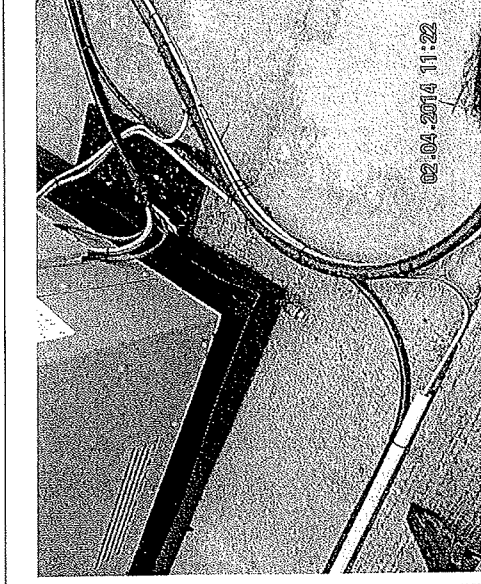
Photo 140402_003 (Near Contractor's site office)

A generator near Contractor's site office was found without skirt curtain. (Previous item)	To provide appropriate skirt curtain as soon as possible.	Skirt curtain was provided for the generator near Contractor's site office.	Closed
	A generator near wet mud zone was found without skirt curtain. (Previous item)	To provide appropriate skirt curtain as soon as possible.	---	Follow-up
	Skirt curtain for a generator near tipping hall No.3 was found covered the drip tray improperly. (New item)	To cover the drip tray properly by using appropriate skirt curtain.	---	Follow-up
16 April 2014	The position of silt curtain near CEDD site office was found shifted. (Previous item)	To re-located the shifted silt curtain properly.	The silt curtain near CEDD site office was relocated to right position.	Closed
	A generator near wet mud zone was found without skirt curtain. (Previous item)	To provide appropriate skirt curtain as soon as possible.	skirt curtain was provided for the generator near wet mud zone.	Closed

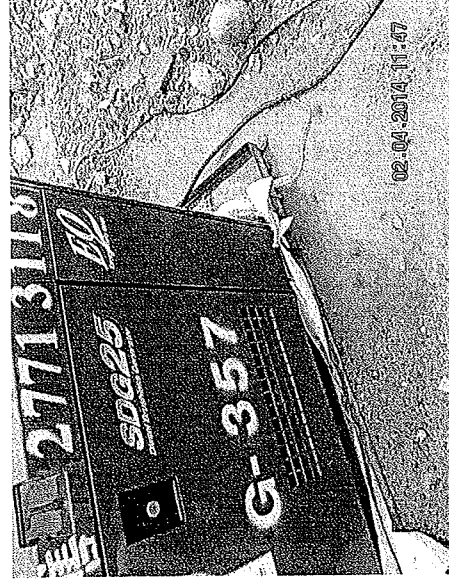
Photo 140402_004 (Near wet mud zone)

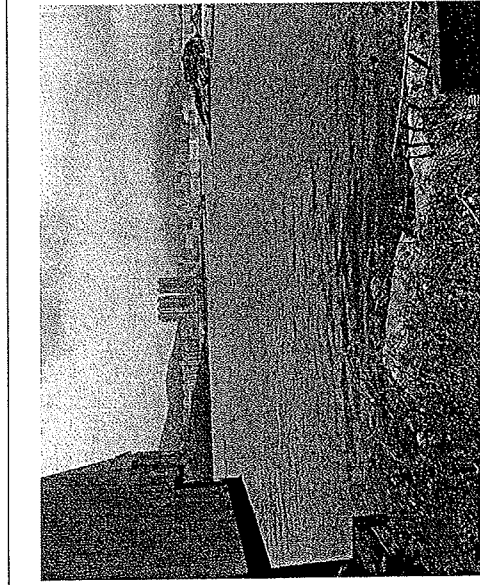
Photo 140409_001 (Silt curtain near CEDD site office)

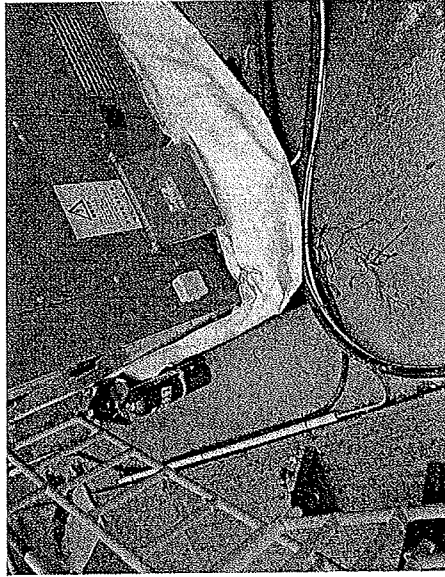
Photo 140409_002 (Near Contractor's site office) (Improved)

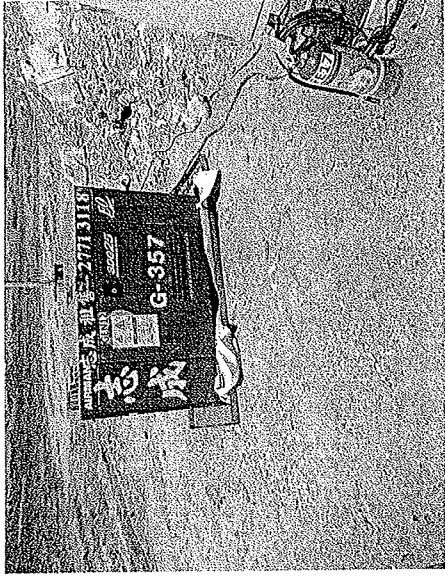
Photo 140409_003 (Near wet mud zone)

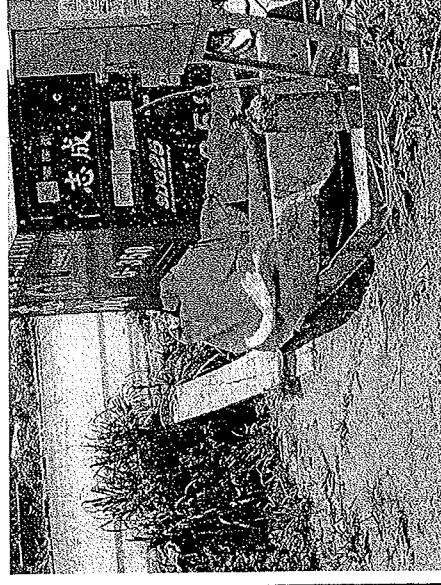
Photo 140409_004 (Near tipping hall No.3)

Skirt curtain for a generator near tipping hall No.3 was found covered the drip tray improperly. (Previous item)	To cover the drip tray properly by using appropriate skirt curtain.	Skirt curtain for a generator near tipping hall No.3 was found covered the drip tray properly.	Closed
23 April 2014	No defective work or observation was recorded during the weekly site inspection.

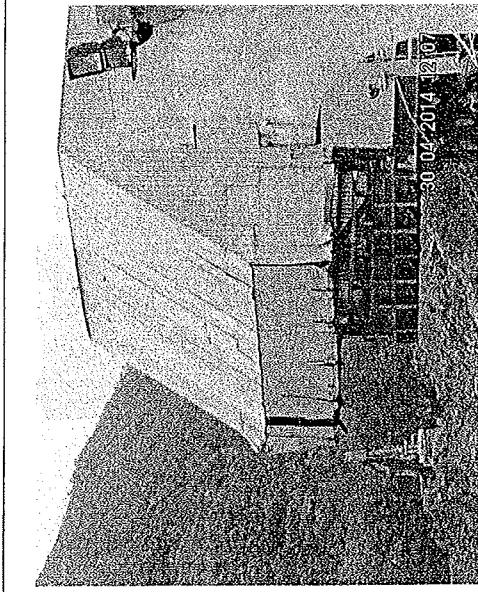
Photo 140430_001 (Tipping hall No. 1)

Date	Key Findings	Action(s) Taken recommended by ET	Action(s) Taken by the Contractor during the ET weekly site audit	Rectification Status by ET
30 April 2014	The enclosure of tipping hall No.1 was broken. (New item)	To repair the damaged part of tipping hall properly.	---	Follow-up
	Oil stain was found on the ground at Chun Wo site office. (New item)	To clear the oil stain and treat the contaminated materials as chemical waste.	---	Follow-up
	Tussock near CEDD site office was found overgrown. (New item)	To clear the overgrown grass to avoid mosquito breeding.	---	Follow-up
