**Contract No.: CV/2013/06
Handling of Surplus Public Fill
(2014-2016)**

TSEUNG KWAN O AREA 137 FILL BANK

MONTHLY EM&A REPORT NO.7

(JULY 2014)

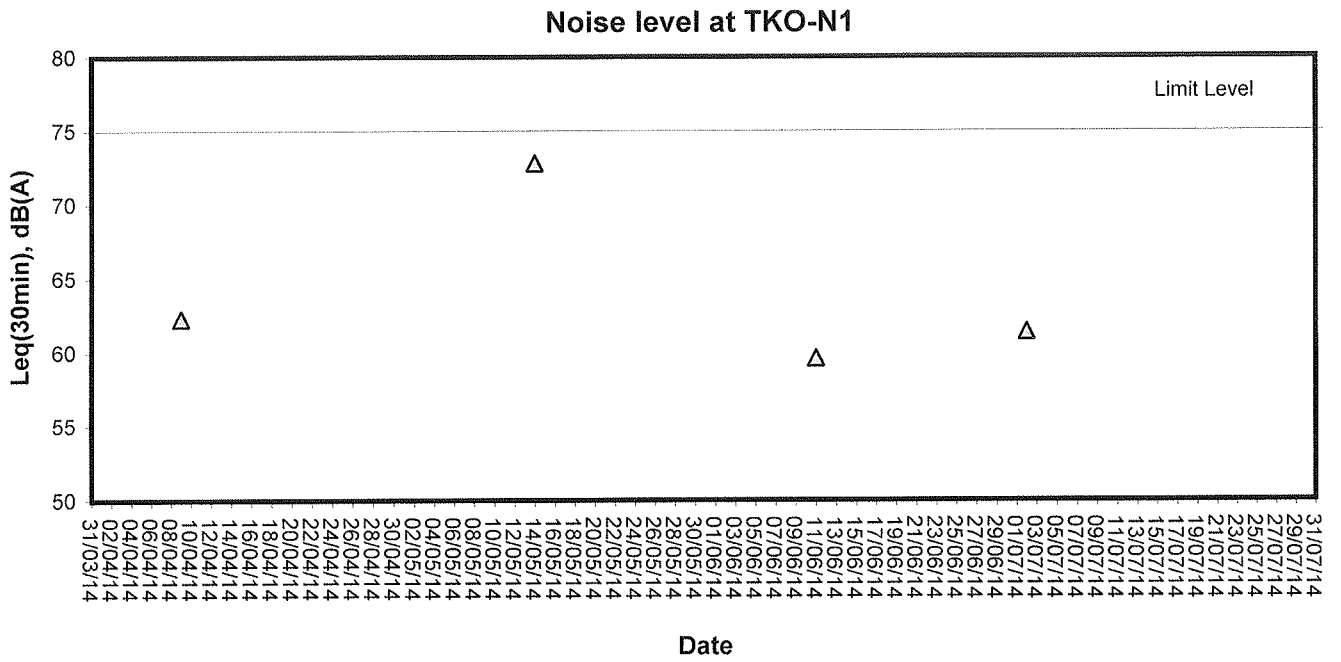
Noise Monitoring (Day-time)

Date	Start Sampling Time (hh:mm)	Noise Level dB (A)			Wind Speed (m/s)	Weather Condition
		L _{eq} (30min)	L ₁₀	L ₉₀		
02/07/14	09:00	61.4	64.6	58.7	0.4	Fine
