**CONTRACT NO. CV/2013/09
TEMPORARY CONSTRUCTION WASTE
SORTING FACILITIES, 2014-2016
AT TSEUNG KWAN O AREA 137
MONTHLY EM&A REPORT NO.7
(JULY 2014)**

Issue Date: 11 August 2014

Report No.: ENA41340

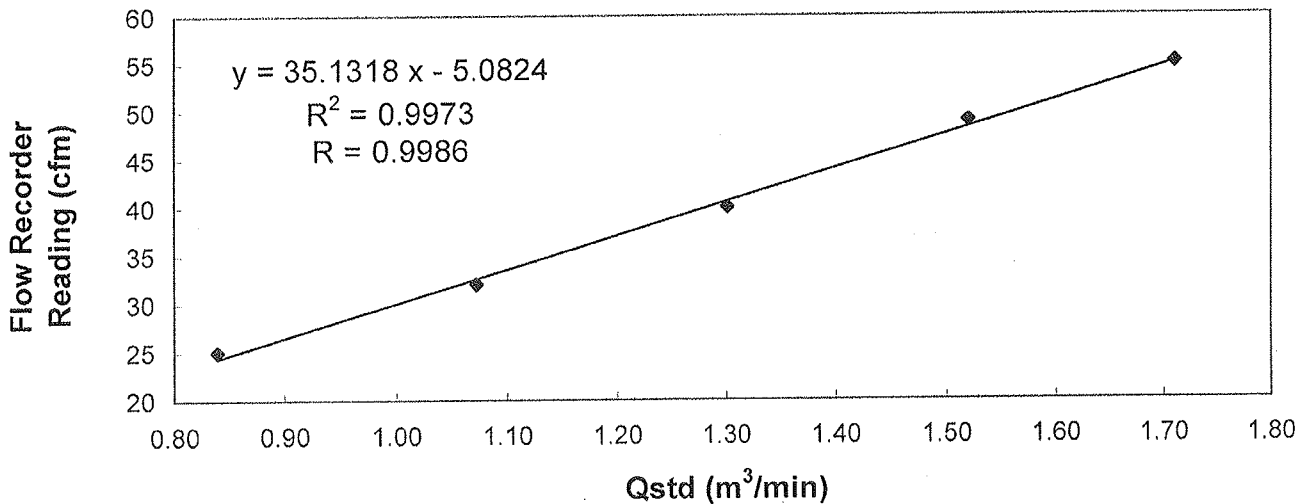
Sampler 2485 Calibration Curve
Site: TKO CWSF - TKO2

Results	Flow recorder reading (cfm)	55	49	40	32	25
	Qstd (Actual flow rate, m ³ /min)	1.71	1.52	1.30	1.07	0.84
Pressure :		763.56 mm Hg		Temp. :		303 K

Acceptance Criteria : Correlation coefficient (r) of the calibration curve greater than 0.990 after a 5-point calibration

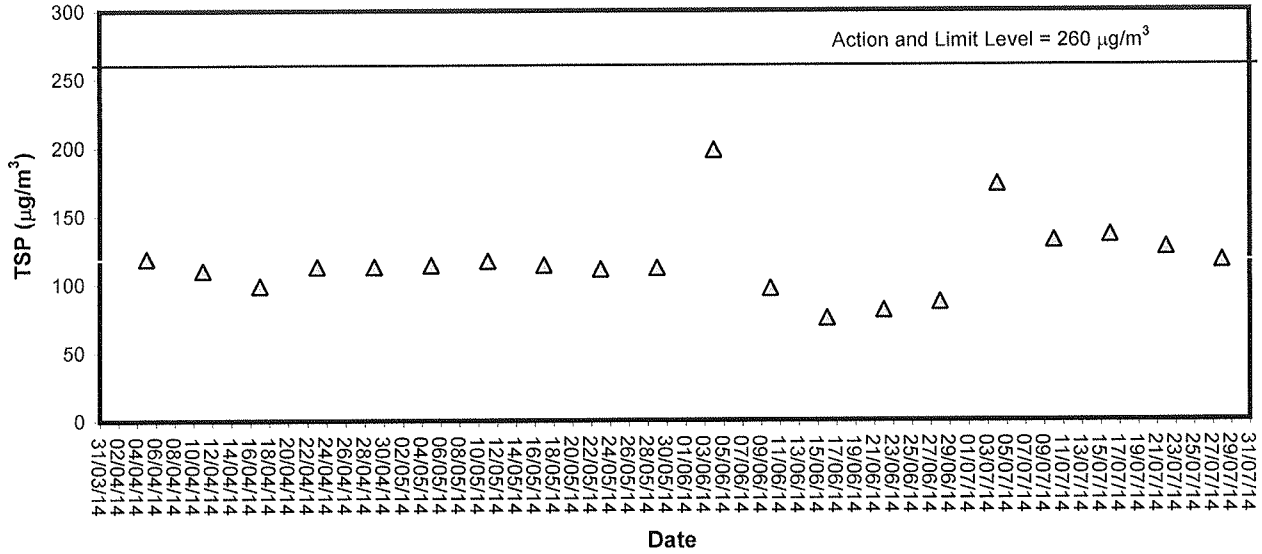
24-hour TSP level at TKO2

No exceedance of Action and Limit levels was recorded for 1-hr and 24-hr TSP monitoring in the reporting month.

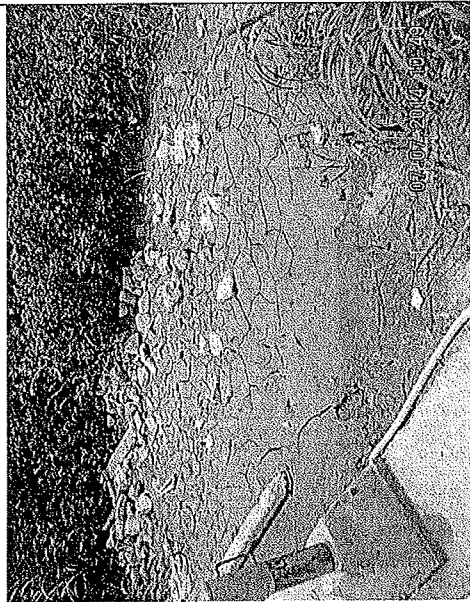
Photo 140707_001 (Catchpit near CEDD site office at Portion A)

Item	Details of defective works or observations	Proposed Follow Up Action	Photo Ref.	Further Action Required (Yes/No)	Target Completion Date
1	The Catchpit near CEDD site office at Portion A was found full of mud.	To clear the accumulated mud and maintain the catchpit properly.	140707_001	Yes	14/07/14

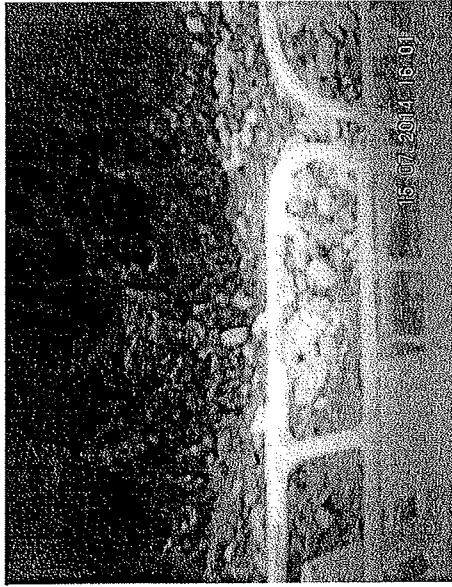
Photo 140715_001 (Catchpit near CEDD site office at Portion A)

Item	Details of defective works or observations	Proposed Follow Up Action	Photo Ref.	Further Action Required (Yes/No)	Target Completion Date
1	Follow up action to item 1 on 07/07/14, mud was still found accumulated inside the Catchpit near CEDD site office at Portion A.	To clear the accumulated mud and maintain the catchpit properly.	140715_001	Yes	22/07/14

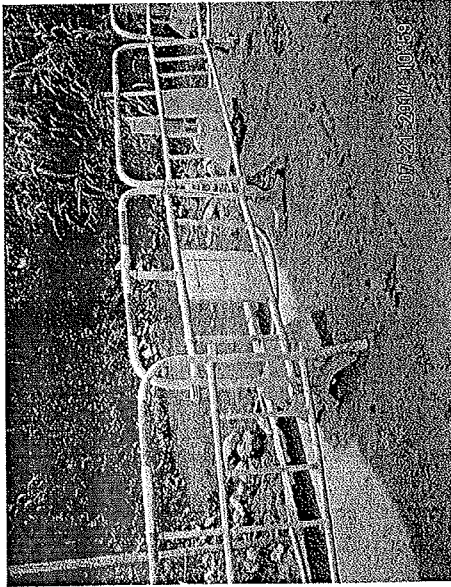
Photo 140721_001 (Catchpit near CEDD site office at Portion A)

Item	Details of defective works or observations	Proposed Follow Up Action	Photo Ref.	Further Action Required (Yes/No)	Target Completion Date
1	Follow up action to item 1 on 07/07/14 and item 1 on 15/07/14, mud accumulated inside the Catchpit near CEDD site office at Portion A was cleared.	--	140721_001	No	--
2	Oil stain was noted on the ground at Contractor's site office (China Harbour).	To clear the oil stain properly.	140721_002	Yes	28/07/14

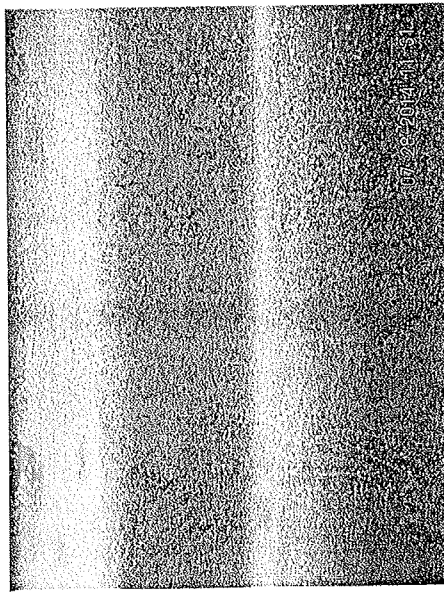
<p>Photo 140728_001 (Contractor's site office)</p>

Item	Details of defective works or observations	Proposed Follow Up Action	Photo Ref.	Further Action Required (Yes/No)	Target Completion Date
1	Follow up action to item 2 on 21/07/14, oil stain noted on the ground at Contractor's site office (China Harbour) was cleared.	---	140728_001	No	---
2	Stagnant water was found inside the drip tray at Contractor's site office (China Harbour).	To drain the stagnant water out or apply pesticide to avoid mosquito breeding.	140728_002	Yes	04/08/14
3	The skirt curtain for a generator at Contractor's site office was found covered improperly.	To cover the generator by using appropriate skirt curtain properly.	140728_003	Yes	04/08/14
4	Several oil containers were found discarded at Contractor's site office.	To store the oil containers in an appropriate chemical storage area.	140728_004	Yes	04/08/14
5	Weed was found over-grown at Portion A.	To clear the overgrown weed to avoid mosquito breeding.	140728_005	Yes	04/08/14
