**Contract No.: CV/2013/06
Handling of Surplus Public Fill
(2014-2016)**

TSEUNG KWAN O AREA 137 FILL BANK

MONTHLY EM&A REPORT NO.9

(SEPTEMBER 2014)

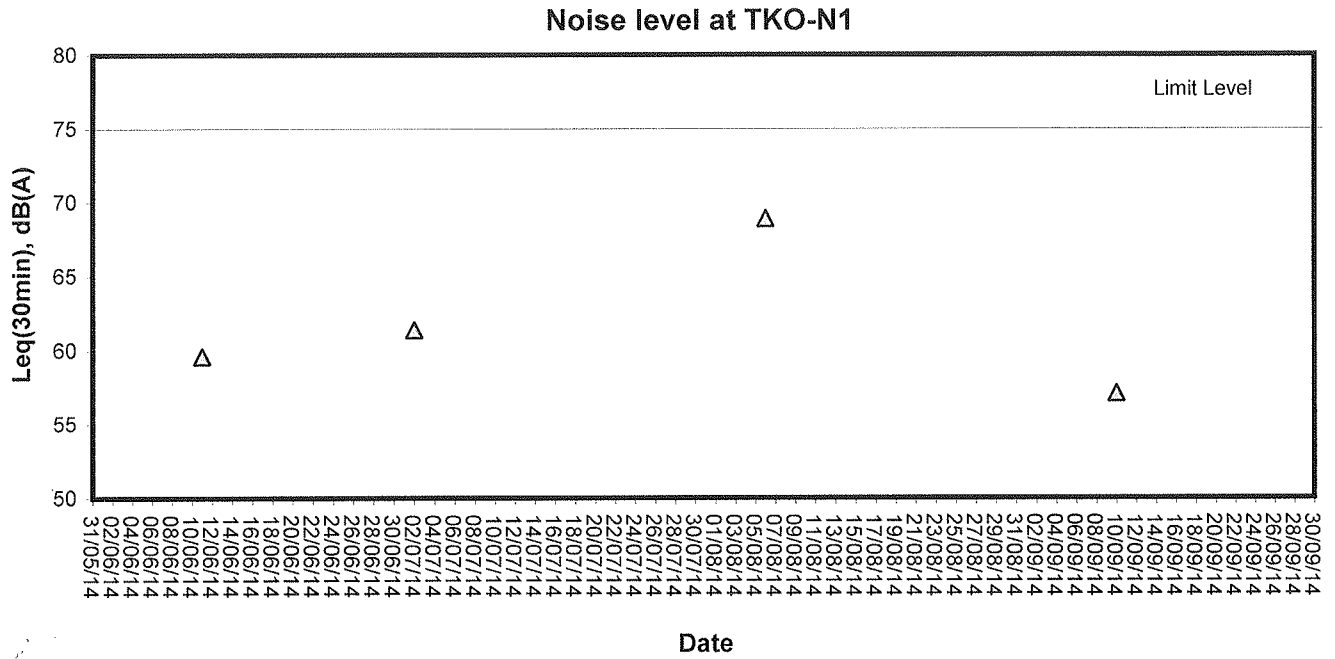
Noise Monitoring (Day-time)

Date	Start Sampling Time (hh:mm)	Noise Level dB (A)			Wind Speed (m/s)	Weather Condition
		L _{eq} (30min)	L ₁₀	L ₉₀		
10/09/14	13:35	57.1	59.4	55.3	0.3	Fine

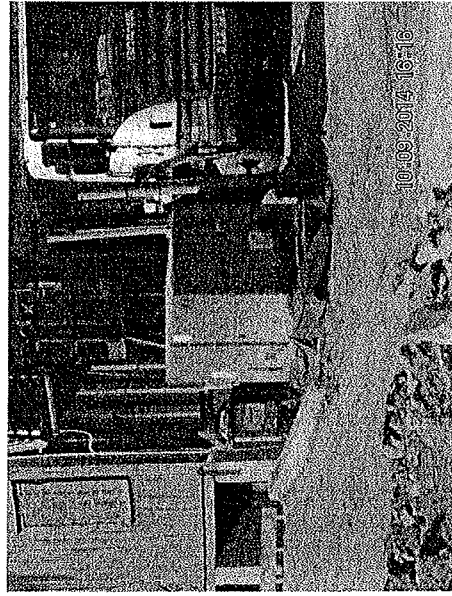
Photo 140910_001 (A4 zone)

10 September 2014	Oil leakage was found from a generator without coving with skirt curtain at A4 zone. (Previous item)	To clean up the oil stain and contaminated material as chemical waste, and provide appropriate skirt curtain for the generator.	no oil leakage was found from a generator without coving with skirt curtain at A4 zone.	Closed
	Stockpiles of sand were found near the assess road to sorting facilities at Area A4. (New item)	To cover the stockpiles with tarpaulin sheets properly to avoid dust emission.	---	Follow-up
	Assess road to sorting facilities at Area A4 was overgrown with grass and weeds. (New item)	To clear the overgrown grass and weeds as soon as possible.	---	Follow-up
19 September 2014	Stockpiles of sand were found near the assess road to sorting facilities at Area A4. (Previous item)	To cover the stockpiles with tarpaulin sheets properly to avoid dust emission.	Stockpiles of sand found near the assess road to sorting facilities at Area A4 were removed.	Closed

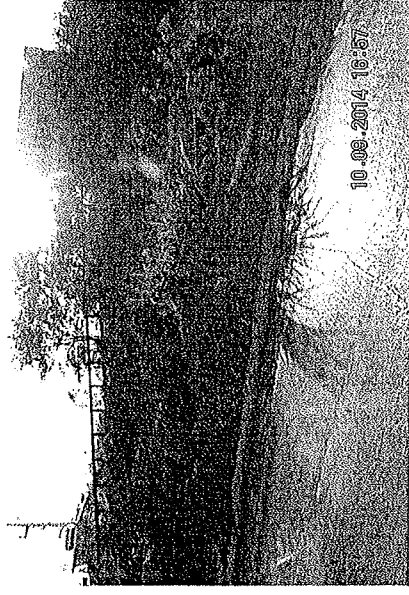
Photo 140910_002 (Assess road to sorting facilities at Area A4)

Assess road to sorting facilities at Area A4 was overgrown with grass and weeds. (Previous item)	To clear the overgrown grass and weeds as soon as possible.	Overgrown grass and weeds at the assess road to sorting facilities at Area A4 was cleared.	Closed
	Black smoke was noted emitted from a excavator at A4 Zone. (New item)	To stop to use the defect excavator until repair properly.	---	Follow-up
24 September 2014	Black smoke was noted emitted from a excavator at A4 Zone. (Previous item)	To stop to use the defect excavator until repair properly.	The excavator emitted black smoke at A4 Zone was replaced.	Closed
