**Contract No.: CV/2013/06
Handling of Surplus Public Fill
(2014-2016)**

TSEUNG KWAN O AREA 137 FILL BANK

MONTHLY EM&A REPORT NO.27

(MARCH 2016)

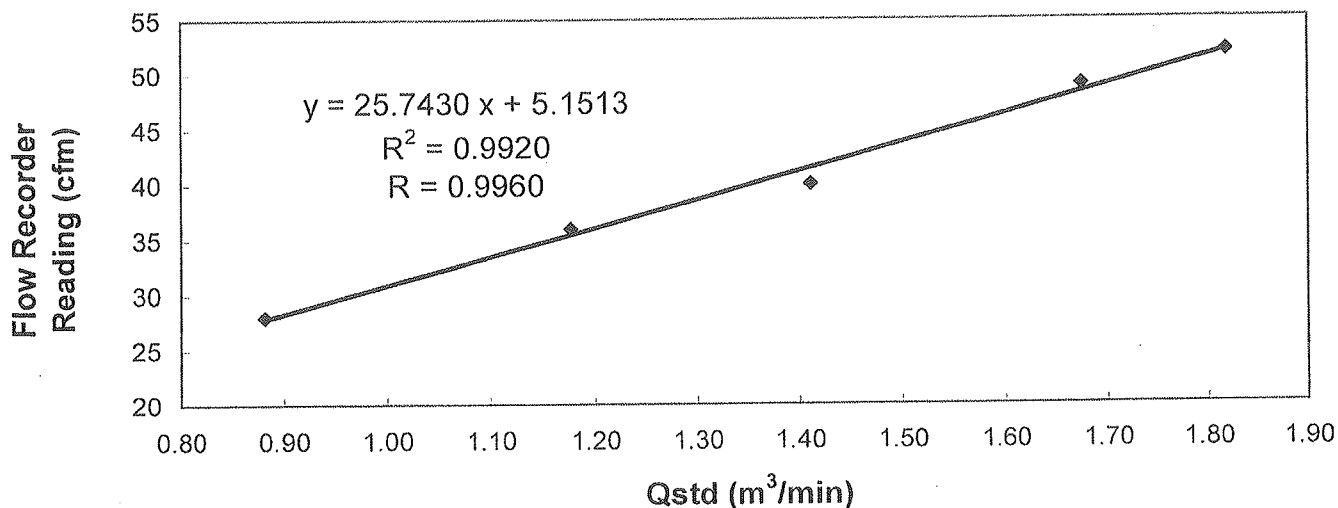
Sampler 1172 Calibration Curve
Site: Tseung Kwan O 137 (TKO-A2a)

Flow recorder reading (cfm)	52	49	40	36	28
Qstd (Actual flow rate, m ³ /min)	1.82	1.68	1.41	1.18	0.88
Pressure :	763.56	mm Hg	Temp. :	284	K

Acceptance Criteria : Correlation coefficient (r) of the calibration curve greater than 0.990 after a 5-point calibration.

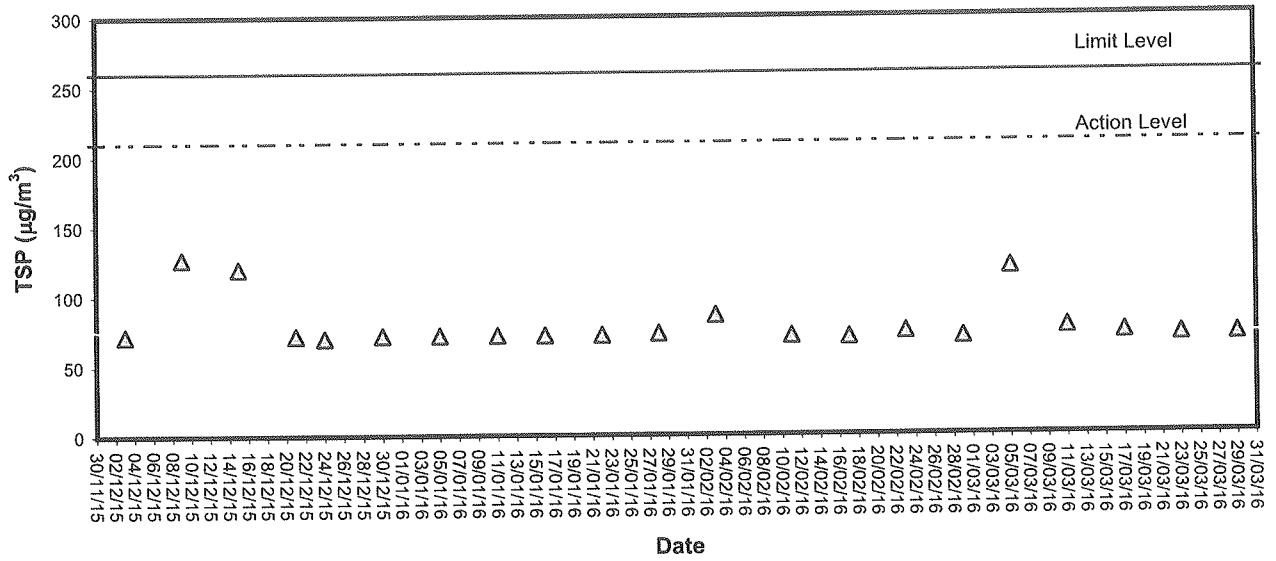
24-hour TSP level at TKO-A1

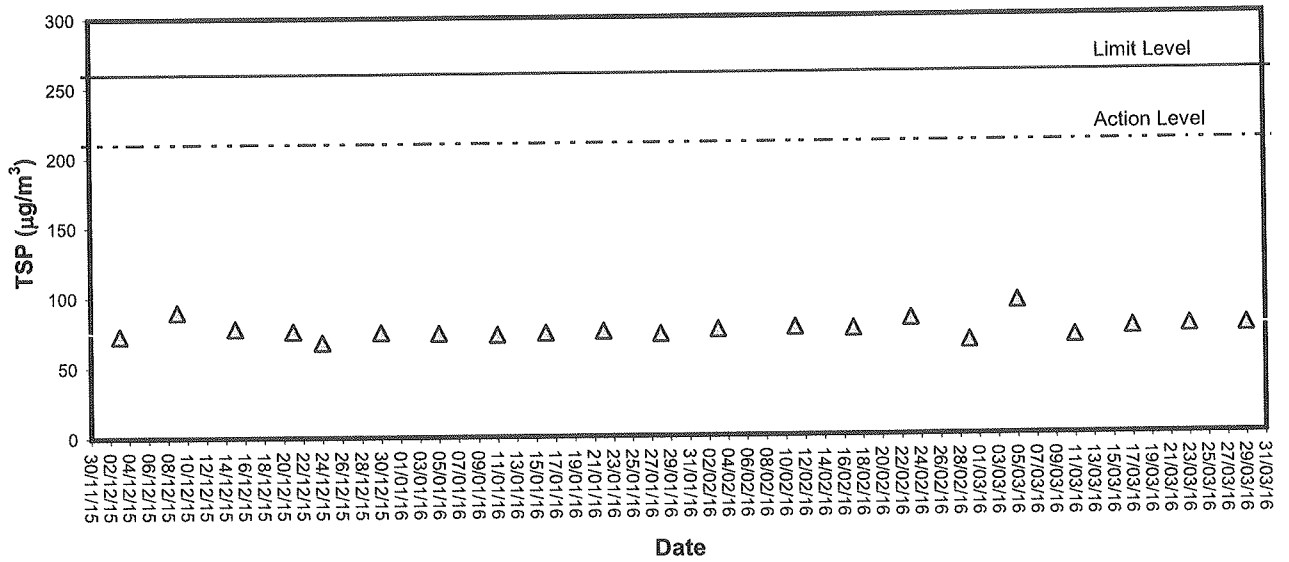
24-hour TSP level at TKO-A2a

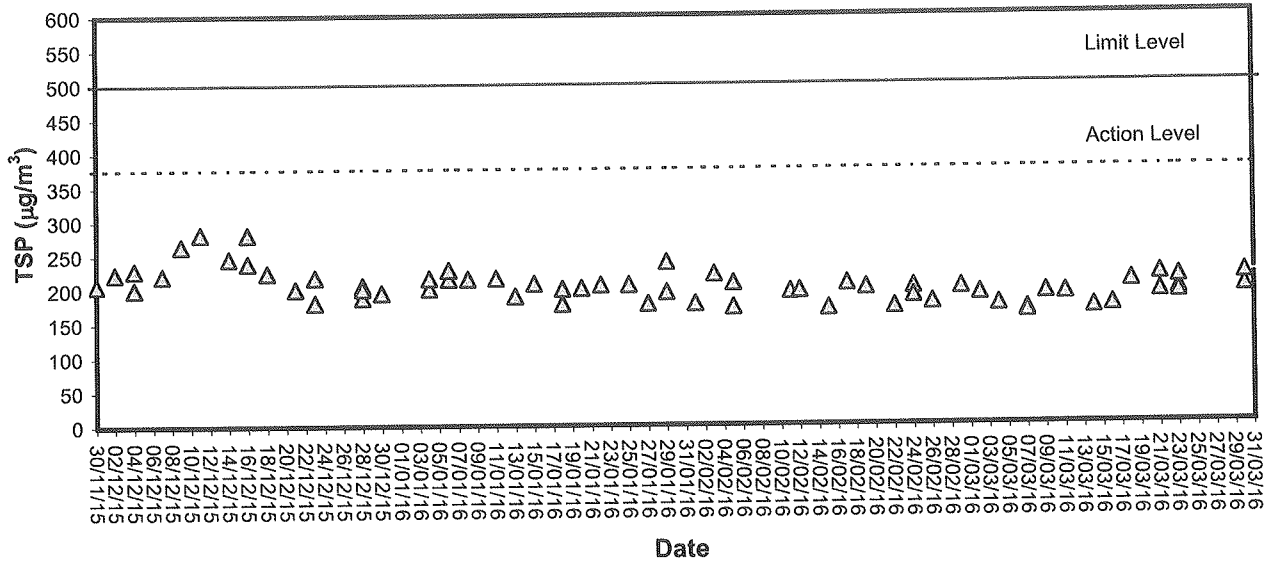
1-hour TSP level at TKO-A1

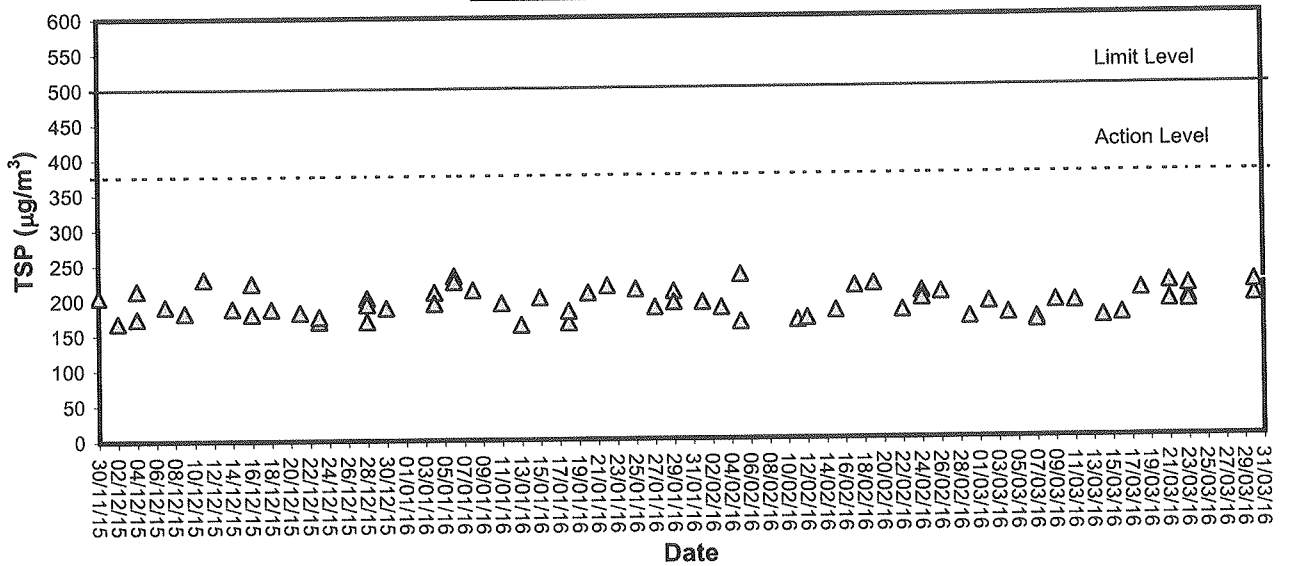
1-hour TSP level at TKO-A2a

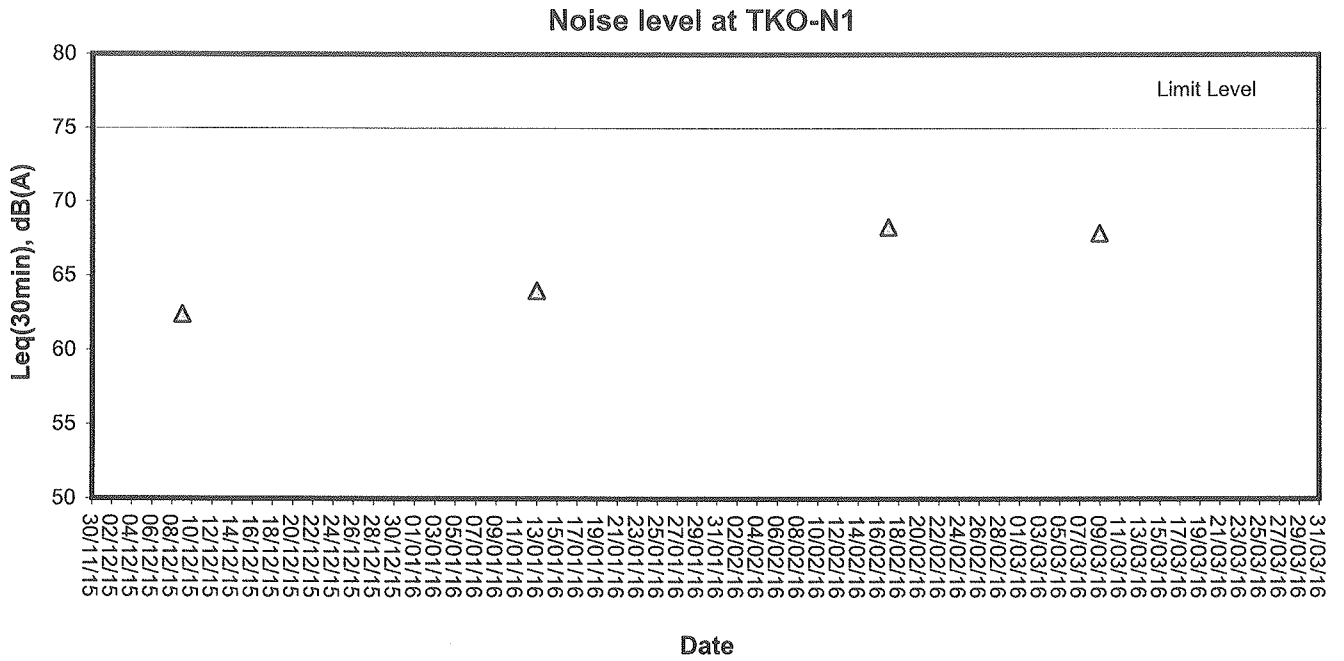
Noise Monitoring (Day-time)

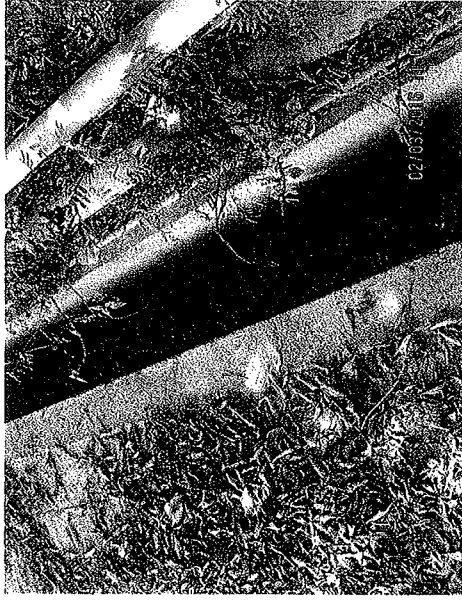
Photo 160302_001 (U-channel near site entrance)

Item	Details of defective works or observations	Proposed Follow Up Action	Photo Ref.	Further Action Required (Yes/No)	Target Completion Date
1	Debris of dead leaves were accumulated inside the u-channel near site entrance.	To clear the accumulated leaves in order to avoid any blockage.	160302_001	Yes	09/03/16

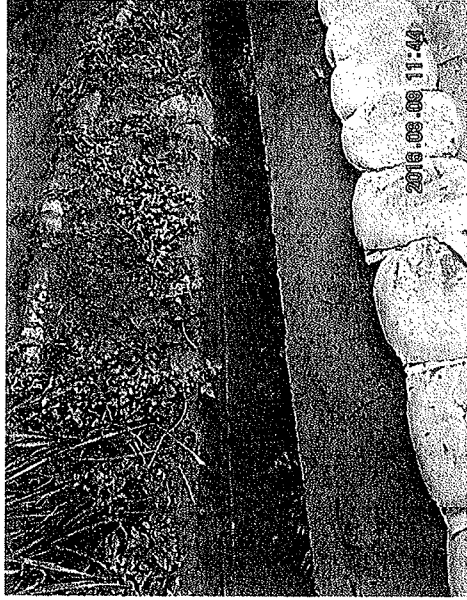
Photo 160309_001 (U-channel near site entrance)

Item	Details of defective works or observations	Proposed Follow Up Action	Photo Ref.	Further Action Required (Yes/No)	Target Completion Date
1	Follow up the action to item 1 on 02/03/2016, Debris of dead leaves were still accumulated inside the u-channel near site entrance. <i>debris</i>	To clear the accumulated leaves in order to avoid any blockage.	160309_001	Yes	09/03/16 <i>16</i>
2	Stagnant Water was observed on the ground near work shop. <i>Water</i>	To remove the stagnant water as soon as possible.	160309_002	Yes	16/03/16

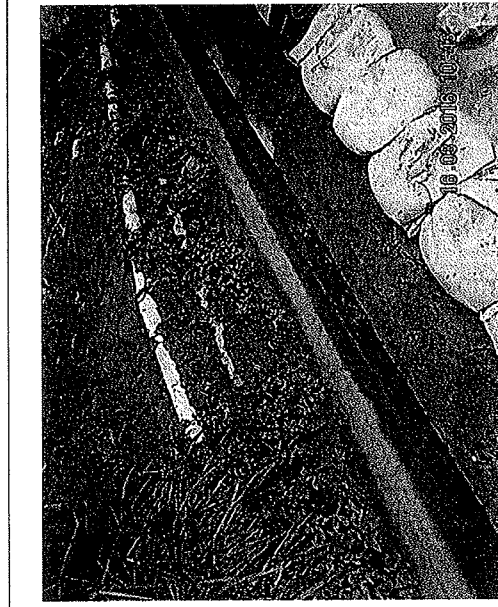
Photo 160316_001 (U-channel near site entrance) (Improved)

Item	Details of defective works or observations	Proposed Follow Up Action	Photo Ref.	Further Action Required (Yes/No)	Target Completion Date
1	Follow up the action to item 1 on 02/03/2016 and item 1 on 09/03/16, debris of dead leaves accumulated inside the u-channel near site entrance were cleared.	--	160316_001	No	--
2	Follow up the action to item 2 on 09/03/16, stagnant water observed on the ground near work shop was cleared.	--	160316_002	No	--
	Mud and silt were noted accumulated inside the u-channel near wheel washing bay.	To clear the accumulated mud and silt in order to avoid any blockage.	160316_003	Yes	23/03/16

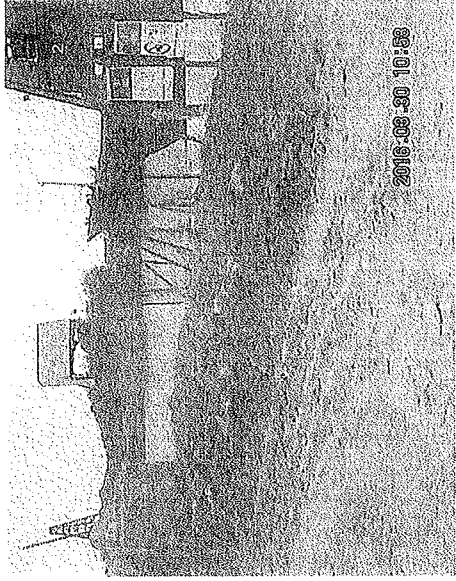
Photo 160330_002(BHA)

Mud was found accumulated along the barge handling area (BHA). (New item)	To clear the accumulated mud properly and provide the barrier to prevent fill material dropping to the sea.	---	Follow-up

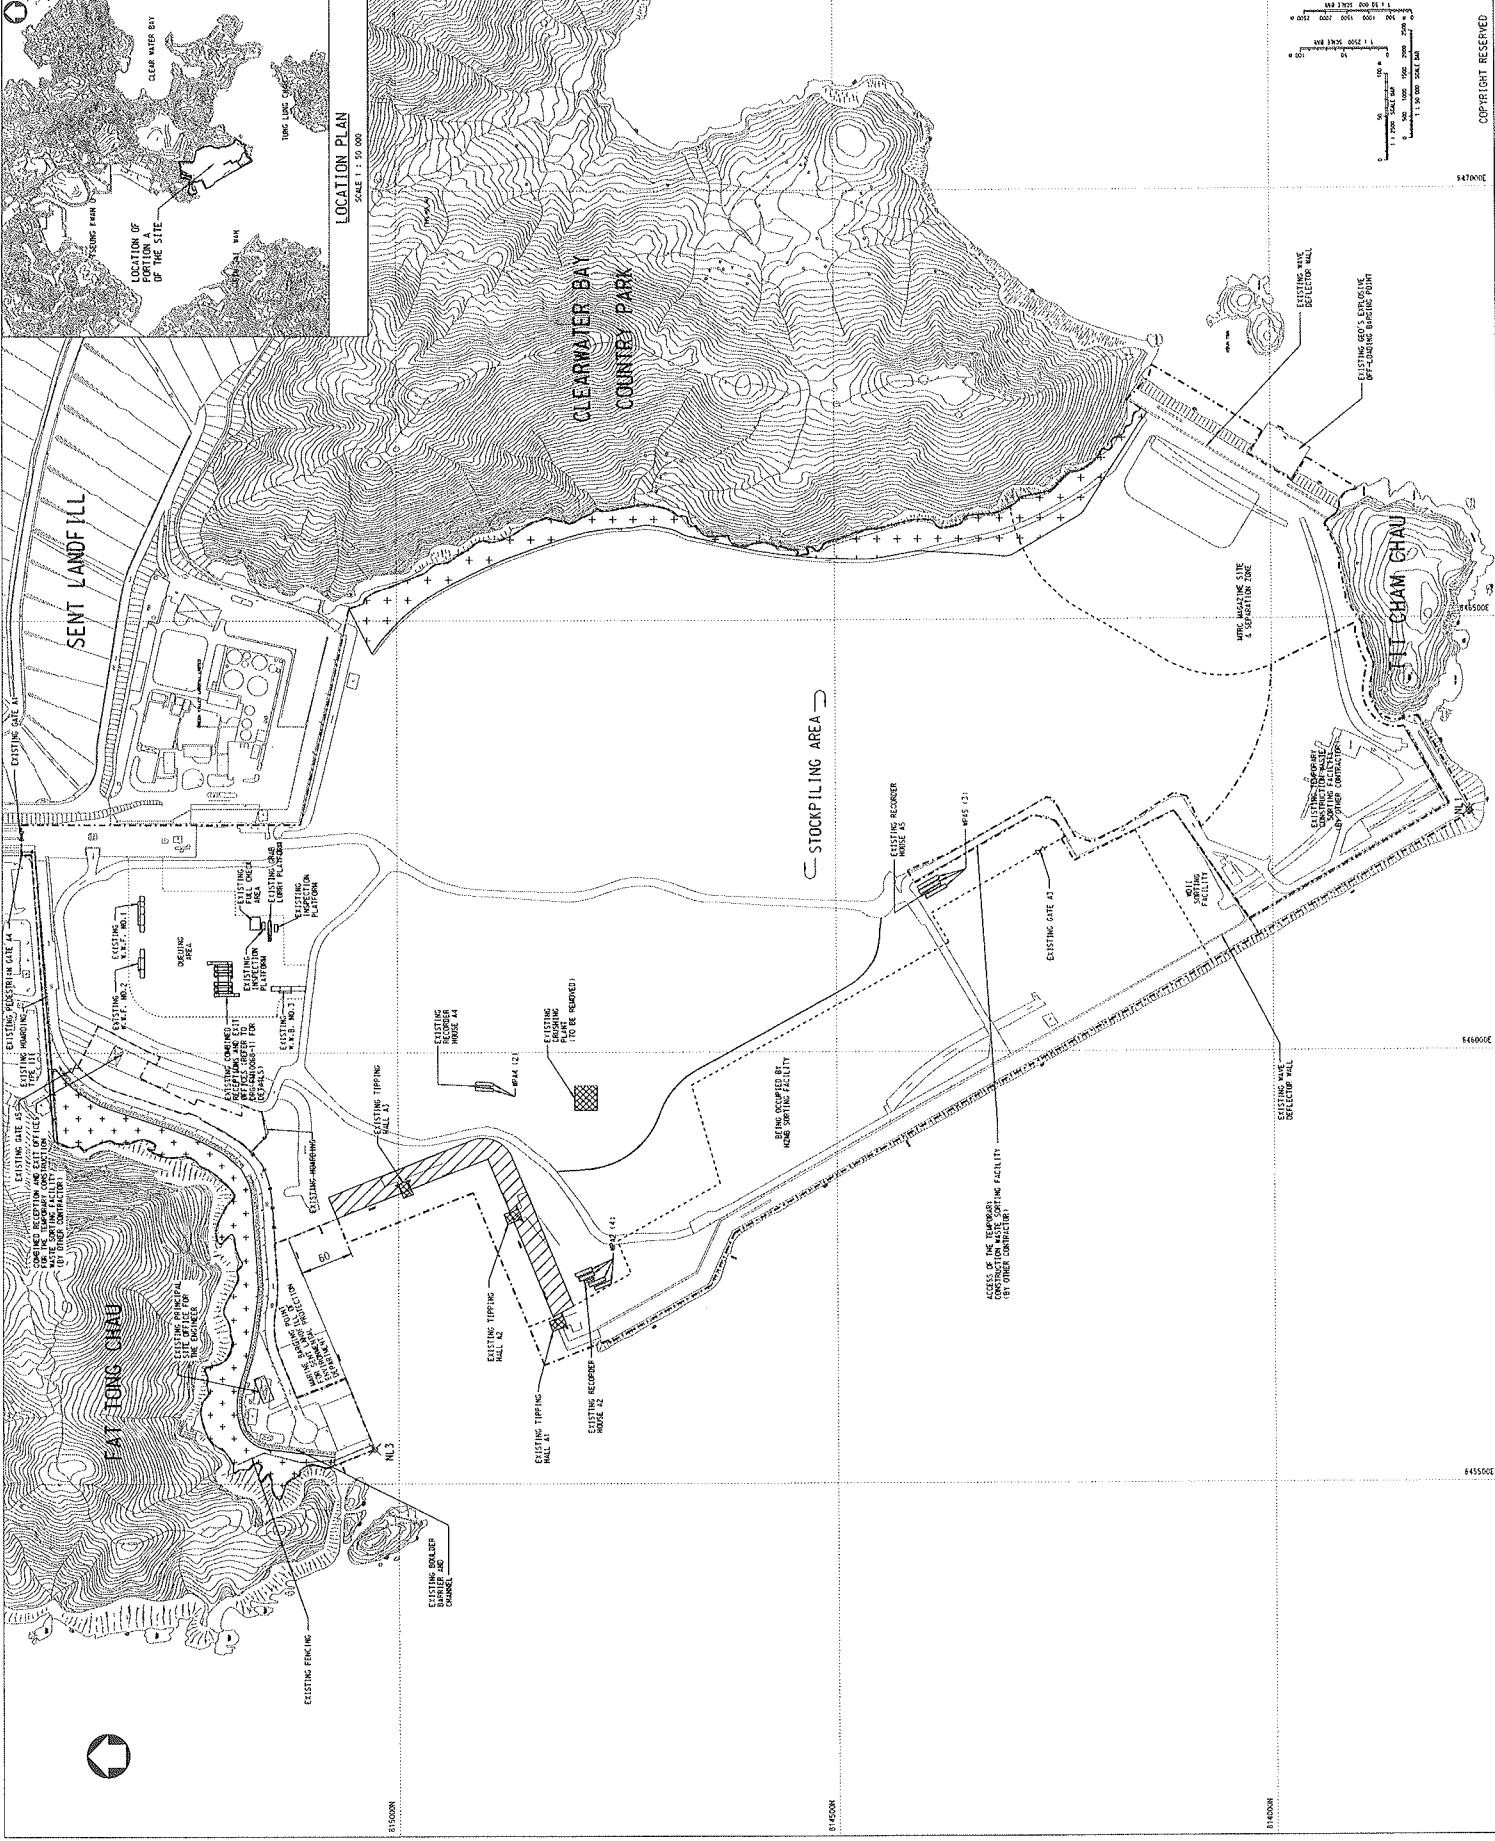
DRAWING NO. **FM10068-6**
 SCALE 1:1000
 SHEET NO. 45 OF 48
 OFFICE: **FILL MANAGEMENT DIVISION CIVIL ENGINEERING OFFICE**
CEDD
 CIVIL ENGINEERING AND DEVELOPMENT DEPARTMENT

DRAWING TITLE
TSEUNG KWAN O AREA 137 FILL BANK - GENERAL LAYOUT OF EXISTING FACILITIES
