**Contract No.: CV/2013/06  
Handling of Surplus Public Fill  
(2014-2016)**

**TSEUNG KWAN O AREA 137 FILL BANK**

**MONTHLY EM&A REPORT NO.28**

**(APRIL 2016)**

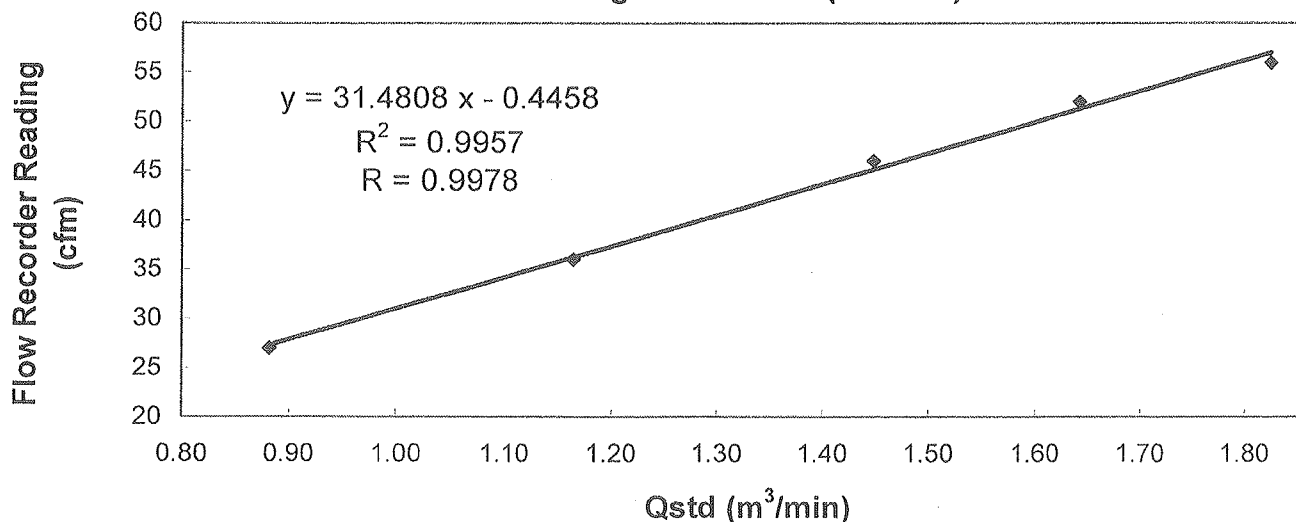
**Sampler 10581 Calibration Curve**  
Site: Tseung Kwan O 137 (TKO-A1)

Results	Flow recorder reading (cfm)	56	52	46	36	27
	Qstd (Actual flow rate, m <sup>3</sup> /min)	1.83	1.64	1.45	1.17	0.88
	Pressure : 763.56 mm Hg	Temp. : 284 K

Acceptance Criteria : Correlation coefficient (r) of the calibration curve greater than 0.990 after a 5-point calibration.

The high volume sampler complies\* / does-not-comply\* with the specified requirements and is deemed acceptable\* / unacceptable\* for use.

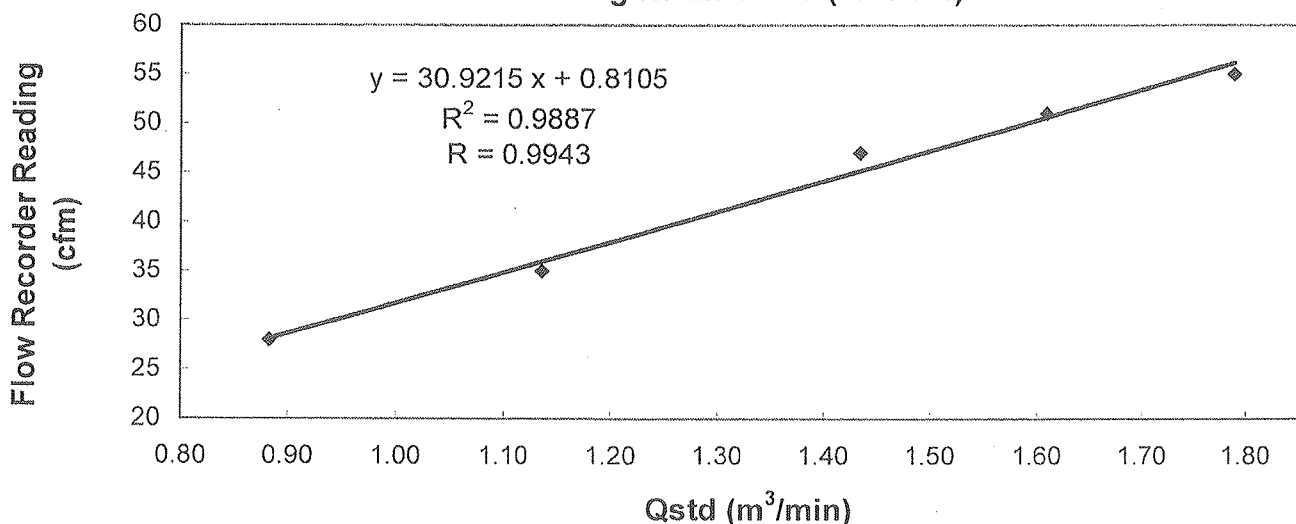
**Sampler 10581 Calibration Curve**  
Site: Tseung Kwan O 137 (TKO-A1)

Flow recorder reading (cfm)	55	51	47	35	28
Qstd (Actual flow rate, m <sup>3</sup> /min)	1.79	1.61	1.43	1.14	0.88
Pressure :	763.56			Temp. :	293 K

Acceptance Criteria : Correlation coefficient (r) of the calibration curve greater than 0.990 after a 5-point calibration.

The high volume sampler complies\* / does not comply\* with the specified requirements and is deemed acceptable\* / unacceptable\* for use.

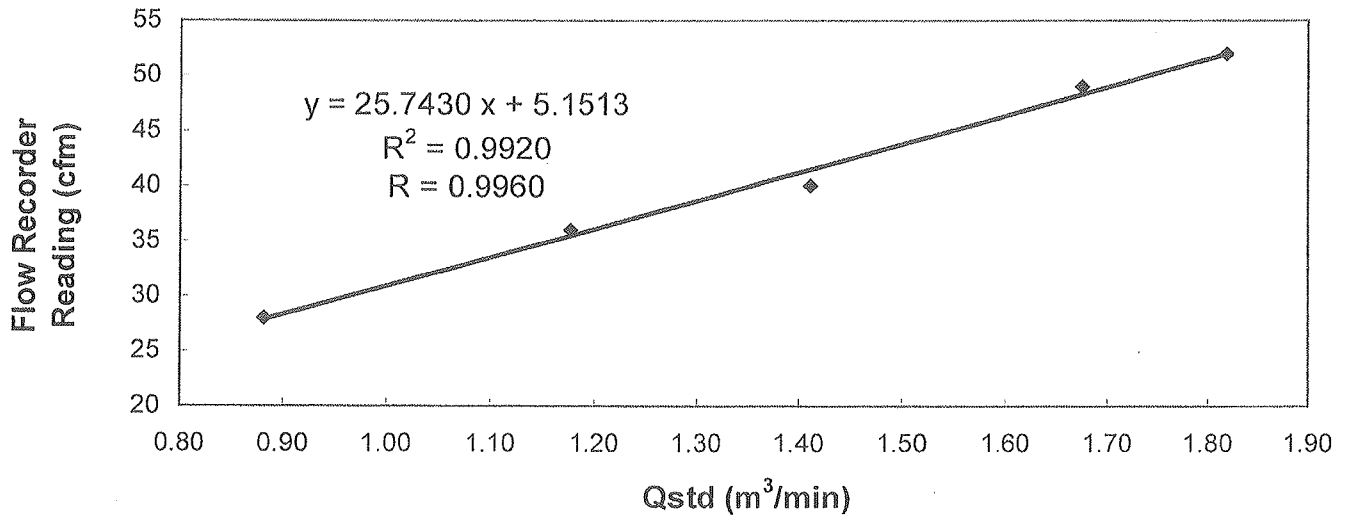
**Sampler 1172 Calibration Curve**  
Site: Tseung Kwan O 137 (TKO-A2a)

Results	Flow recorder reading (cfm)	52	49	40	36	28
	Qstd (Actual flow rate, m <sup>3</sup> /min)	1.82	1.68	1.41	1.18	0.88
	Pressure : 763.56 mm Hg	Temp. : 284 K

Acceptance Criteria : Correlation coefficient (r) of the calibration curve greater than 0.990 after a 5-point calibration.

The high volume sampler complies\* / ~~does not comply\*~~ with the specified requirements and is deemed acceptable\* / unacceptable\* for use.

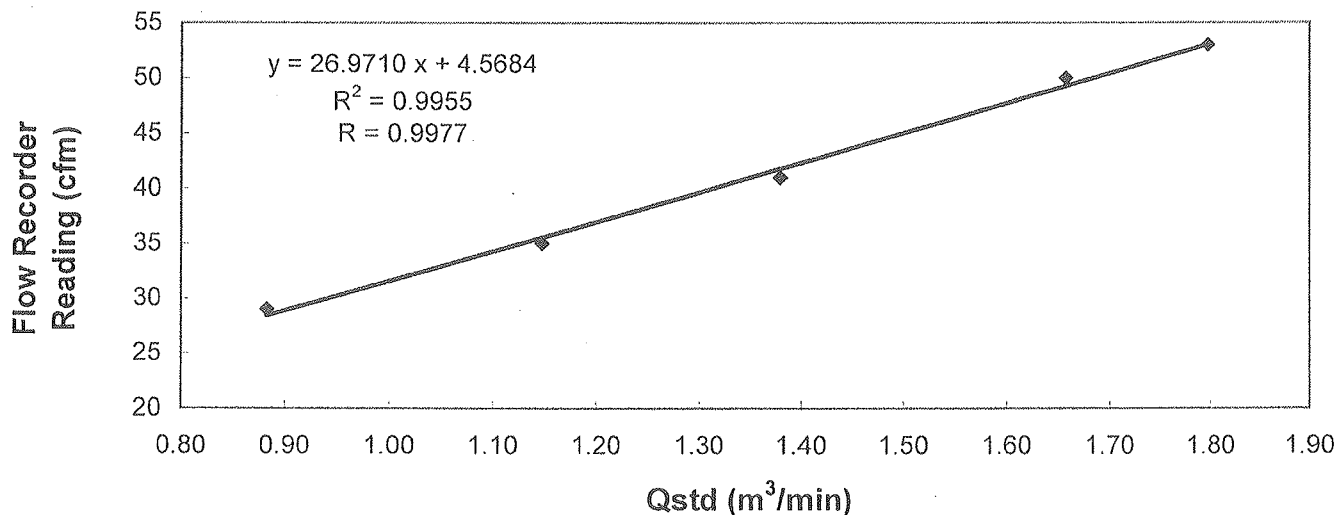
**Sampler 1172 Calibration Curve**  
Site: Tseung Kwan O 137 (TKO-A2a)

Flow recorder reading (cfm)	53	50	41	35	29
Qstd (Actual flow rate, m <sup>3</sup> /min)	1.80	1.66	1.38	1.15	0.88
Pressure :	763.56	mm Hg	Temp. :	293	K

Acceptance Criteria : Correlation coefficient (r) of the calibration curve greater than 0.990 after a 5-point calibration.

The high volume sampler complies\* / ~~does not comply\*~~ with the specified requirements and is deemed acceptable\* / unacceptable\* for use.

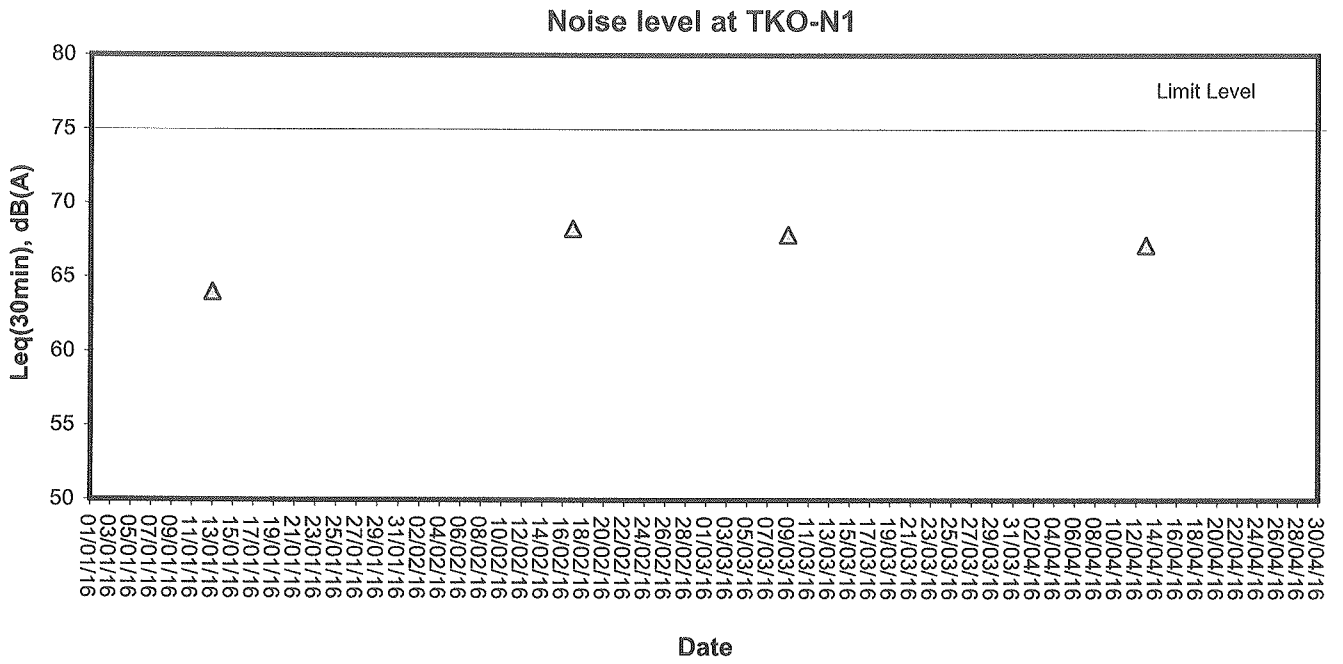
## Noise Monitoring (Day-time)

Date	Start Sampling Time (hh:mm)	Noise Level dB (A)			Wind Speed (m/s)	Weather Condition
		L <sub>eq</sub> (30min)	L <sub>10</sub>	L <sub>90</sub>		
13/04/16	09:00	67.2	69.5	65.3	0.2	Cloudy

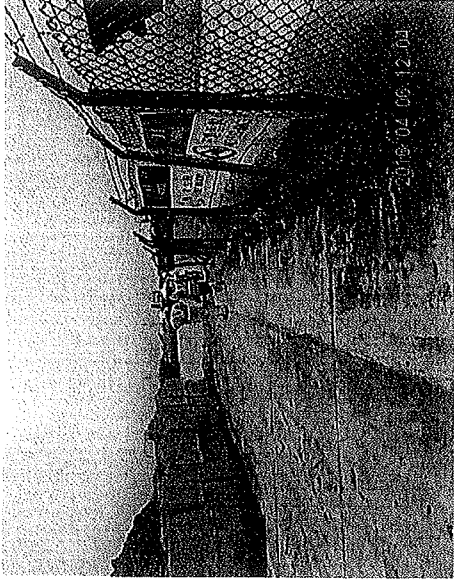
Photo 160406\_001 (BHA)

Item	Details of defective works or observations	Proposed Follow Up Action	Photo Ref.	Further Action Required (Yes/No)	Target Completion Date
1	Follow up action to item 2 on 30/03/2016, mud accumulated on the concrete pavement along the barge handling area (BHA) was cleared. However, the Contractor was reminded to provide sand bags along the BHA to prevent fill material dropping into the sea.	To provide sand bags along the BHA to prevent fill material dropping into the sea.	160406_001	Yes	13/04/16

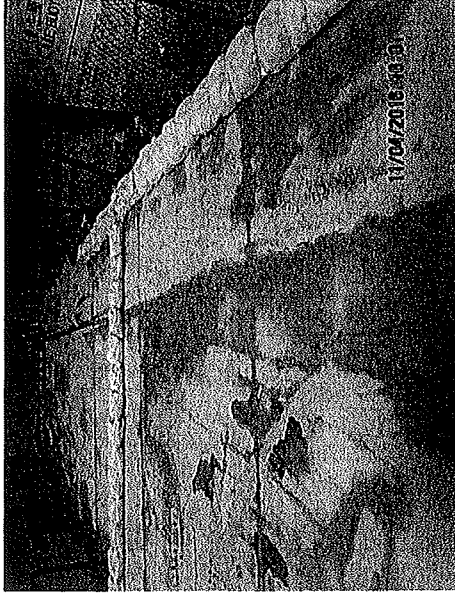
Photo 160411\_001 (BHA) (Improved)

Item	Details of defective works or observations	Proposed Follow Up Action	Photo Ref.	Further Action Required (Yes/No)	Target Completion Date
1	Follow up action to item 2 on 30/03/2016 and item 1 on 06/04/16, sand bags were placed along the BHA to prevent fill material dropping into the sea.	--	160411_001	No	---
2	Stagnant water was noted near drainage channel near Wetsep.	To clear the stagnant water or apply pesticide to avoid mosquito breeding.	160411_002	Yes	20/04/16
3	Sand bags provided for the drainage channel near Wetsep were noted damaged.	To replace the broken sand bags.	160411_002	Yes	20/04/16

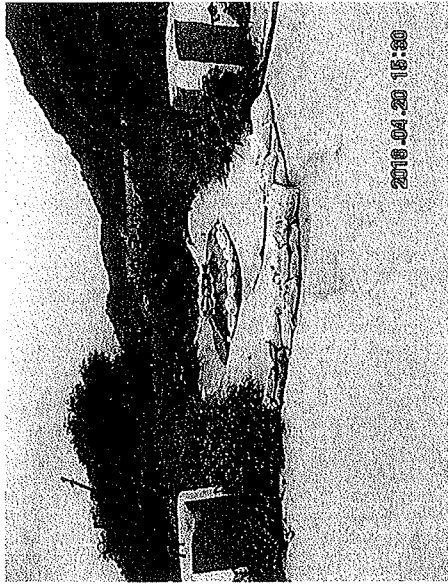
Photo 160420\_001 (Drainage channel near Wetsep) (Improved)

20 April 2016	Stagnant water was noted near drainage channel near Wetsep. (Previous item)	To clear the stagnant water or apply pesticide to avoid mosquito breeding.	Stagnant water found beside drainage channel near Wetsep was cleared.	Closed
	Sand bags provided for the drainage channel near Wetsep were noted damaged. (Previous item)	To replace the broken sand bags.	Broken sand bags for the drainage channel near Wetsep were replaced by new sand bags.	Closed
	Debris of dead leaves was accumulated inside the u-channel near site entrance. (New item)	To clear the accumulated leaves in order to avoid any blockage.	---	Follow-up
27 April 2016	Debris of dead leaves was accumulated inside the u-channel near site entrance. (Previous item)	To clear the accumulated leaves in order to avoid any blockage.	Dead leaves accumulated inside the u-channel near site entrance was cleared.	Closed
	Stagnant water was found accumulated on the road near Zone A1. (New item)	To clean the stagnant water as soon as possible.	---	Follow-up

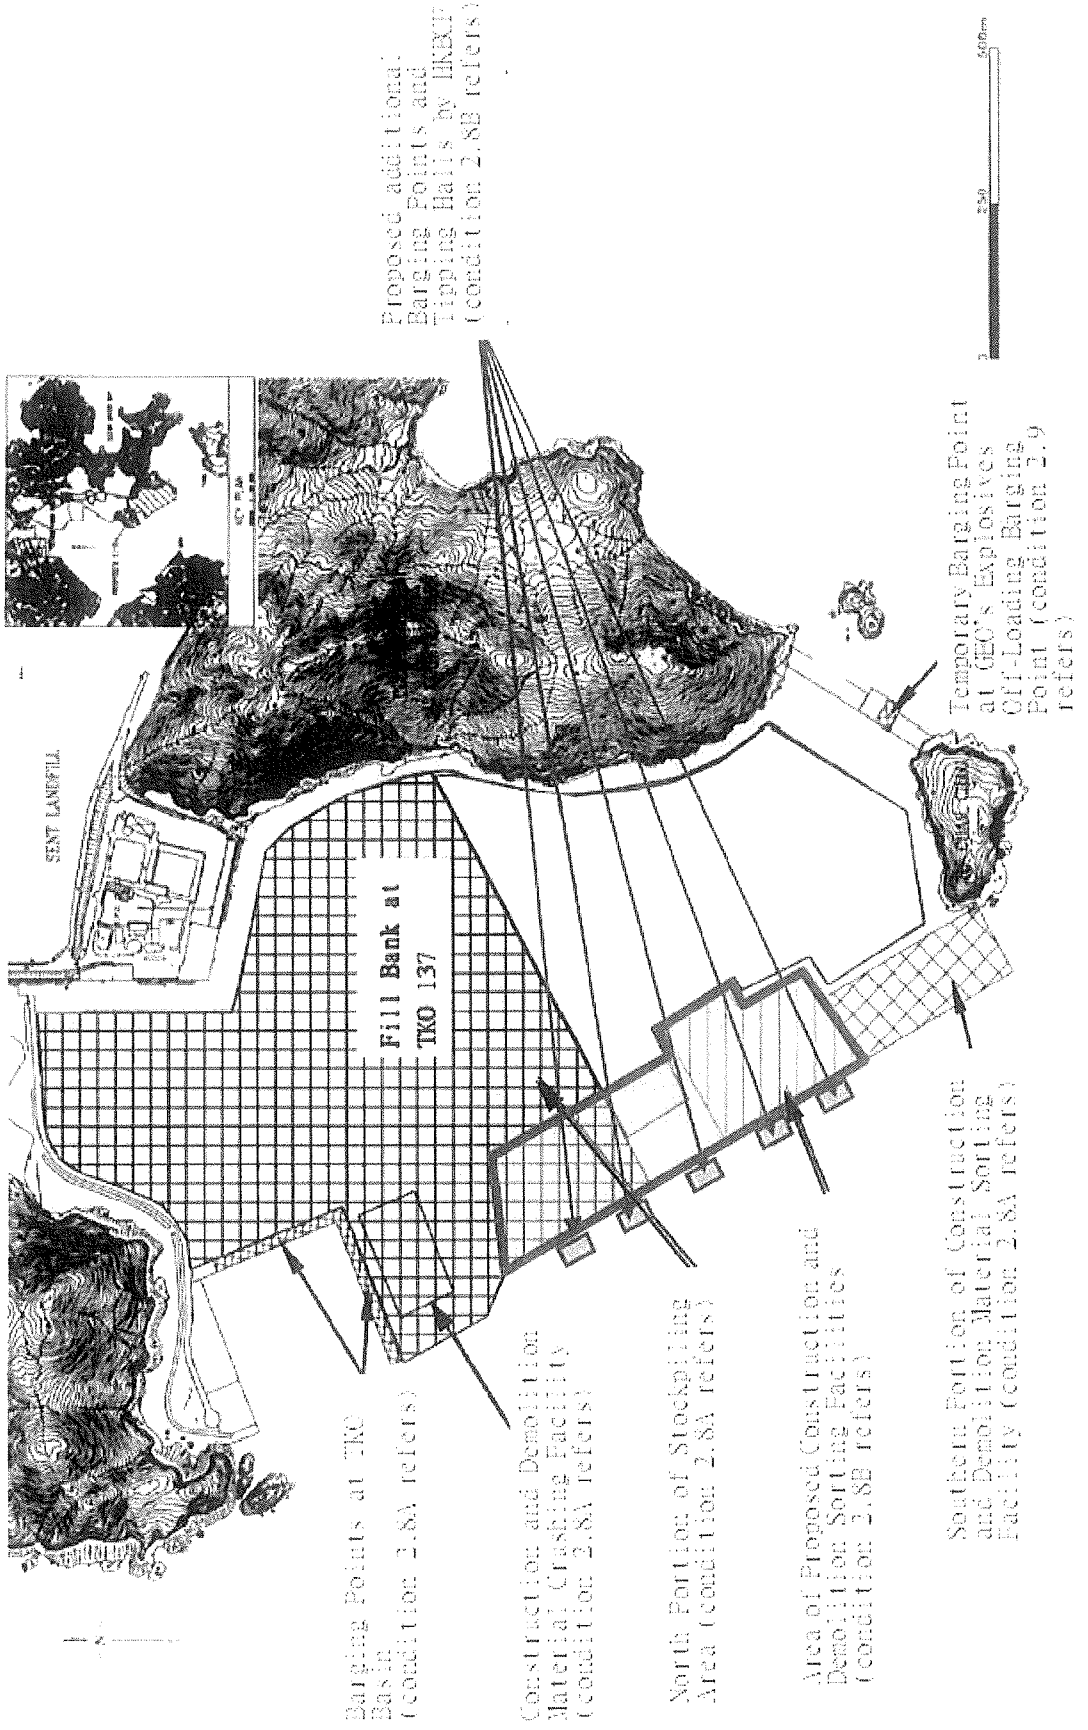
**Site Layout Plan for TKO 137 Fill Bank**

(Plan Originated from Figure 2 of Environmental Permit No.: EP-134/2002/K)
