**Contract No.: CV/2015/07
Handling of Surplus Public Fill
(2016-2018)**

TSEUNG KWAN O AREA 137 FILL BANK

MONTHLY EM&A REPORT NO.7

(NOVEMBER 2017)

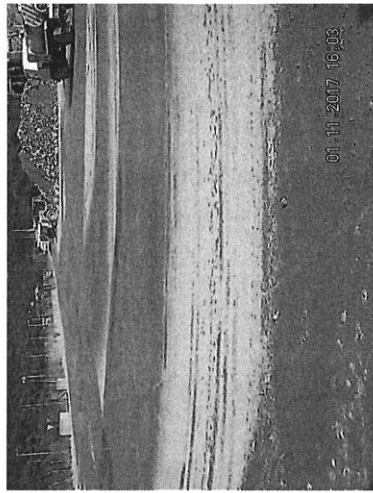
Item	Details of defective works or observations	Proposed Follow Up Action	Photo Ref.	Further Action Required (Yes/No)	Follow up Date
1	Follow up action to item 2 on 25/10/17, watering was noted at the pier at A9.	---	171101_001	No	---
2	Oil stains were noted on the ground at A6 workshop.	To clean up the oil stains and treat the contained materials as chemical waste.	171101_002	Yes	08/11/17

Photo 171101_001 (Pier at A9) (Improved)

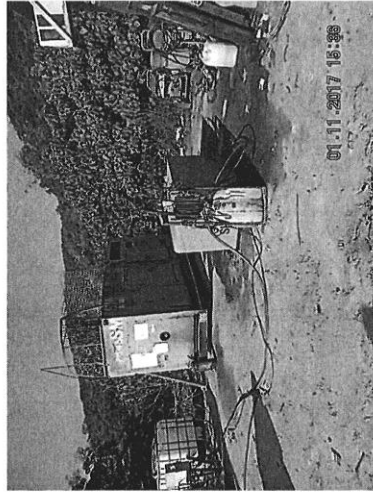
Photo 171101_002 (Workshop at A6)

The Contractor should provide sufficient preventive measures during equipment maintenance works so as to avoid oil leakage on the ground. In the event of any oil leakage, the Contractor should clean up the polluted soil and handle all the materials used for this cleaning works as chemical waste.

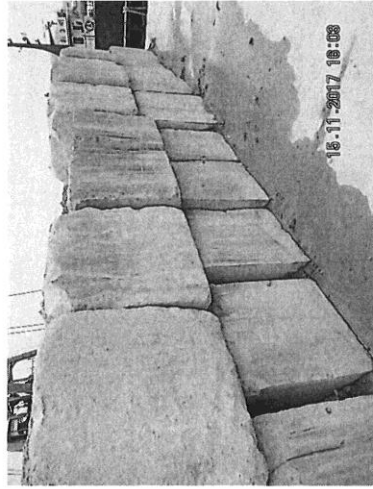
Photo 171115_001 (Near the pier at A9)
(Improved)

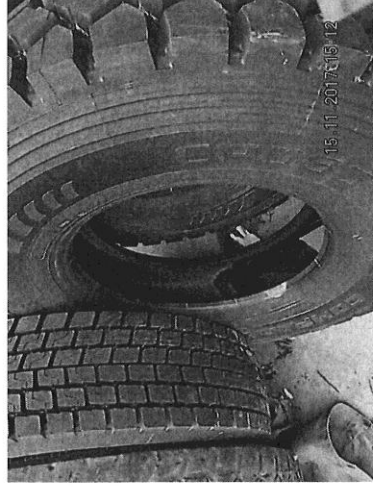
Item	Details of defective works or observations	Proposed Follow Up Action	Photo Ref.	Further Action Required (Yes/No)	Follow up Date
1	Follow up action to item 2 on 08/11/17, sand and soil accumulated near the pier at A9 were cleared.	---	171115_001	No	---
2	Stagnant water was found inside a tire at workshop at A6.	To clear the stagnant water to avoid mosquito breeding.	171115_002 & 171115_003	Yes	22/11/17

Photo 171115_002 (Workshop at A6)

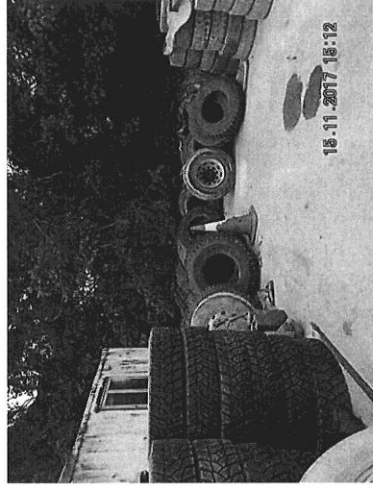
Photo 171115_003 (Workshop at A6)

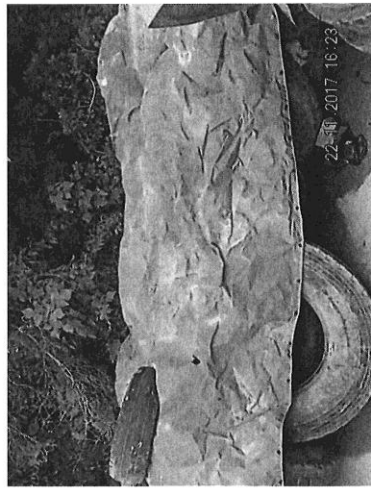
Photo 171122_001 (Workshop at A6)
(Improved)
