**Contract No.: CV/2015/07  
Handling of Surplus Public Fill  
(2016-2018)**

**TSEUNG KWAN O AREA 137 FILL BANK**

**MONTHLY EM&A REPORT NO.12**

**(APRIL 2018)**

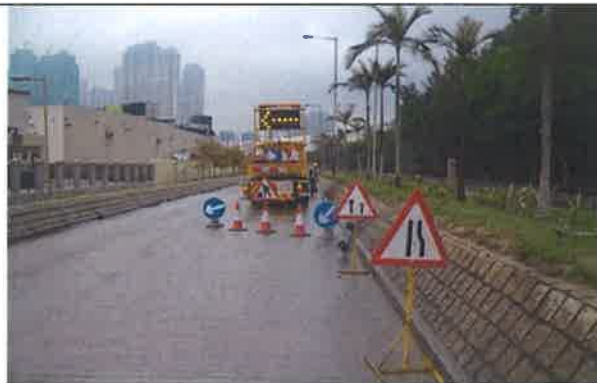
**Wan Po Road**

One complaint received on 09 April 2018, which was forwarded to ET on 18 April 2018, from public against the rocks and debris deposited on the road surface along Wan Po Road near TKO137 Fill Bank. The complainant complained that waste generated caused an environmental nuisance.
