**Re: Agreement No. CE 48/2011 (EP)
Environmental Project Office for the
HZMB Hong Kong Link Road, HZMB Hong Kong Boundary Crossing Facilities,
and Tuen Mun-Chek Lap Kok Link – Investigation**

**Contract No. HY/2011/09 HZMB Hong Kong Link Road –
Section between HKSAR Boundary and Scenic Hill
Monthly EM&A Report for July 2013 (EP-352/2009/B)**

Contract HY/2011/09
Hong Kong-Zhuhai-Macao Bridge
Hong Kong Link Road-Section between
HKSAR Boundary and Scenic Hill
Monthly EM&A Report
July 2013
(Version 2.0)

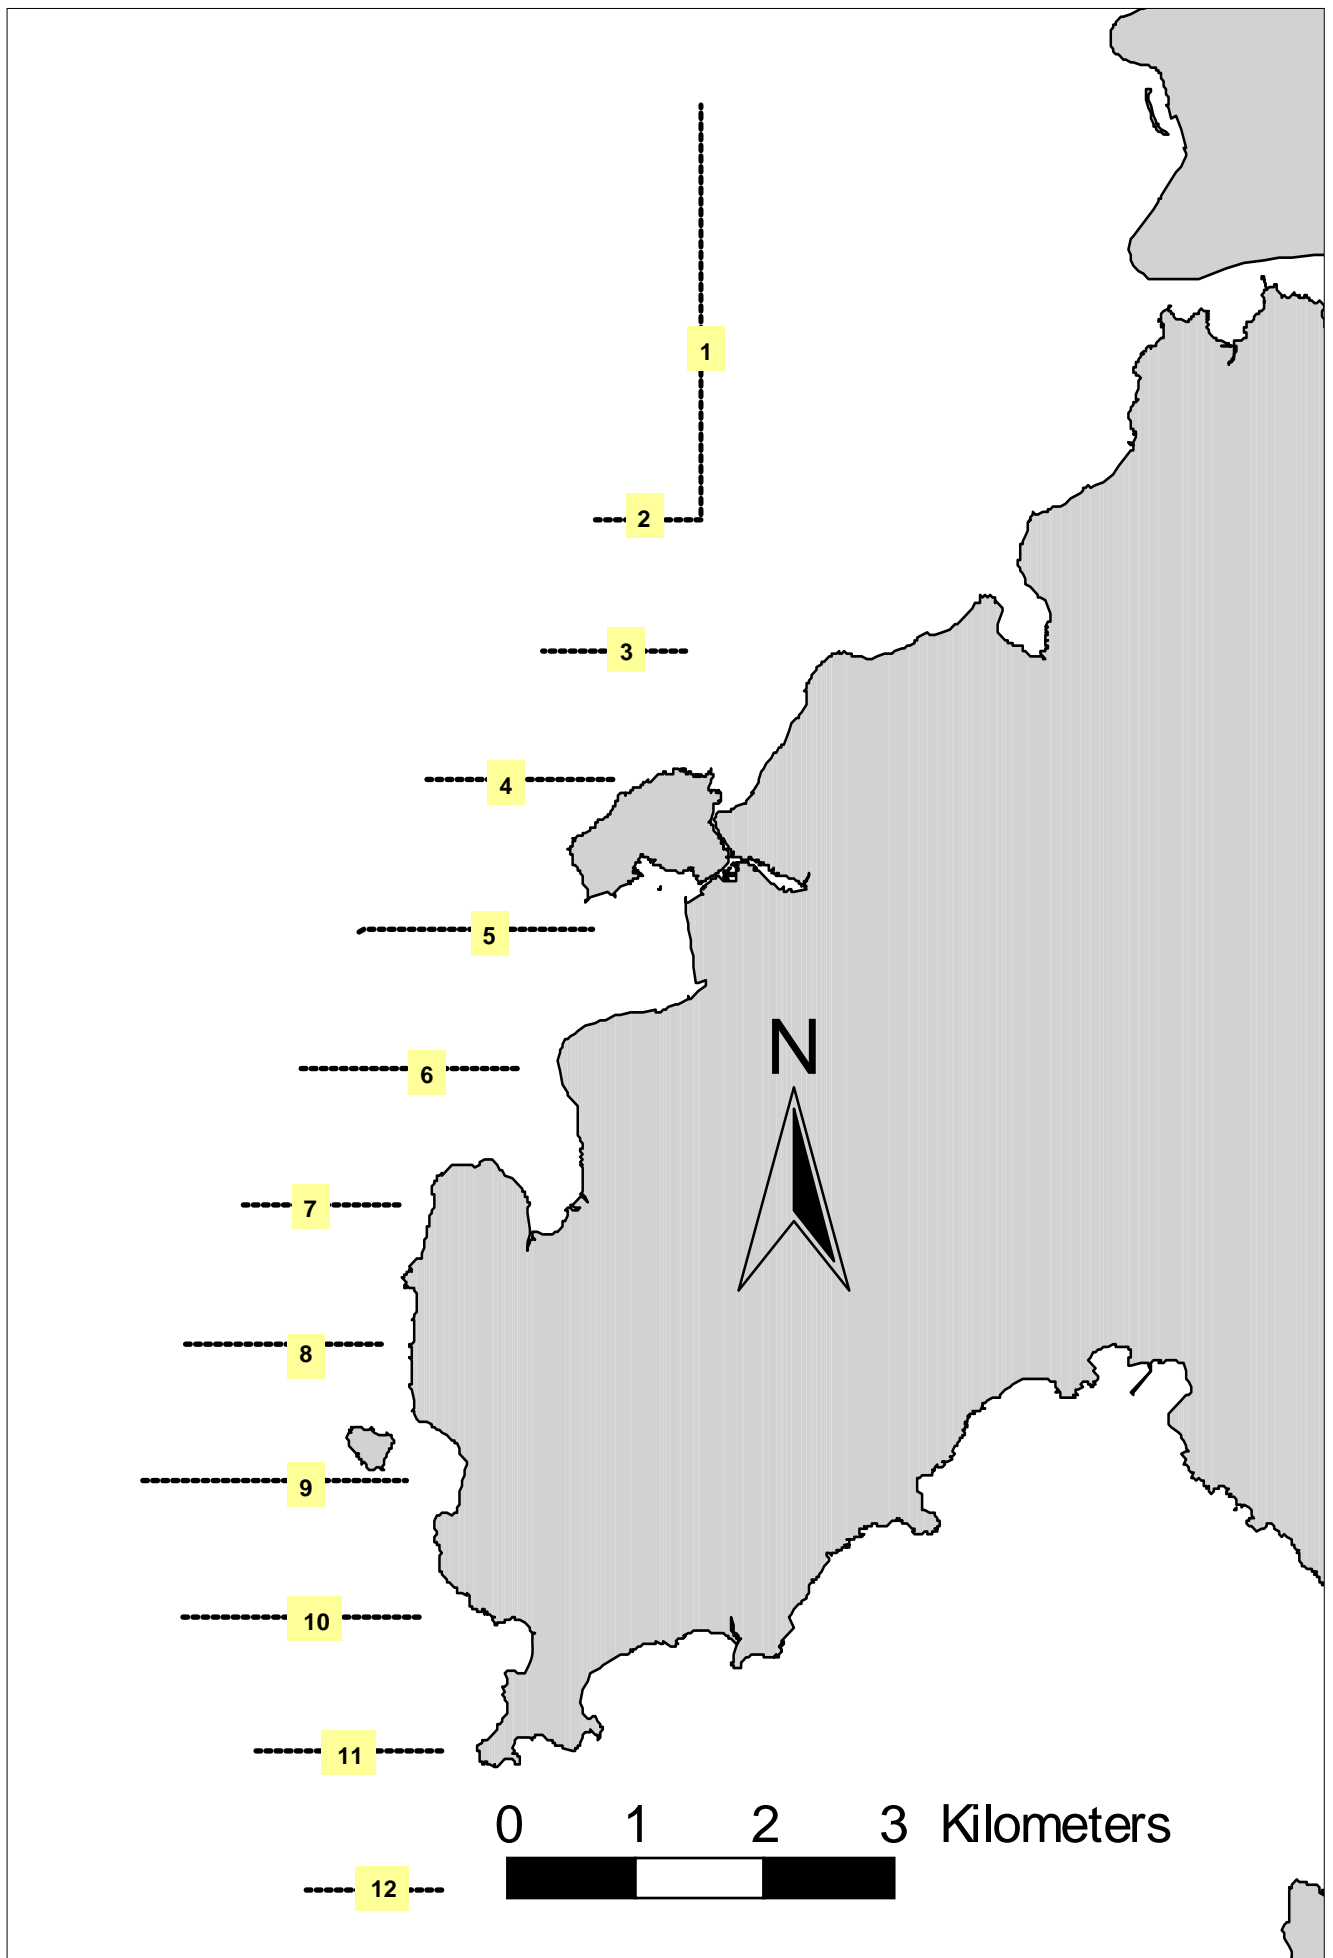
Figure 1. Transect Line Layout in West Lantau Survey Areas

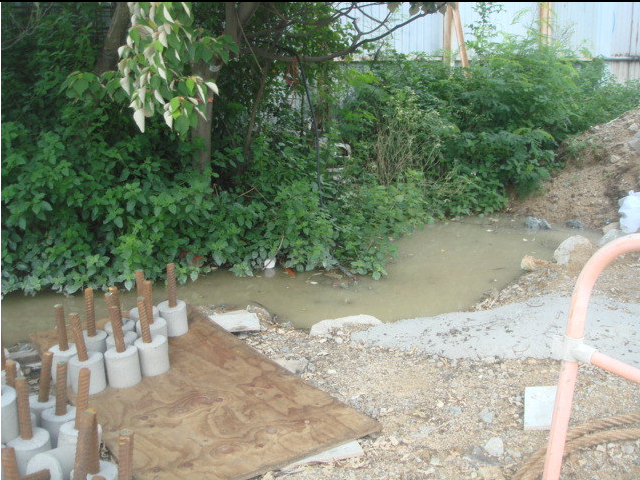
A photograph showing a muddy runoff area. In the foreground, there is a wooden boardwalk or platform. To the left, several concrete pillars are visible. The background shows dense green vegetation and a building with a corrugated metal roof.	<p>Ref No: 130702-R01</p> <p>Impact: Water Quality (B3)</p> <p>Details: To review the sedimentation process of the surface runoff at Portion C.</p>
---	--

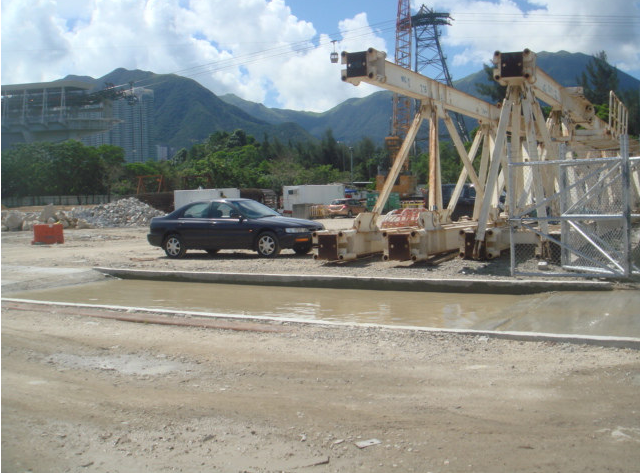
<p>Ref No: 130709-R01</p> <p>Impact: Water Quality (B10iv.)</p> <p>Details: To clear the water at wheel washing bay at Portion C.</p>

<p>Ref No: 130709-R01</p> <p>Impact: Water Quality (B10iv.)</p> <p>Details: To clear the water at wheel washing bay at Portion C.</p> <p>Follow Up:- The water inside the wheel washing bay was clear.</p>

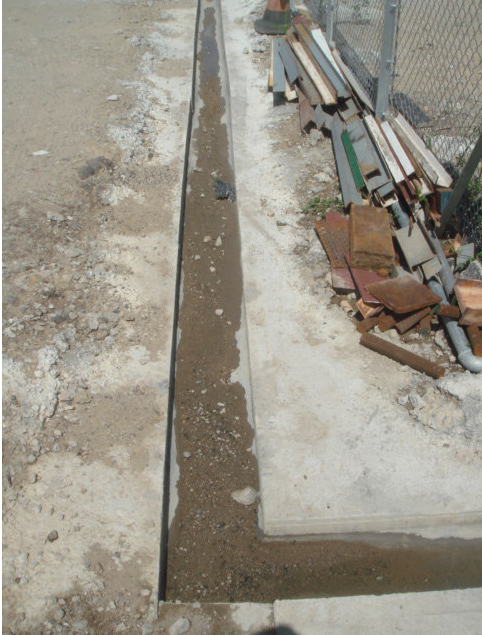
<p>Ref No: 130709-R02</p> <p>Impact: Water Quality (B4)</p> <p>Details: To clear the sand and silt settled at the drain at Portion C.</p>

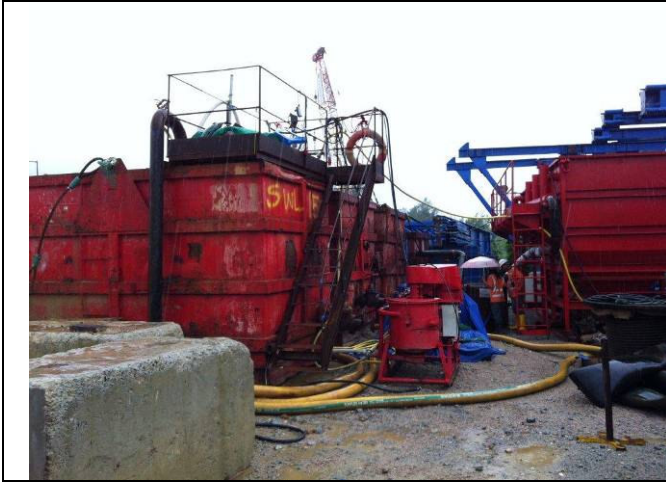
Ref No: 130702-R01

Impact:
Water Quality (B3)

Follow Up:-
Sedimentation facility was observed on site for settling runoff prior to disposal.

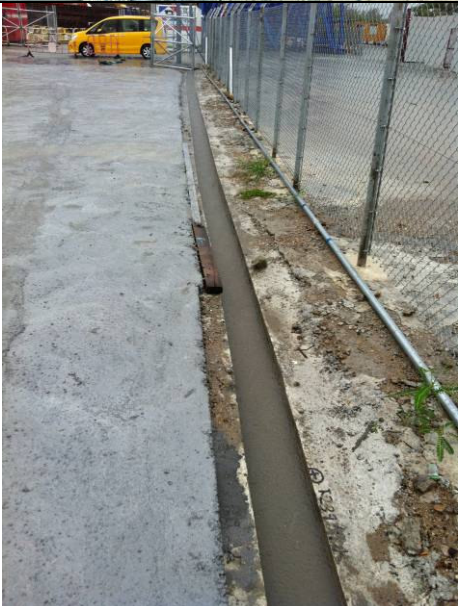
<p>Ref No: 130709-R02</p> <p>Impact: Water Quality (B4)</p> <p>Details: To clear the sand and silt settled at the drain at Portion C.</p> <p>Follow Up:- The sand and silt settled at the drain at Portion C were cleared.</p>

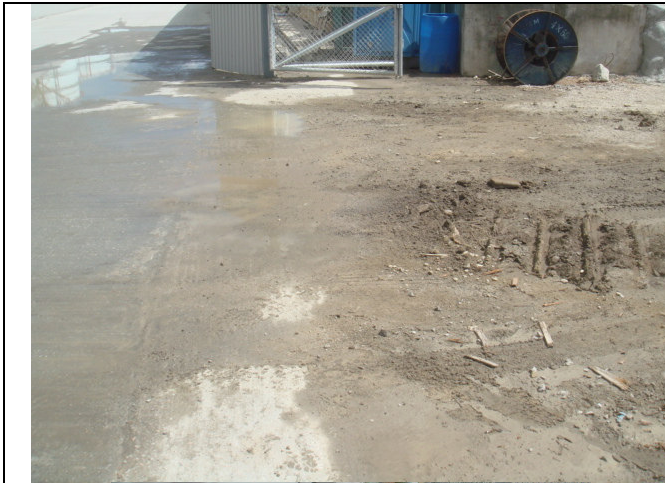
Ref No: 130723-R03

Impact:
Waste / Chemical Management (F6)

Details:
Clear the deposit silt and sediment at the site exit and drainage channel at Portion C.

The silt and sediment at the site exit was cleared by the workers.

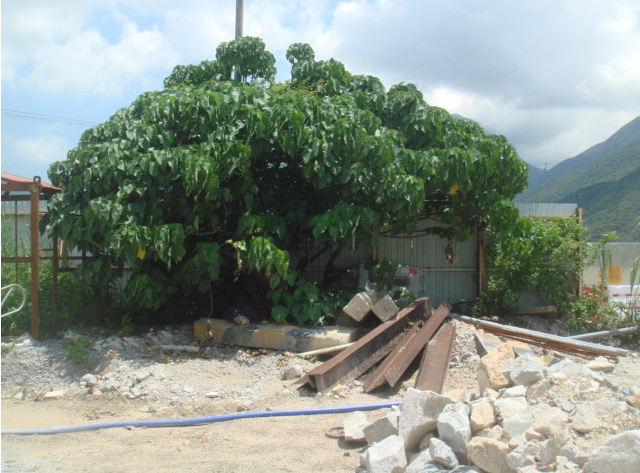
<p>Ref No: 130730-R01</p> <p>Impact: Waste / Chemical Management (F4ii.)</p> <p>Details: To remove the construction materials which were placed at near the tree at Portion C.</p>

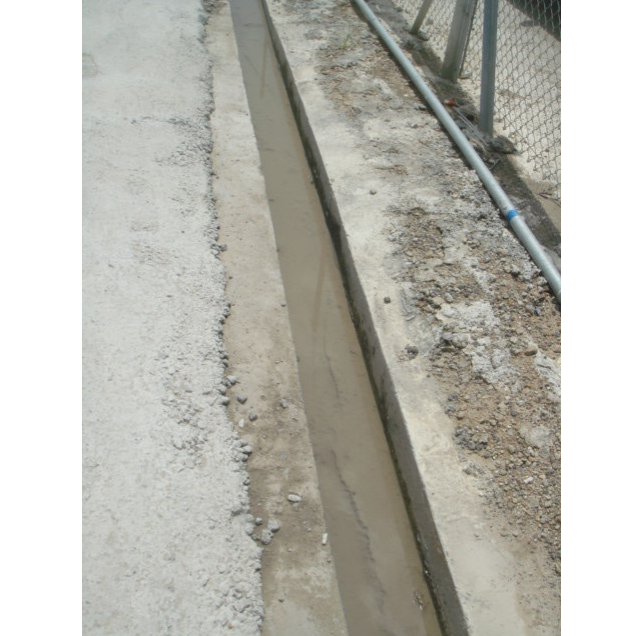
<p>Ref No: 130730-R02</p> <p>Impact: Waste / Chemical Management (F6)</p> <p>Details: Clear the deposit silt and sediment at the drainage channel at Portion C.</p>

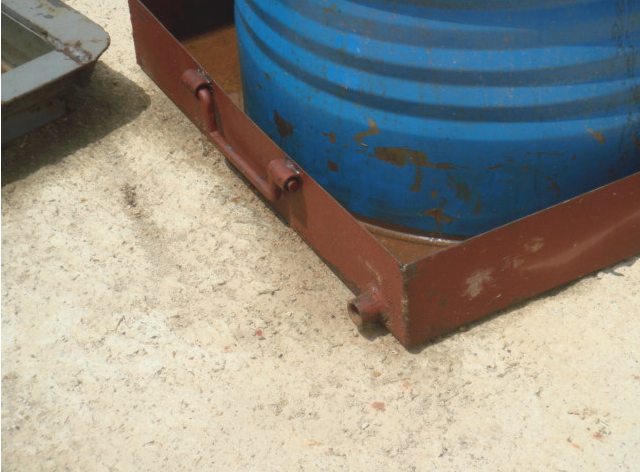
<p>Ref No: 130730-R03</p> <p>Impact: Waste / Chemical Management (F9)</p> <p>Details: To seal the hole of the drip tray near the office containers at Portion C.</p>
