### ASB Biodiesel (Hong Kong) Limited

### Development of a Biodiesel Plant at Tseung Kwan O Industrial Estate

Monthly EM&A Report April 2017 (Version 2.0)

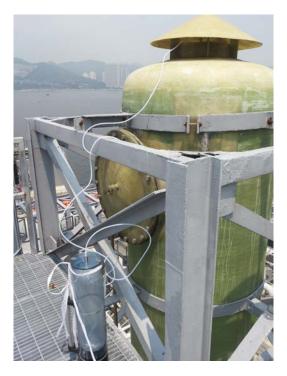
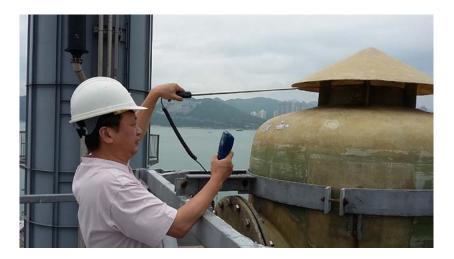
Final air scrubber

The photos about the on-site sampling activity at the final air scrubber are presented below,
