# ASB Biodiesel (Hong Kong) Limited

# Development of a Biodiesel Plant at Tseung Kwan O Industrial Estate

Monthly EM&A Report May 2017 (Version 1.0)

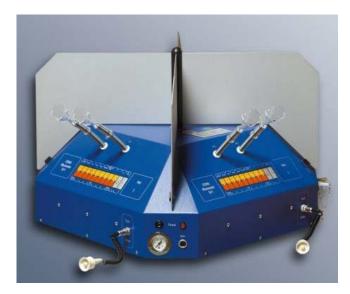
#### Olfactometer

Odour concentration is determined by a Dynamic Olfactometer (TO9) in accordance with the European Standard Method (EN13725). This European Standard specifies a method for the objective determination of the odour concentration of a gaseous sample using dynamic olfactometry with human assessors and the emission rate of odours emanating from point sources, area sources with outward flow and area sources without outward flow. This European Standard is applicable to the measurement of odour concentration of pure substances, defined mixtures and undefined mixtures of gaseous odorants in air or nitrogen, using dynamic olfactometry with a panel of human assessors being the sensor. The unit of measurement is the odour unit percubic metre:  $OU_E/m^3$ . The odour concentration is measured by determining the dilution factor required to reach the detection threshold. The odour concentration at the detection threshold is defined as 1  $OU_E/m^3$ . The odour concentration is then expressed in terms of multiples of the detection threshold. The range of measurement is typically from  $2^2 OU_E/m^3$  to  $2^{17} OU_E/m^3$  (excluding pre-dilution).
