# ASB Biodiesel (Hong Kong) Limited

## Development of a Biodiesel Plant at Tseung Kwan O Industrial Estate

Monthly EM&A Report

October 2017

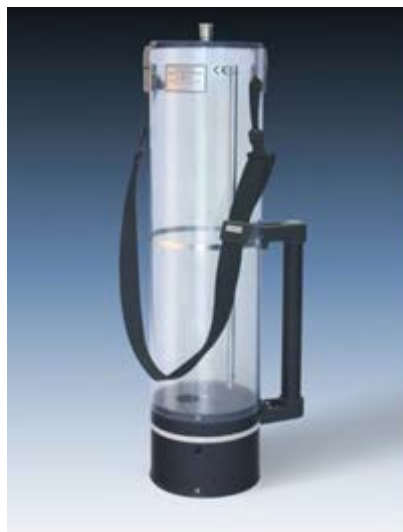
Odour gas sample is collected by a Sampling Device Standard consists of a vacuum container, which is evacuated by a vacuum pump. The sampling point and the standard sampler are connected by a probe. Due to the evacuation in the sampling device, the sample bag, inside the device, sucks in sample air via the probe. During this process, none of its components come into contact with the sample air due to the construction of the sampling device.

Odour Sampling System
