# ASB Biodiesel (Hong Kong) Limited

## Development of a Biodiesel Plant at Tseung Kwan O Industrial Estate

Monthly EM&A Report

November 2017

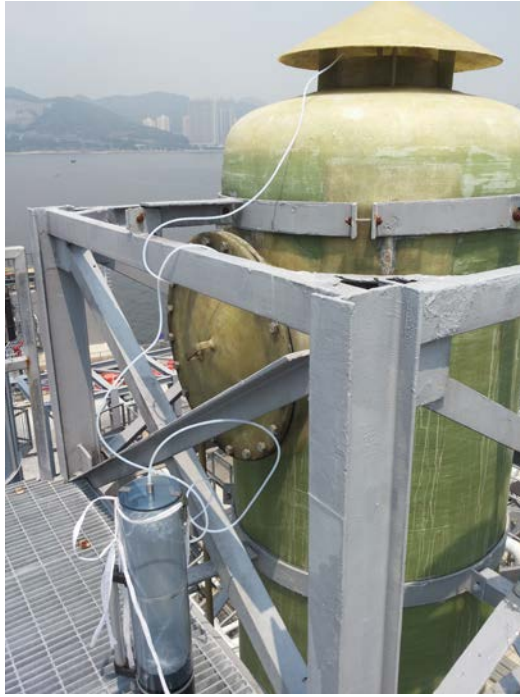
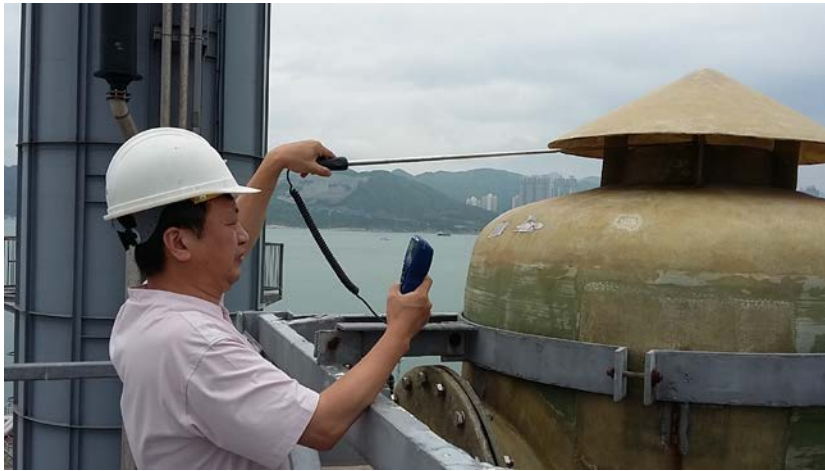
The photos about the on-site sampling activity at the final air scrubber are presented below,

Final air scrubber

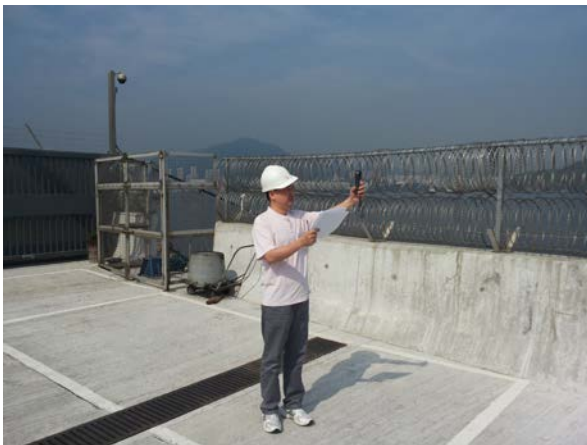
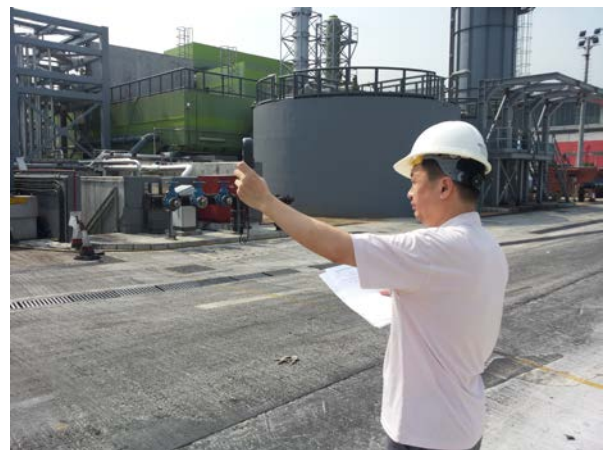
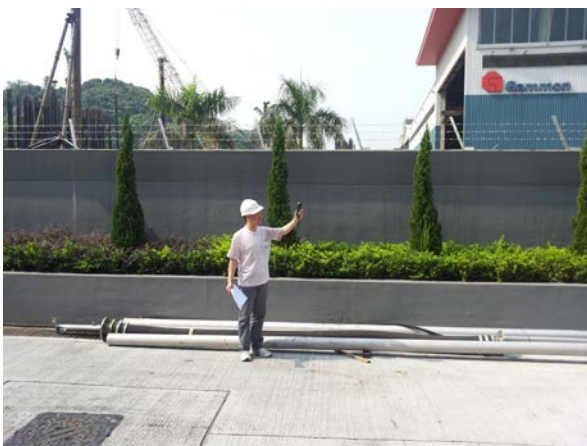
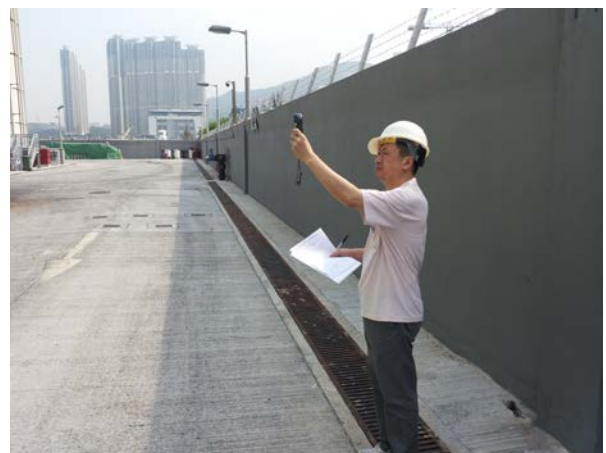
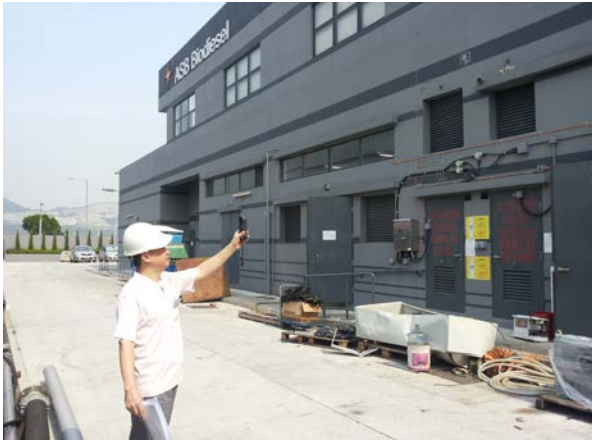
4.5 The illustrations about odour patrol activities at different locations are presented below:

Date	Location	Time	Weather	Wind		Odour Intensity	Observations
				Speed (m/s)	Direction		Odour Nature
15 November 2017	1	10:38	Cloudy	2.6	NE	1	Oil and Grease
	2	10:42		3.3	NE	1~2	Oil and Grease
	3	10:47		2.5	NE	0	
	4	10:51		1.8	NE	0~1	Oil and Grease
	5	10:54		1.5	NE	0	
	1	12:22	Cloudy	1.7	NE	0~1	Oil and Grease
	2	12:26		2.9	NE	1~2	Oil and Grease
	3	12:31		1.8	NE	0	
	4	12:35		0.5	NE	0~1	Oil and Grease
	5	12:39		0.8	NE	0
