Development of a Biodiesel Plant at Tseung Kwan O Industrial Estate

Monthly EM&A Report

Sept 2018

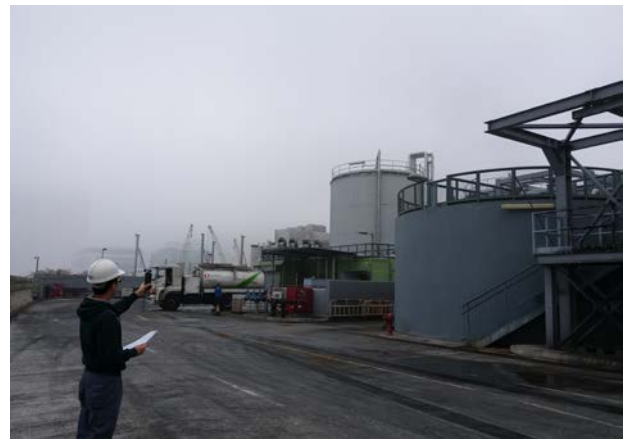
- 4.5 The illustrations about odour patrol activities at different locations are presented below:
