Development of a Biodiesel Plant at Tseung Kwan O Industrial Estate

Monthly EM&A Report

Oct 2018

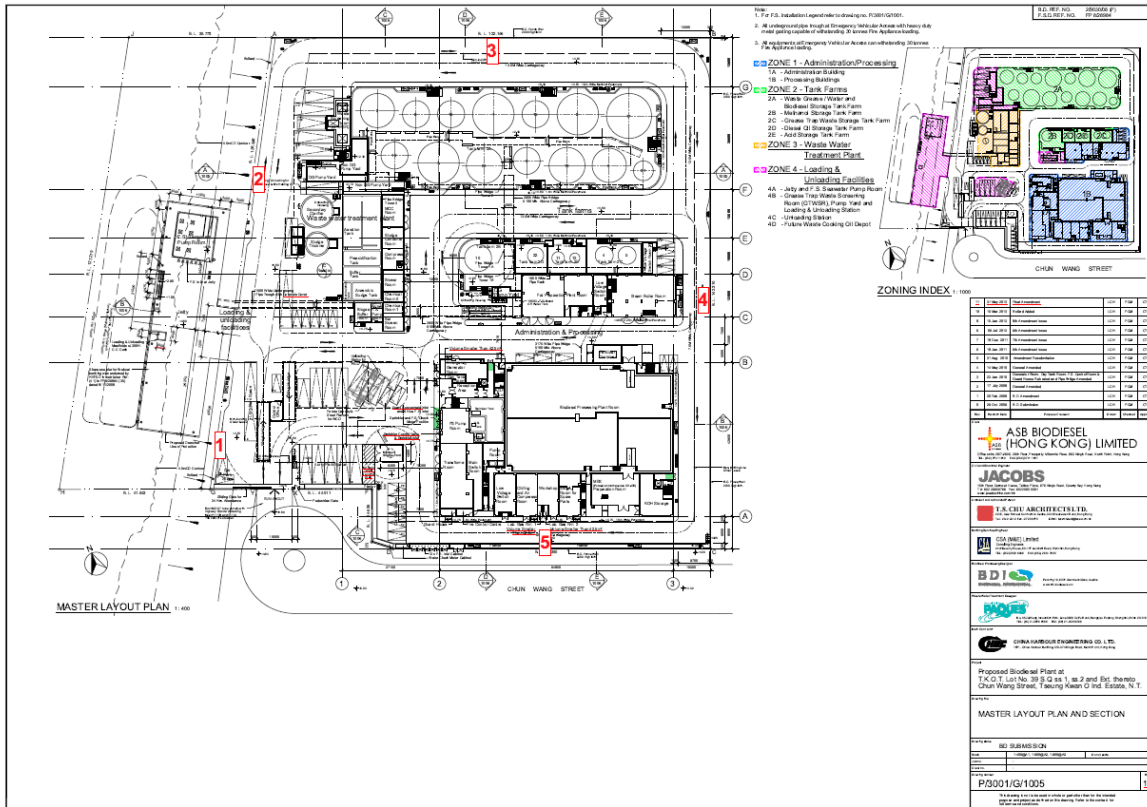
Figure 1: Five locations of odour patrol survey at the boundary of ASB Biodiesel Plant

- 4.3 The odour patrol survey was conducted in the morning and the afternoon on 10 October 2018.
- 4.4 During each survey, the odour panelist recorded the weather conditions including prevailing weather, wind direction and wind speed, determined the odour intensity and also identified the odour nature at each location.

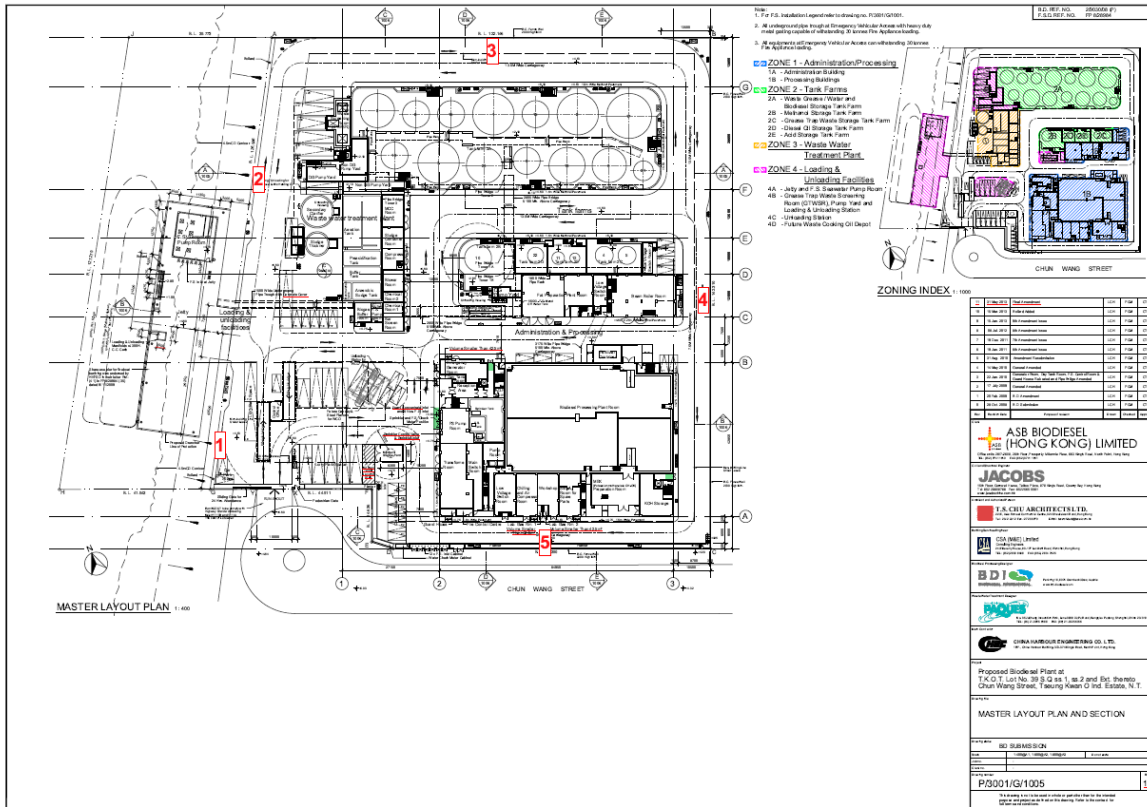
Figure 1: Five locations of odour patrol survey at the boundary of ASB Biodiesel Plant

- 4.3 The odour patrol survey was conducted in the morning and the afternoon on 29 October 2018.
- 4.4 During each survey, the odour panelist recorded the weather conditions including prevailing weather, wind direction and wind speed, determined the odour intensity and also identified the odour nature at each location.
