ASB Biodiesel (Hong Kong) Limited

Development of a Biodiesel Plant at Tseung Kwan O Industrial Estate

Monthly EM&A Report Nov 2018 (Version 1.0)

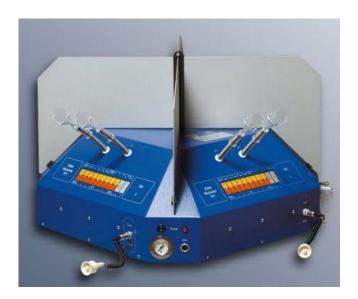
Odour concentration is determined by a Dynamic Olfactometer (TO9) in accordance with the European Standard Method (EN13725). This European Standard specifies a method for the objective determination of the odour concentration of a gaseous sample using dynamic olfactometry with human assessors and the emission rate of odours emanating from point sources, area sources with outward flow and area sources without outward flow. This European Standard is applicable to the measurement of odour concentration of pure substances, defined mixtures and undefined mixtures of gaseous odorants in air or nitrogen, using dynamic olfactometry with a panel of human assessors being the sensor. The unit of measurement is the odour unit percubic metre: OU_E/m^3 . The odour concentration is measured by determining the dilution factor required to reach the detection threshold. The odour concentration at the detection threshold is defined as $1 OU_E/m^3$. The odour concentration is then expressed in terms of multiples of the detection threshold. The range of measurement is typically from $2^2 OU_E/m^3$ to $2^{17} OU_E/m^3$ (excluding pre-dilution).

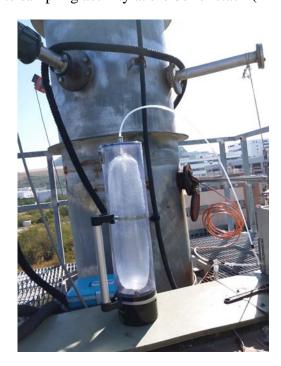
The photos about the on-site sampling activity at the boiler stack (EP2) are presented below,

Boiler stack (EP2)

During the odour sampling, the wind speed was measured on the outlet of boiler stack (EP2). The location description and sampling condition are summarized in Table 1.

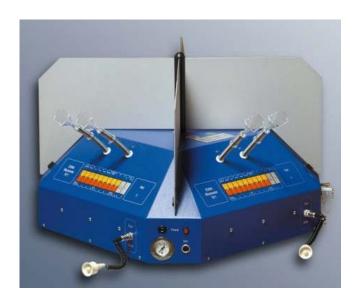
Odour concentration is determined by a Dynamic Olfactometer (TO9) in accordance with the European Standard Method (EN13725). This European Standard specifies a method for the objective determination of the odour concentration of a gaseous sample using dynamic olfactometry with human assessors and the emission rate of odours emanating from point sources, area sources with outward flow and area sources without outward flow. This European Standard is applicable to the measurement of odour concentration of pure substances, defined mixtures and undefined mixtures of gaseous odorants in air or nitrogen, using dynamic olfactometry with a panel of human assessors being the sensor. The unit of measurement is the odour unit percubic metre: OU_E/m^3 . The odour concentration is measured by determining the dilution factor required to reach the detection threshold. The odour concentration at the detection threshold is defined as $1 OU_E/m^3$. The odour concentration is then expressed in terms of multiples of the detection threshold. The range of measurement is typically from $2^2 OU_E/m^3$ to $2^{17} OU_E/m^3$ (excluding pre-dilution).

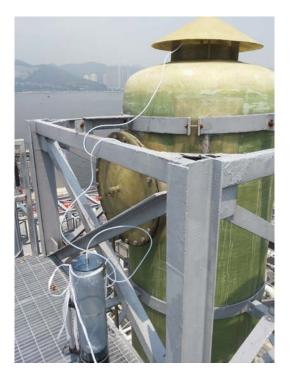
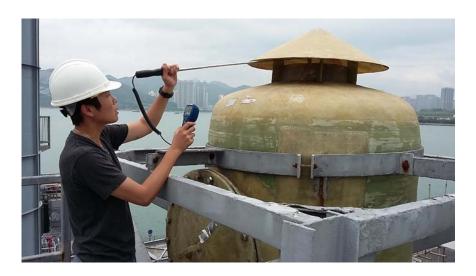
The photos about the on-site sampling activity at the final air scrubber are presented below,

Final air scrubber

During the odour sampling, the wind speed was measured on the outlet of final air scrubber. The location description and sampling condition are summarized in Table 1.
