Development of a Biodiesel Plant at Tseung Kwan O Industrial Estate

Monthly EM&A Report

Dec 2018

Development of a Biodiesel Plant at Tseung Kwan O Industrial Estate - Operation Phase

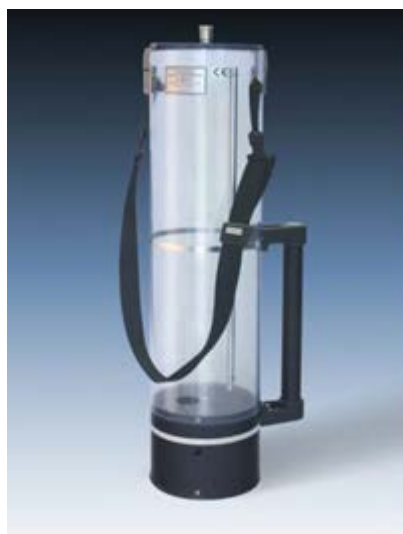
Odour Sampling System

Odour gas sample is collected by a Sampling Device Standard consists of a vacuum container, which is evacuated by a vacuum pump. The sampling point and the standard sampler are connected by a probe. Due to the evacuation in the sampling device, the sample bag, inside the device, sucks in sample air via the probe. During this process, none of its components come into contact with the sample air due to the construction of the sampling device.

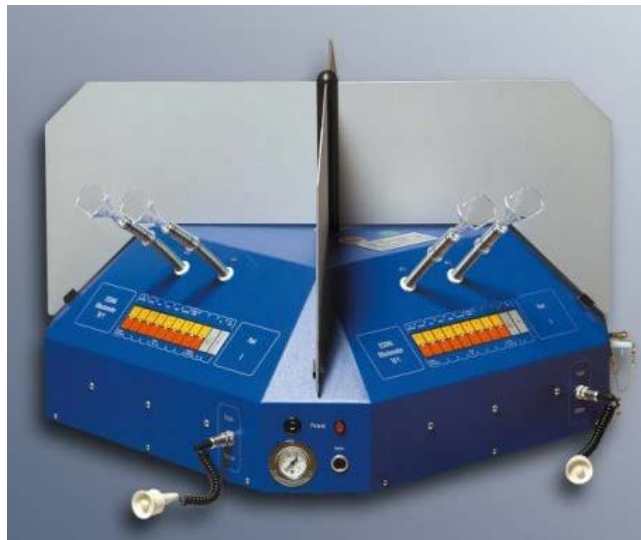
Odour concentration is determined by a Dynamic Olfactometer (TO9) in accordance with the European Standard Method (EN13725). This European Standard specifies a method for the objective determination of the odour concentration of a gaseous sample using dynamic olfactometry with human assessors and the emission rate of odours emanating from point sources, area sources with outward flow and area sources without outward flow. This European Standard is applicable to the measurement of odour concentration of pure substances, defined mixtures and undefined mixtures of gaseous odorants in air or nitrogen, using dynamic olfactometry with a panel of human assessors being the sensor. The unit of measurement is the odour unit per cubic metre: OU_E/m^3 . The odour concentration is measured by determining the dilution factor required to reach the detection threshold. The odour concentration at the detection threshold is defined as $1 \text{ OU}_E/\text{m}^3$. The odour concentration is then expressed in terms of multiples of the detection threshold. The range of measurement is typically from $2^2 \text{ OU}_E/\text{m}^3$ to $2^{17} \text{ OU}_E/\text{m}^3$ (excluding pre-dilution).

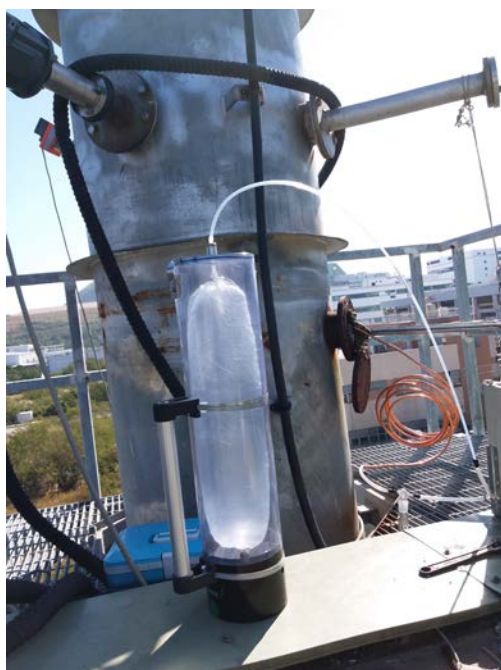
Boiler stack (EP2)

During the odour sampling, the wind speed was measured on the outlet of boiler stack (EP2). The location description and sampling condition are summarized in Table 1.

The photos about the on-site sampling activity at the boiler stack (EP2) are presented below,

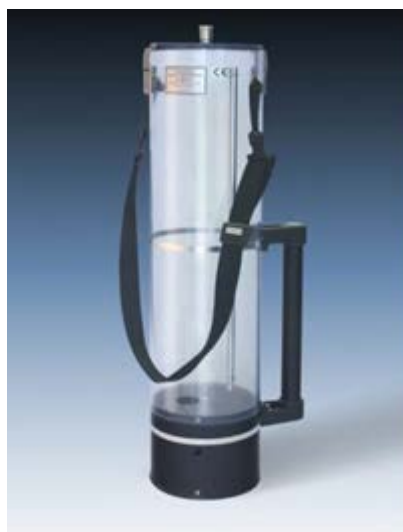
Odour Sampling System

Odour gas sample is collected by a Sampling Device Standard consists of a vacuum container, which is evacuated by a vacuum pump. The sampling point and the standard sampler are connected by a probe. Due to the evacuation in the sampling device, the sample bag, inside the device, sucks in sample air via the probe. During this process, none of its components come into contact with the sample air due to the construction of the sampling device.

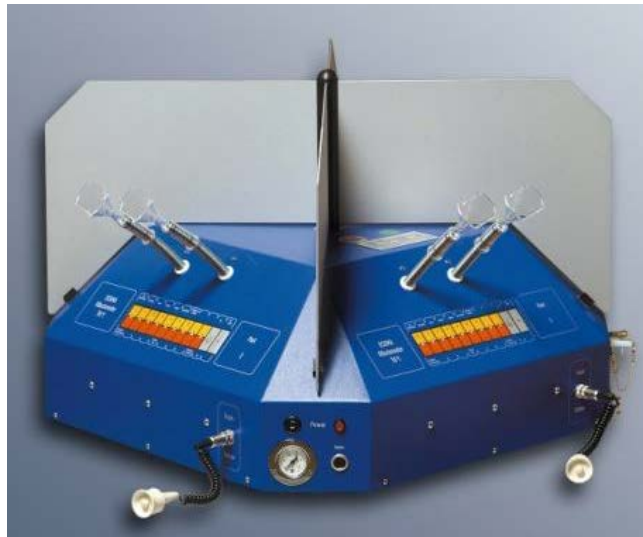
Odour concentration is determined by a Dynamic Olfactometer (TO9) in accordance with the European Standard Method (EN13725). This European Standard specifies a method for the objective determination of the odour concentration of a gaseous sample using dynamic olfactometry with human assessors and the emission rate of odours emanating from point sources, area sources with outward flow and area sources without outward flow. This European Standard is applicable to the measurement of odour concentration of pure substances, defined mixtures and undefined mixtures of gaseous odorants in air or nitrogen, using dynamic olfactometry with a panel of human assessors being the sensor. The unit of measurement is the odour unit per cubic metre: OU_E/m^3 . The odour concentration is measured by determining the dilution factor required to reach the detection threshold. The odour concentration at the detection threshold is defined as $1 \text{ OU}_E/\text{m}^3$. The odour concentration is then expressed in terms of multiples of the detection threshold. The range of measurement is typically from $2^2 \text{ OU}_E/\text{m}^3$ to $2^{17} \text{ OU}_E/\text{m}^3$ (excluding pre-dilution).

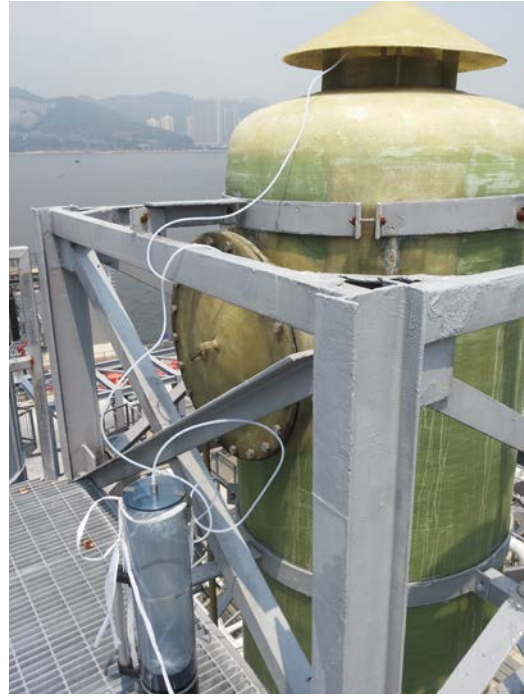
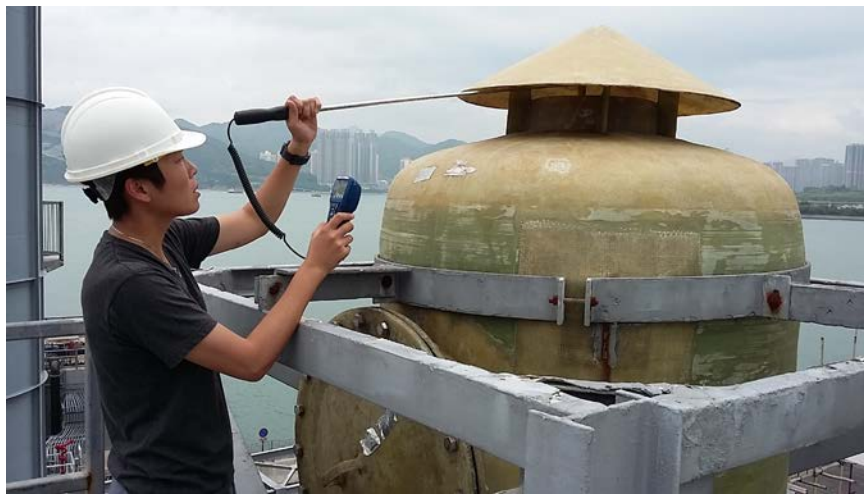
Final air scrubber

During the odour sampling, the wind speed was measured on the outlet of final air scrubber. The location description and sampling condition are summarized in Table 1.

The photos about the on-site sampling activity at the final air scrubber are presented below,

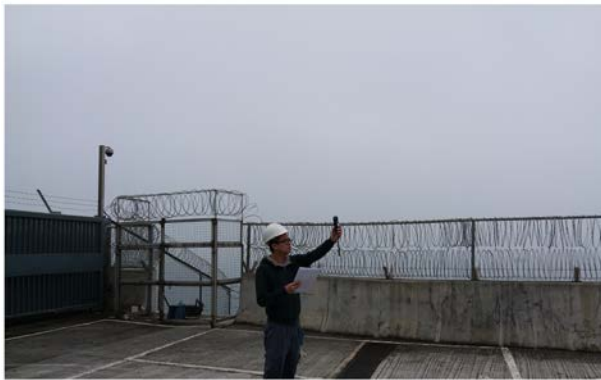
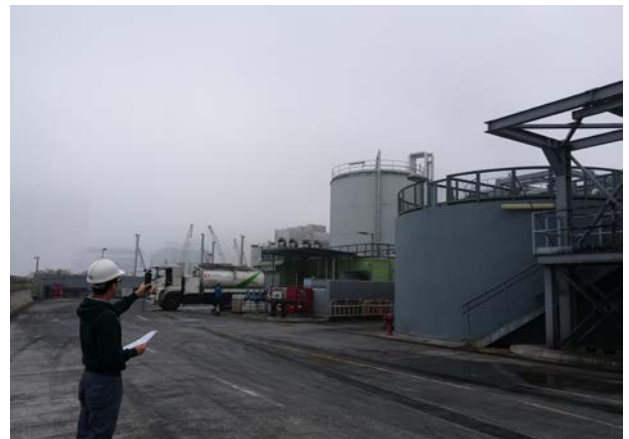
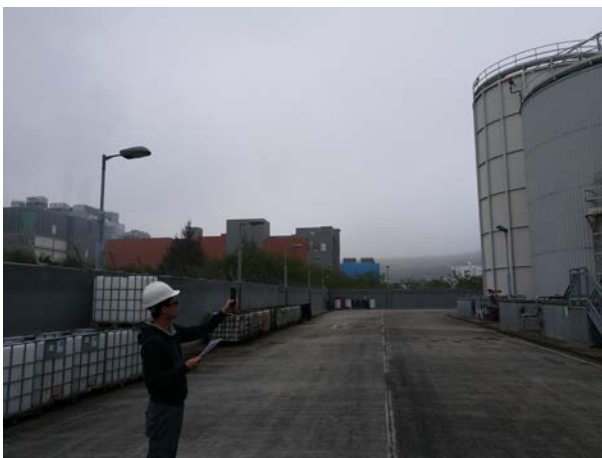
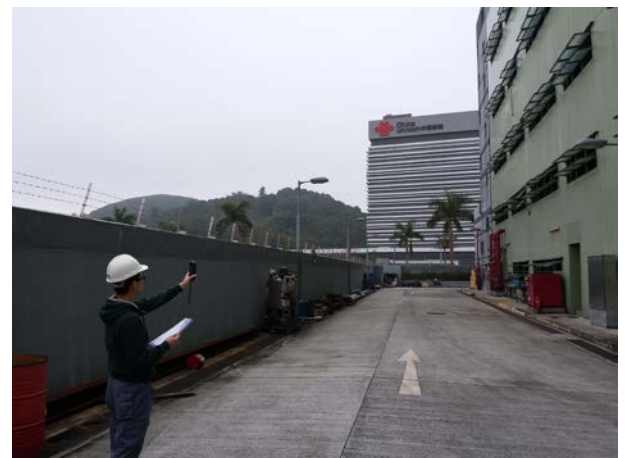
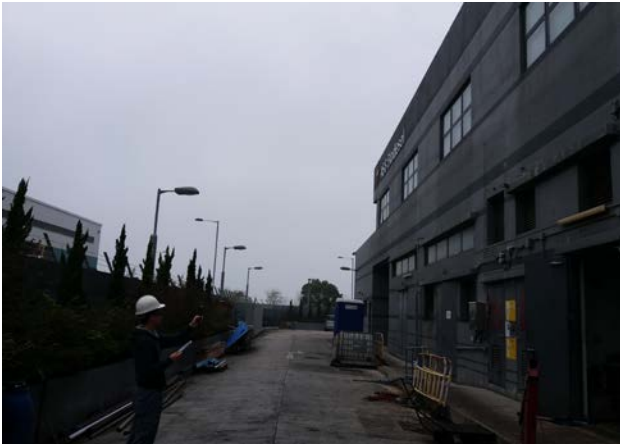
- 4.5 The illustrations about odour patrol activities at different locations are presented below:

Date	Location	Time	Weather	Wind		Odour Intensity	Observations
				Speed (m/s)	Direction		Odour Nature
4 December 2018	1	10:31	Fine	1.6	E-NE	1	Oil and Grease
	2	10:35		2.3	E-NE	1	Oil and Grease
	3	10:40		1.9	E-NE	0	
	4	10:44		1.2	E-NE	1	Oil and Grease
	5	10:47		0.8	E-NE	0	
	1	13:37	Fine	3.1	E-NE	1	Oil and Grease
	2	13:41		3.4	E-NE	1	Oil and Grease
	3	13:46		2.7	E-NE	1	Oil and Grease
	4	13:50		1.8	E-NE	0	
	5	13:54		1.5	E-NE	0

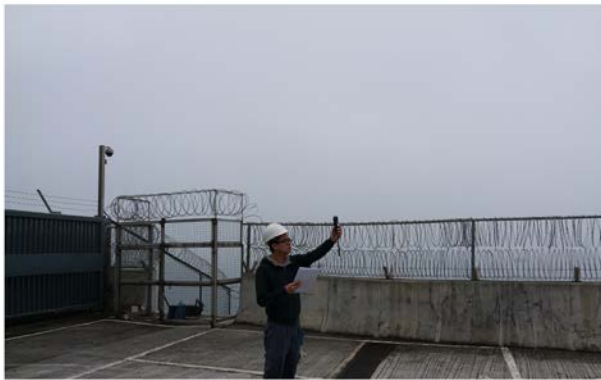
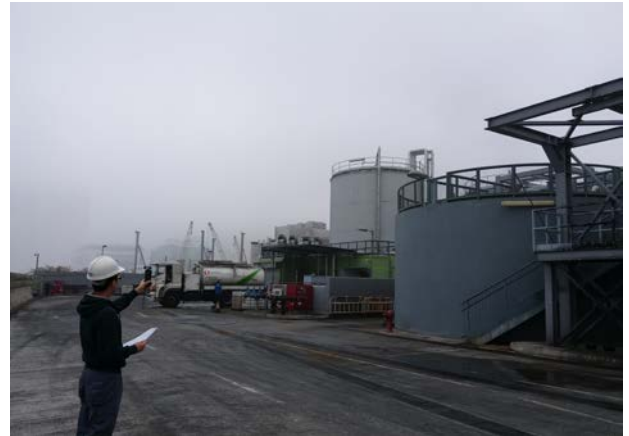
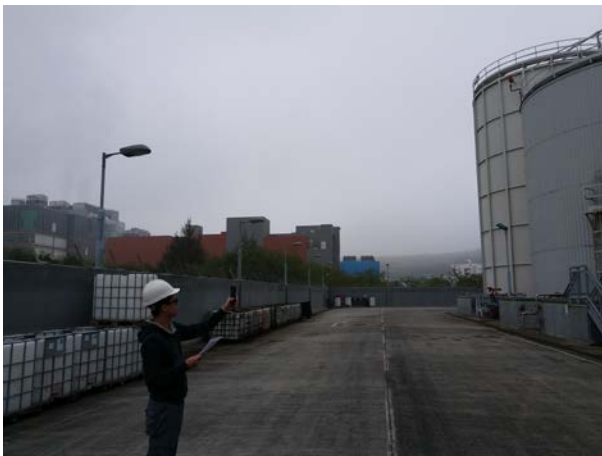
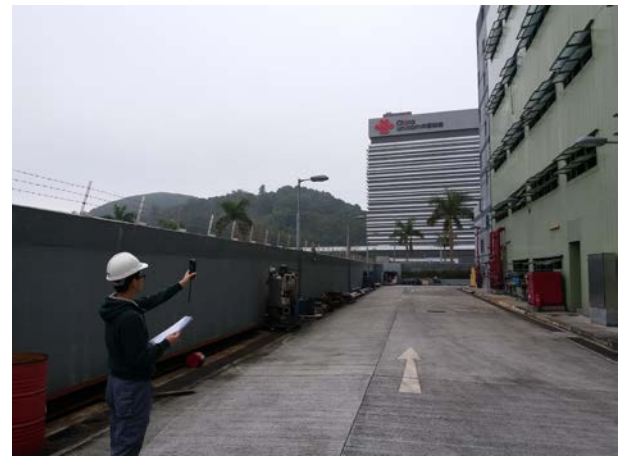
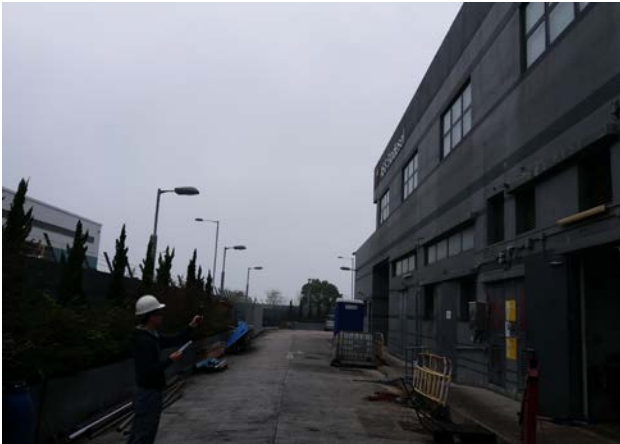
- 4.5 The illustrations about odour patrol activities at different locations are presented below:

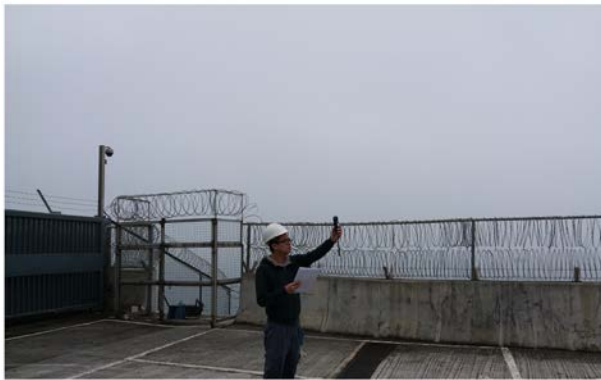
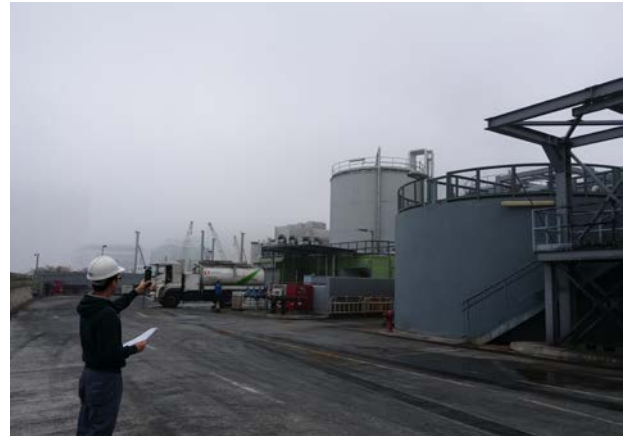
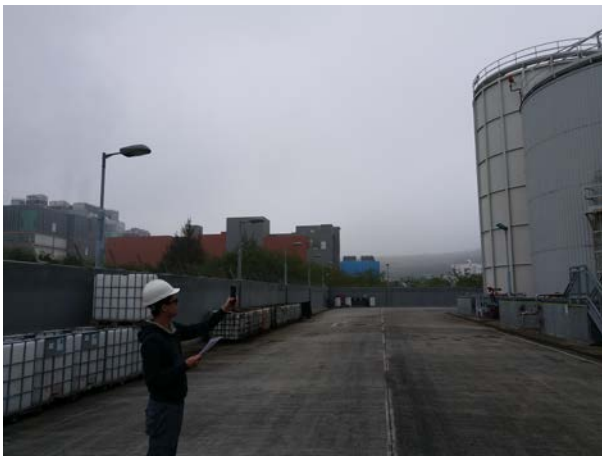
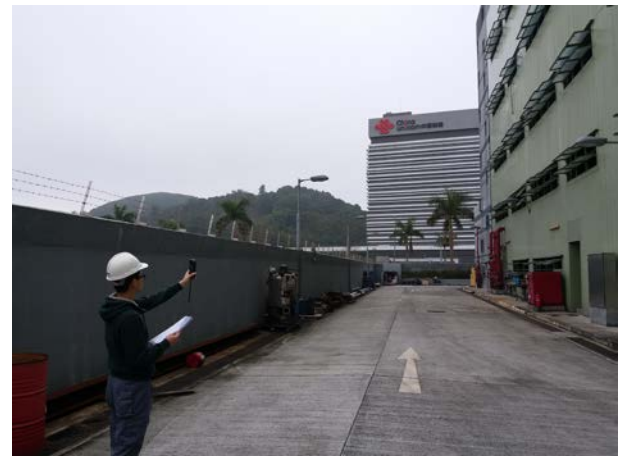
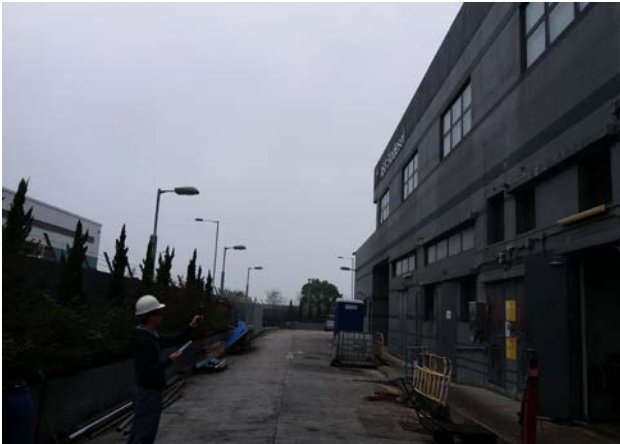
- 4.5 The illustrations about odour patrol activities at different locations are presented below:
