ASB Biodiesel (Hong Kong) Limited

Development of a Biodiesel Plant at Tseung Kwan O Industrial Estate

Monthly EM&A Report

March 2019

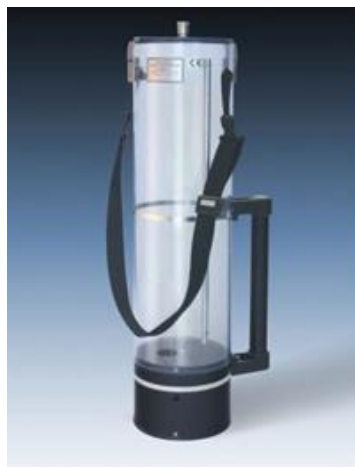
Odour Sampling System

Odour gas sample is collected by a Sampling Device Standard consists of a vacuum container, which is evacuated by a vacuum pump. The sampling point and the standard sampler are connected by a probe. Due to the evacuation in the sampling device, the sample bag, inside the device, sucks in sample air via the probe. During this process, none of its components come into contact with the sample air due to the construction of the sampling device.

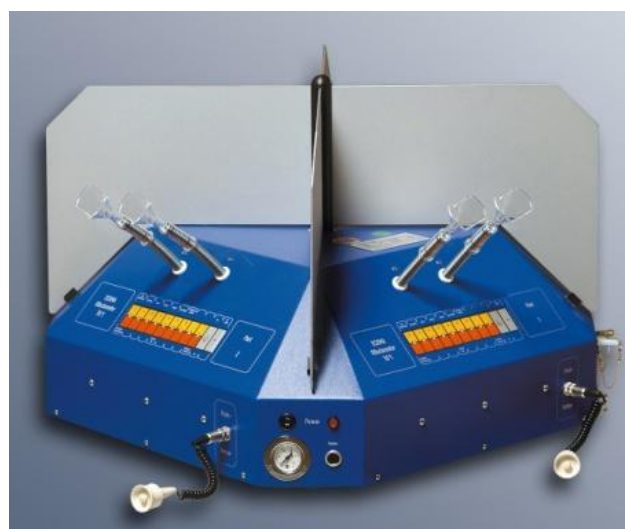
Odour concentration is determined by a Dynamic Olfactometer (TO9) in accordance with the European Standard Method (EN13725). This European Standard specifies a method for the objective determination of the odour concentration of a gaseous sample using dynamic olfactometry with human assessors and the emission rate of odours emanating from point sources, area sources with outward flow and area sources without outward flow. This European Standard is applicable to the measurement of odour concentration of pure substances, defined mixtures and undefined mixtures of gaseous odorants in air or nitrogen, using dynamic olfactometry with a panel of human assessors being the sensor. The unit of measurement is the odour unit per cubic metre: OU_E/m^3 . The odour concentration is measured by determining the dilution factor required to reach the detection threshold. The odour concentration at the detection threshold is defined as $1 \text{ OU}_E/\text{m}^3$. The odour concentration is then expressed in terms of multiples of the detection threshold. The range of measurement is typically from $2^2 \text{ OU}_E/\text{m}^3$ to $2^{17} \text{ OU}_E/\text{m}^3$ (excluding pre-dilution).

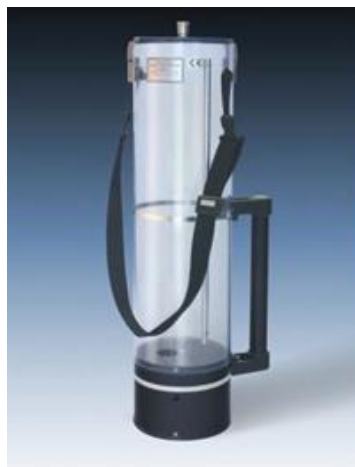
Odour Sampling System

Odour gas sample is collected by a Sampling Device Standard consists of a vacuum container, which is evacuated by a vacuum pump. The sampling point and the standard sampler are connected by a probe. Due to the evacuation in the sampling device, the sample bag, inside the device, sucks in sample air via the probe. During this process, none of its components come into contact with the sample air due to the construction of the sampling device.

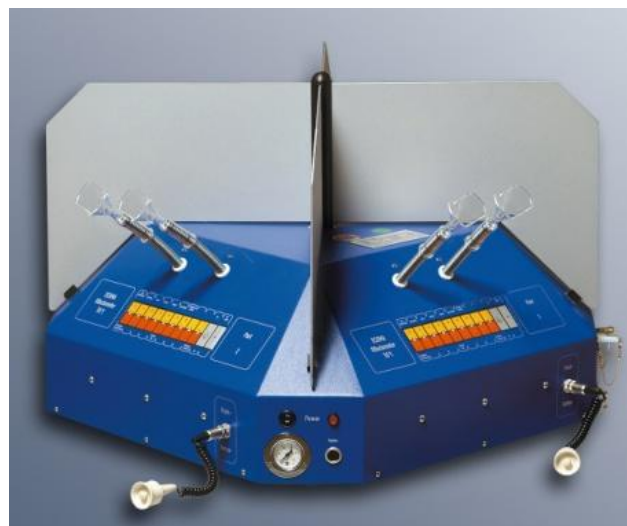
Odour concentration is determined by a Dynamic Olfactometer (TO9) in accordance with the European Standard Method (EN13725). This European Standard specifies a method for the objective determination of the odour concentration of a gaseous sample using dynamic olfactometry with human assessors and the emission rate of odours emanating from point sources, area sources with outward flow and area sources without outward flow. This European Standard is applicable to the measurement of odour concentration of pure substances, defined mixtures and undefined mixtures of gaseous odorants in air or nitrogen, using dynamic olfactometry with a panel of human assessors being the sensor. The unit of measurement is the odour unit per cubic metre: OU_E/m^3 . The odour concentration is measured by determining the dilution factor required to reach the detection threshold. The odour concentration at the detection threshold is defined as $1 \text{ OU}_E/\text{m}^3$. The odour concentration is then expressed in terms of multiples of the detection threshold. The range of measurement is typically from $2^2 \text{ OU}_E/\text{m}^3$ to $2^{17} \text{ OU}_E/\text{m}^3$ (excluding pre-dilution).

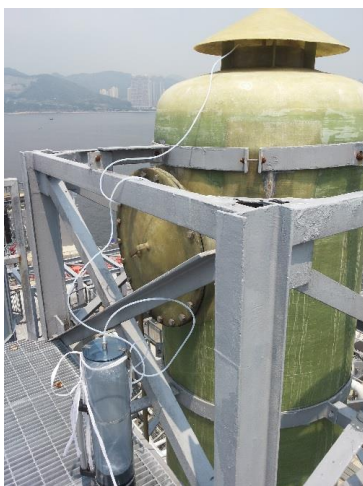
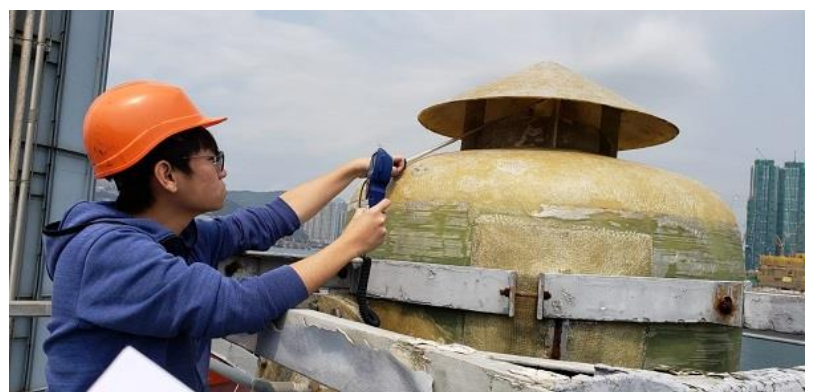
The photos about the on-site sampling activity at the final air scrubber are presented below,

Final air scrubber

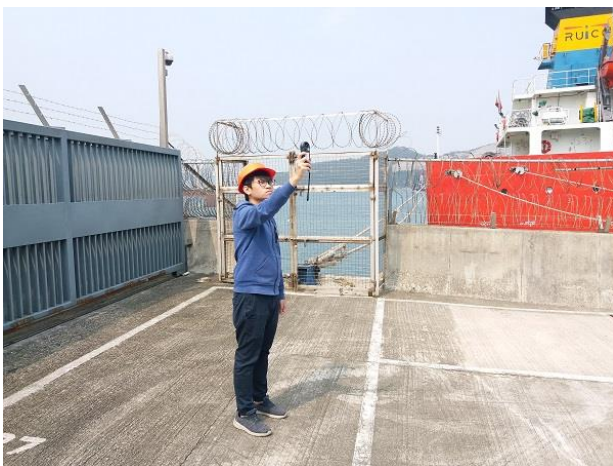
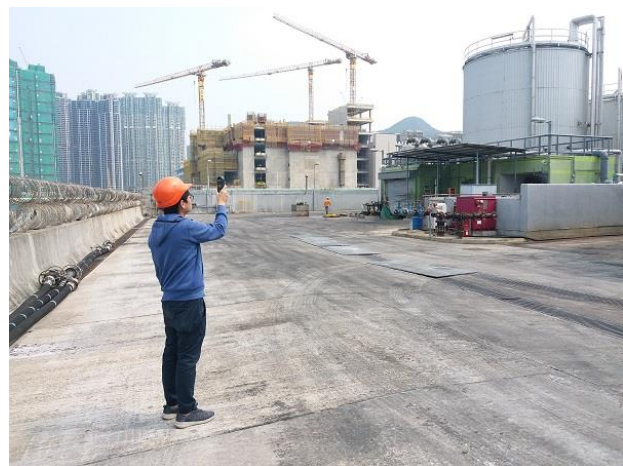
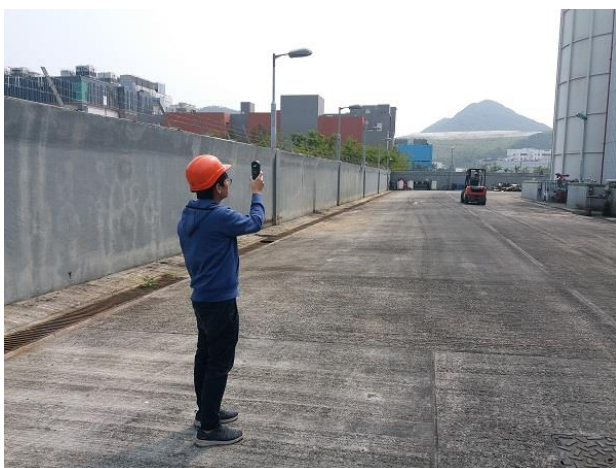
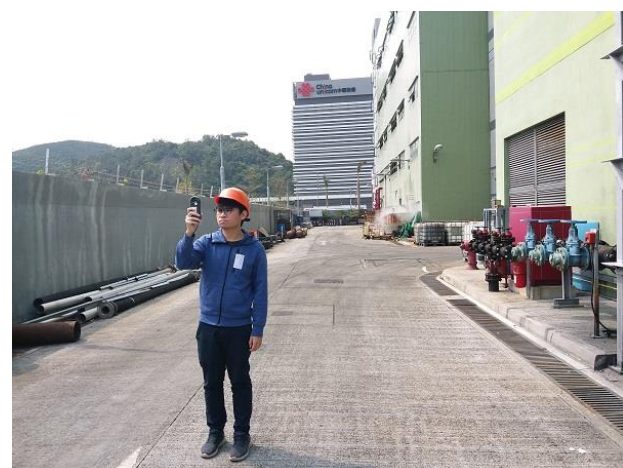
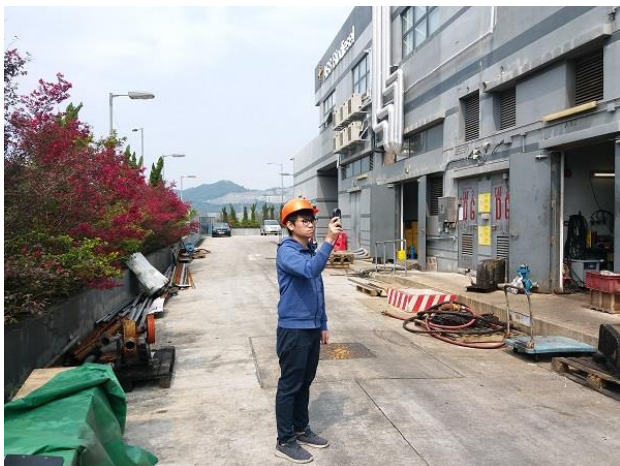
- 4.3 The odour patrol survey was conducted in the morning and the afternoon on 13 March 2019.
- 4.4 During each survey, the odour panelist recorded the weather conditions including prevailing weather, wind direction and wind speed, determined the odour intensity and also identified the odour nature at each location.

- 4.5 The illustrations about odour patrol activities at different locations are presented below:

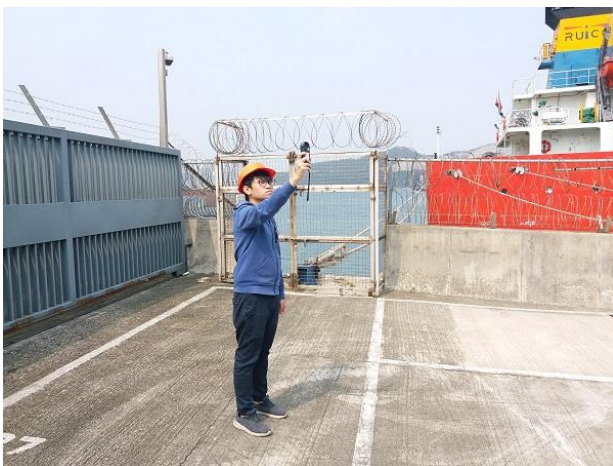
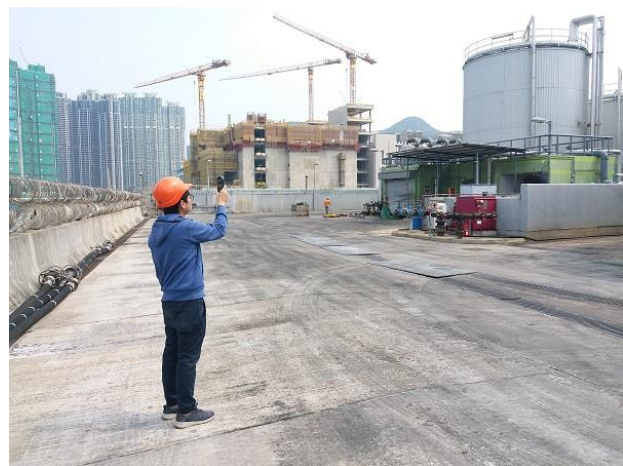
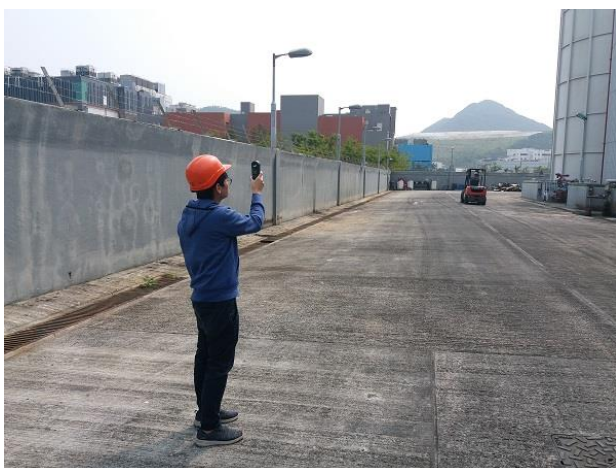
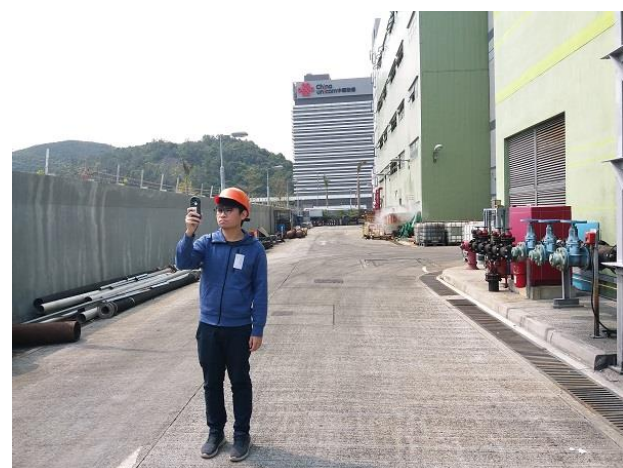
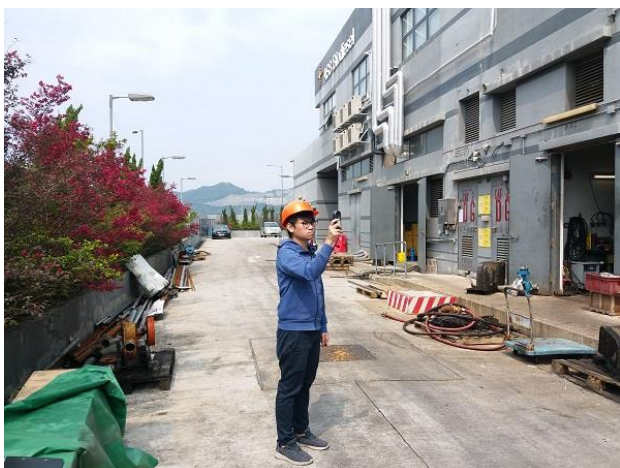
- 4.3 The odour patrol survey was conducted in the morning and the afternoon on 22 March 2019.
- 4.4 During each survey, the odour panelist recorded the weather conditions including prevailing weather, wind direction and wind speed, determined the odour intensity and also identified the odour nature at each location.

- 4.5 The illustrations about odour patrol activities at different locations are presented below:
