Development of a Biodiesel Plant at Tseung Kwan O Industrial Estate

Monthly EM&A Report

April 2020

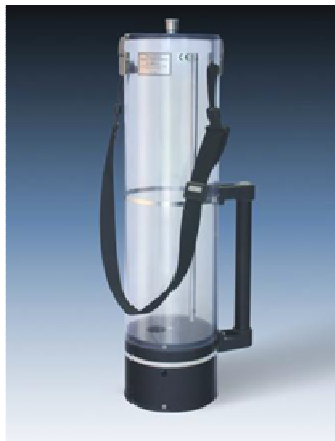
Odour Sampling System

Odour gas sample is collected by a Sampling Device Standard consists of a vacuum container, which is evacuated by a vacuum pump. The sampling point and the standard sampler are connected by a probe. Due to the evacuation in the sampling device, the sample bag, inside the device, sucks in sample air via the probe. During this process, none of its components come into contact with the sample air due to the construction of the sampling device.

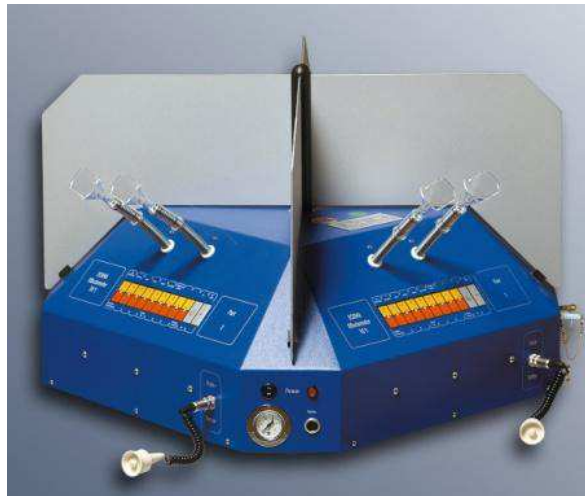
Odour concentration is determined by a Dynamic Olfactometer (TO9) in accordance with the European Standard Method (EN13725). This European Standard specifies a method for the objective determination of the odour concentration of a gaseous sample using dynamic olfactometry with human assessors and the emission rate of odours emanating from point sources, area sources with outward flow and area sources without outward flow. This European Standard is applicable to the measurement of odour concentration of pure substances, defined mixtures and undefined mixtures of gaseous odorants in air or nitrogen, using dynamic olfactometry with a panel of human assessors being the sensor. The unit of measurement is the odour unit per cubic metre: OU_E/m^3 . The odour concentration is measured by determining the dilution factor required to reach the detection threshold. The odour concentration at the detection threshold is defined as $1 OU_E/m^3$. The odour concentration is then expressed in terms of multiples of the detection threshold. The range of measurement is typically from $2^2 OU_E/m^3$ to $2^{17} OU_E/m^3$ (excluding pre-dilution).

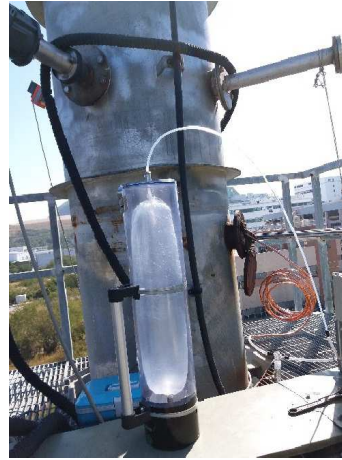
Boiler stack (EP2)

During the odour sampling, the wind speed was measured on the outlet of boiler stack (EP2). The location description and sampling condition are summarized in Table 1.

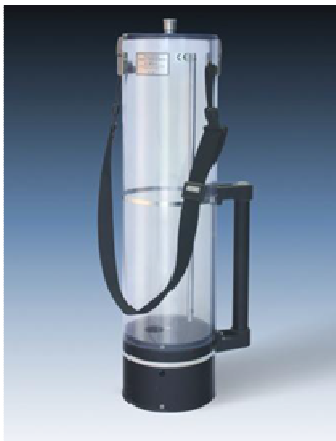
Odour Sampling System

Odour gas sample is collected by a Sampling Device Standard consists of a vacuum container, which is evacuated by a vacuum pump. The sampling point and the standard sampler are connected by a probe. Due to the evacuation in the sampling device, the sample bag, inside the device, sucks in sample air via the probe. During this process, none of its components come into contact with the sample air due to the construction of the sampling device.

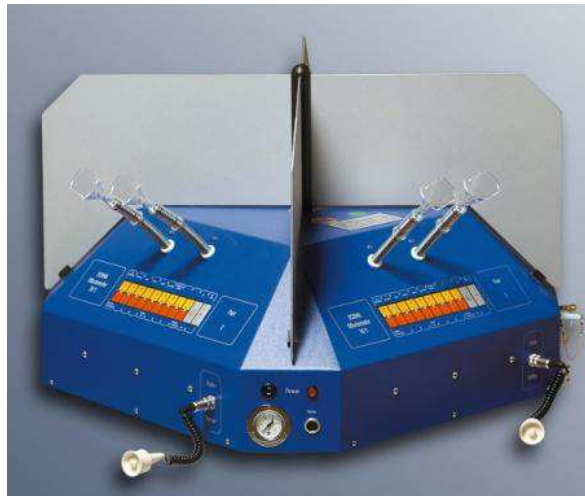
Odour concentration is determined by a Dynamic Olfactometer (TO9) in accordance with the European Standard Method (EN13725). This European Standard specifies a method for the objective determination of the odour concentration of a gaseous sample using dynamic olfactometry with human assessors and the emission rate of odours emanating from point sources, area sources with outward flow and area sources without outward flow. This European Standard is applicable to the measurement of odour concentration of pure substances, defined mixtures and undefined mixtures of gaseous odorants in air or nitrogen, using dynamic olfactometry with a panel of human assessors being the sensor. The unit of measurement is the odour unit per cubic metre: OU_E/m^3 . The odour concentration is measured by determining the dilution factor required to reach the detection threshold. The odour concentration at the detection threshold is defined as $1 OU_E/m^3$. The odour concentration is then expressed in terms of multiples of the detection threshold. The range of measurement is typically from $2^2 OU_E/m^3$ to $2^{17} OU_E/m^3$ (excluding pre-dilution).

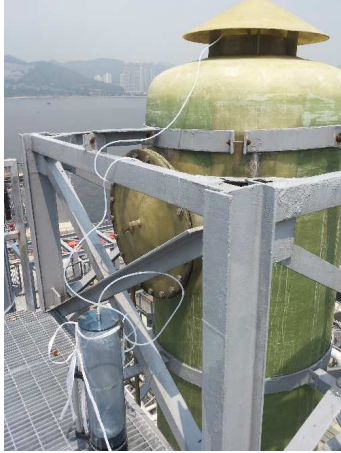
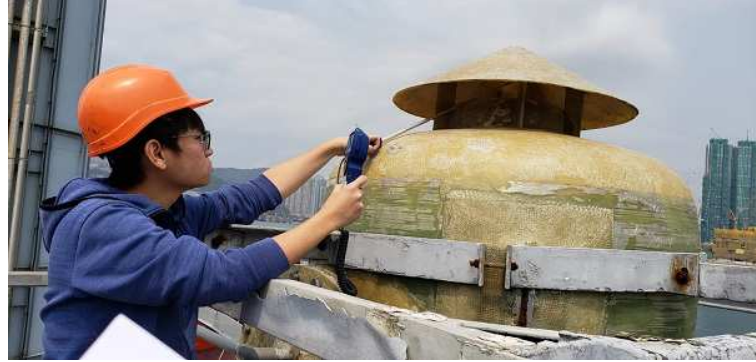
Final air scrubber

During the odour sampling, the wind speed was measured on the outlet of final air scrubber. The location description and sampling condition are summarized in Table 1.

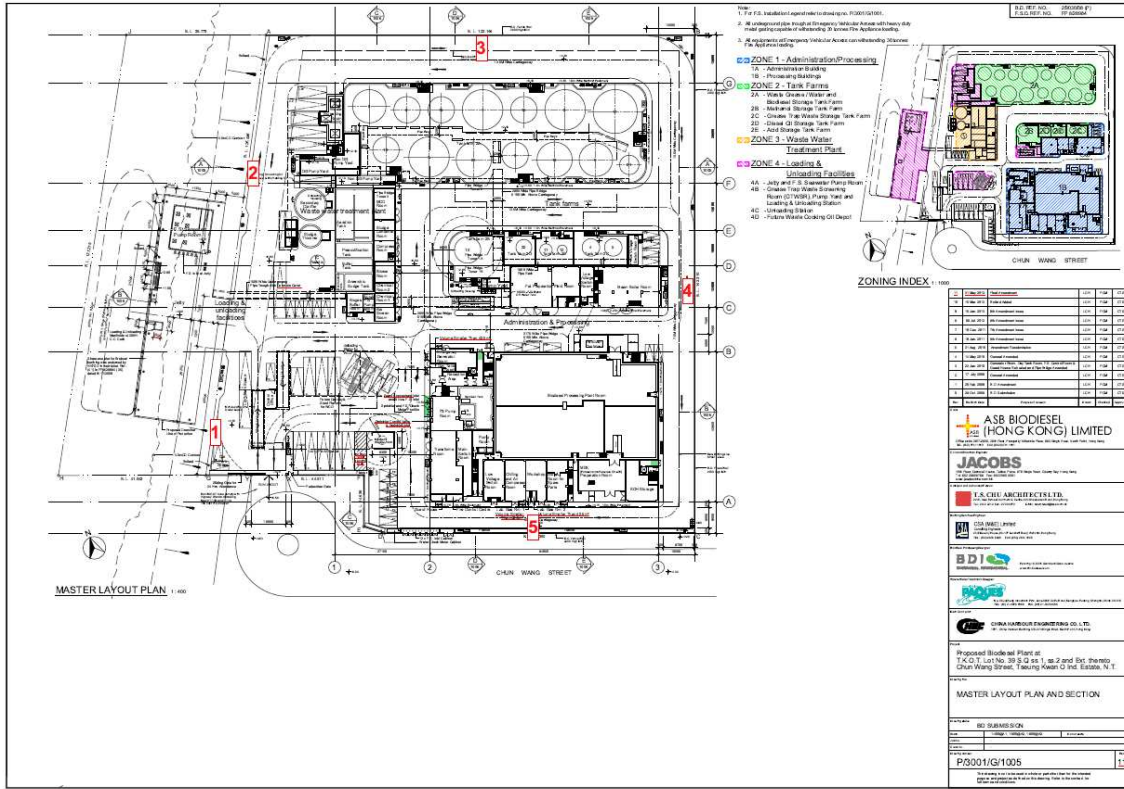
Figure 1: Five locations of odour patrol survey at the boundary of ASB Biodiesel Plant

- 4.3 The odour patrol survey was conducted in the morning and the afternoon on 9 April 2020.
- 4.4 During each survey, the odour panelist recorded the weather conditions including prevailing weather, wind direction and wind speed, determined the odour intensity and also identified the odour nature at each location.

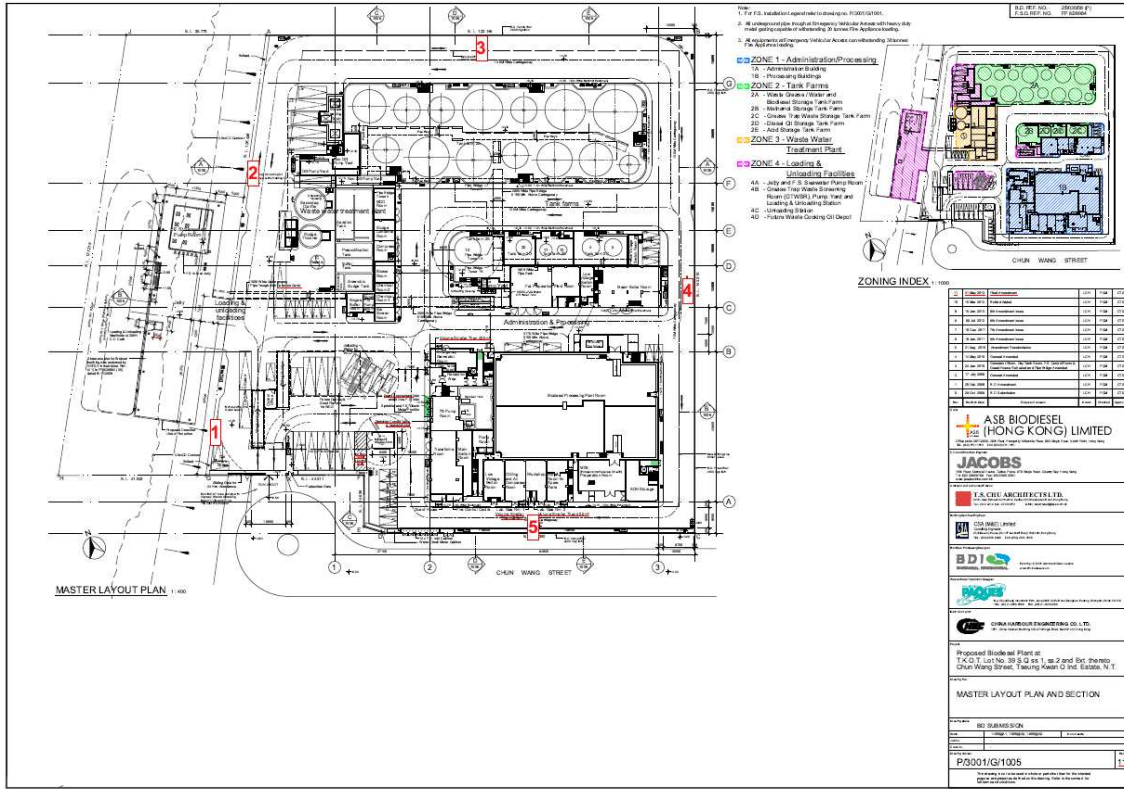
Figure 1: Five locations of odour patrol survey at the boundary of ASB Biodiesel Plant

- 4.3 The odour patrol survey was conducted in the morning and the afternoon on 17 April 2020.
- 4.4 During each survey, the odour panelist recorded the weather conditions including prevailing weather, wind direction and wind speed, determined the odour intensity and also identified the odour nature at each location.
