**ASB Biodiesel (Hong Kong) Limited**

**Development of a Biodiesel Plant at  
Tseung Kwan O Industrial Estate**

**Monthly Environmental Monitoring and  
Audit Report for  
July 2020**

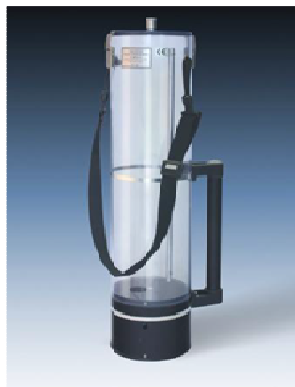
Odour Sampling System

Odour gas sample is collected by a Sampling Device Standard consists of a vacuum container, which is evacuated by a vacuum pump. The sampling point and the standard sampler are connected by a probe. Due to the evacuation in the sampling device, the sample bag, inside the device, sucks in sample air via the probe. During this process, none of its components come into contact with the sample air due to the construction of the sampling device.

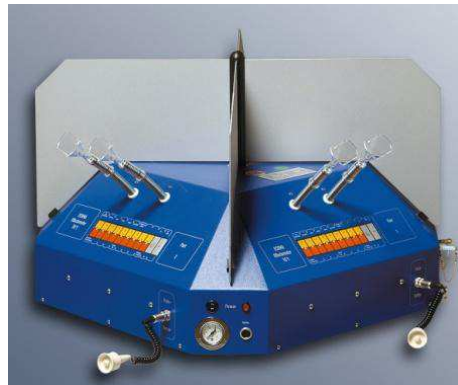
Odour concentration is determined by a Dynamic Olfactometer (TO9) in accordance with the European Standard Method (EN13725). This European Standard specifies a method for the objective determination of the odour concentration of a gaseous sample using dynamic olfactometry with human assessors and the emission rate of odours emanating from point sources, area sources with outward flow and area sources without outward flow. This European Standard is applicable to the measurement of odour concentration of pure substances, defined mixtures and undefined mixtures of gaseous odorants in air or nitrogen, using dynamic olfactometry with a panel of human assessors being the sensor. The unit of measurement is the odour unit per cubic metre:  $OU_E/m^3$ . The odour concentration is measured by determining the dilution factor required to reach the detection threshold. The odour concentration at the detection threshold is defined as  $1 OU_E/m^3$ . The odour concentration is then expressed in terms of multiples of the detection threshold. The range of measurement is typically from  $2^2 OU_E/m^3$  to  $2^{17} OU_E/m^3$  (excluding pre-dilution).

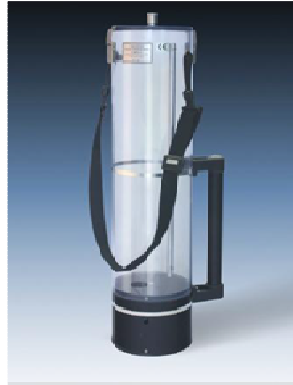
Odour Sampling System

Odour gas sample is collected by a Sampling Device Standard consists of a vacuum container, which is evacuated by a vacuum pump. The sampling point and the standard sampler are connected by a probe. Due to the evacuation in the sampling device, the sample bag, inside the device, sucks in sample air via the probe. During this process, none of its components come into contact with the sample air due to the construction of the sampling device.

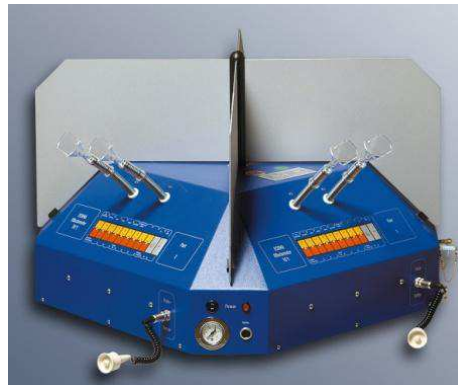
Odour concentration is determined by a Dynamic Olfactometer (TO9) in accordance with the European Standard Method (EN13725). This European Standard specifies a method for the objective determination of the odour concentration of a gaseous sample using dynamic olfactometry with human assessors and the emission rate of odours emanating from point sources, area sources with outward flow and area sources without outward flow. This European Standard is applicable to the measurement of odour concentration of pure substances, defined mixtures and undefined mixtures of gaseous odorants in air or nitrogen, using dynamic olfactometry with a panel of human assessors being the sensor. The unit of measurement is the odour unit per cubic metre:  $OU_E/m^3$ . The odour concentration is measured by determining the dilution factor required to reach the detection threshold. The odour concentration at the detection threshold is defined as  $1 OU_E/m^3$ . The odour concentration is then expressed in terms of multiples of the detection threshold. The range of measurement is typically from  $2^2 OU_E/m^3$  to  $2^{17} OU_E/m^3$  (excluding pre-dilution).
