Development of a Biodiesel Plant at Tseung Kwan O Industrial Estate

Monthly Environmental Monitoring and Audit Report for August 2020 (version 1.0)

Development of a Biodiesel Plant at Tseung Kwan O Industrial Estate - Operation Phase

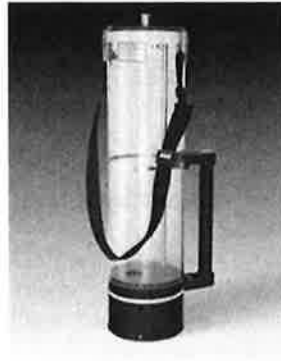
Odour Sampling System

Odour gas sample is collected by a Sampling Device Standard consists of a vacuum container, which is evacuated by a vacuum pump. The sampling point and the standard sampler are connected by a probe. Due to the evacuation in the sampling device, the sample bag, inside the device, sucks in sample air via the probe. During this process, none of its components come into contact with the sample air due to the construction of the sampling device.

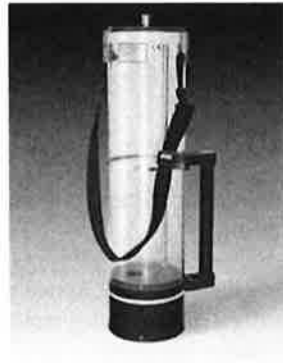
Odour Sampling System

Odour gas sample is collected by a Sampling Device Standard consists of a vacuum container, which is evacuated by a vacuum pump. The sampling point and the standard sampler are connected by a probe. Due to the evacuation in the sampling device, the sample bag, inside the device, sucks in sample air via the probe. During this process, none of its components come into contact with the sample air due to the construction of the sampling device.
