**Development of a Biodiesel Plant at
Tseung Kwan O Industrial Estate**

**Monthly Environmental Monitoring and
Audit Report for
September 2020**

(version 1.0)

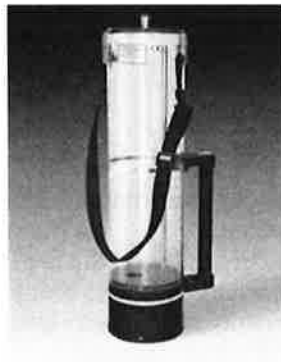
Odour Sampling System

Odour gas sample is collected by a Sampling Device Standard consists of a vacuum container, which is evacuated by a vacuum pump. The sampling point and the standard sampler are connected by a probe. Due to the evacuation in the sampling device, the sample bag, inside the device, sucks in sample air via the probe. During this process, none of its components come into contact with the sample air due to the construction of the sampling device.

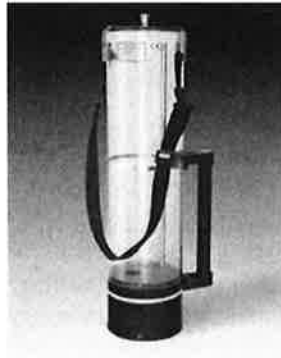
Odour Sampling System

Odour gas sample is collected by a Sampling Device Standard consists of a vacuum container, which is evacuated by a vacuum pump. The sampling point and the standard sampler are connected by a probe. Due to the evacuation in the sampling device, the sample bag, inside the device, sucks in sample air via the probe. During this process, none of its components come into contact with the sample air due to the construction of the sampling device.
